**HEIERMAN - HISTORIC LANDMARK COMMISSION REVIEW**

## The Heierman Building

115 E. 5th Street  
Austin, TX 78701  
Travis County

Renovation, Selective Demolition of Non-Historic Elements,  
New Construction, and Addition to Existing Structure.

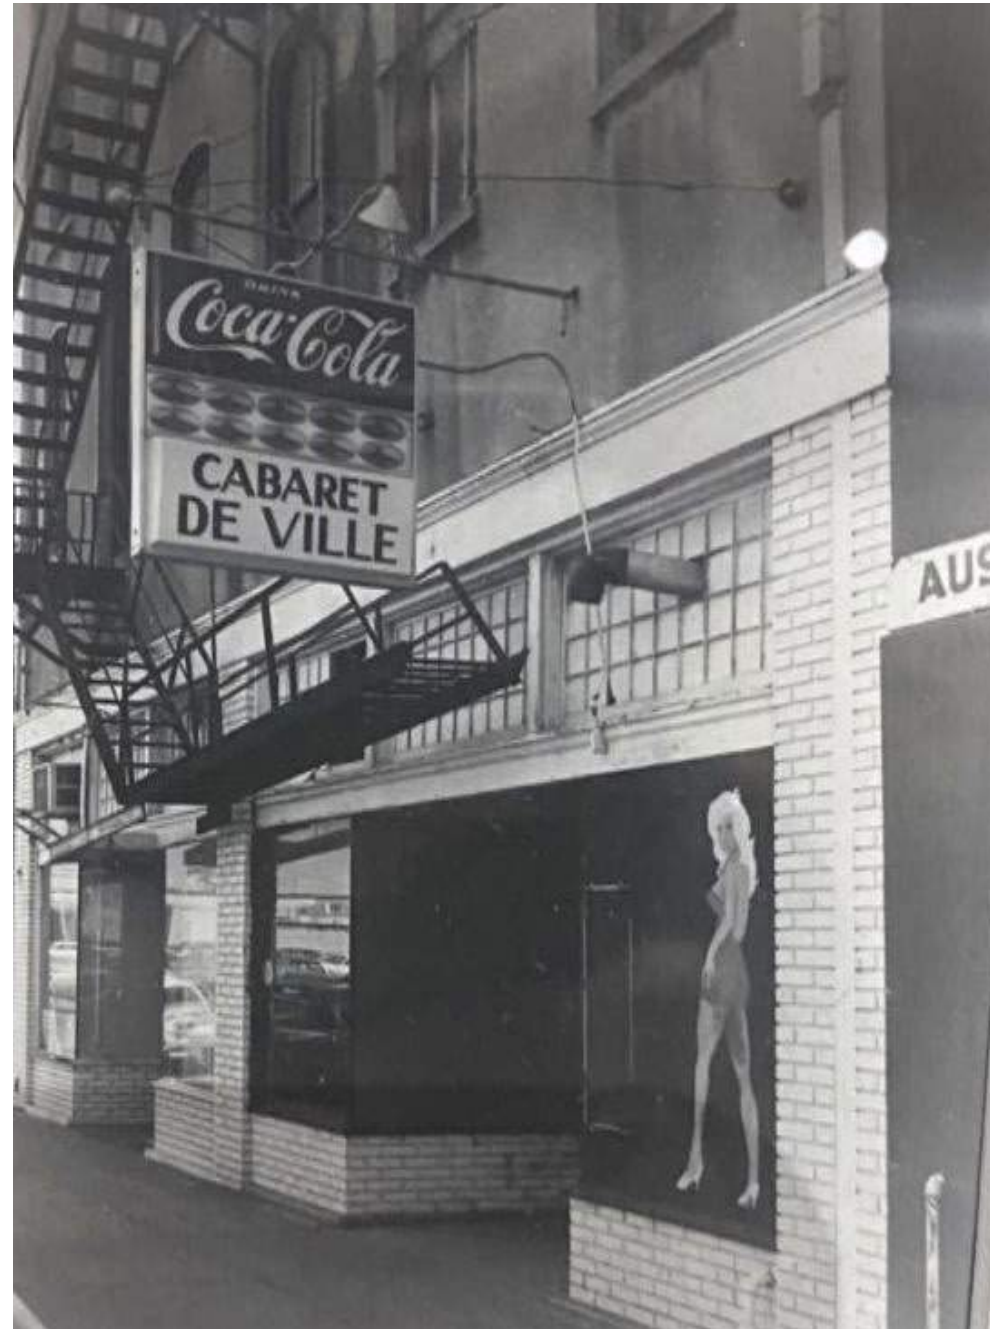
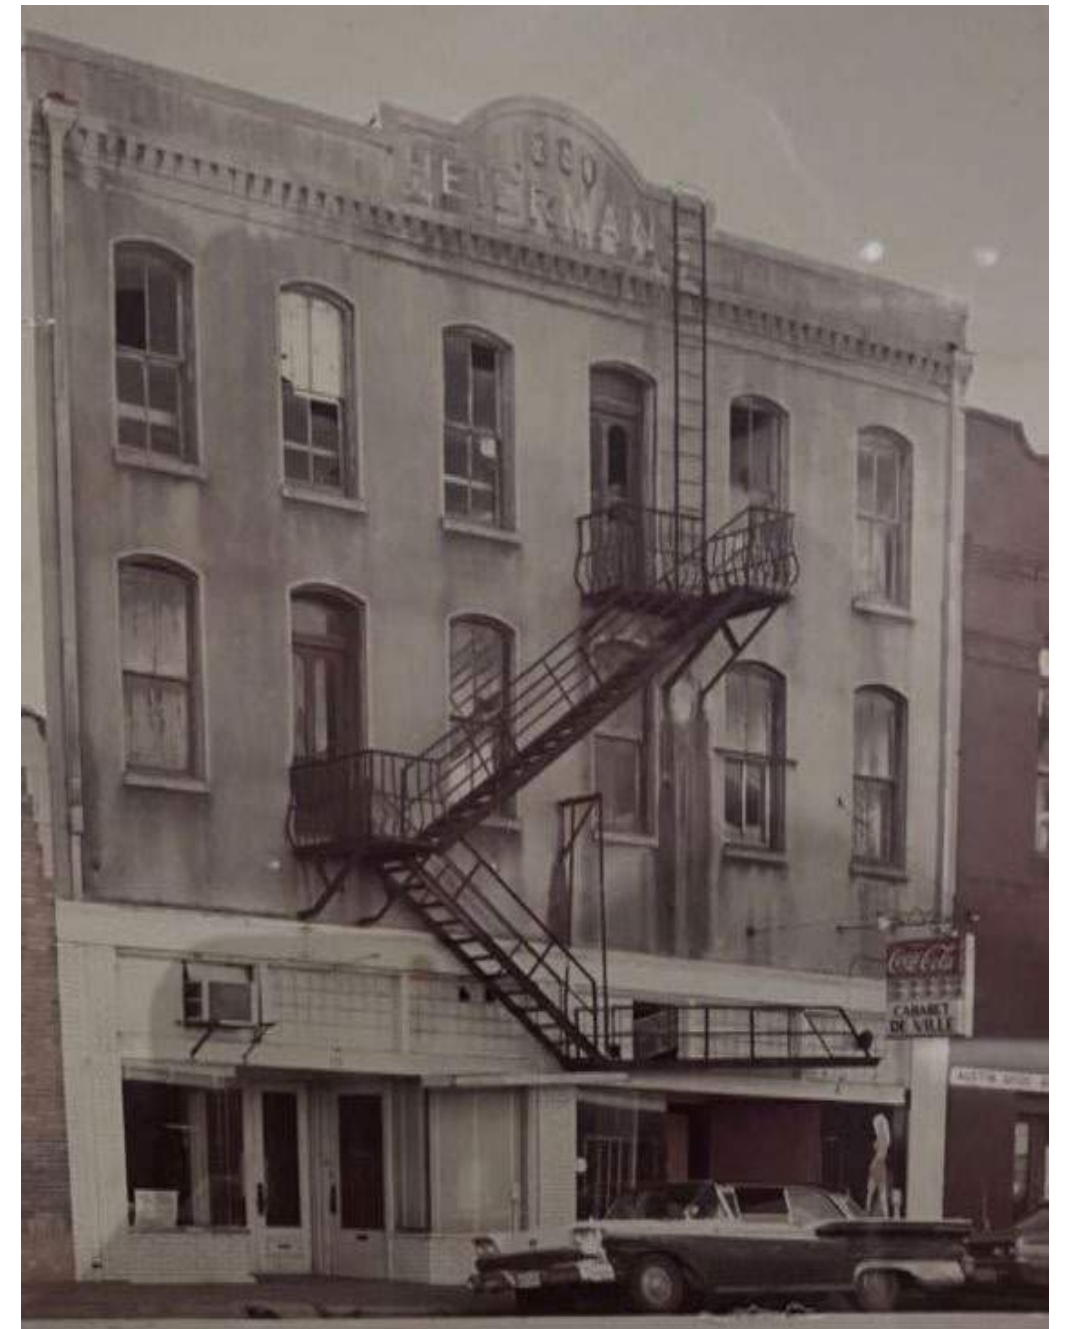
### c. 1975

Renovated design representing the state of the Heierman Building when it was recorded as a Texas Historic Landmark in 1974.

#### Modifications to the 1920's design:

- In 1973, the building was sandblasted inside and out.
- The ground floor 1920's style storefront was replaced with one that mimicked New Orleans style facades.
- All windows on the primary facade were replaced with single pane tinted glass, fixed in wood mullions (previously double-hung).

This is very close the current building design with a few notable exceptions: there is now a door to the egress stair, added sidelites at the entry door, and the entire entry is currently not recessed as shown.

Furthermore, although the 1974 appearance of the building was referenced as a rationale for the proposed inset reconfiguration of the primary façade, the architectural condition of that portion of building had already been significantly altered and would not be considered historically significant, despite the Recorded Texas Historic Landmark designation having been awarded at that time. Similarly, the planned alterations to the rear, south elevation are not a recommended approach due to the extensive removal of original historic brick masonry and original fenestration openings that is proposed. Yet, due to the severity of inappropriate changes to the building over time, along with the most extensive alterations proposed being on the rear elevation and therefore not visible to the public, our staff will not be making a recommendation to pursue removal of the RTHL designation in the case that the current design plans are carried out. Our staff does recommend salvaging and storing (for potential future reuse), as much of the historic material planned for removal as possible.

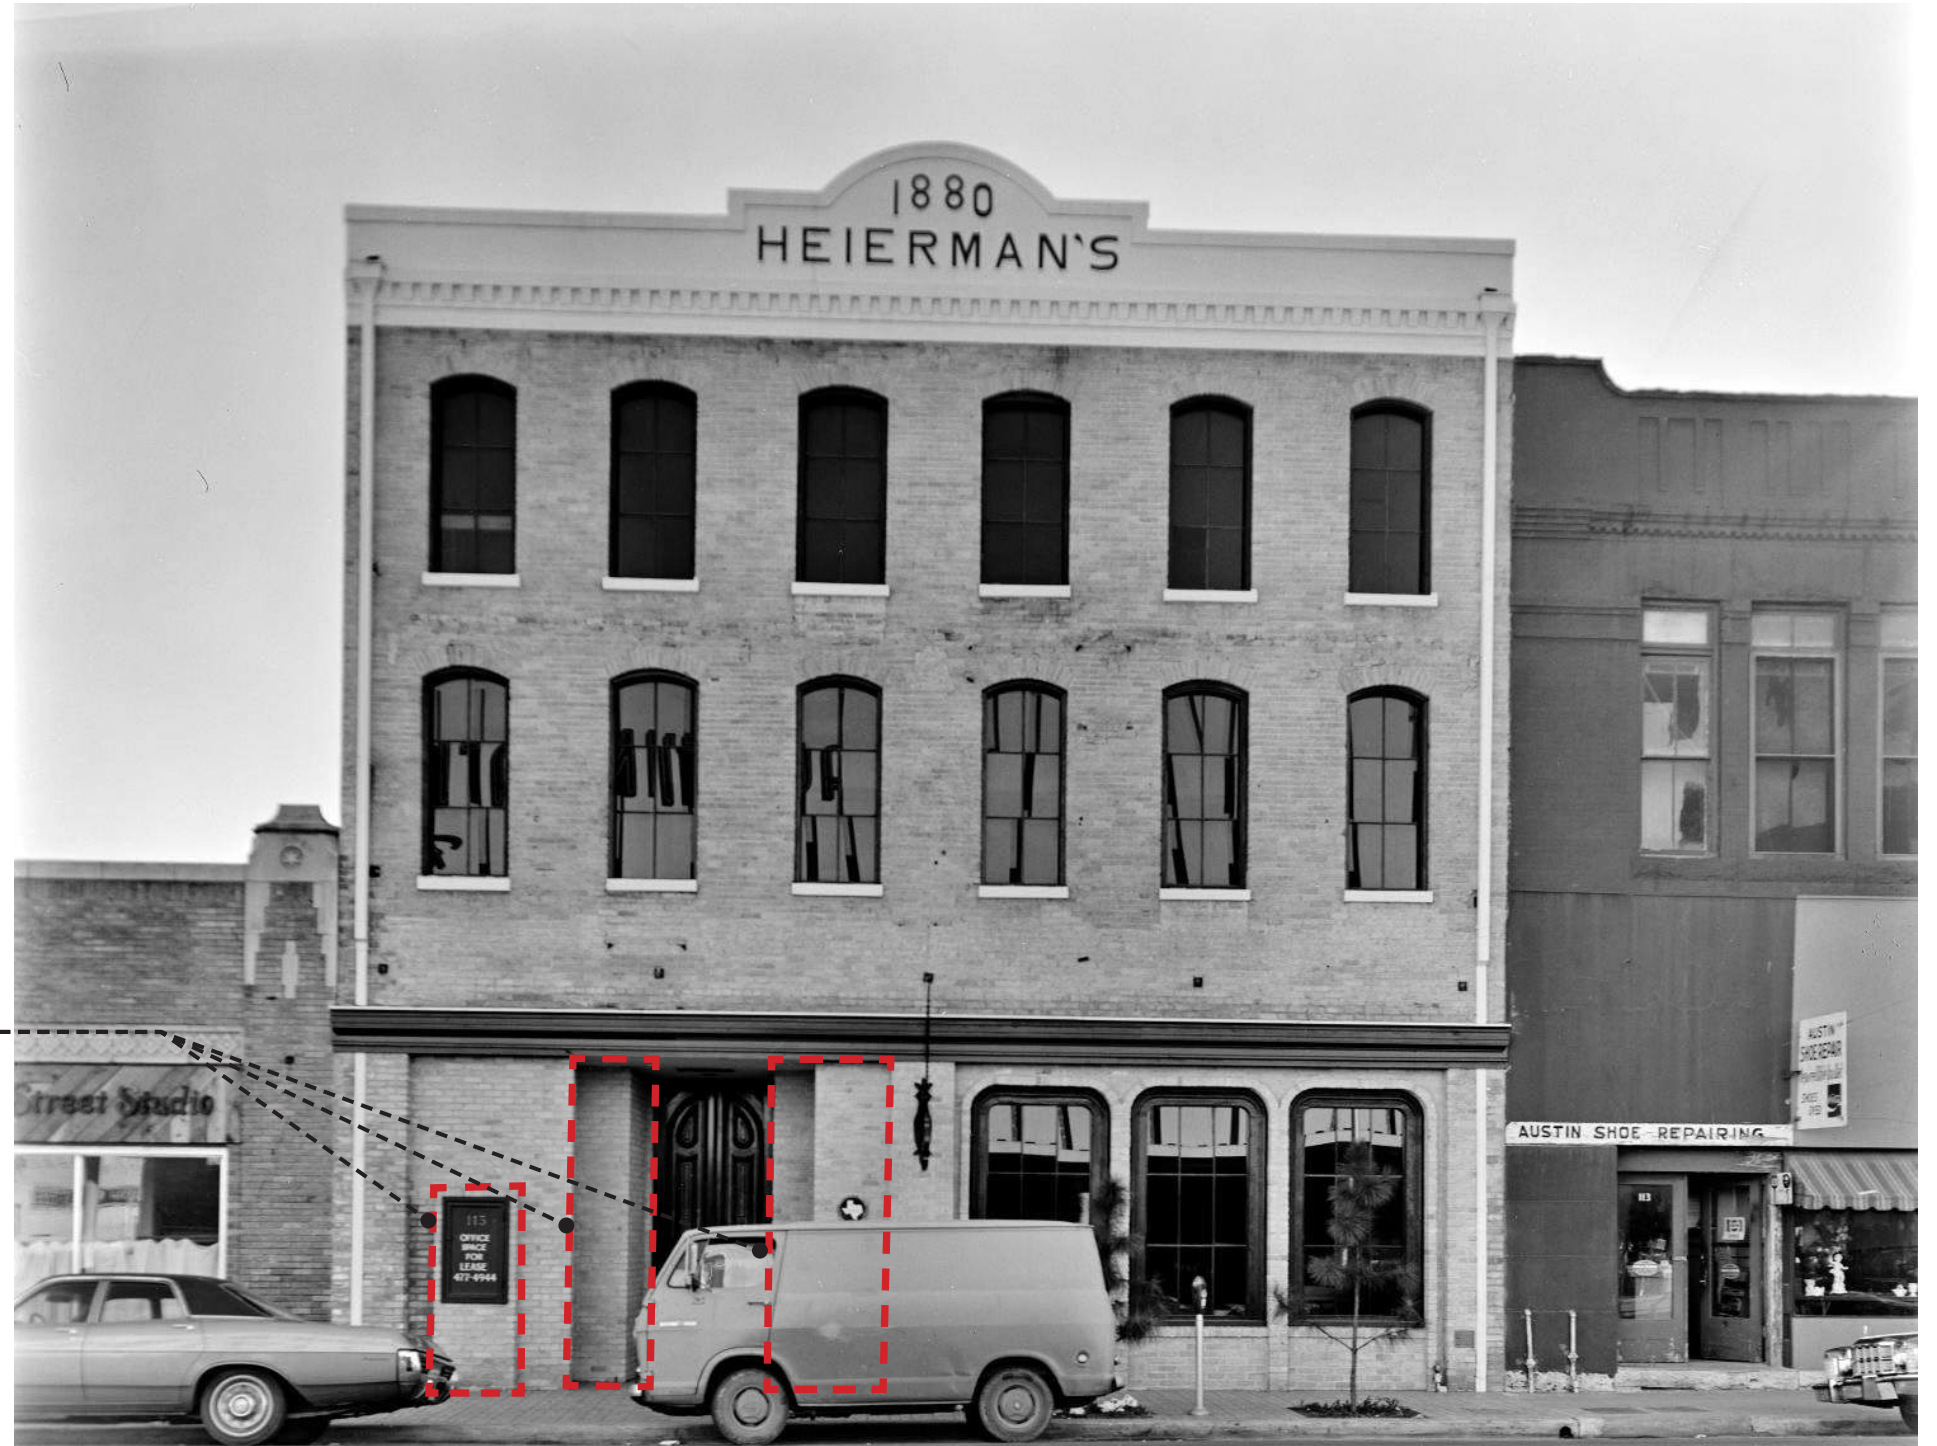
## c. Mid 1980's

Ground floor alteration closely represents the current state of the building, other than paint color changes that occurred around 2007.

### Modifications to the 1974 design:

- Entry no longer recessed.
- Sidelites added adjacent to entry door.
- Egress door added.
- Brickwork framing added to entry door and egress door to surrounds to mimic existing window brickwork treatment.

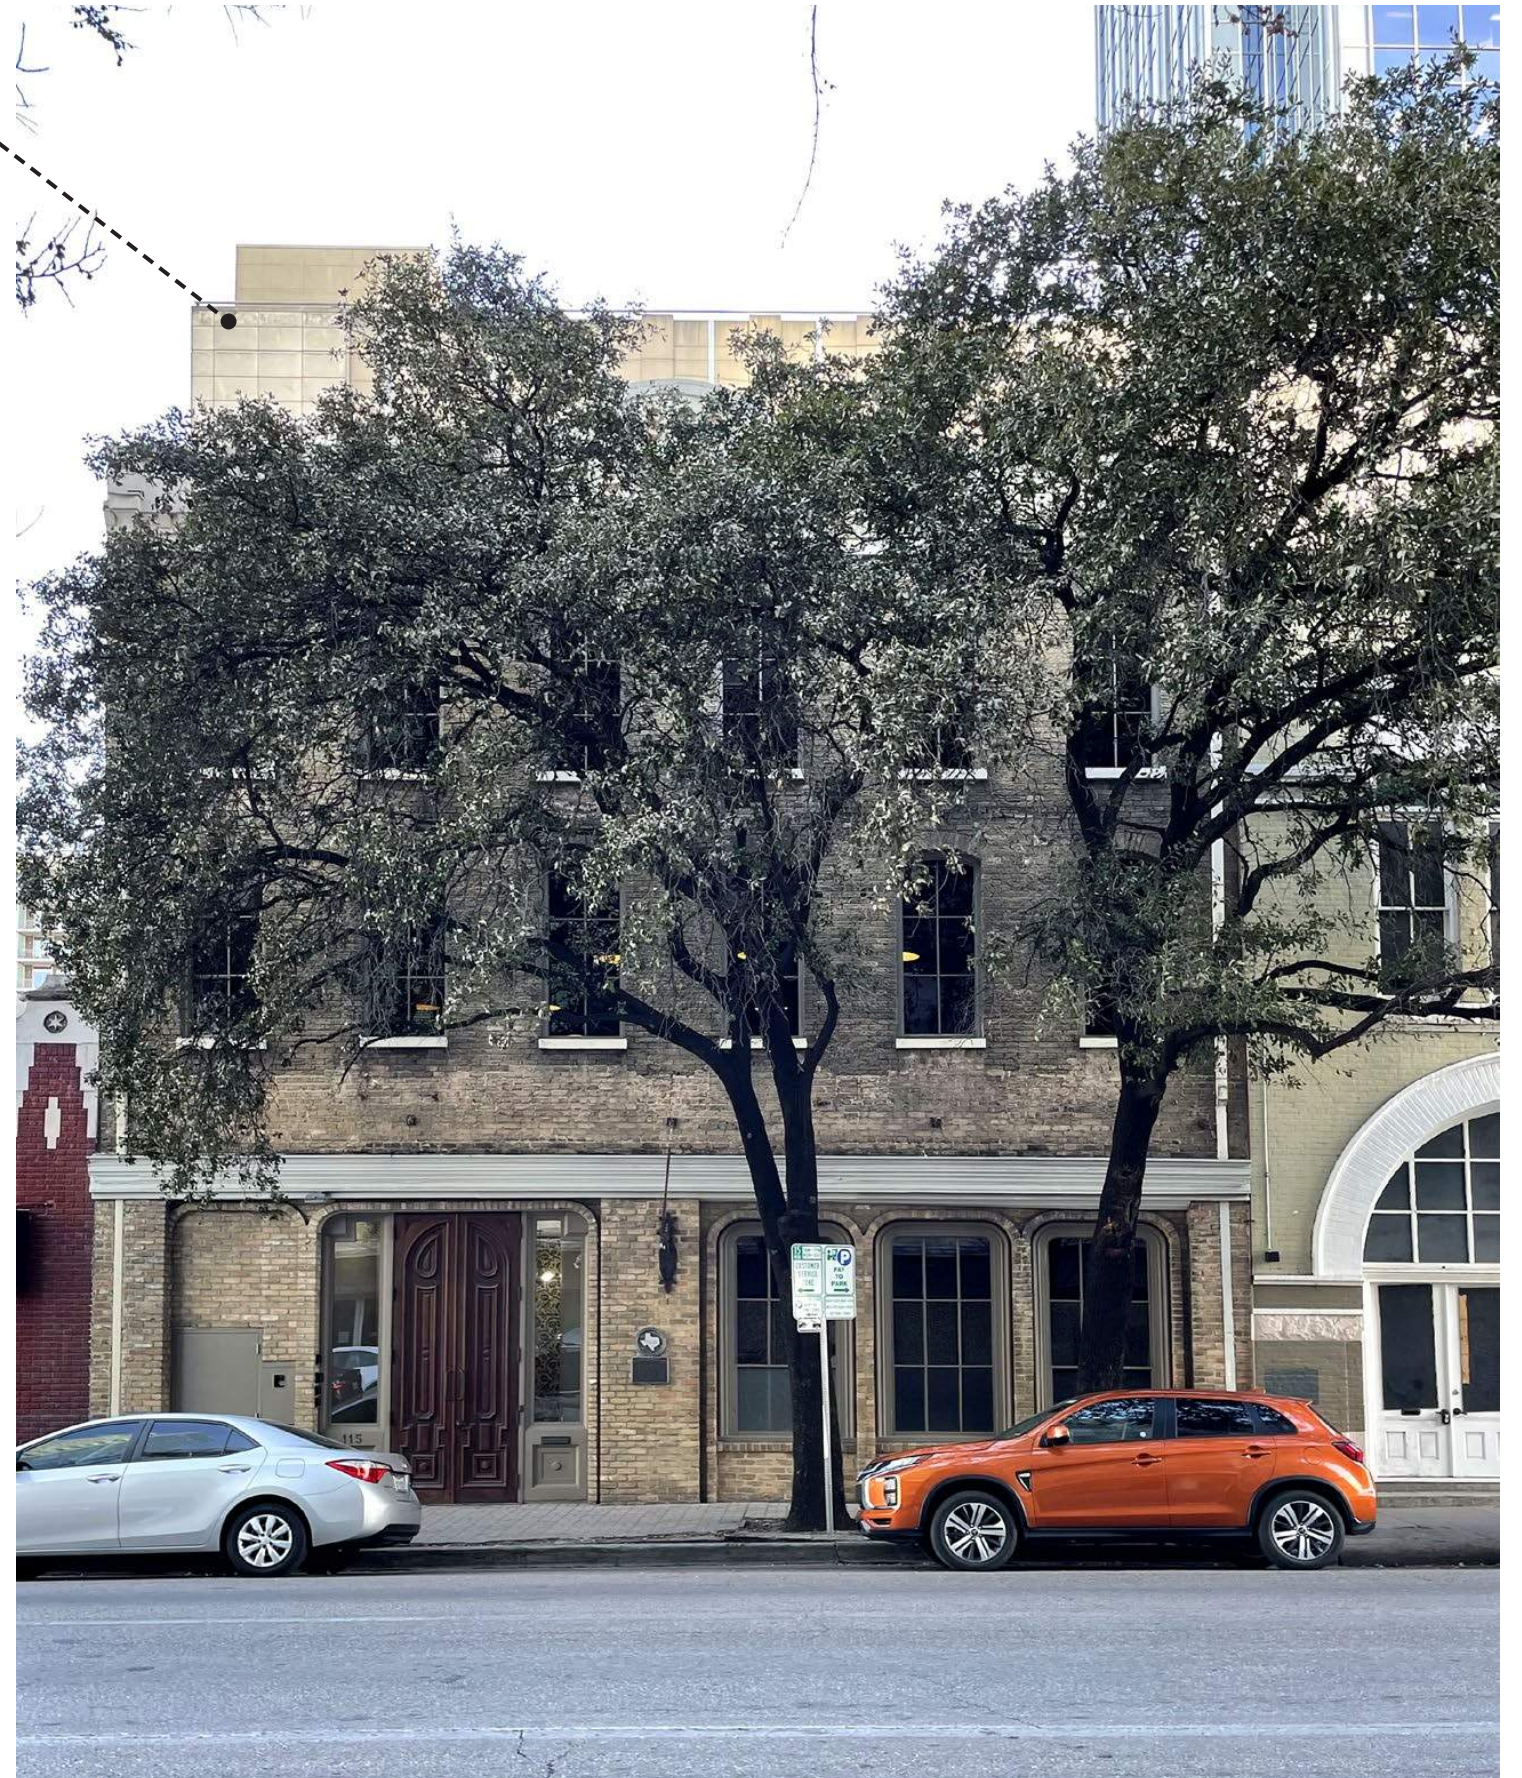
Section Diagram showing limited visibility of the rooftop addition from accross the street. Reference image fig. 24 from National Park Service - Preservation Brief 14 - Rooftop Additions.

Regarding the proposed rooftop addition, our staff appreciates the architect providing the sight line diagram and accordingly setting the associated new construction twenty feet back from the primary façade’s parapet to reduce visibility of the new addition from the principal perspective across 5<sup>th</sup> Street. Yet, our staff recommends the new addition being lowered in height to be more commensurate to the approximately 12’-13’ heights of the historic second and third stories of the building. Furthermore, our staff recommends and expects the proposed steel paneling of the new addition to be painted a lighter color to blend in more with the existing buff colored historic brick of the Heierman Building and the light grey concrete color of the parking garage directly behind the building to the south.

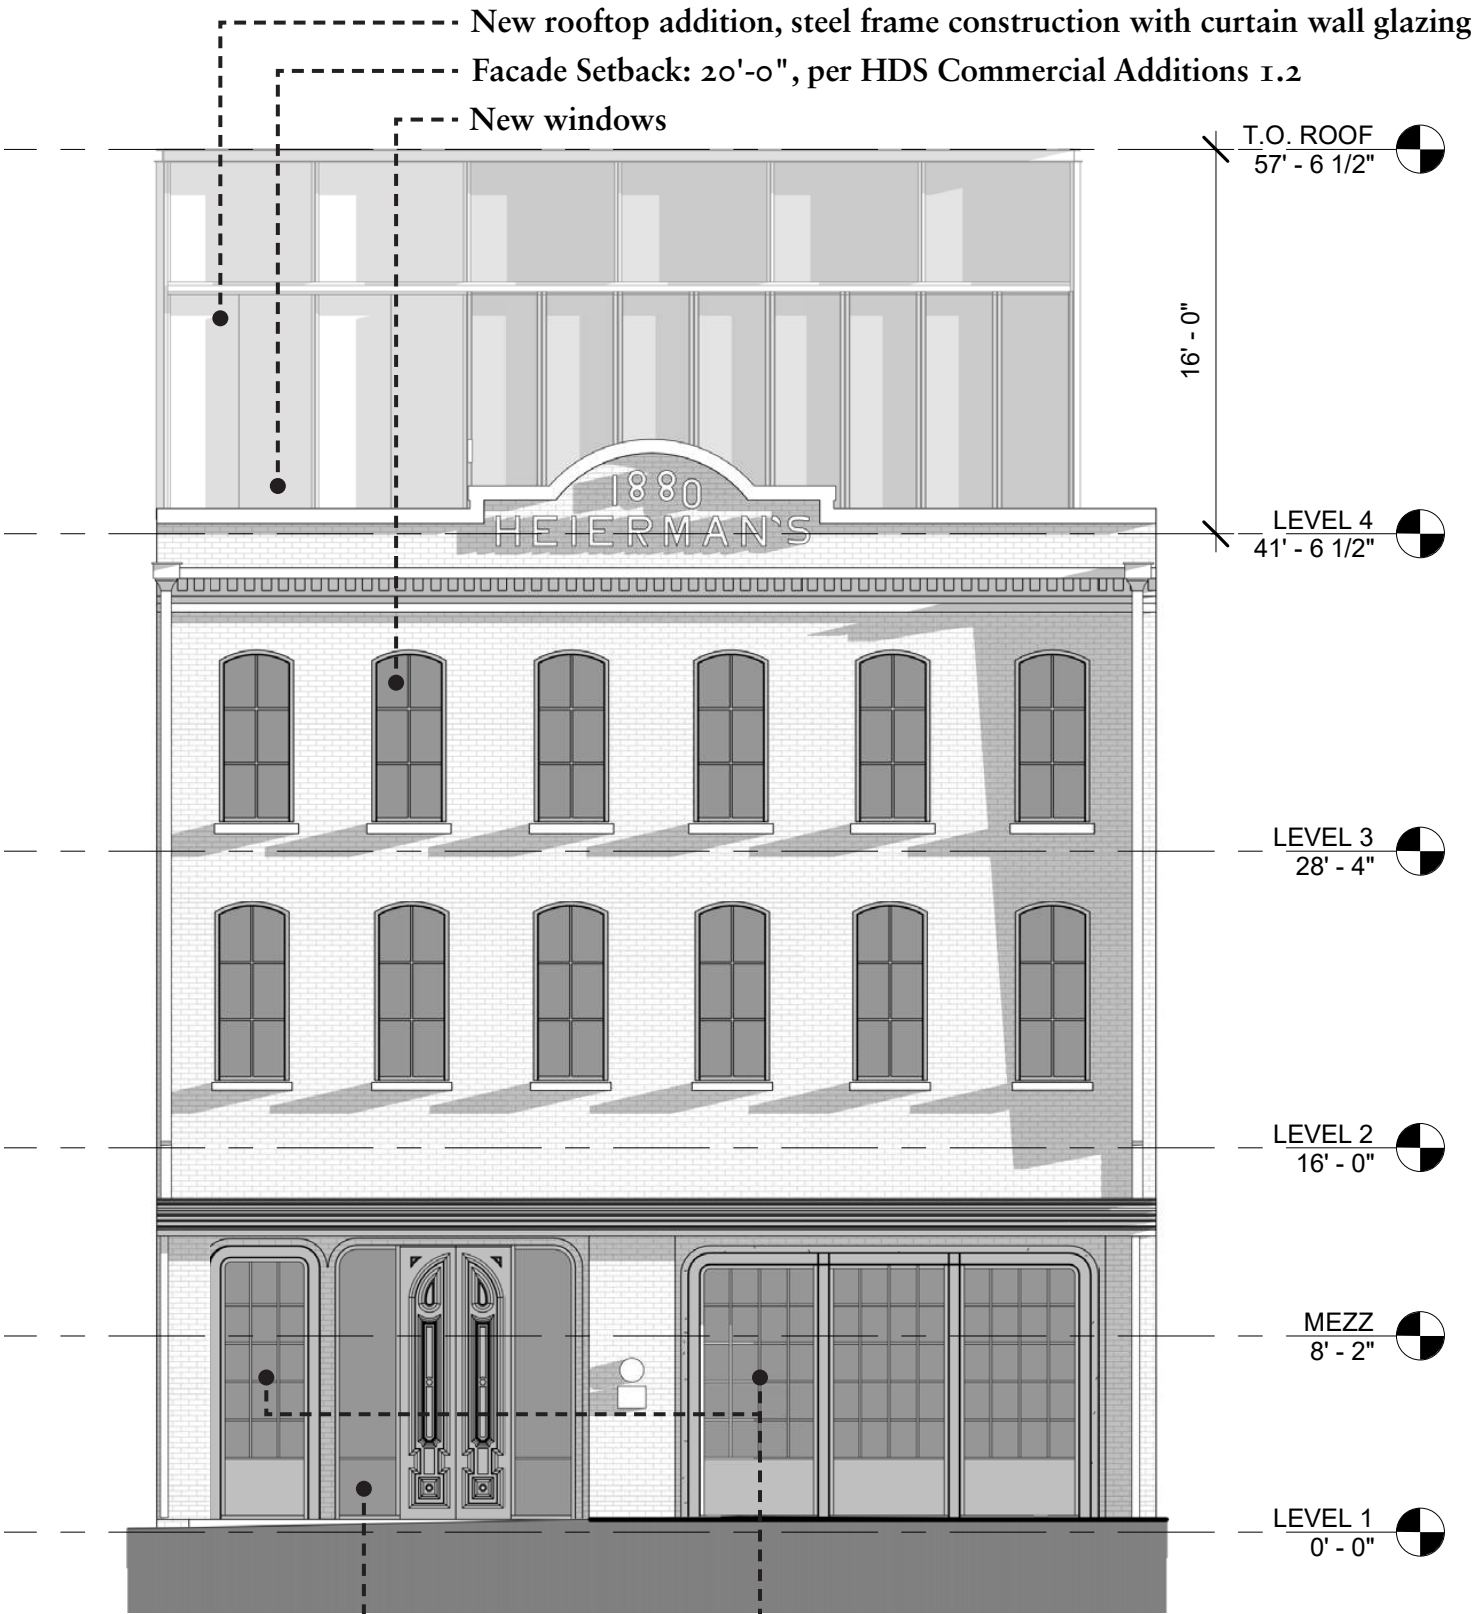
Proposed Design

Custom steel storefront. New glass to be insulated and as clear as possible

New recessed entry with salvaged door

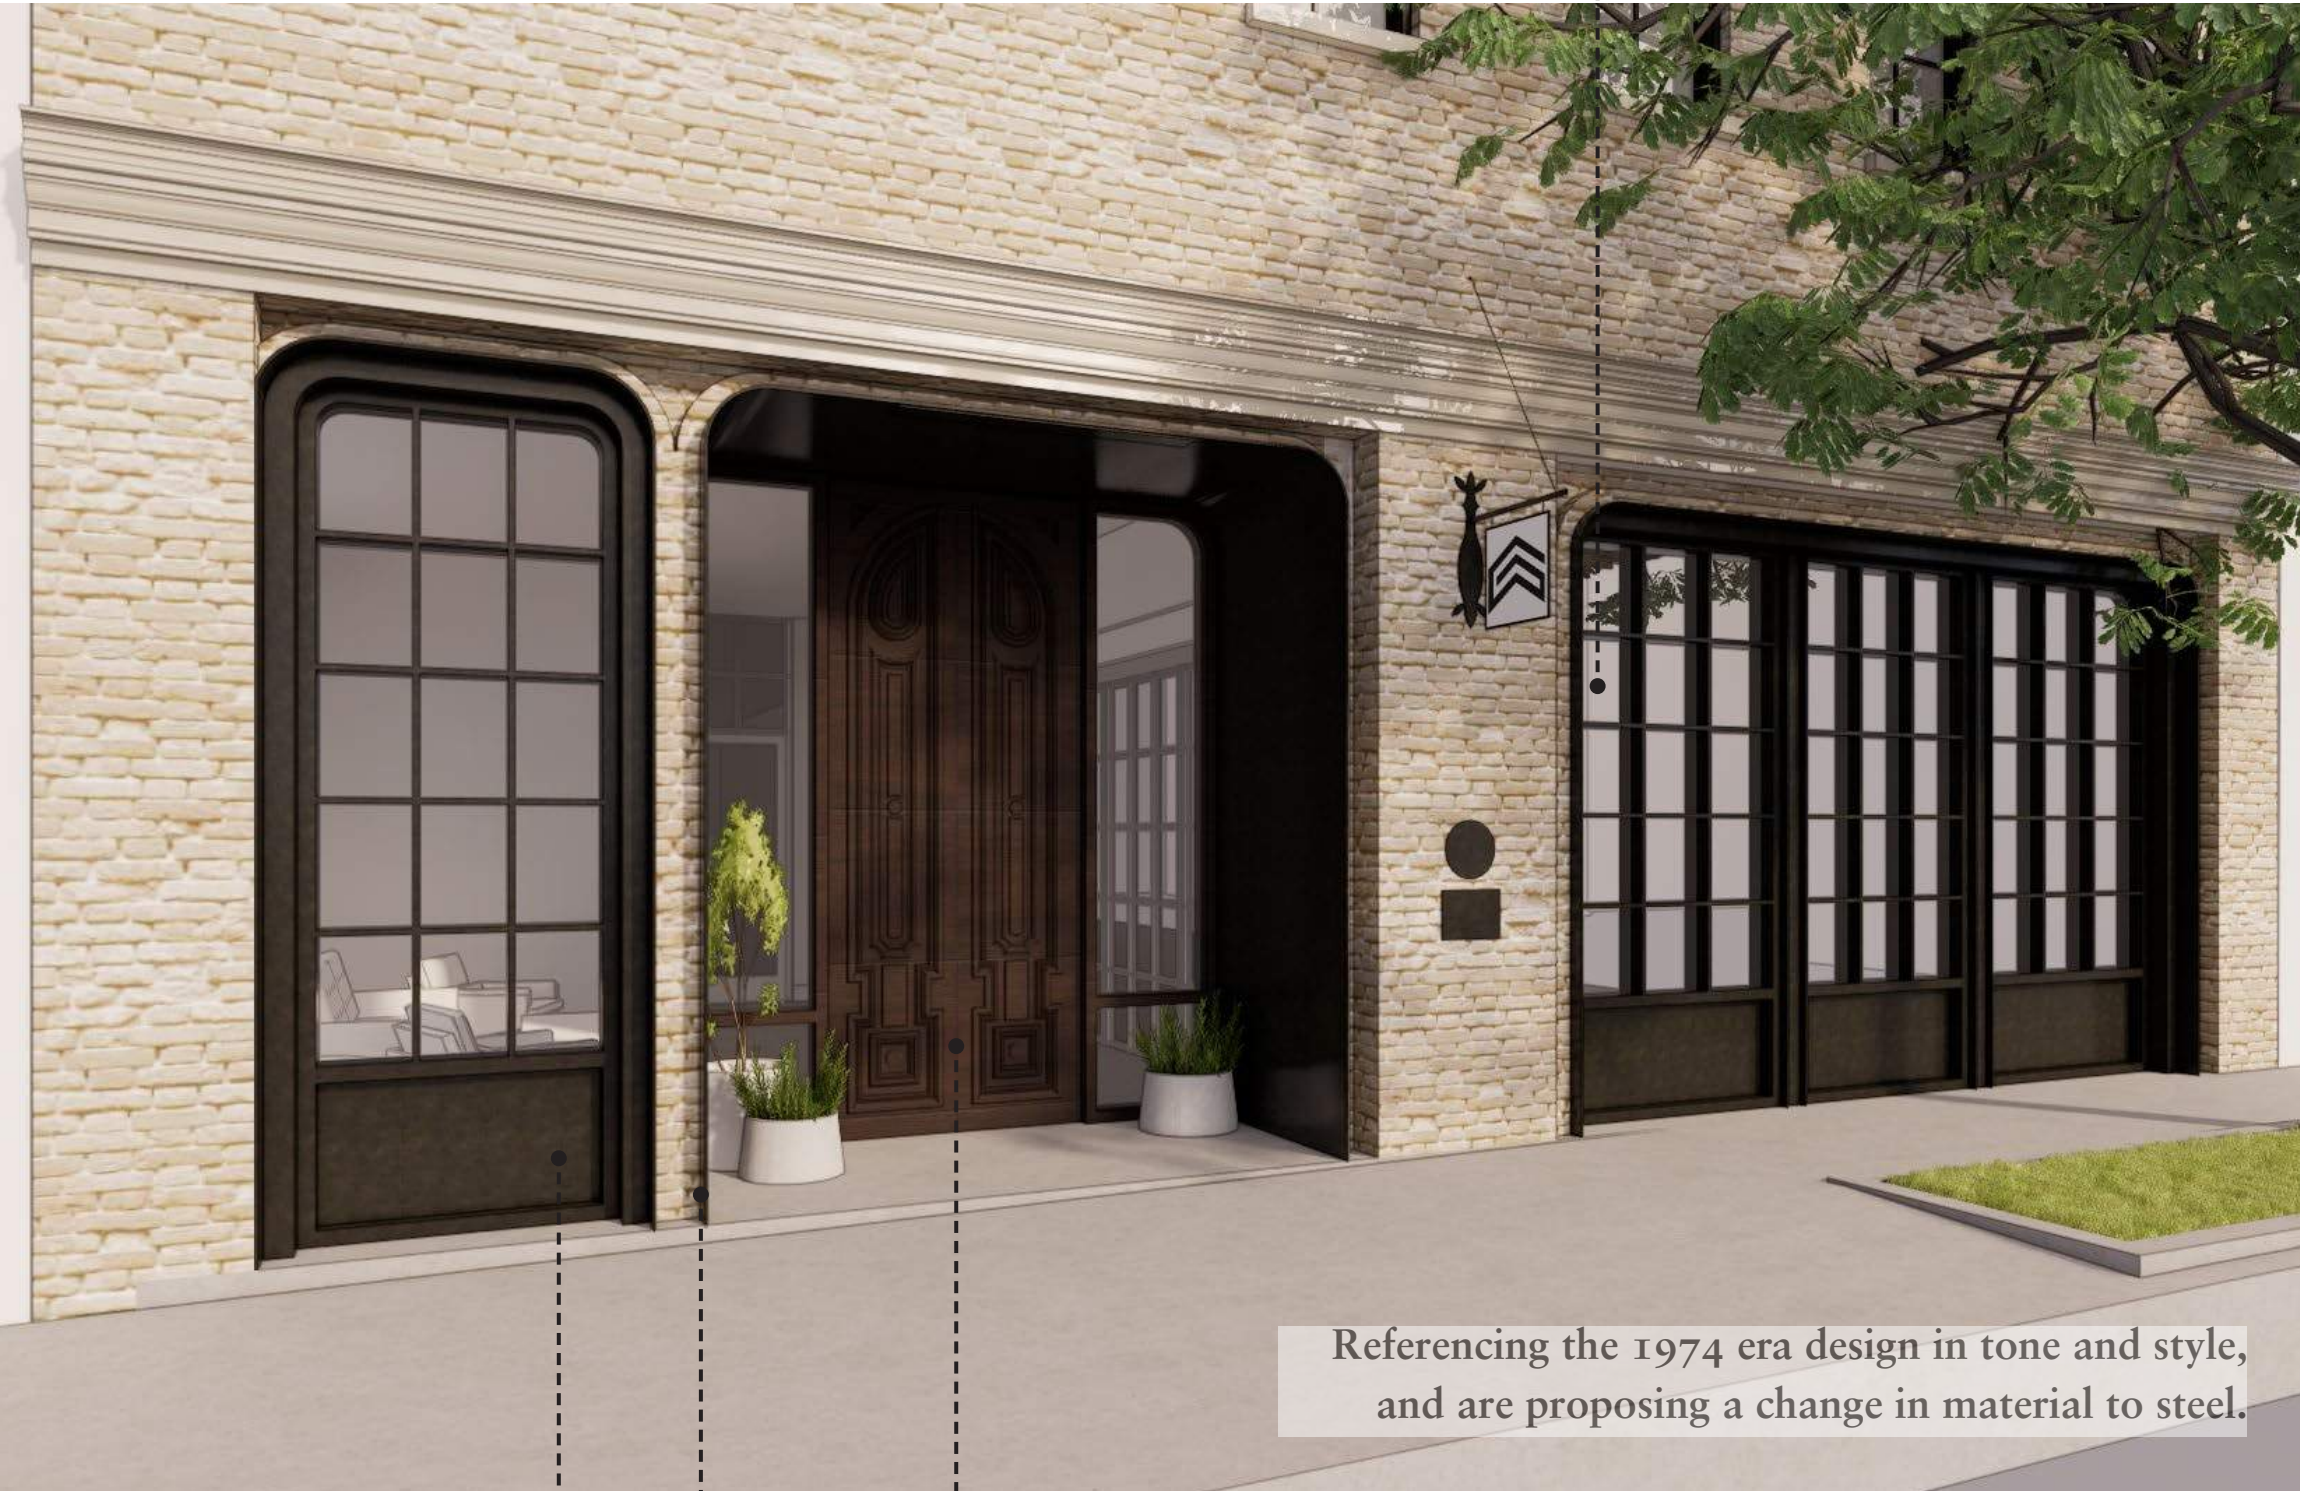
Remove windows and sill  
Remove intermediate brickwork

Custom steel storefront. New glass to be insulated and as clear as possible

Referencing the 1974 era design in tone and style, and are proposing a change in material to steel.

Preserve entry door  
Remove sidelites  
Remove egress door and brick infill

New recessed entry with salvaged door  
Blackened plate steel frame  
Custom steel storefront. New glass to be insulated and as clear as possible

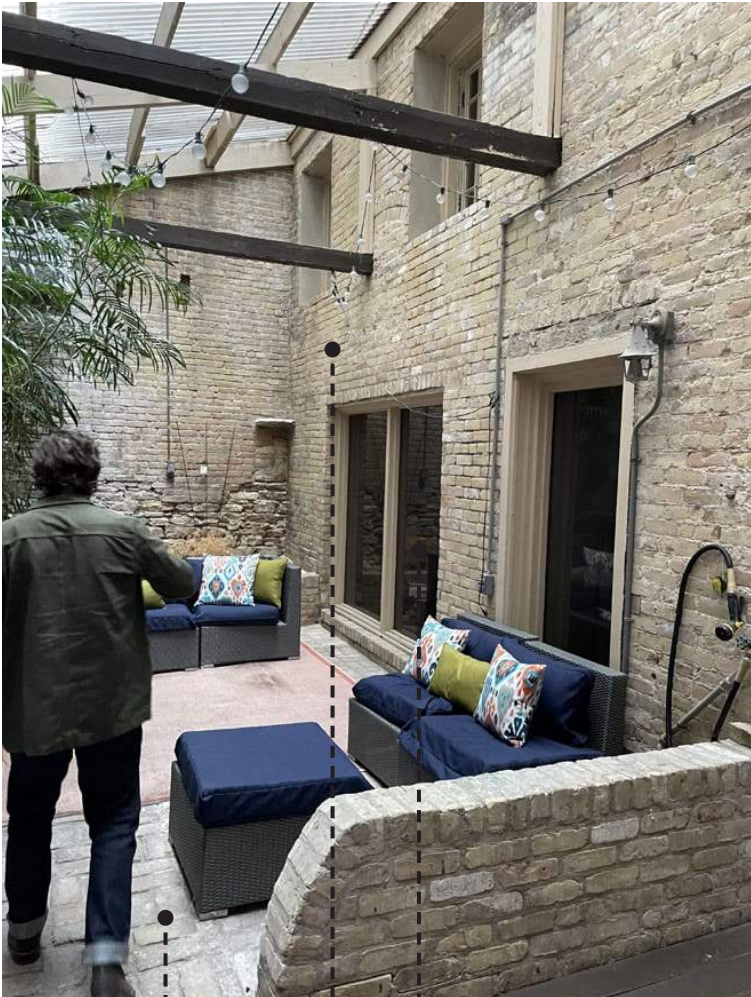
Punched Openings from Level 1

- Remove windows
- Partial demolition of wall
- Rework slab and paving

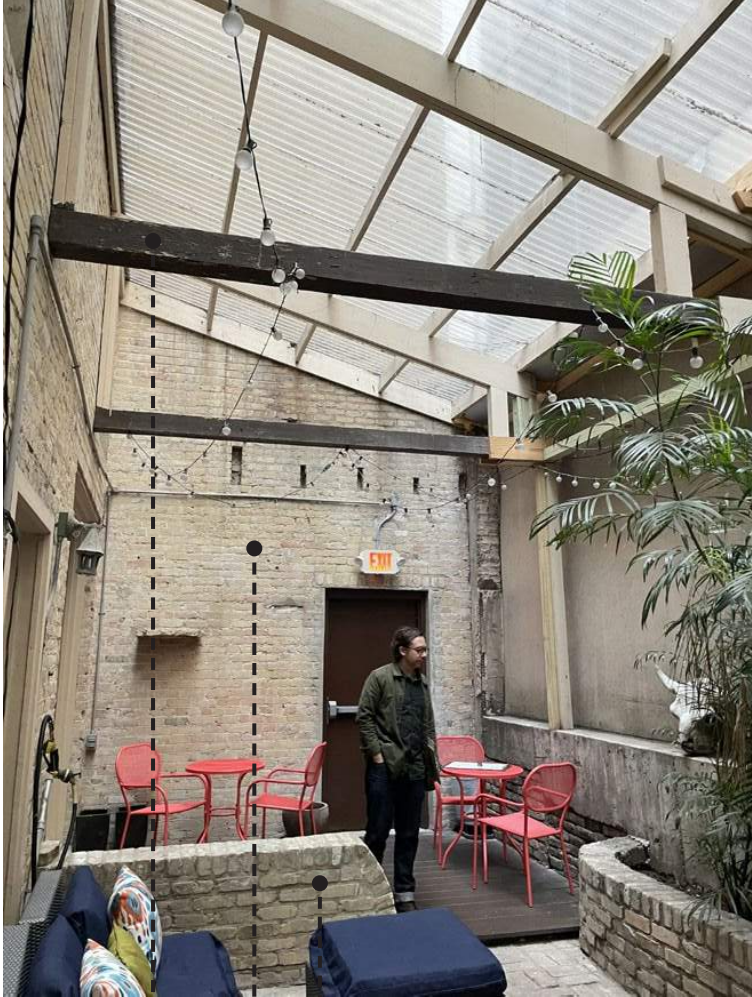
Exit Access through Courtyard

- Demolish half-walls
- Partial demolition of wall
- Remove overhead roof and structure
