# WOODLAWN PRESERVATION PROJECT

Woodlawn is one of the finest examples of Greek Revival architecture in Texas. Our goal is to honor the tradition of master builder Abner Cook and bring new life to the craftsmanship of the original era.

# Preservation Approach

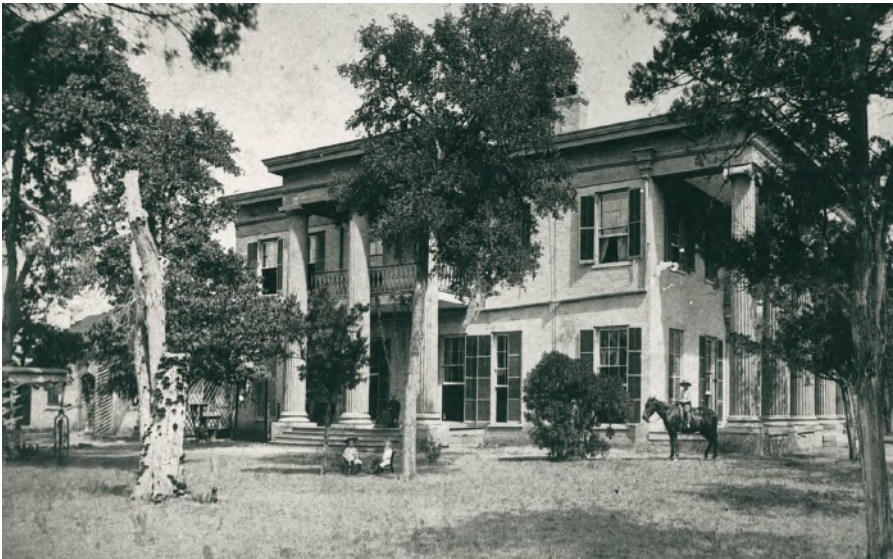
Earliest known photography circa 1885. View of one story addition to the west of the primary two-story 1854 home.

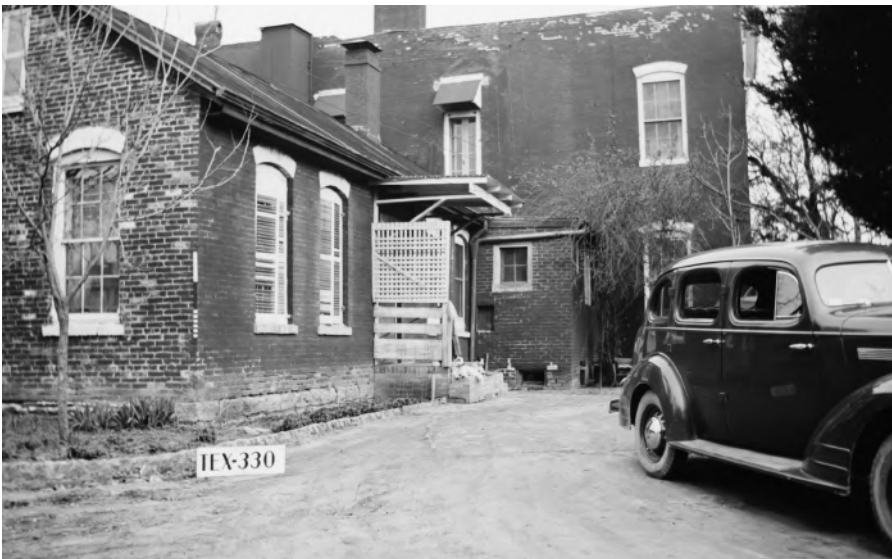
In 1874, significant interior renovations were made. South elevation view of west addition.

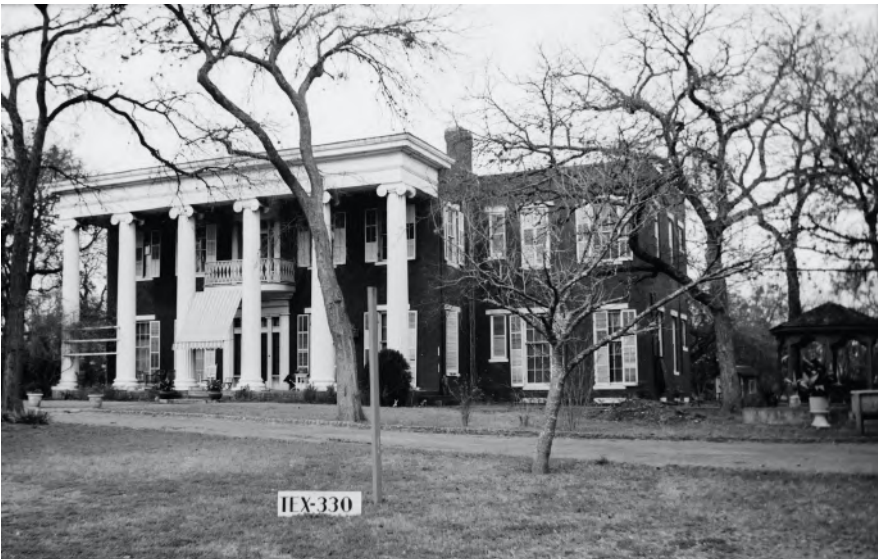
1903 renovation: North addition, shown here, remains intact today.

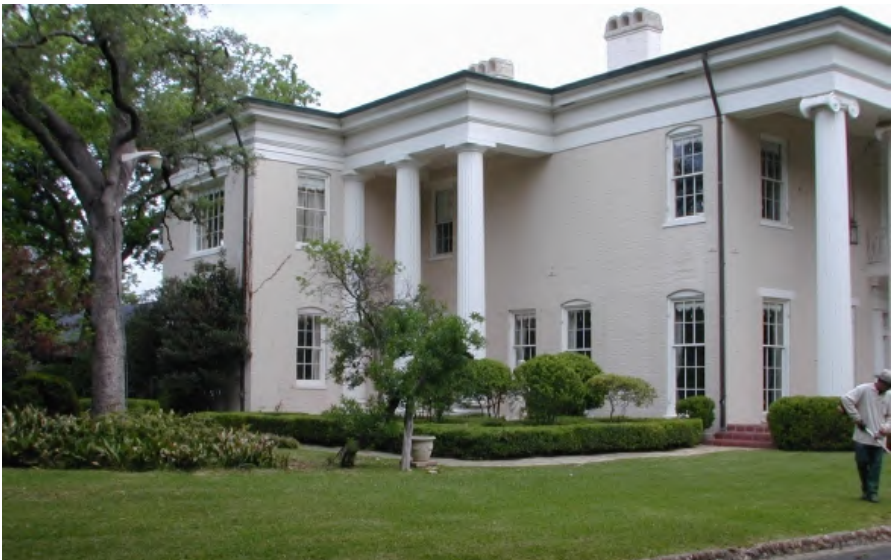
1957 renovation: The south addition remained but the original 1854 south balcony had been removed. It was restored during the 2003 renovation.

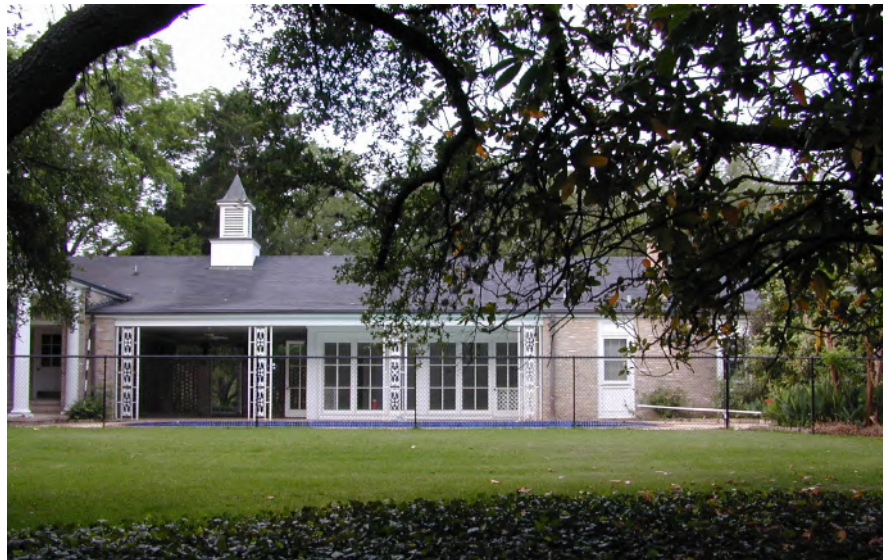
In 1957, the west addition was renovated and expanded, including a smaller support building added with a pool.

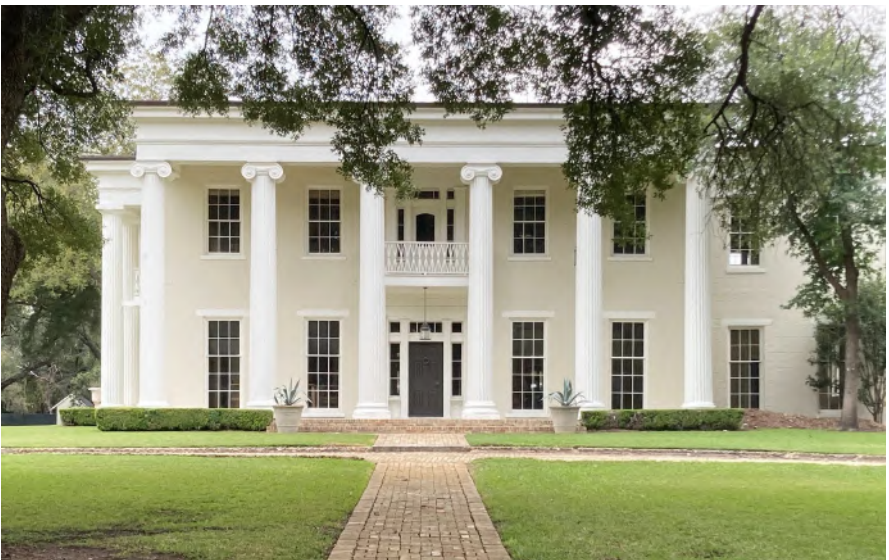
In 2003, the historic house was renovated once again and the footprint was reduced, similar to its 1854 size.

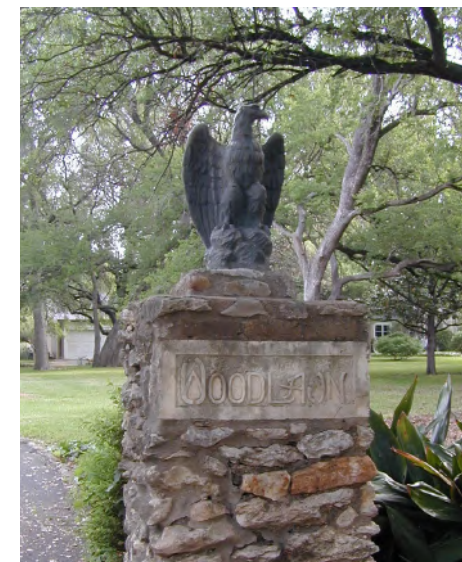
- Clean and restore concrete eagles atop limestone posts at re-instated service drive on Niles Road.

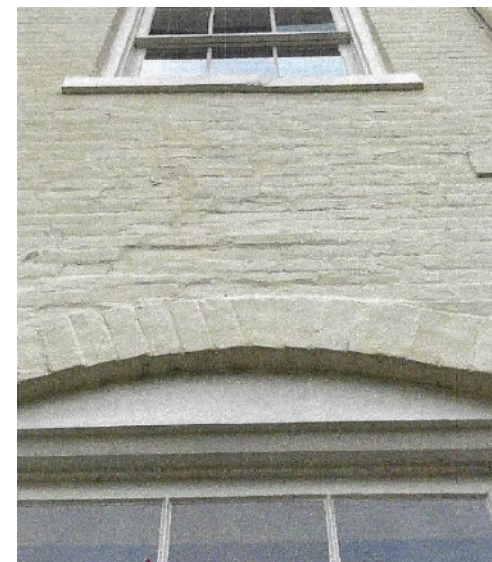
- Repair damaged, settling brick.
- Stabilize and repoint as needed.

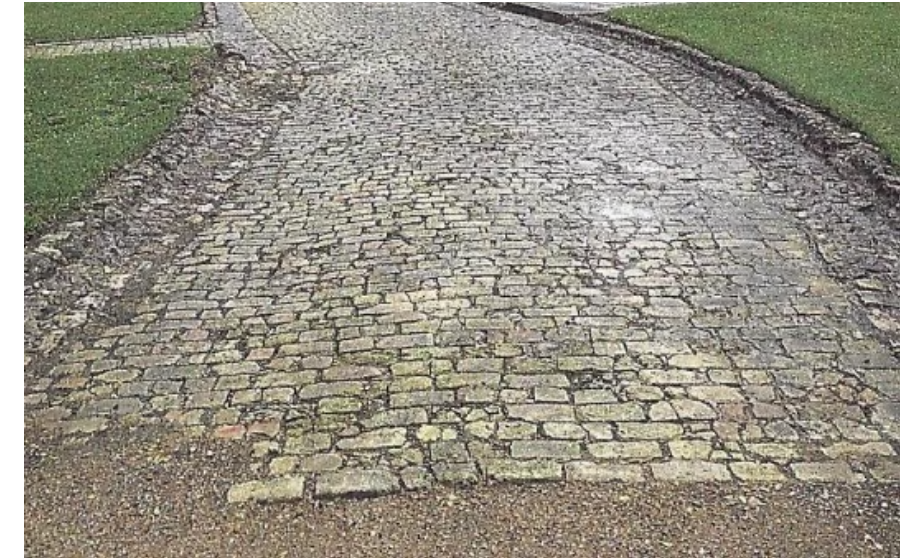
- Stabilize existing brick and decomposed granite driveway with stone edging and low curb.

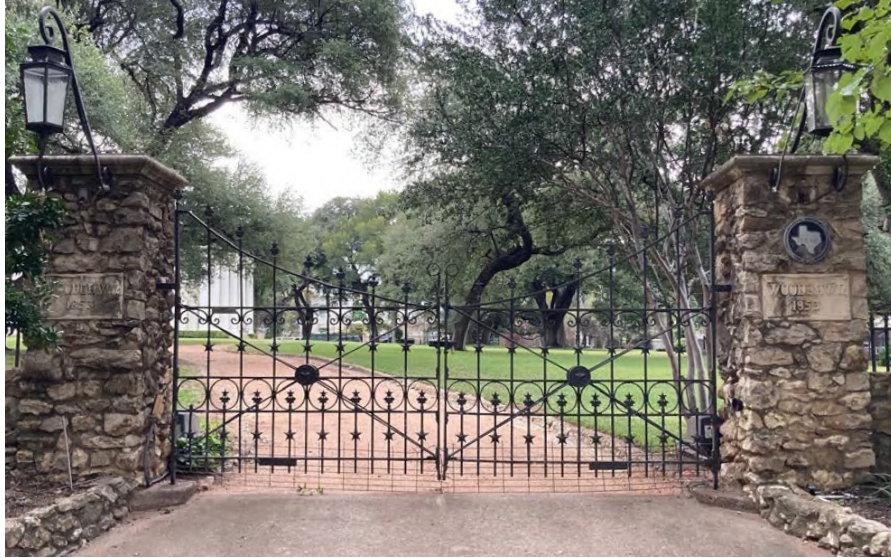
- Clean and restore limestone pillars, low walls and Woodlawn plaque at main vehicular gate at southeast corner.
- Re-instate use of southwest service drive (closed in 2003).

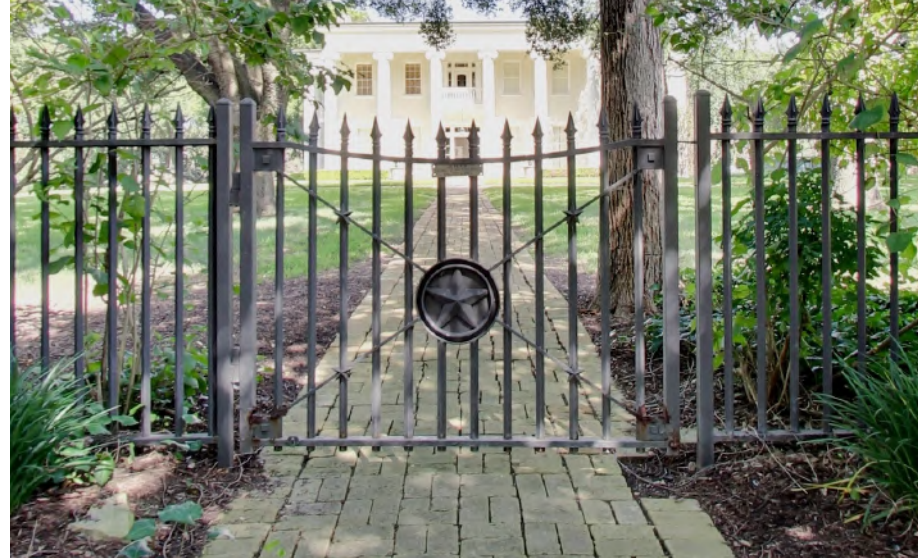
- Re-use historic star and x-bracing at existing main pedestrian gate in proposed new gate at Pease Road.

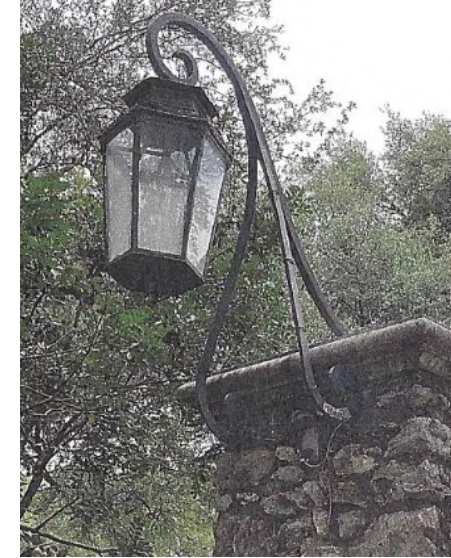
- Restore decorative lanterns installed by Shivers in 1957.

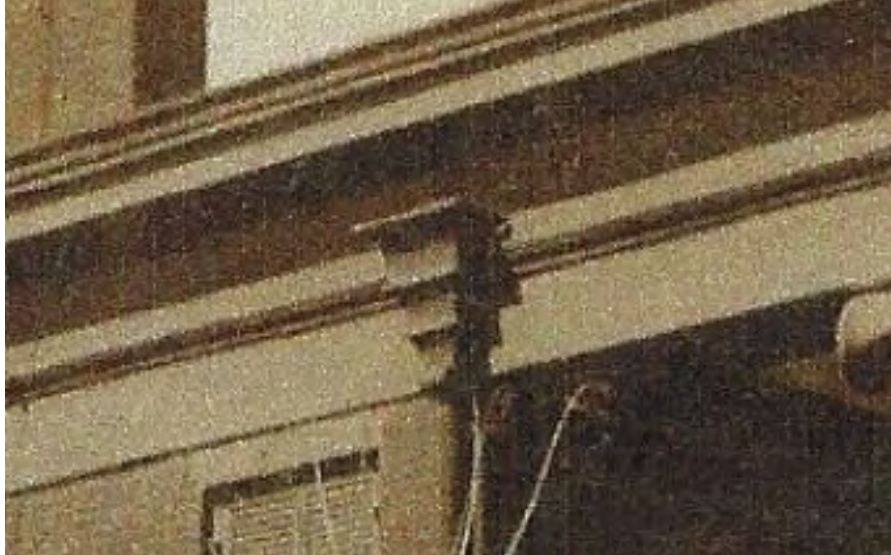
- Re-install scuppers per historic photo.
- Design built-in gutter at edge of roof.

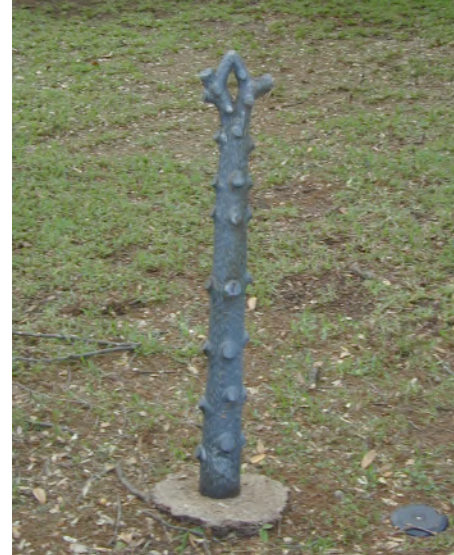
- Restore hitching posts (2) in front lawn, north of house.

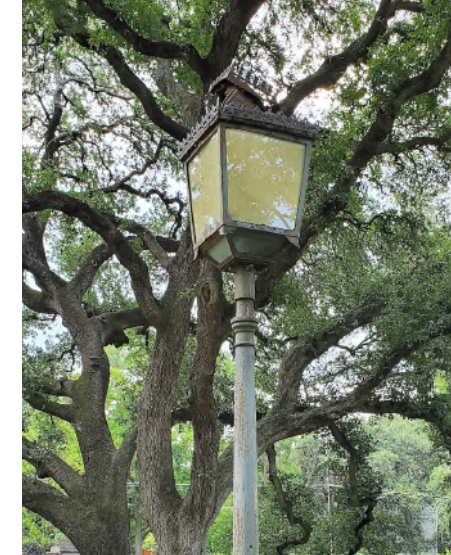
- Restore lamp posts (2) at front lawn.

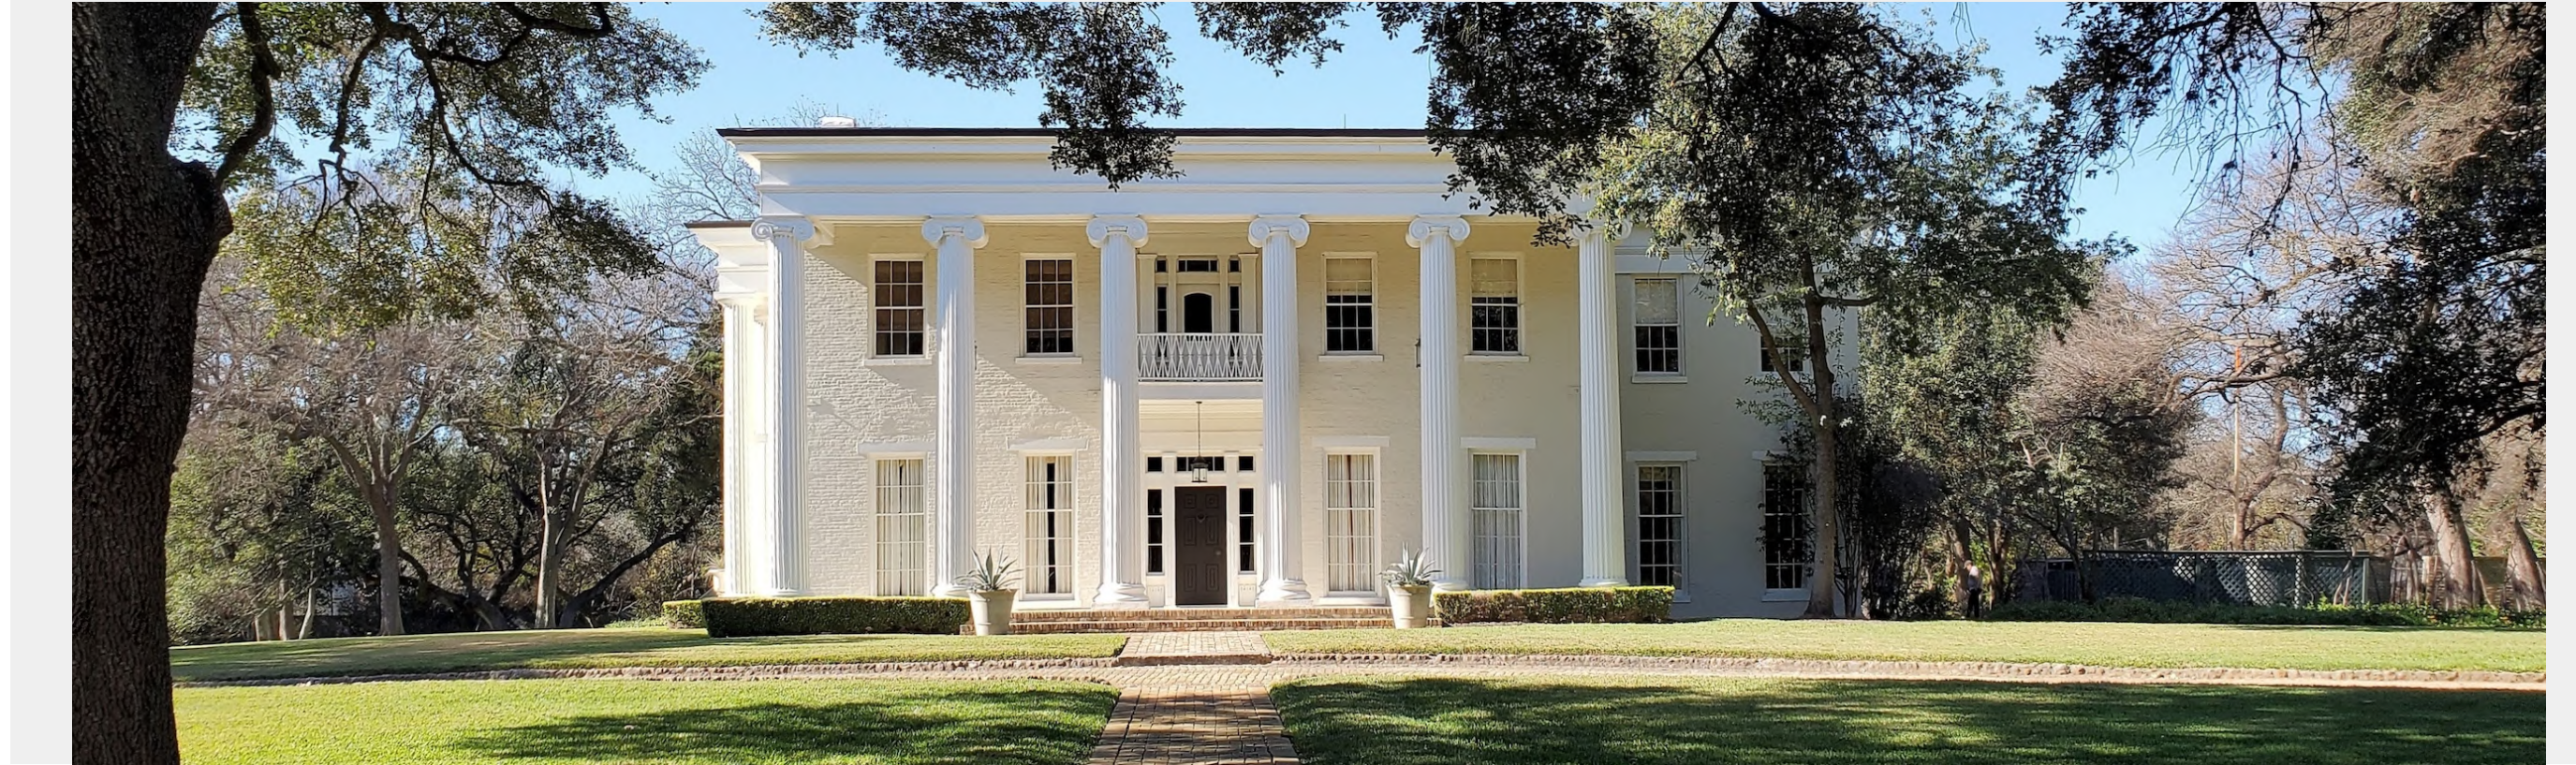
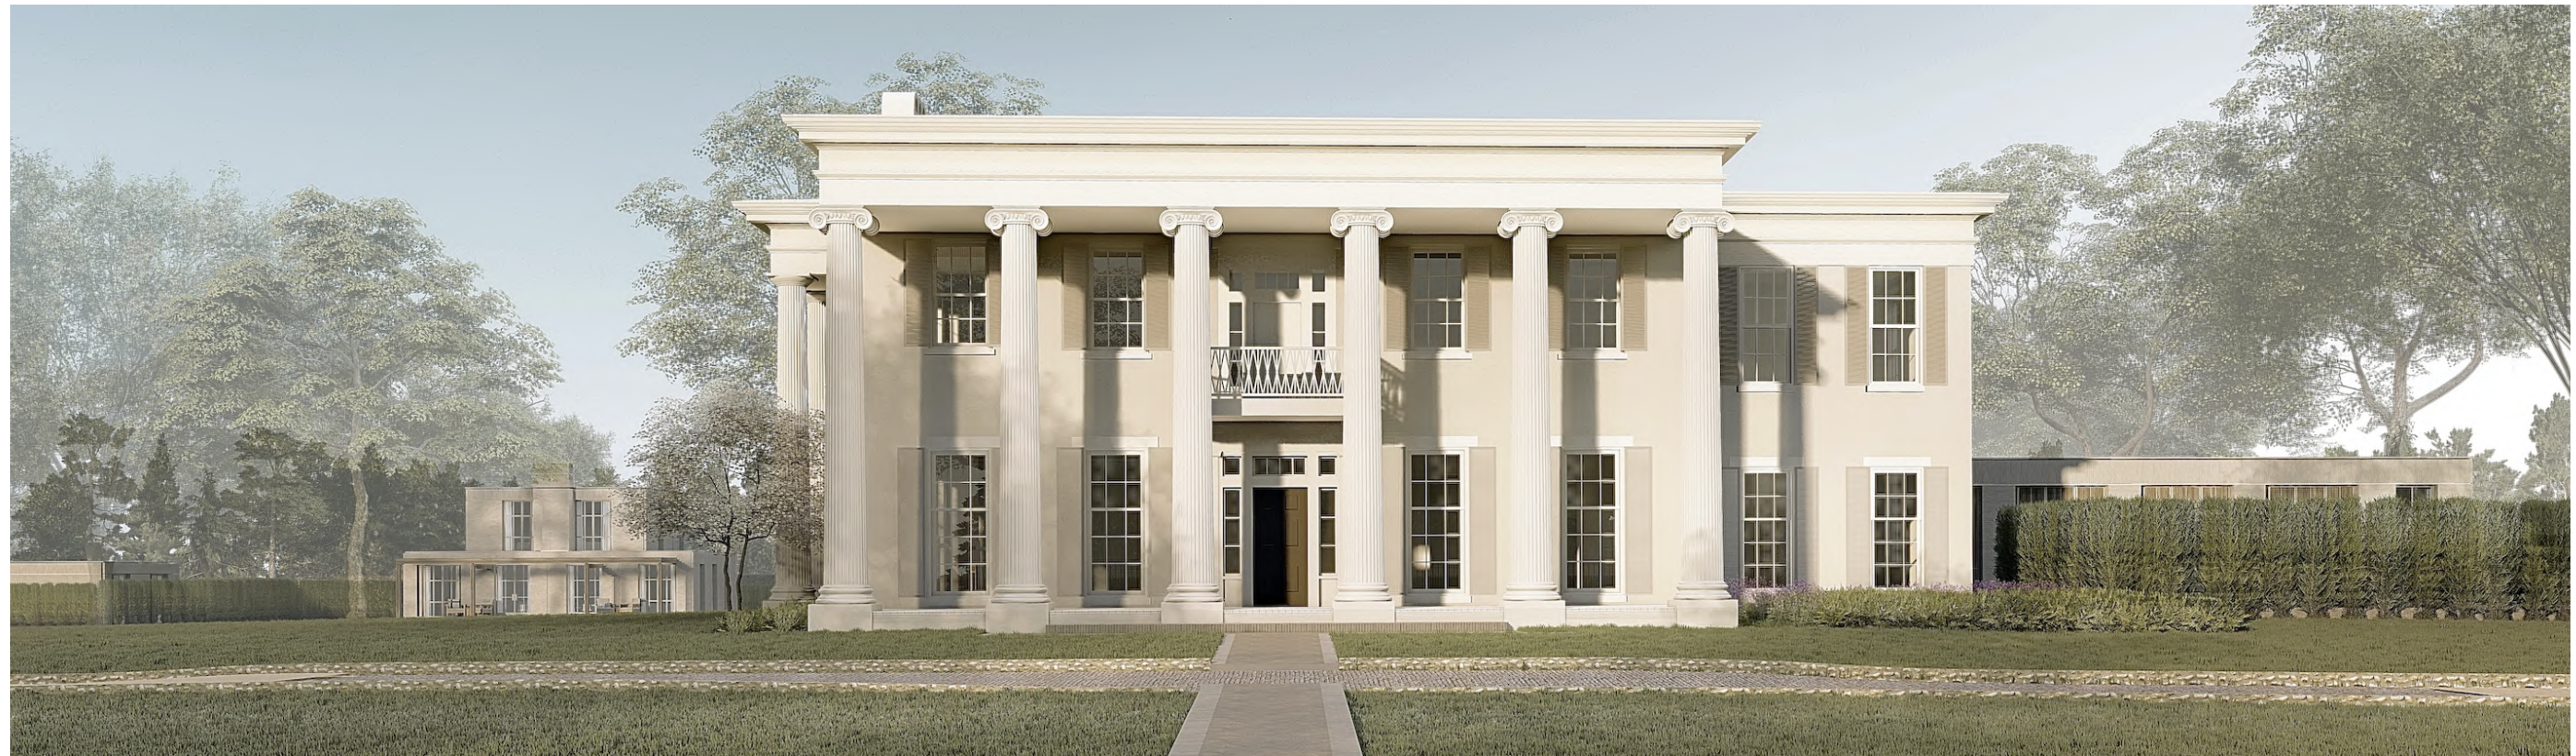
## PRIMARY EXTERIOR ELEVATION – EAST

- Original front door is restored to 1854 design, per physical evidence and historic photos.
- Restoration of front porch and brick step and underpinning per historic photos.
- Balcony framing stabilized; original 1854 railing refurbished.
- Existing pendant lanterns to remain.
- Columns and all exterior wood repaired or replaced, when necessary, to match.
- East façade of north addition partially visible above 8' tall landscape screening hedge.

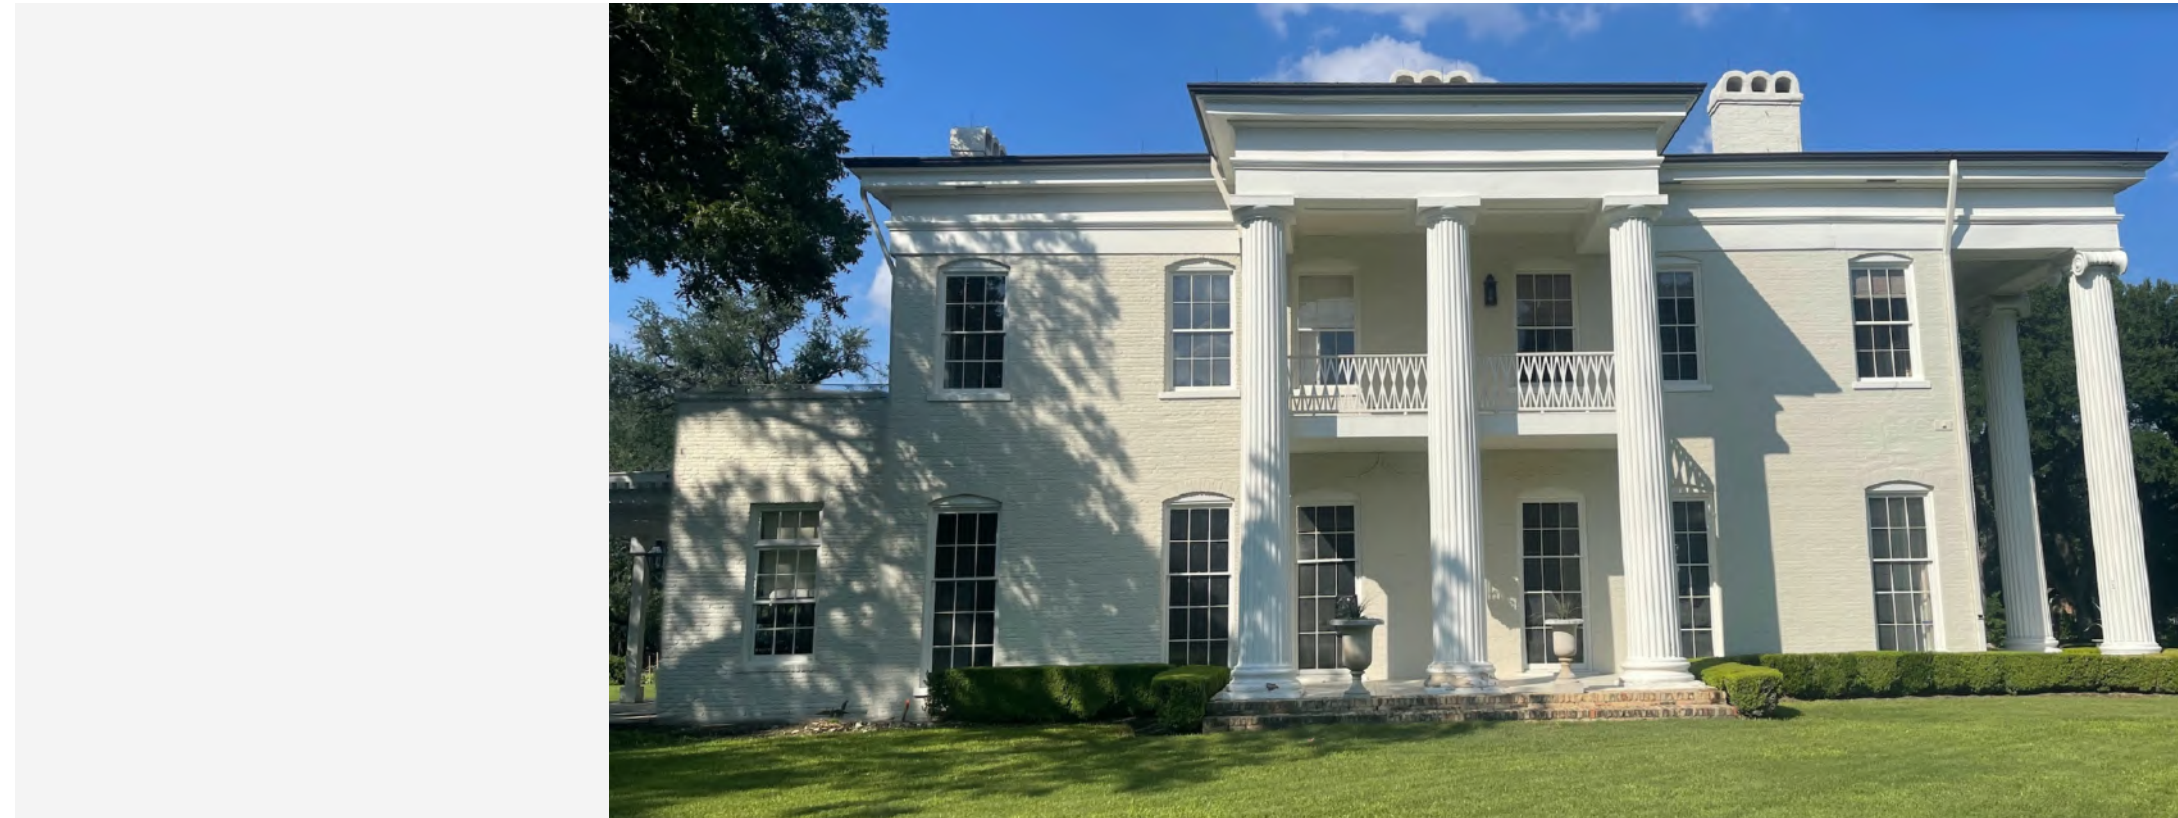
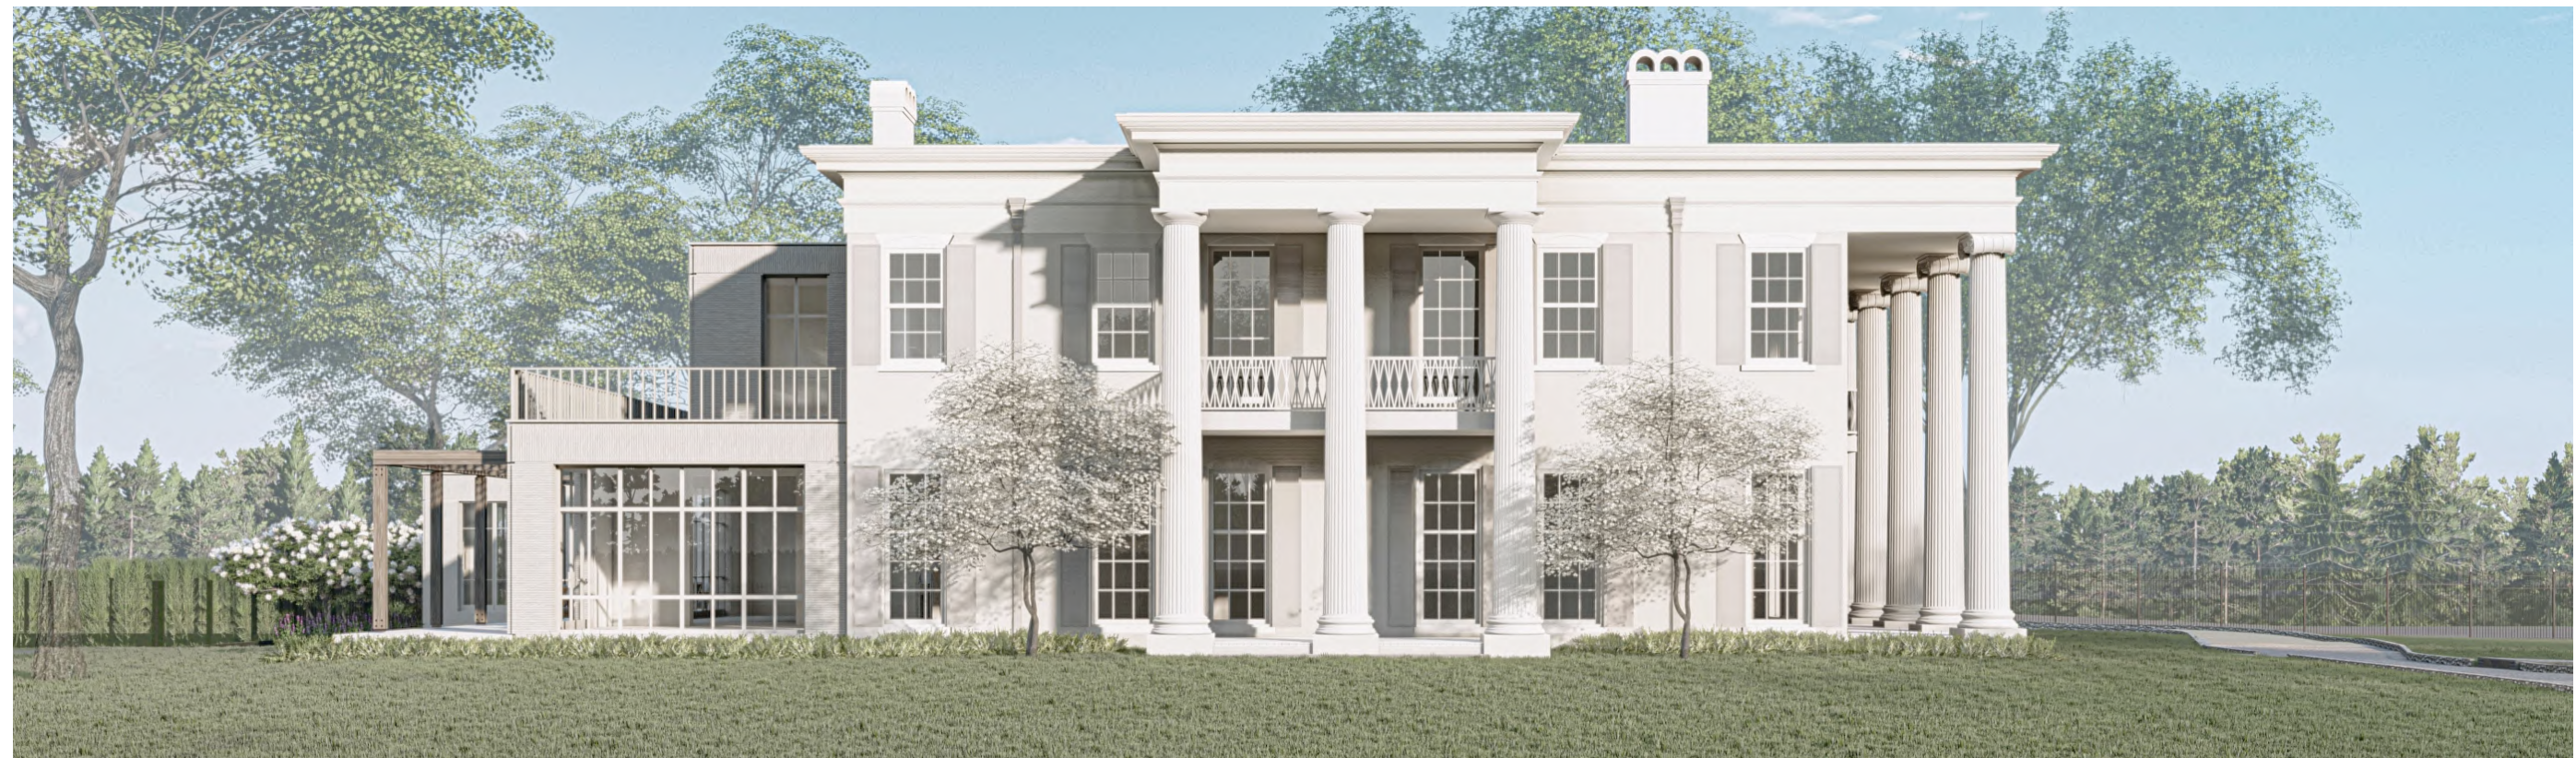
## EXTERIOR ELEVATION – SOUTH

- The most publicly visible new addition is seen here to the west of the historic house. It is subordinate in size with the roof line below the historic roof.
- New one- and two-story stepped west addition, set back 12" from historic south façade and set at bottom of entablature of historic house.
- Compatible, contemporary, elongated white brick will be used at the additions.
- Thin profile metal windows painted white will be used at additions.
- At historic house, restoration of south porch and brick step and underpinning per historic photos.
- Balcony framing stabilized; rebuild 2003 balustrade to match original east balcony.
- Remove 2003 west addition.

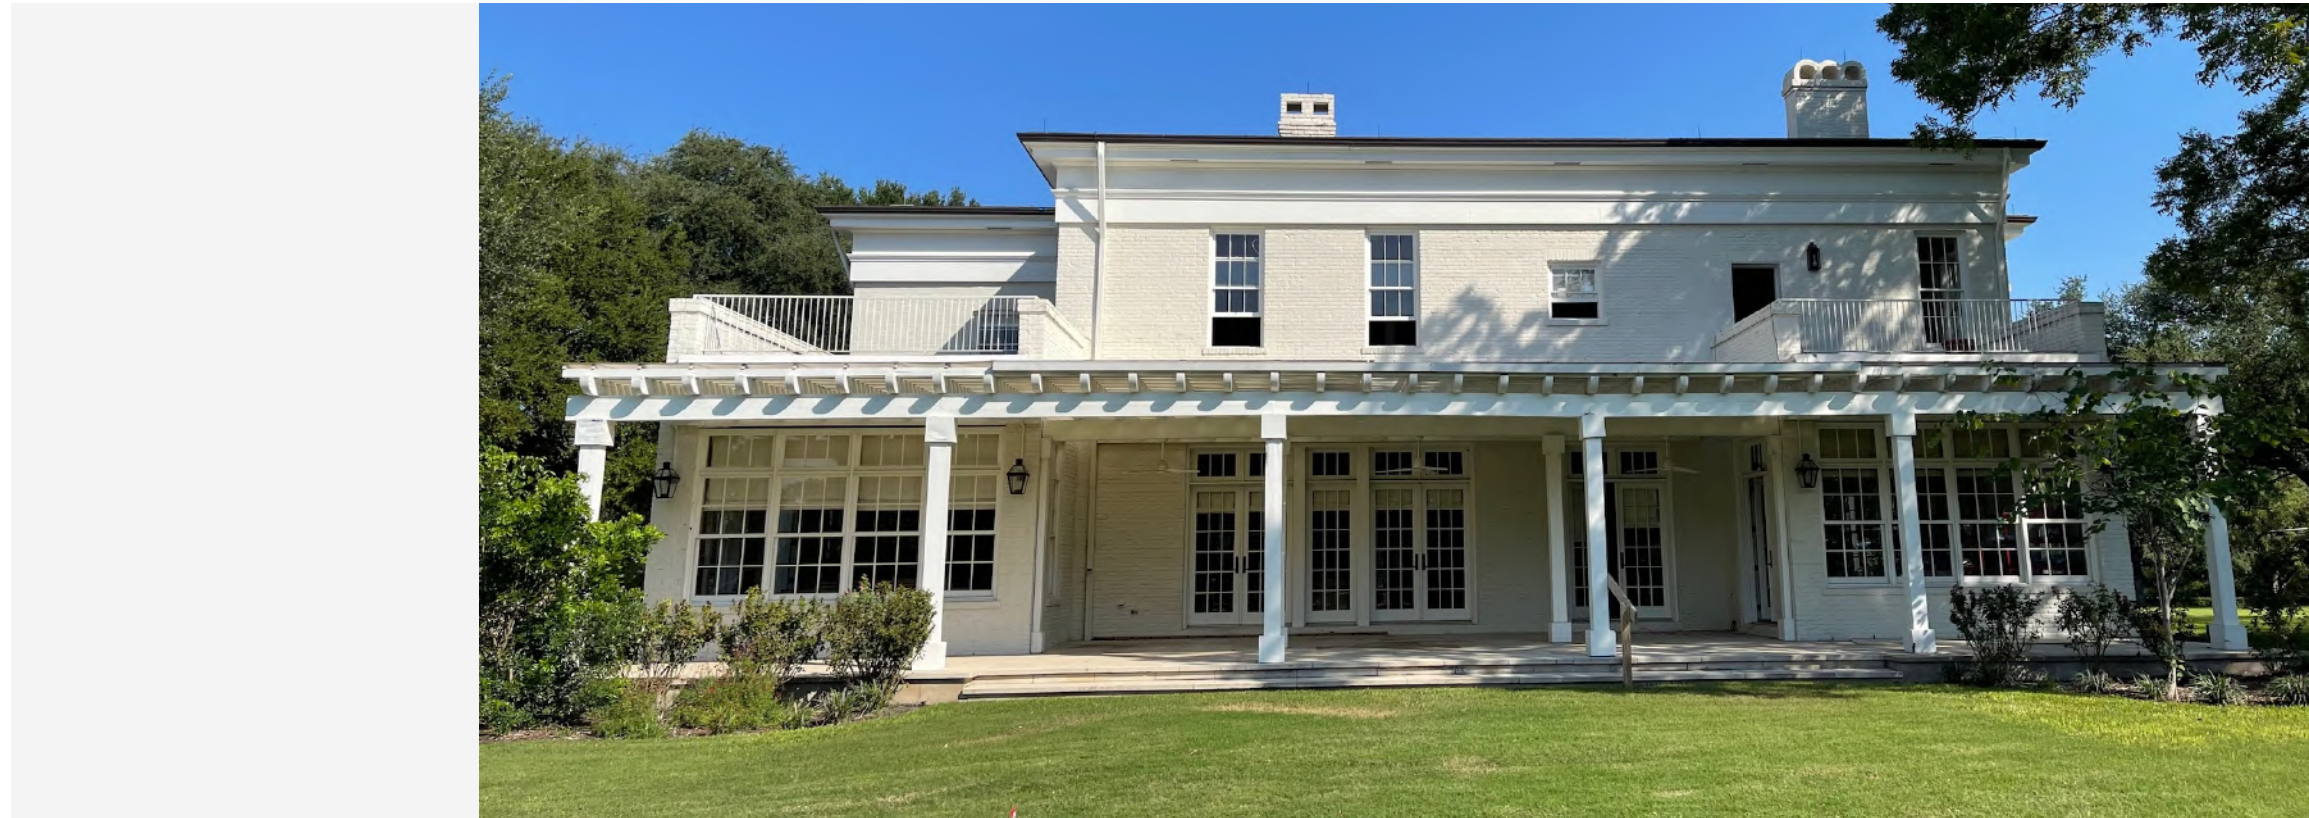
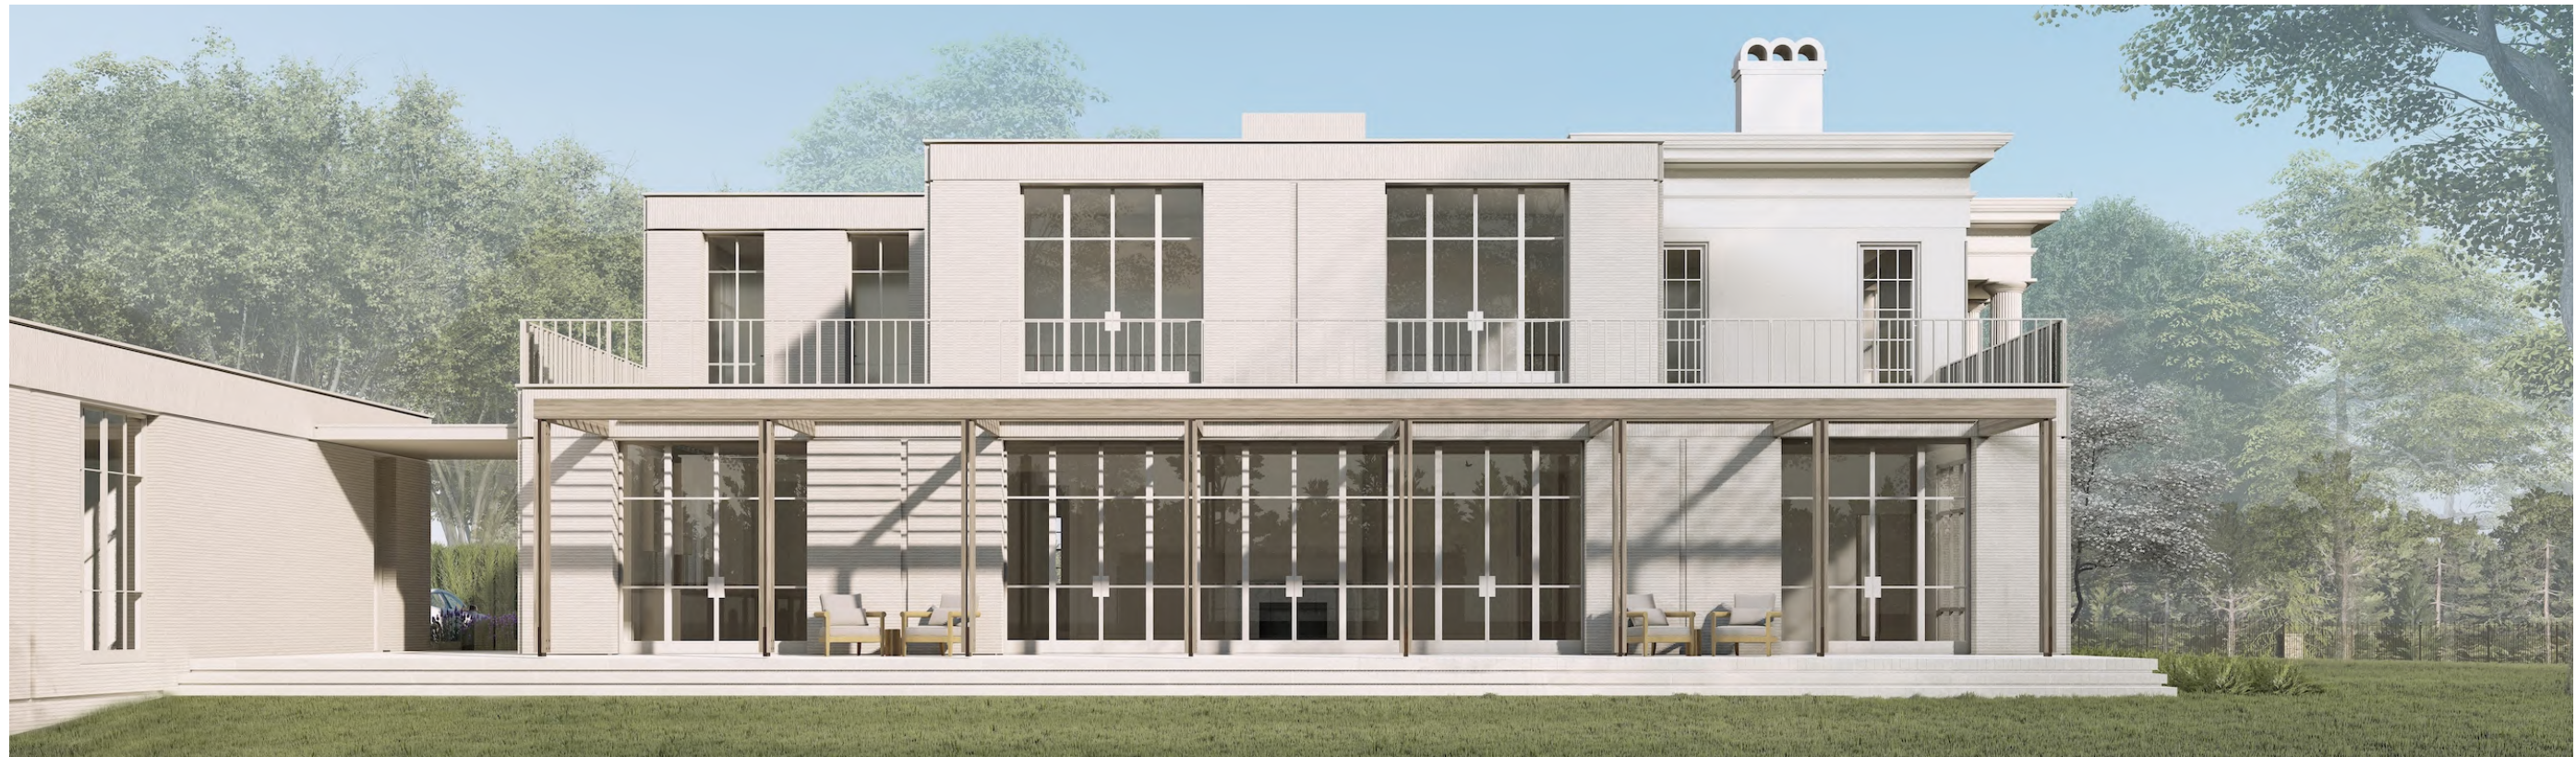
## EXTERIOR ELEVATION – WEST

- The west addition is a respectful, compatible addition that compliments, but does not dominate the historic house.
- Extreme care required at removal of 2003 west addition. The existing 1854 brick wall to remain was blended into the 2003 addition by extending the historic west wall plane.
