# WOODLAWN PRESERVATION PROJECT

Woodlawn is one of the finest examples of Greek Revival architecture in Texas. Our goal is to honor the tradition of master builder Abner Cook and bring new life to the craftsmanship of the original era.

# Preservation Approach

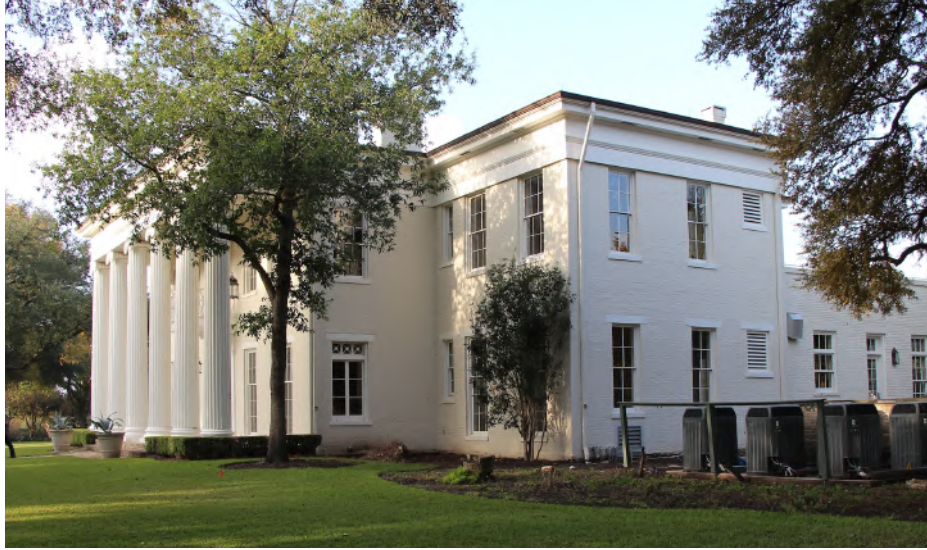
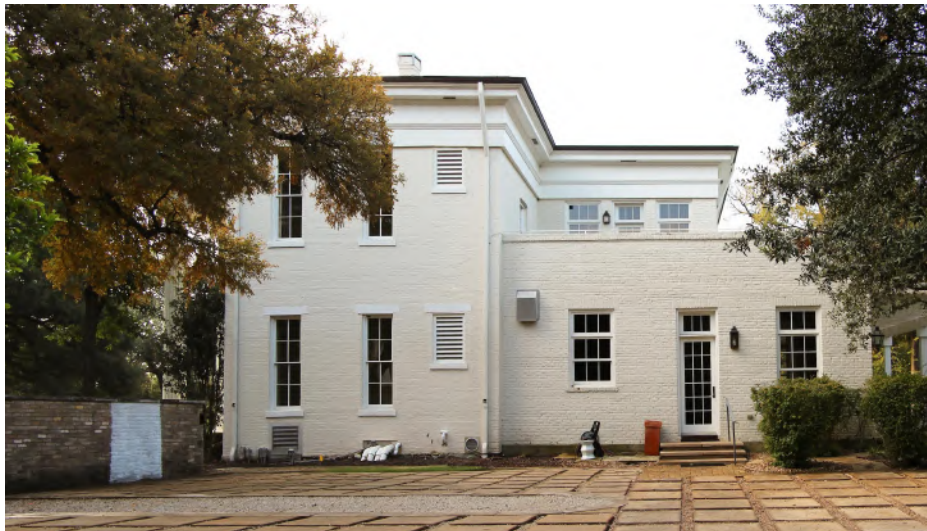
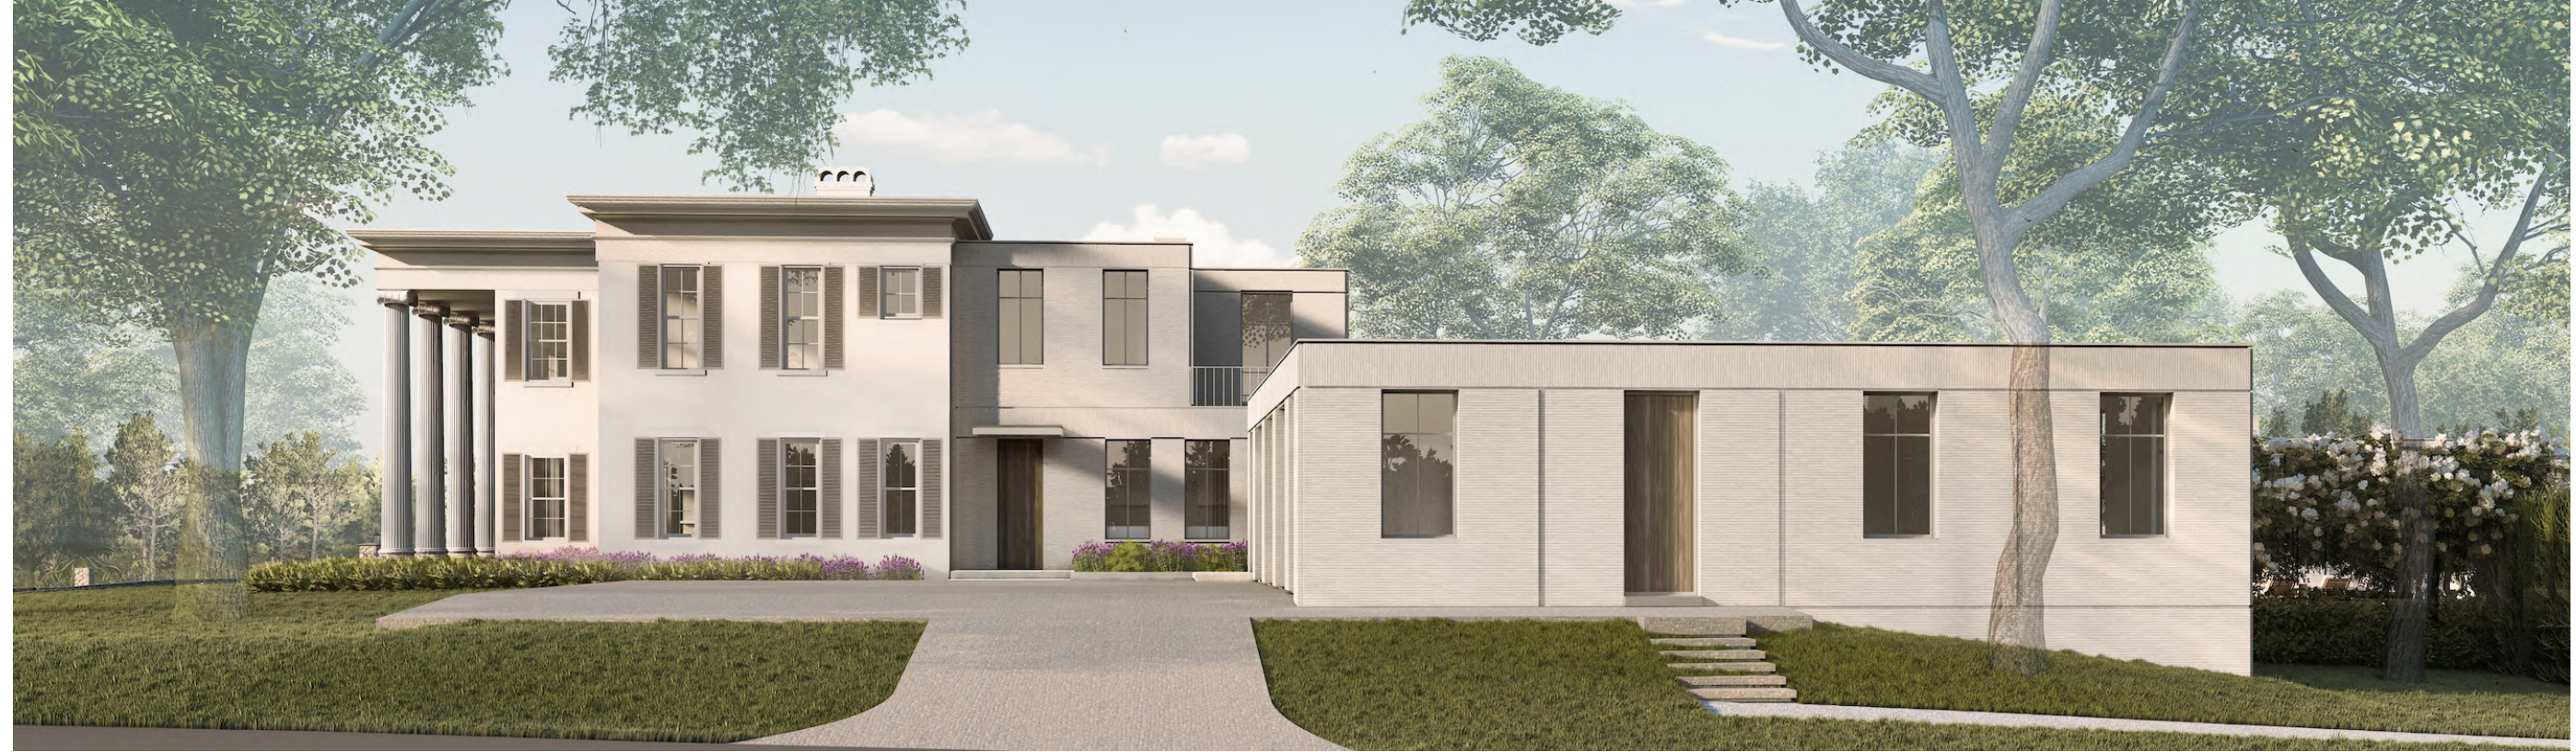
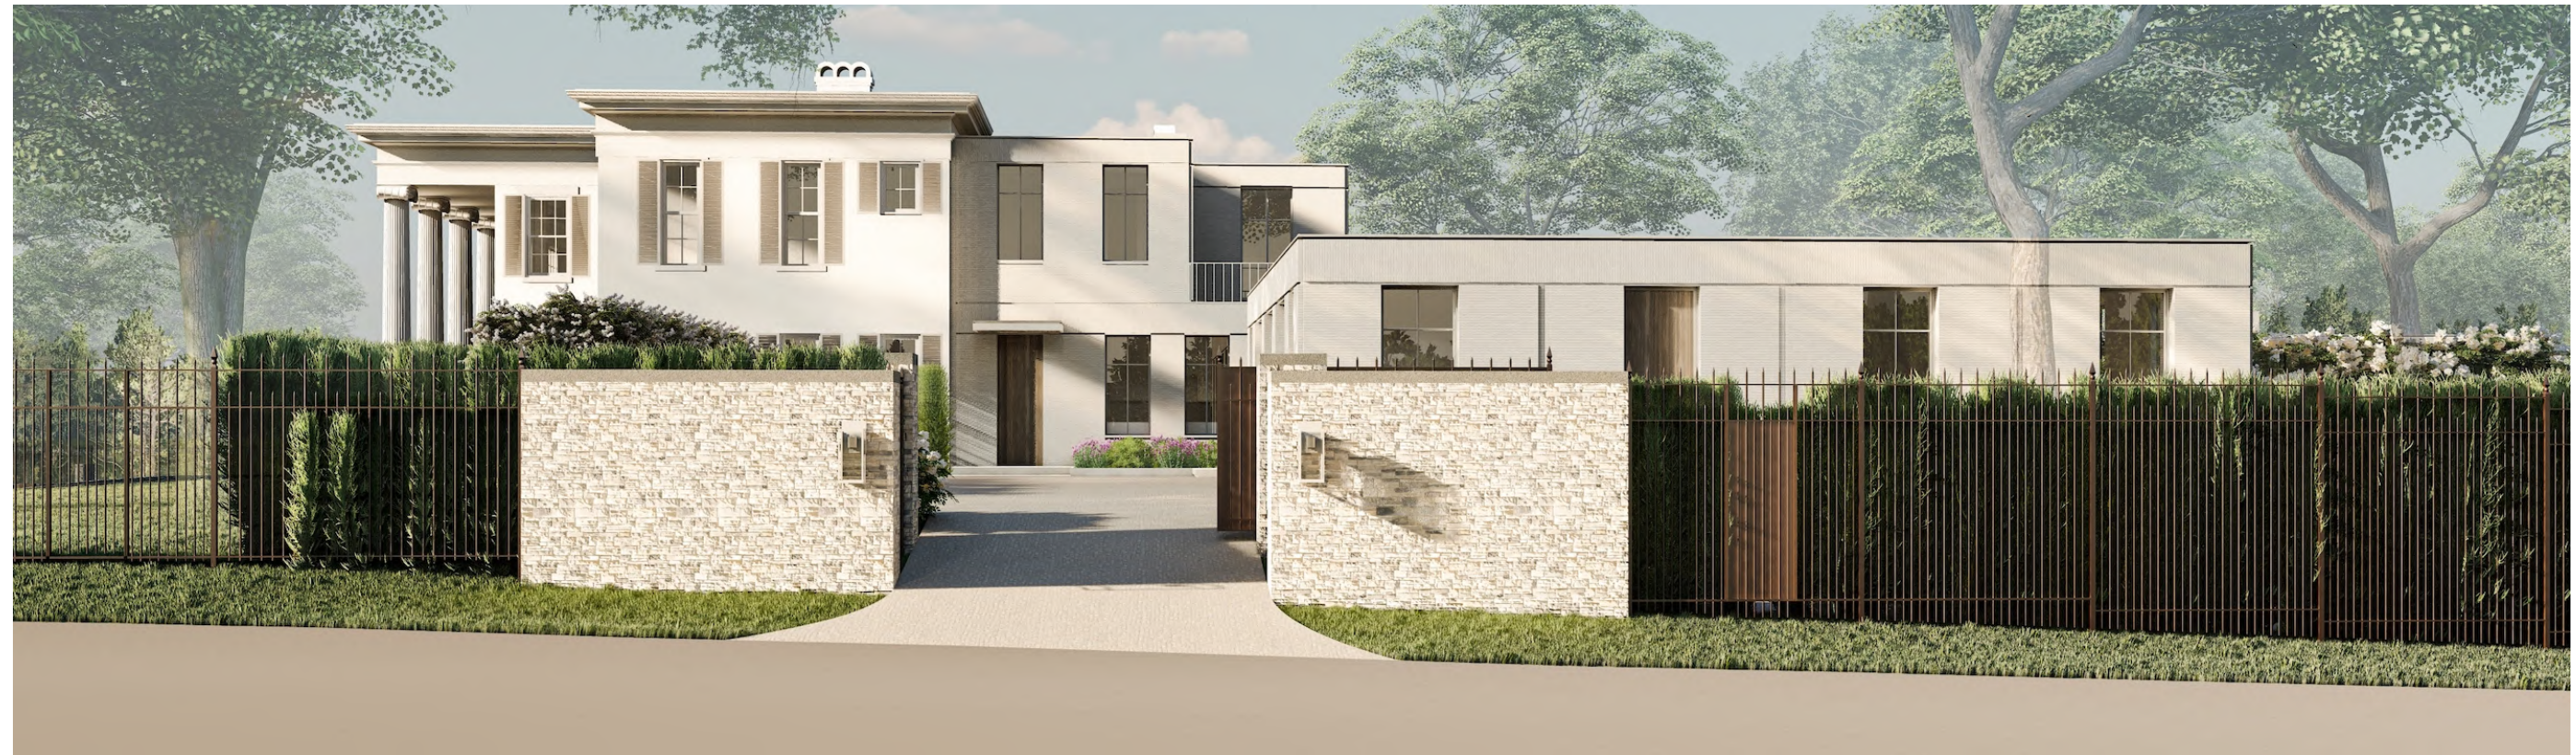
## EXTERIOR ELEVATION – NORTH

- Proposed revision at north 1903 addition: Enlarge first floor west window – currently a vent but originally a 2/2 double hung window. (THC has approved).
- Proposed restoration of 1854 original window at north wall of 1854 house. The existing 1903 window was likely installed during the 1903 remodel.
- North addition garage is one level, set to the rear of historic house.
- Construct new west addition and north addition.
- New driveway to auto court and private entry to the home.

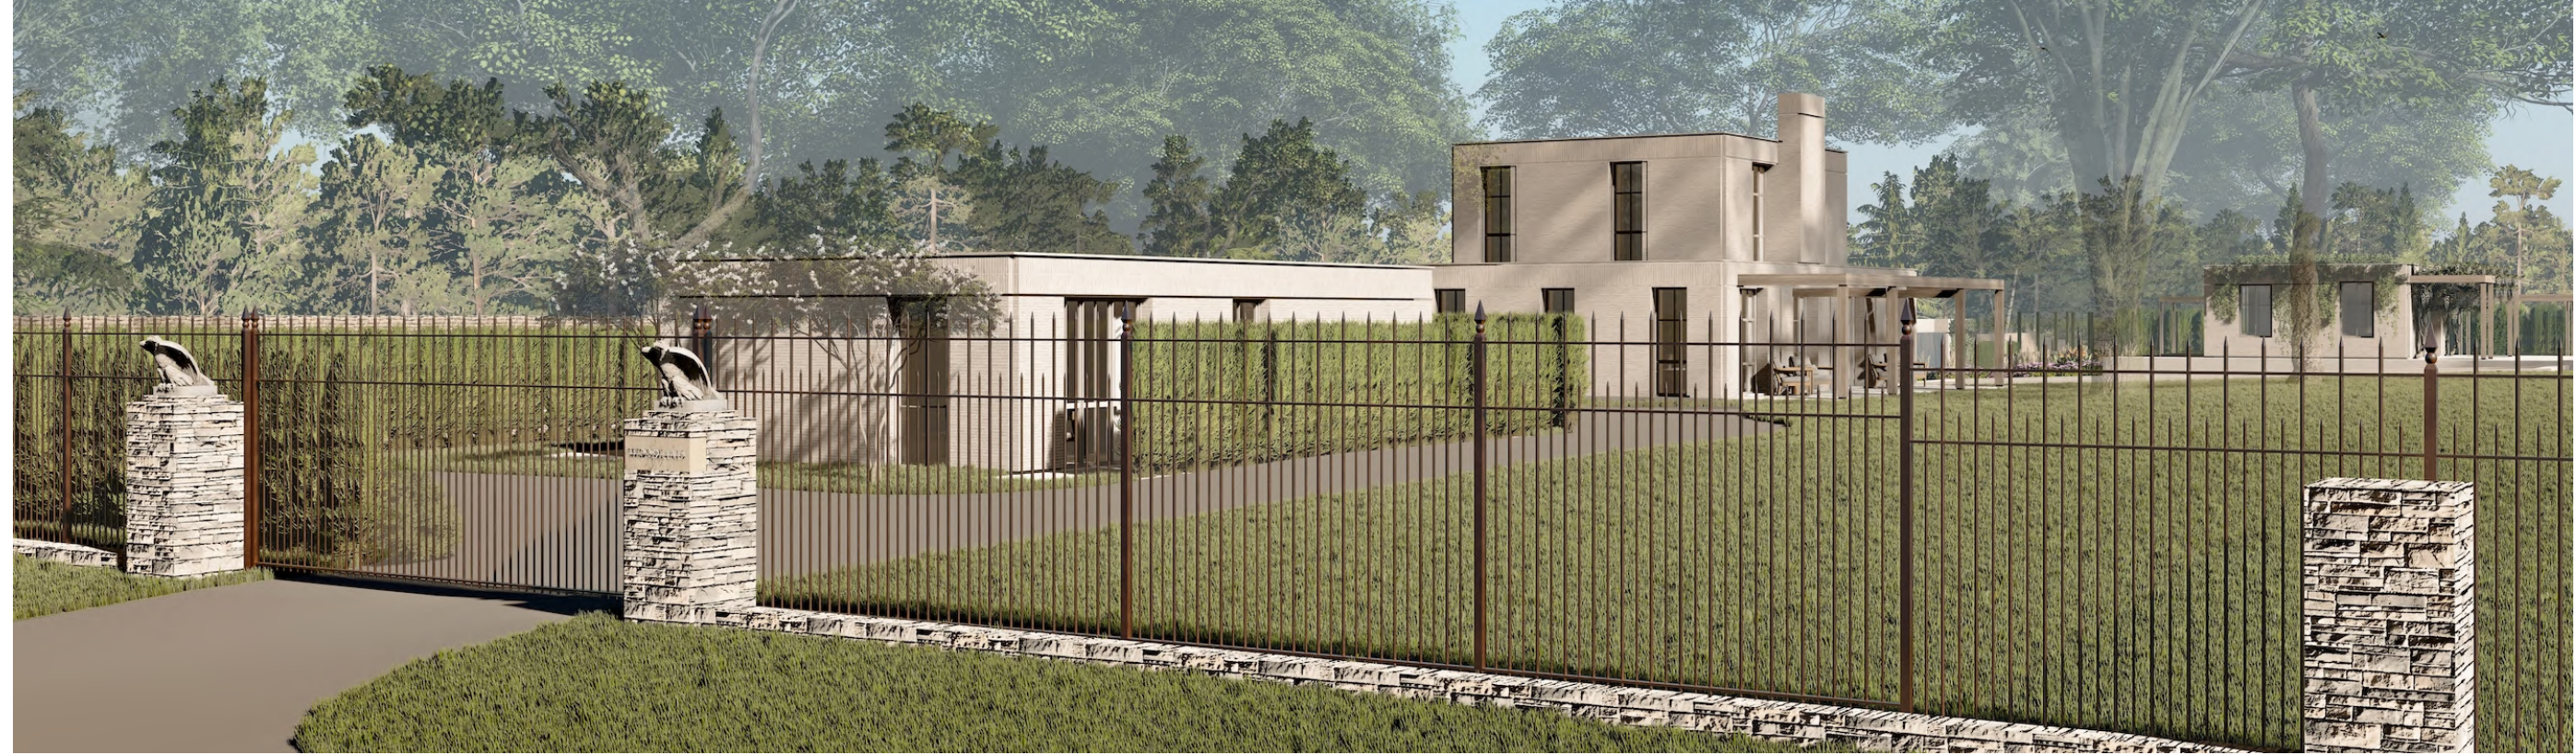
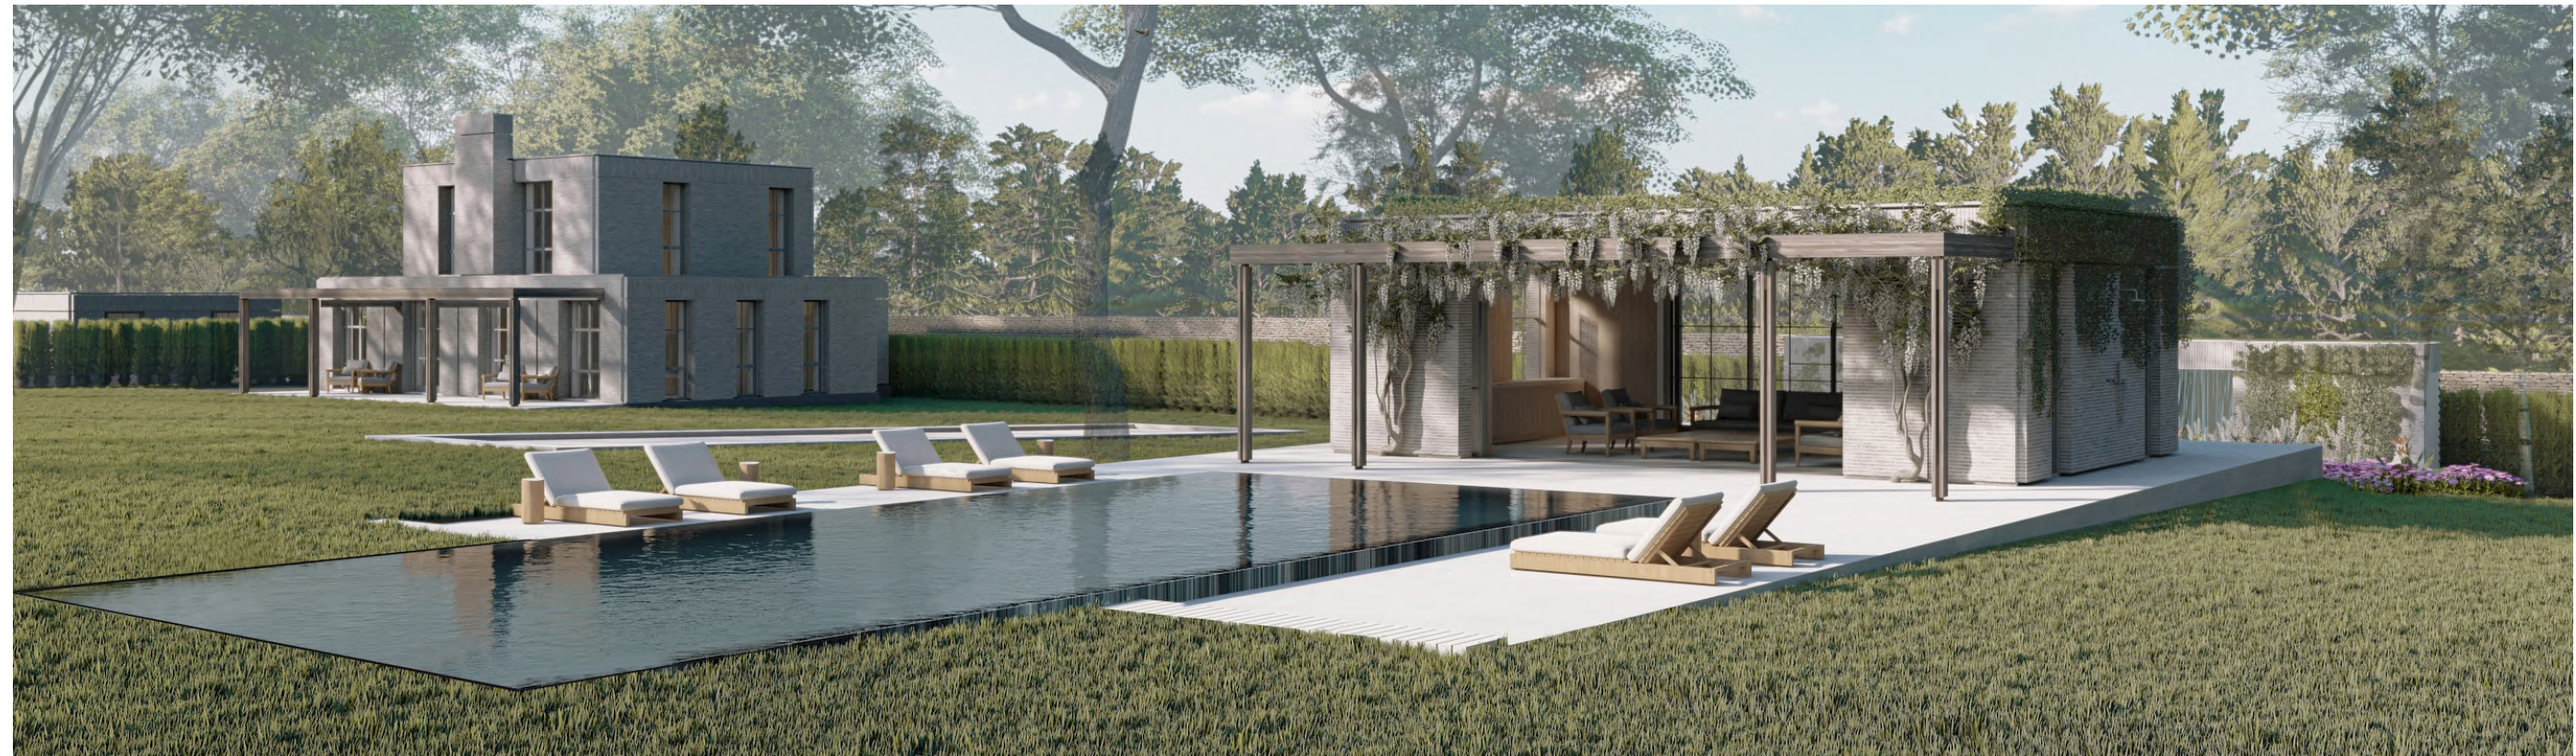
## OUTBUILDINGS

- Placement and scale of the secondary outbuildings are intentionally designed to be subordinate to the historic house and to preserve the public facing views of Woodlawn.
- Significant and historical features are preserved and remain on display for the public.

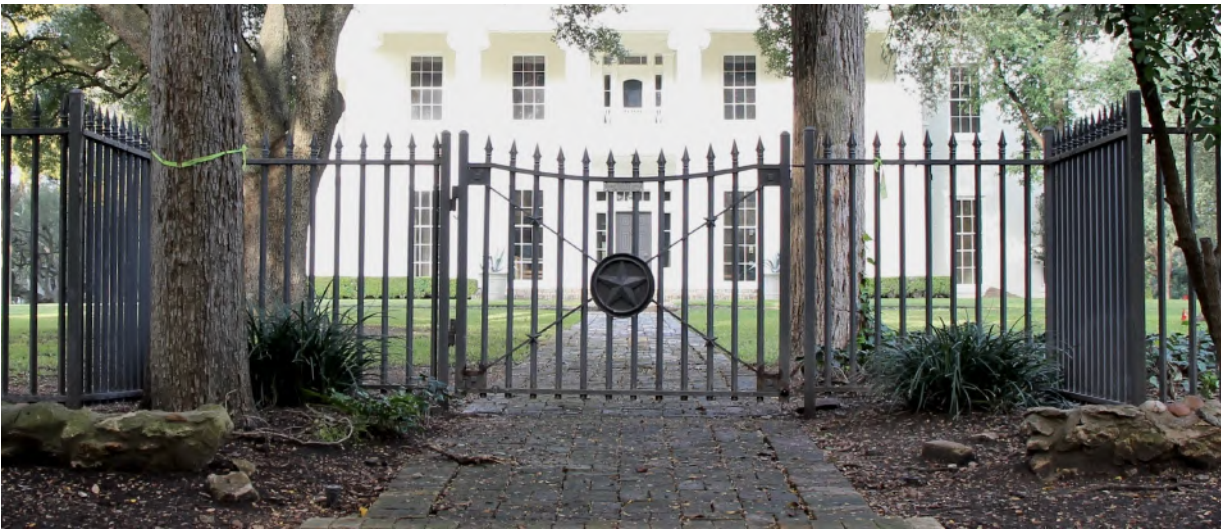
Existing Pedestrian Gate is 5 feet tall

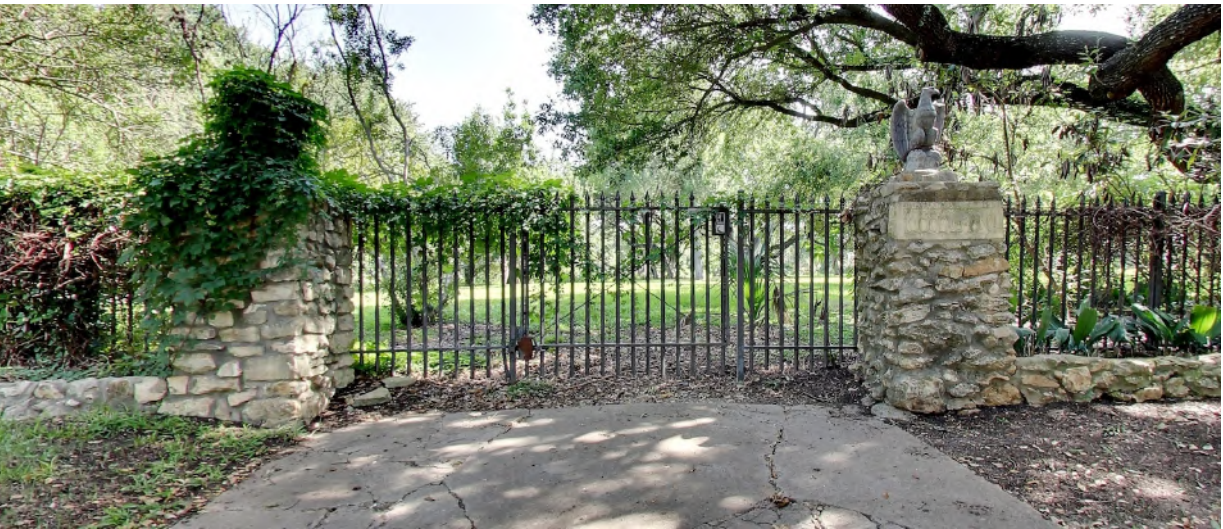
Existing Pedestrian Gate at southwest corner is 5 feet tall

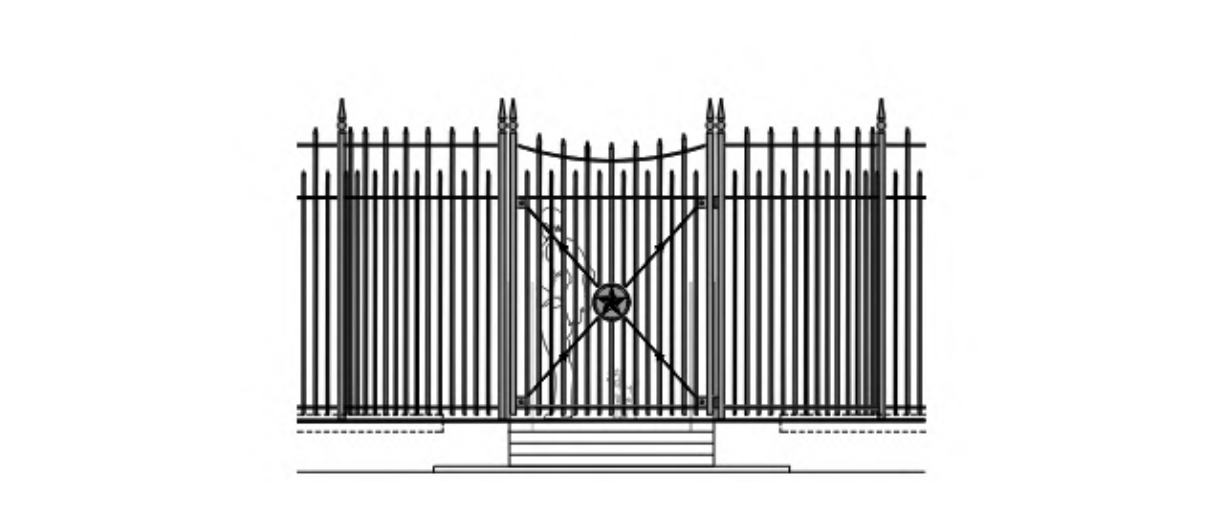
Proposed Pedestrian Gate with reclaimed and restored Texas star medallion & crossbows is 8 feet tall

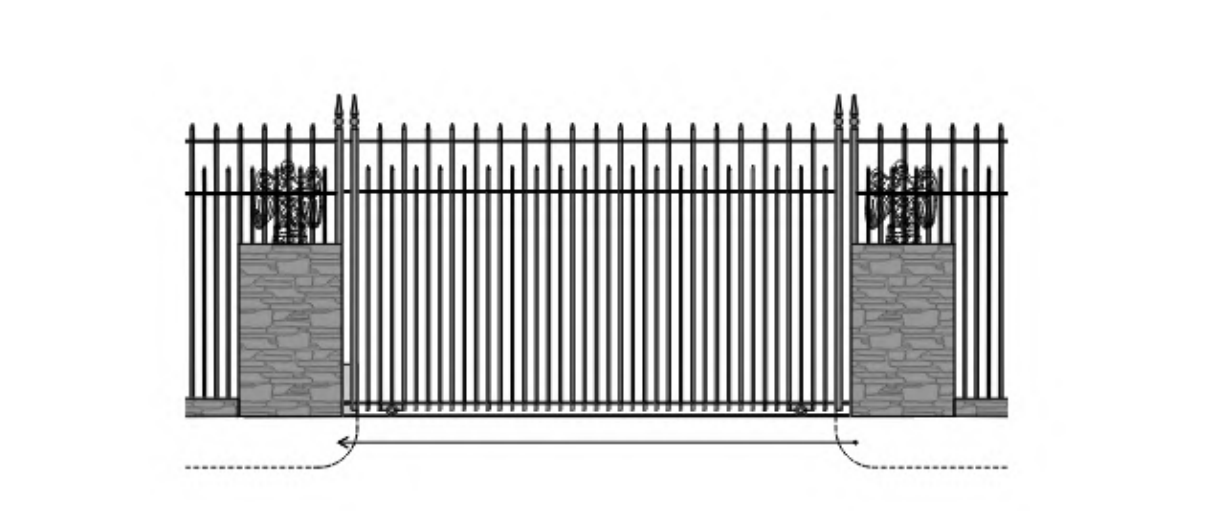
Proposed Vehicular Gate. Re-instate driveway at southwest corner is 8 feet tall

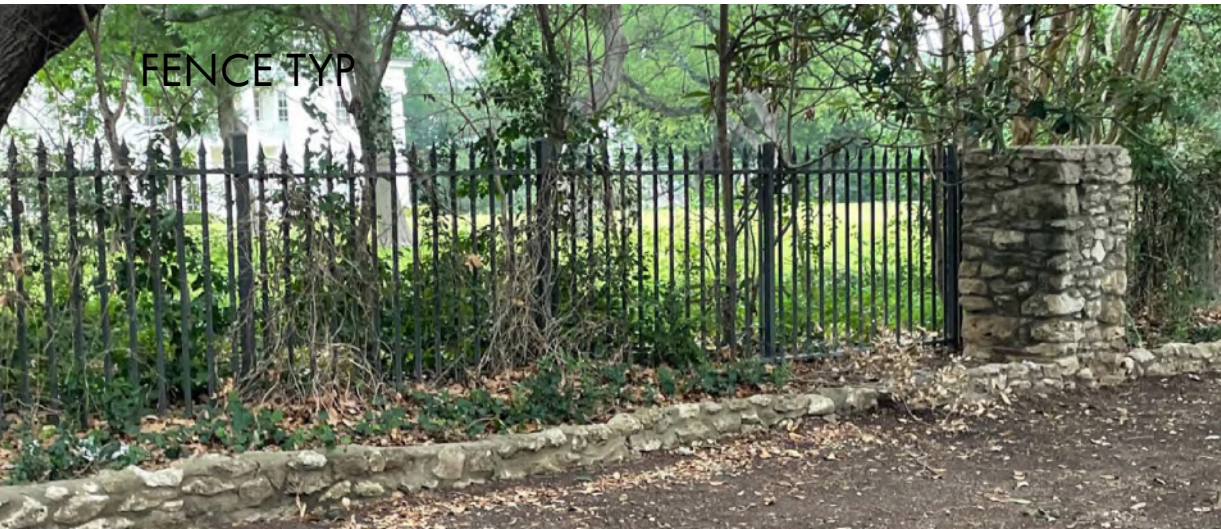
Existing Perimeter Fence is 5 feet tall

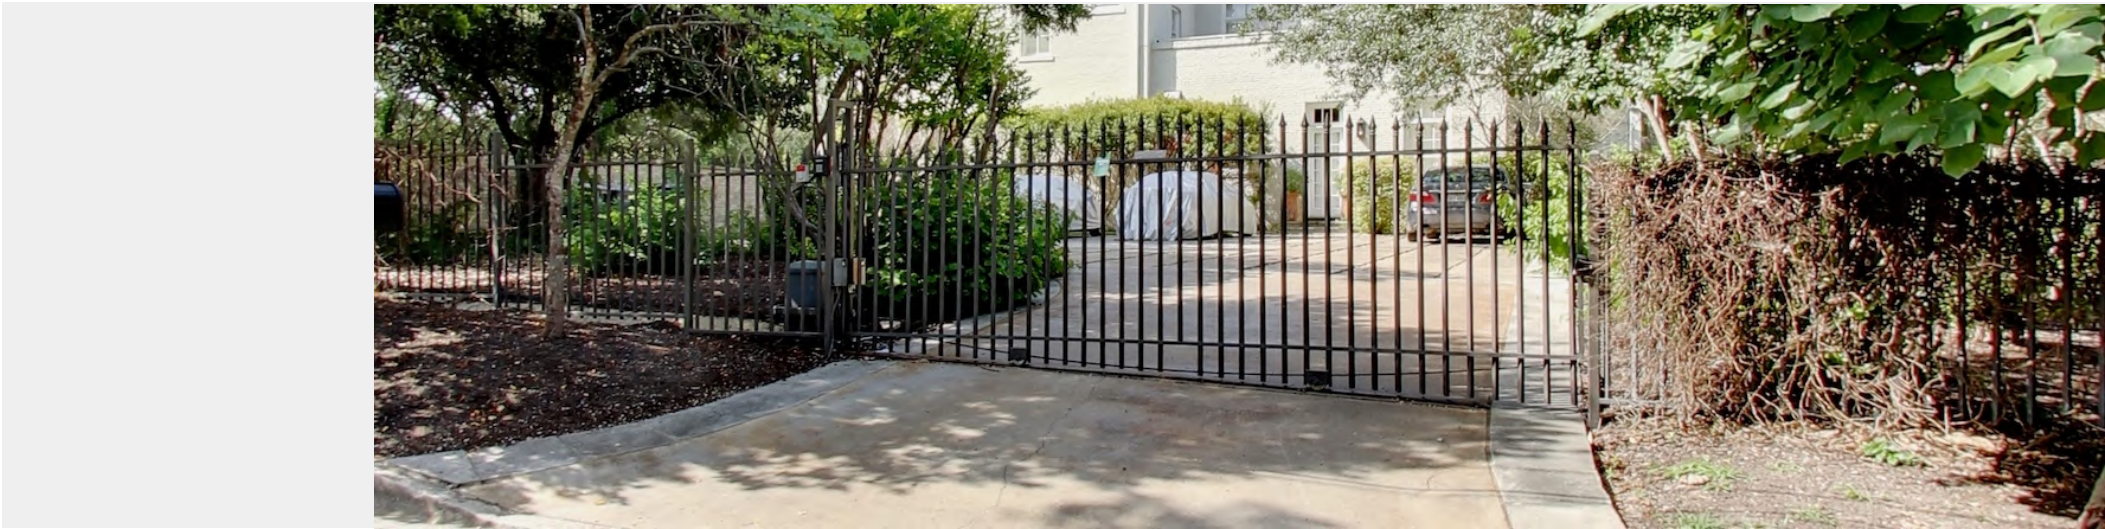
Existing North Vehicular Gate is 5 feet tall

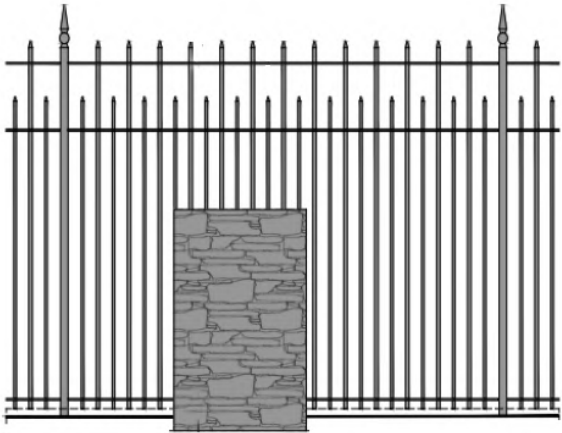
Proposed Perimeter Fence is 8 feet tall

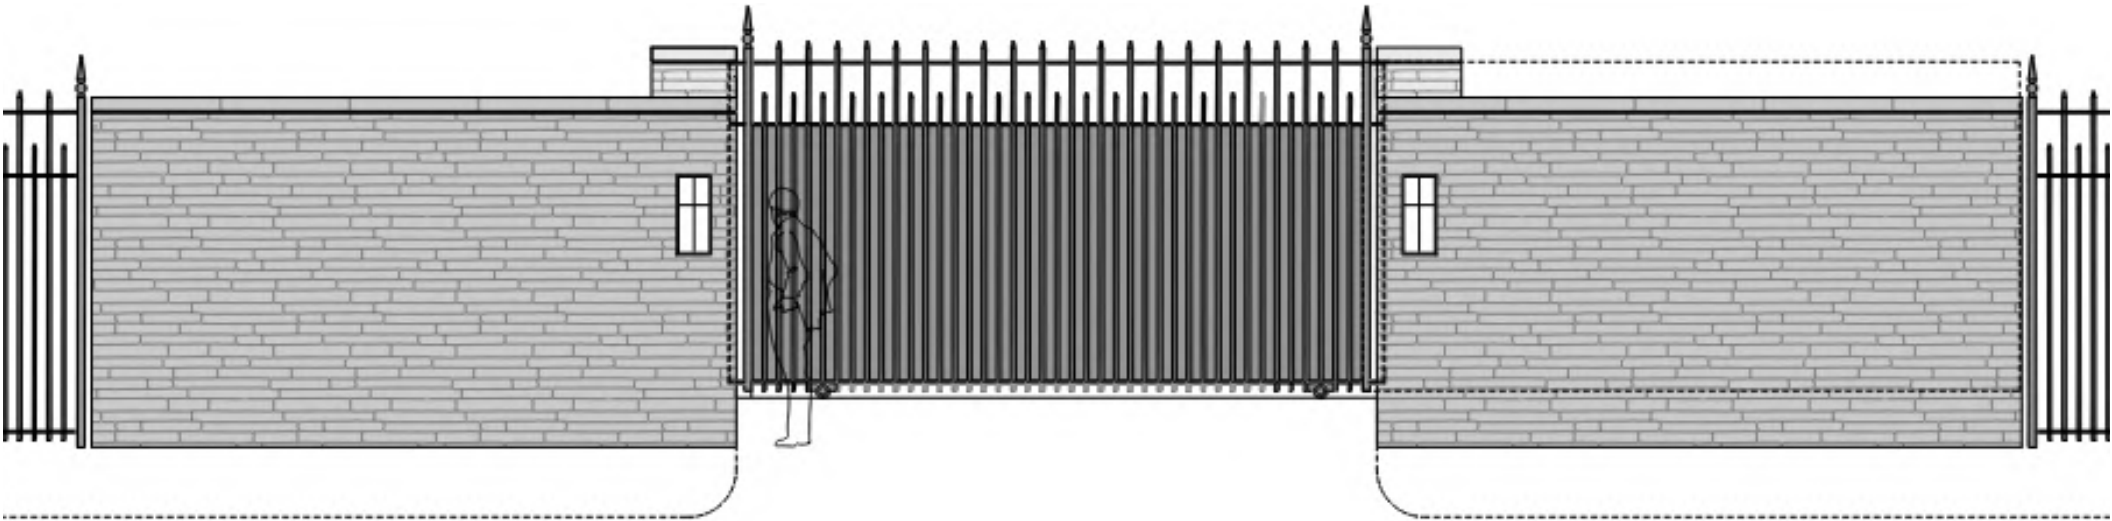
Proposed North Vehicular Gate is 8 feet tall

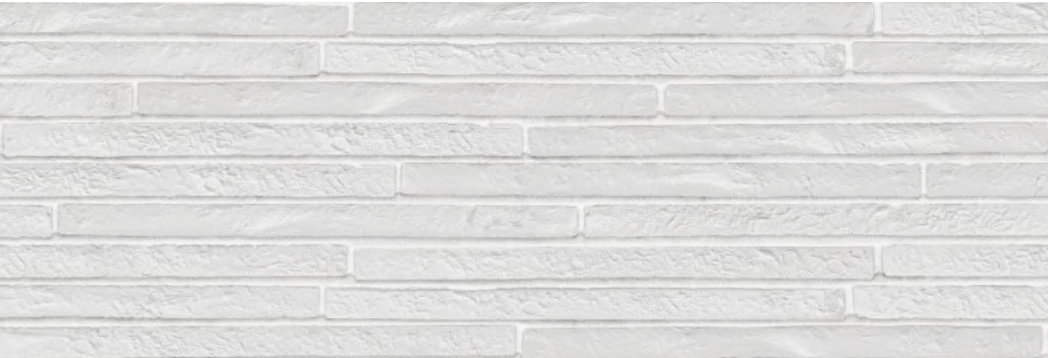
Petersen Brick - K11

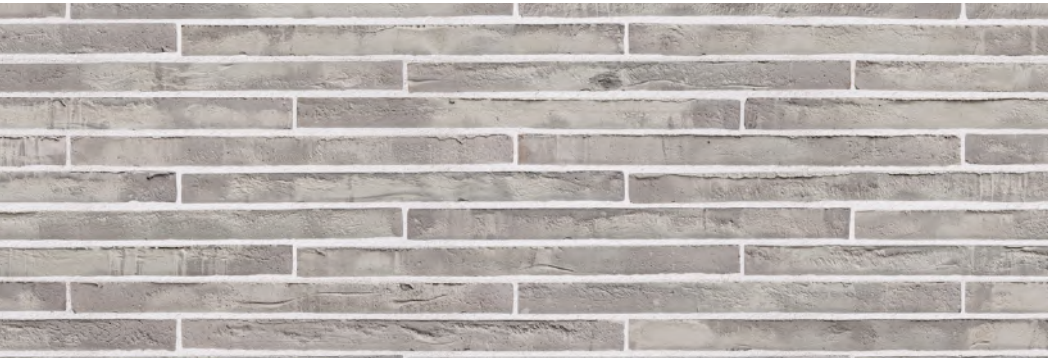
Petersen Brick - K91
