APPENDIX II PHOTO GALLERY

11 SP-2022-0426C.SH - Blueridge Multifamily at Wildhorse Ranch; District 1 3 of 39

CITY OF AUSTIN ENVIRONMENTAL RESOURCE INVENTORY FOR THE WILDHORSE HILLTOP TRACT

Environmental Resource Inventory

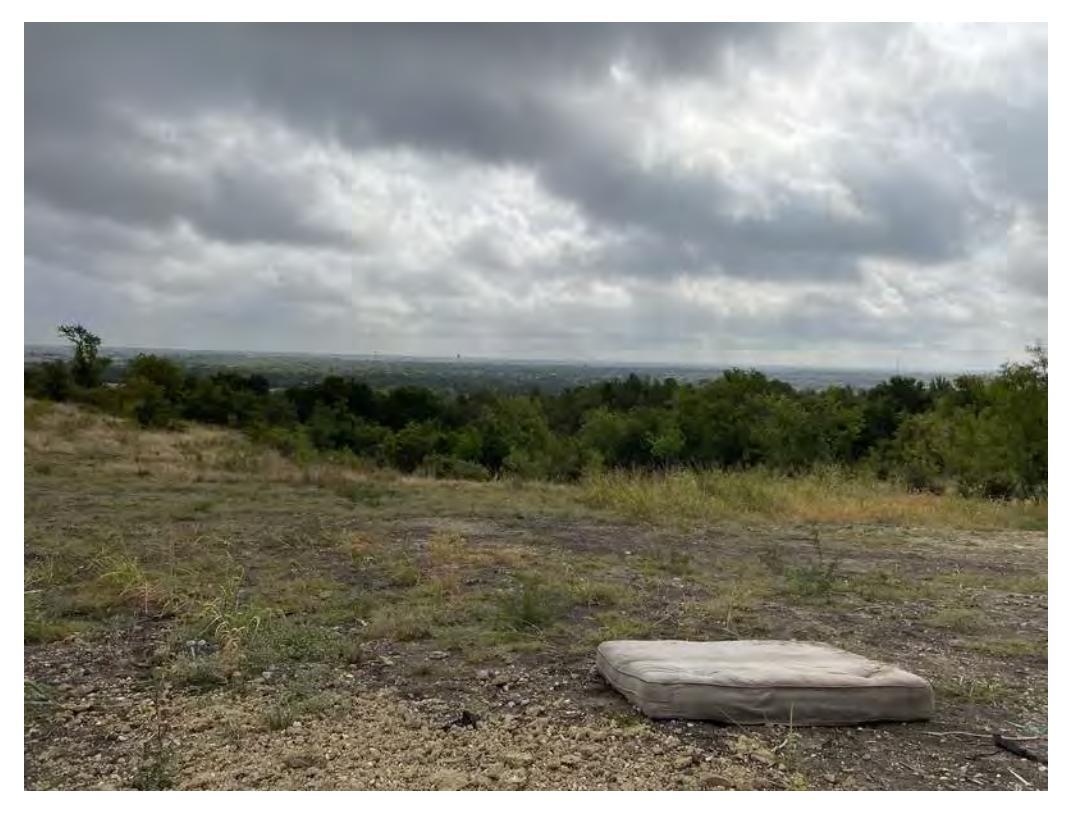
2. Mattress discarded at the southern portion of the subject property

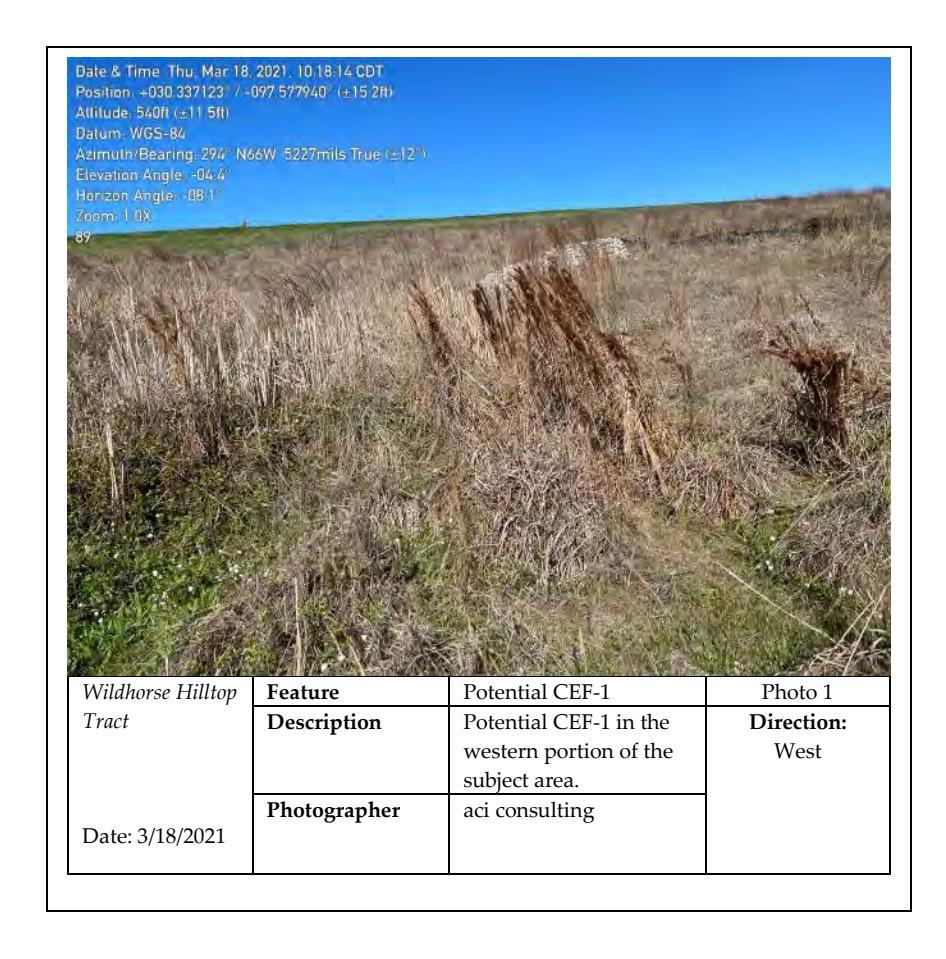
CEF-1 is an emergent riverine wetland located in the western portion of the subject area around a pond. CEF-1 was saturated at the time of the field visit. CEF-1 had wetland hydrology, hydric soils, and is dominated by hydrophytic vegetation such as common spike rush, bushy bluestem, and broadleaf cattails. The boundary between CEF-1 and the adjacent non-wetland was identified based on changes in hydrology, dominant plant composition, and soils. No FEMA Flood Hazard Zones extend onto the subject area at CEF-1. The total area of CEF-1 is approximately 30,582 square feet (0.702 acre) within the subject area (Photo 1).

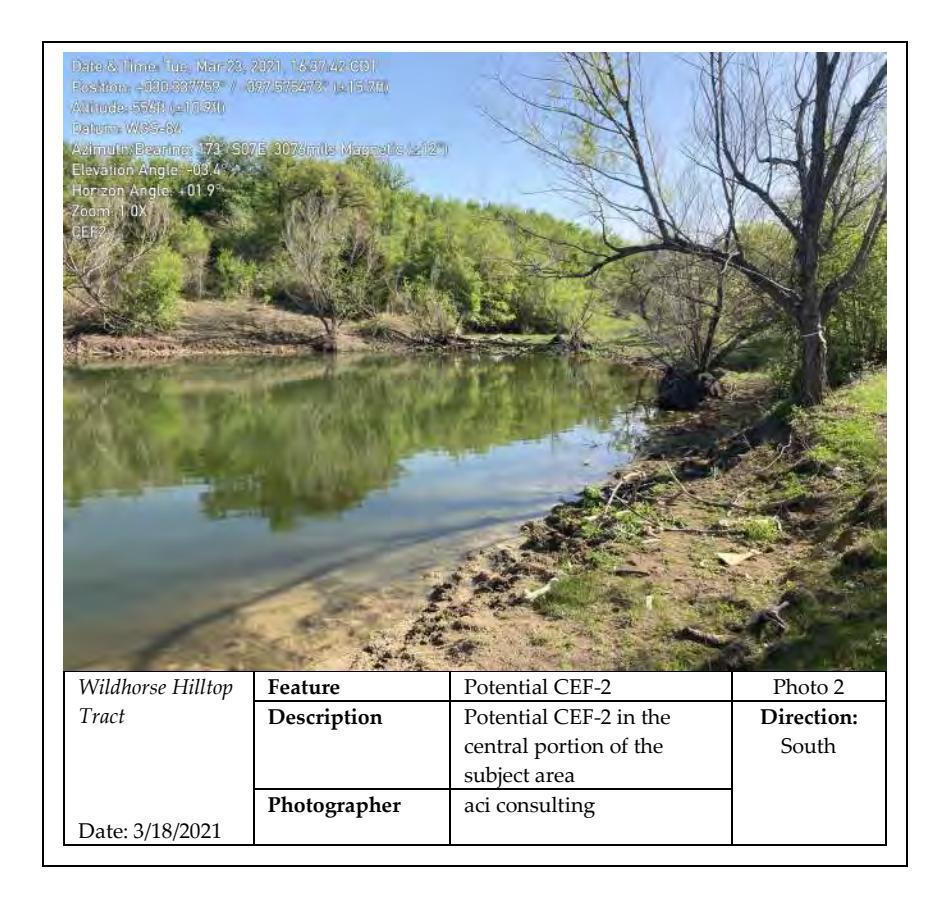
CEF-2 is a wetland fringe located in the central portion of the subject area. CEF-2 was saturated at the time of the field visit. CEF-2 had wetland hydrology, hydric soils, and is dominated by hydrophytic vegetation such as common spike rush and broadleaf cattails. The boundary between CEF-2 and the adjacent non-wetland was identified based on changes in hydrology, dominant plant composition, and soils. No FEMA Flood Hazard Zones extend onto the subject area at CEF-2. The total area of CEF-2 is approximately 3,793 square feet (0.087 acre) within the subject area (Photo 2).

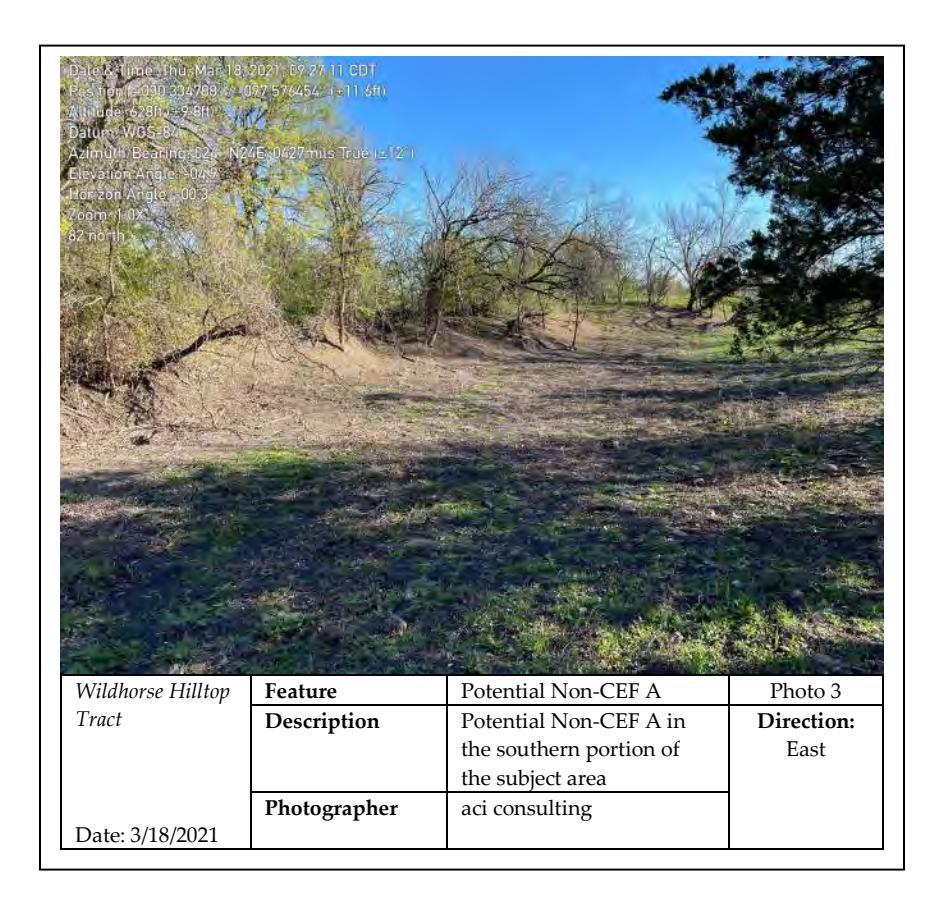
Non-CEF A is a stock pond located in the southeastern portion of the subject area. Non-CEF A was not inundated or saturated at the time of the field visit. No FEMA Flood Hazard Zones extend onto the subject area at Non-CEF A. Non-CEF A lacks emergent vegetation and hydric soils and is therefore a non-wetland. The total area of Non-CEF A is approximately 3,489 square feet, or approximately 0.08 acre within the subject area (Photo 3).

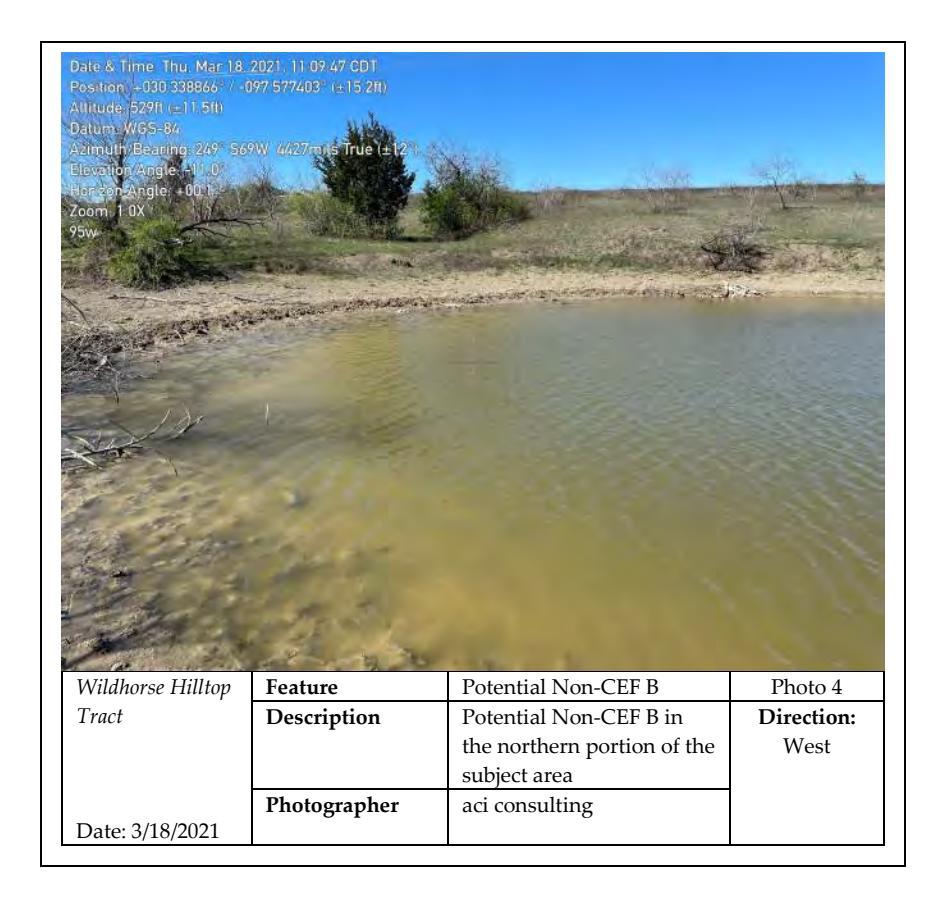
Non-CEF B is a stock pond located in the northern portion of the subject area. Non-CEF B was inundated at the time of the field visit. No FEMA Flood Hazard Zones extend onto the subject area at Non-CEF B. Non-CEF B lacks emergent vegetation and hydric soils and is therefore a non-wetland. The total area of Non-CEF B is approximately 8,603 square feet, or approximately 0.19 acre within the subject area (Photo 4).

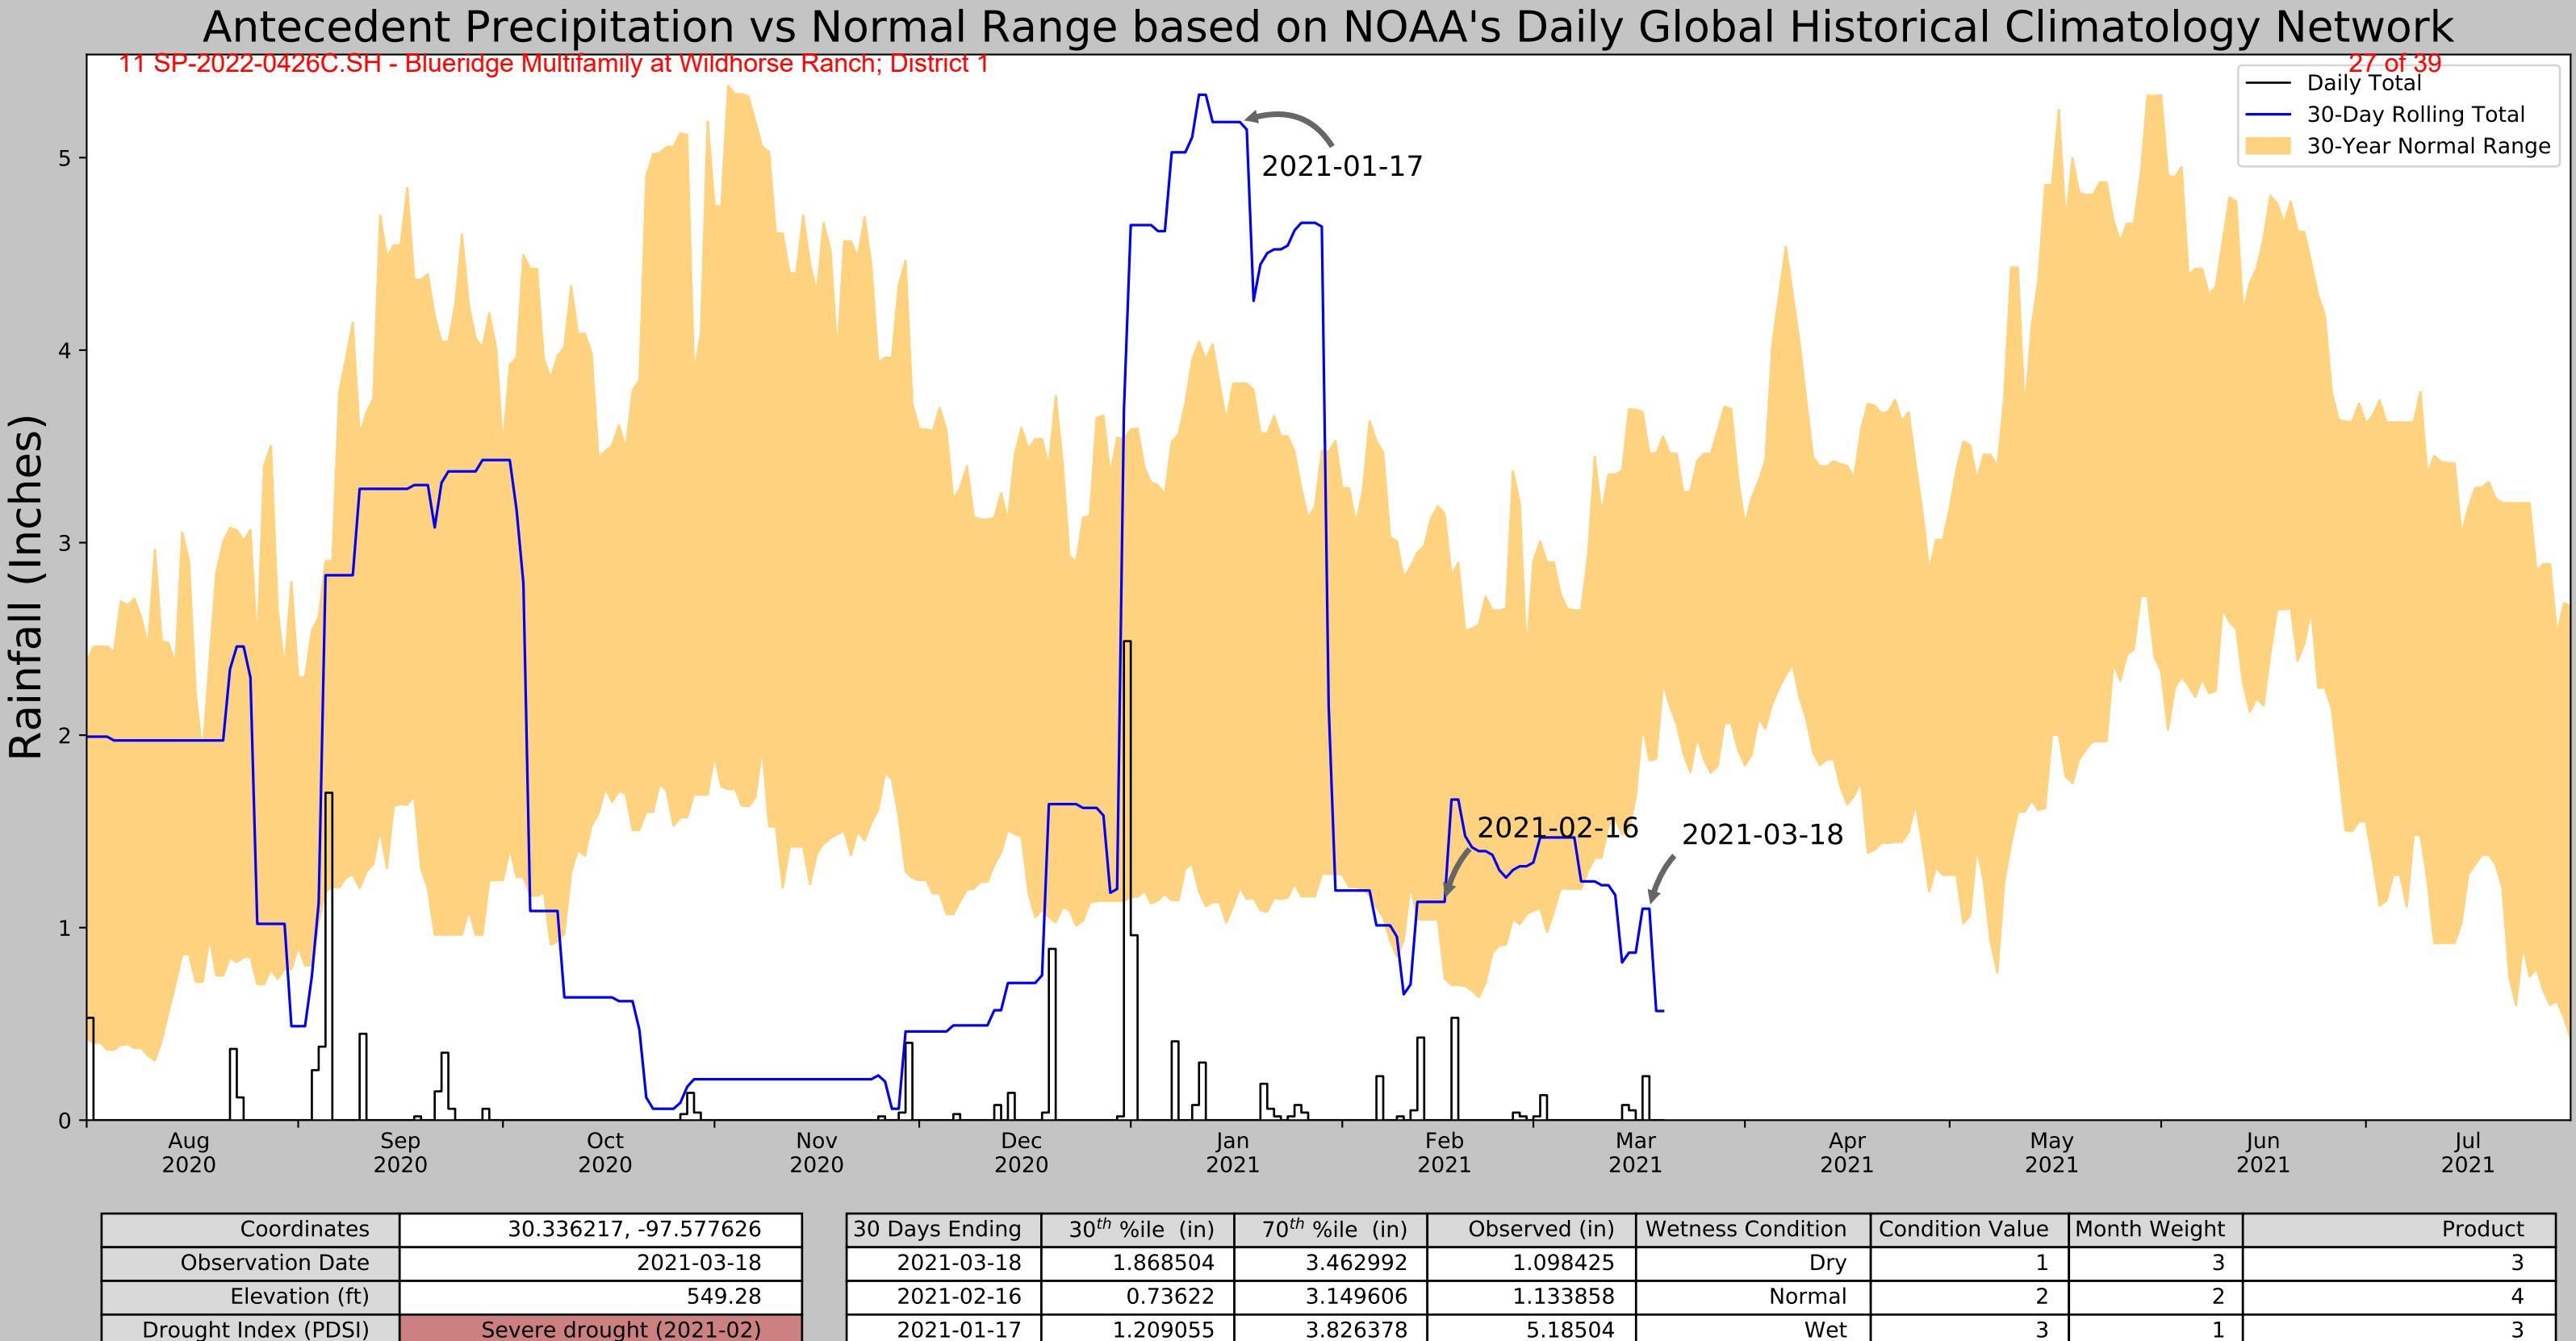
Result

Wet Season

Figure and tables made by the Antecedent Precipitation Tool Version 1.0 Written by Jason Deters

ondition Value	Month Weight	Product
1	3	3
2	2	4
3	1	3
		Normal Conditions - 10

The APT was utilized for the date of **aci consulting's** original site visit on March 18, 2021, to assess the local current conditions. The subject area scored a 10, which indicated normal conditions.
