## Lower Bull Creek District Park Contact Recreation Use Assessment Update, January 2011

January 2011; SR-11-07

City of Austin Watershed Protection Department  
Austin/Travis County Health and Human Services Department

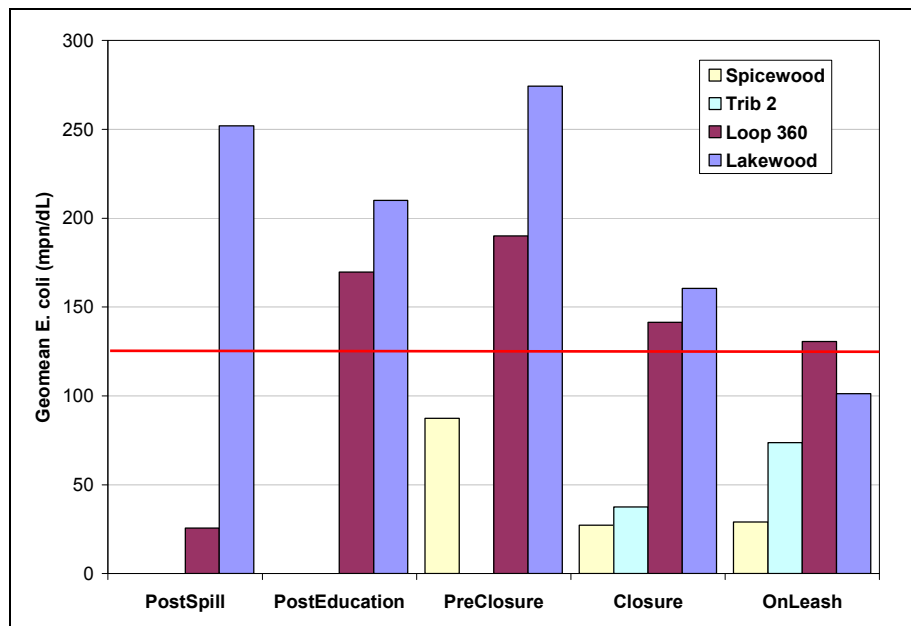
Figure 2. Site geometric mean *E. coli* by time period for groups with at least 5 measurement dates. Sites in upstream to downstream order, left to right. Monitoring at Trib 2 and Spicewood

began late in the post-education period and the Trib 2 site was frequently dry. The red line represents the Texas contact recreation standard (126 mpn/dL).

Site geometric means were calculated by time period for each site with sufficient data and compared to the TCEQ contact recreation standard (Figure 2). The time periods are defined by relevant management actions (Table 2). The historic geometric mean *E. coli* at the Loop 360 site based on 17 measurements from 2003 to 2007 is 70 mpn/dL. Monitoring at Trib 2 and Spicewood was not initiated until late in the post-education period, and the Trib 2 site was frequently dry.

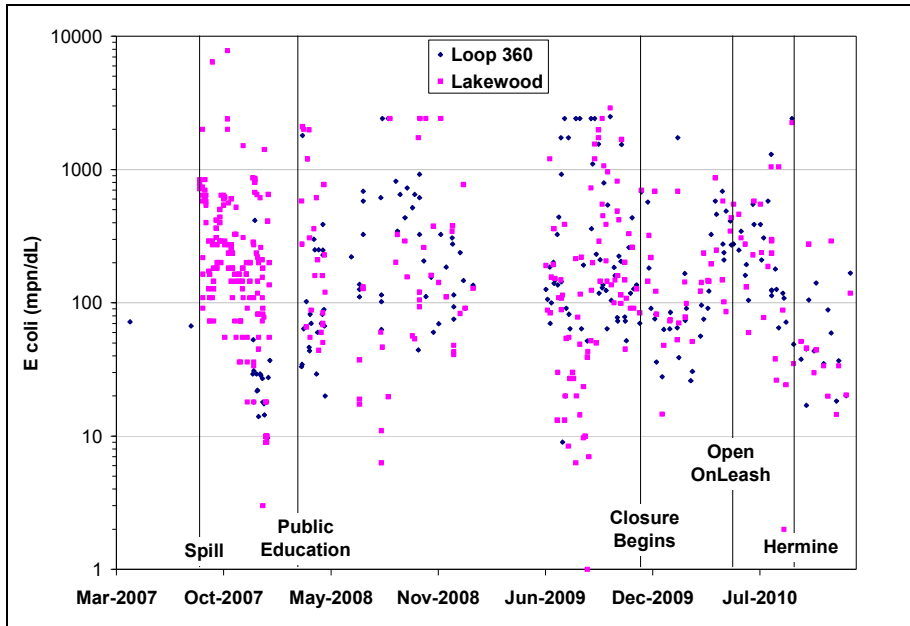
Figure 3. *E. coli* at the Lakewood and Loop 360 monitoring locations over time from 2007 to 2010 with vertical bars marking significant events in time.

Bacteria levels increased at the Loop 360 site following the onset of public education and remained elevated throughout the remainder of the study until Tropical Storm Hermine in September 2010 (Figure 3). The historic *E. coli* geometric mean at Loop 360 is 70 mpn/dL (n=17, 2003-2007). Bacteria levels began to decrease at the Lakewood Drive monitoring site during the closure period, and fell below the standard during the on-leash period for the first time. The Trib 2 site flows less frequently than mainstem Bull Creek, and the upstream sites maintain lower bacteria levels than sites in the park.

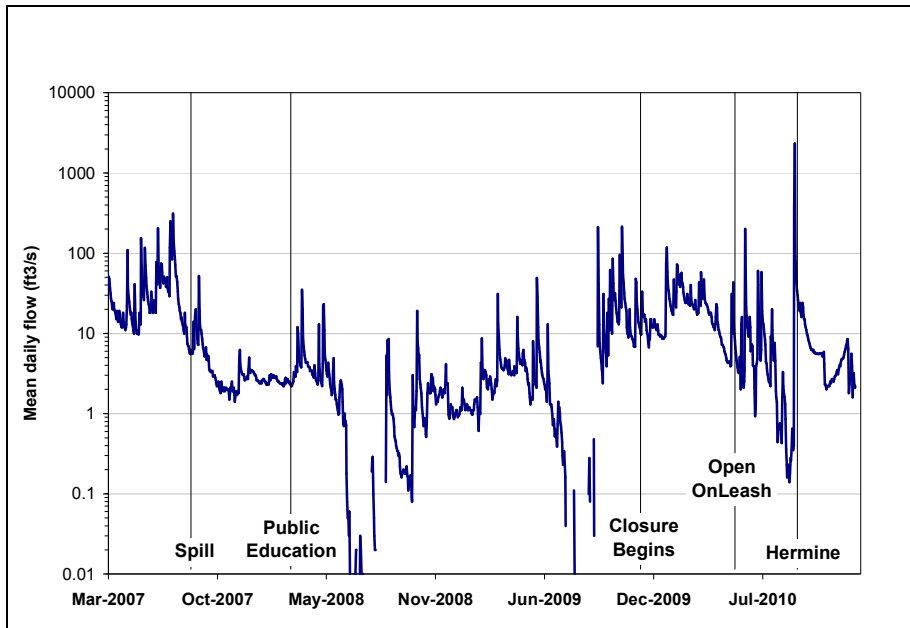
Figure 4. Mean daily flow in Bull Creek from the USGS gauge at Loop 360 (08154700).

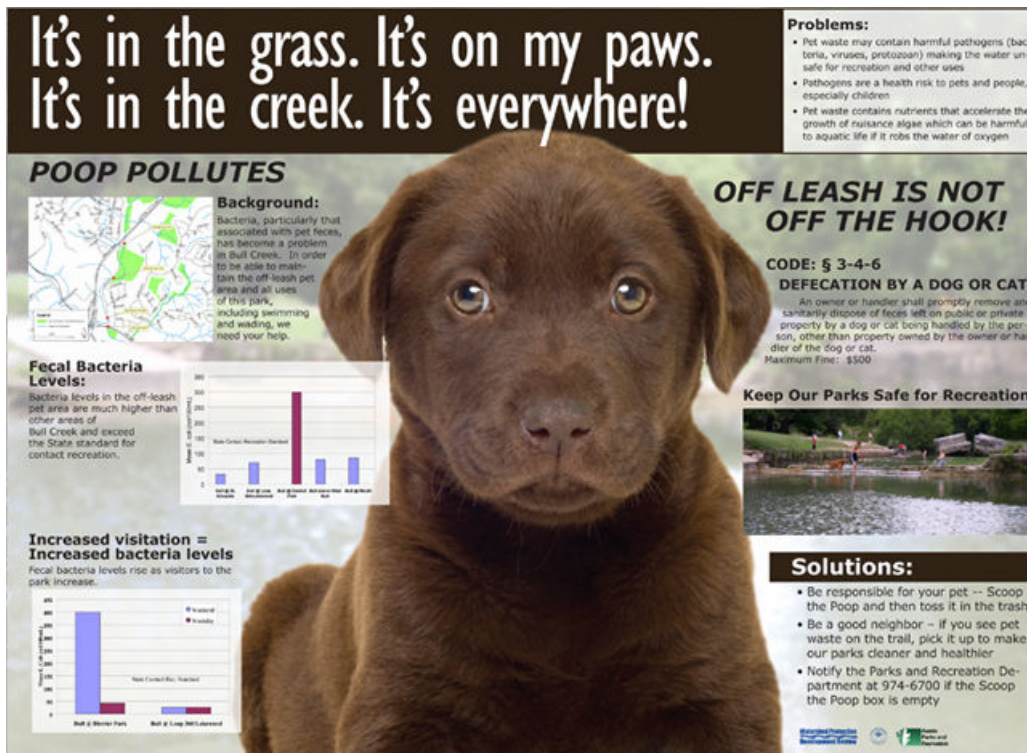
Figure 5. Example of educational signage posted in Bull Creek District Park.

A public education campaign was initiated in March 2008 in an attempt to inform the public of the potential for fecal contamination of Bull Creek from uncollected dog waste. A press conference was held in the park that was well covered by local media, signage was posted in the park (Figure 5), and individual outreach was conducted to park users. *E. coli* monitoring results were regularly posted in a kiosk at the park along with warning signs. Public opinion surveys were conducted before and after the education campaign. There was a 31% increase in the number of respondents who believed that uncollected dog waste was a potential water quality problem, and 60% of respondents claimed to pick up dog waste more frequently.

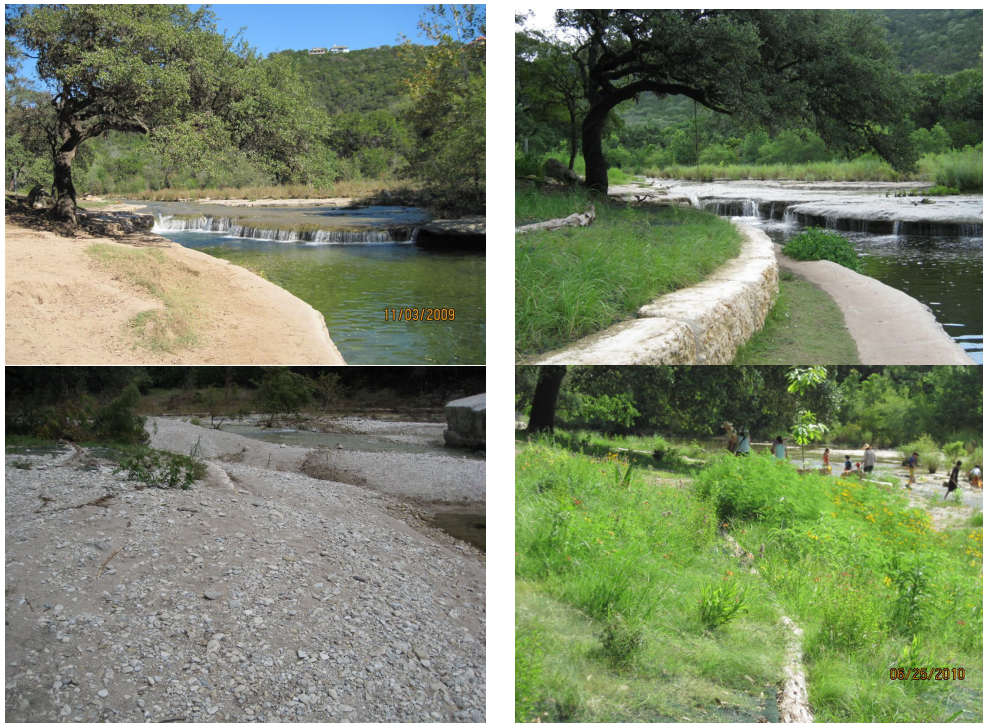
Figure 7. Area near the “horseshoe” waterfall looking upstream: Before restoration (Top left), after restoration (top right), after Tropical Storm Hermine (lower left); Area upstream of waterfall soon after restoration showing successful revegetation (lower right)

park is in a floodplain, the flooding and deposition is a natural occurrence and was not unexpected. In the long term this deposited material will be beneficial to the riparian landscape. However, in the short term WPD is proceeding to re-establish the limited areas of vegetation that were impacted which may extend the time required for full establishment of the new vegetation. Although the damage to the overall project was considered minimal, the landscape near the limestone block wall will require additional time to heal. As for the creek itself, the former “horseshoe” waterfall area was completely filled in by sediments (Figure 7).

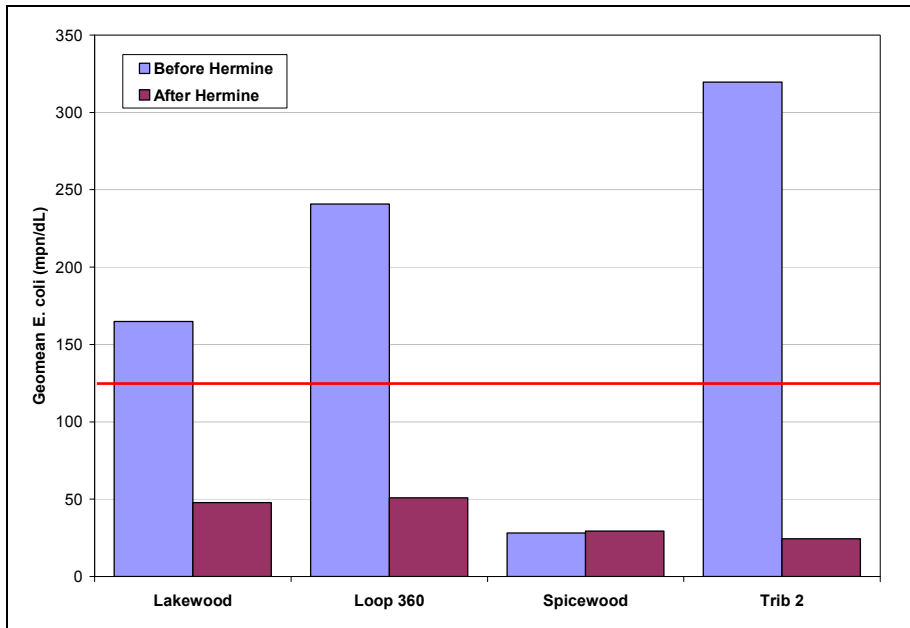
Figure 8. *E. coli* geometric means before (left, blue bar) and after Hermine (right, red bar), during the on-leash only period June 2010 to December 2010.

Unfortunately Tropical Storm Hermine caused considerable damage to the mitigation areas related to the new Lakewood Drive low water crossing project, with trees and a parking lot removed by floodwaters on the south side of the creek. The flood either scoured or buried older sediment deposits near the Lakewood Drive monitoring site. This impact to the sediment was related to an overall reduction in the *E. coli* levels as shown in figure 8.

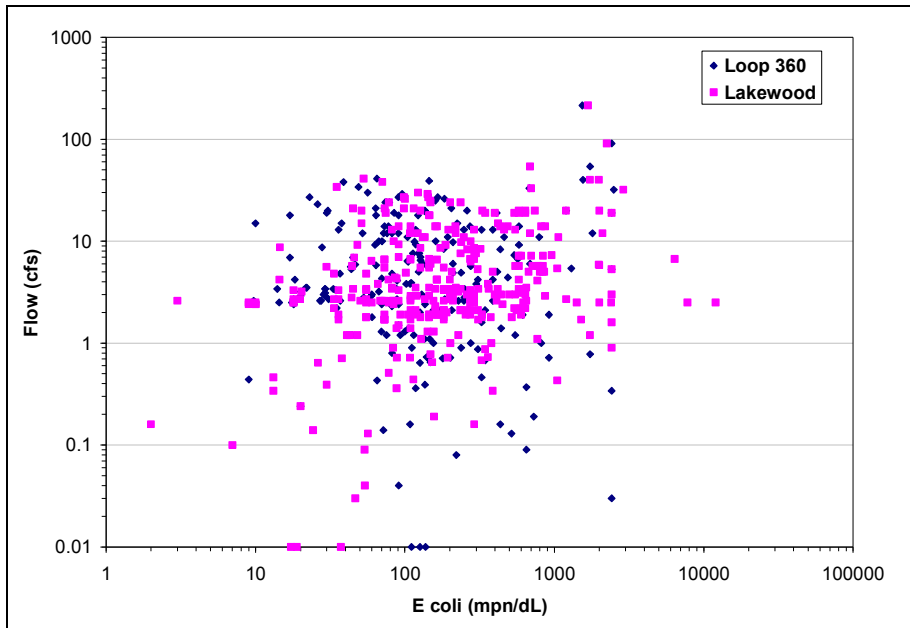
Figure 9. E. coli (mpn/dL) versus mean daily stream flow (ft<sup>3</sup>/s) for the Lakewood and Loop 360 sites using all data.

In general there is little significant correlation between *E. coli* and mean daily stream flow measured by the USGS gauge at Loop 360 (08154700) as assessed by Kendall's tau-B correlation analysis (Table 5, Figure 9). *E. coli* at Lakewood was positively correlated with flow during the post-spill, post-education and on-leash monitoring periods. *E. coli* values at the Loop 360 site were inversely related to flow during the post-education period.

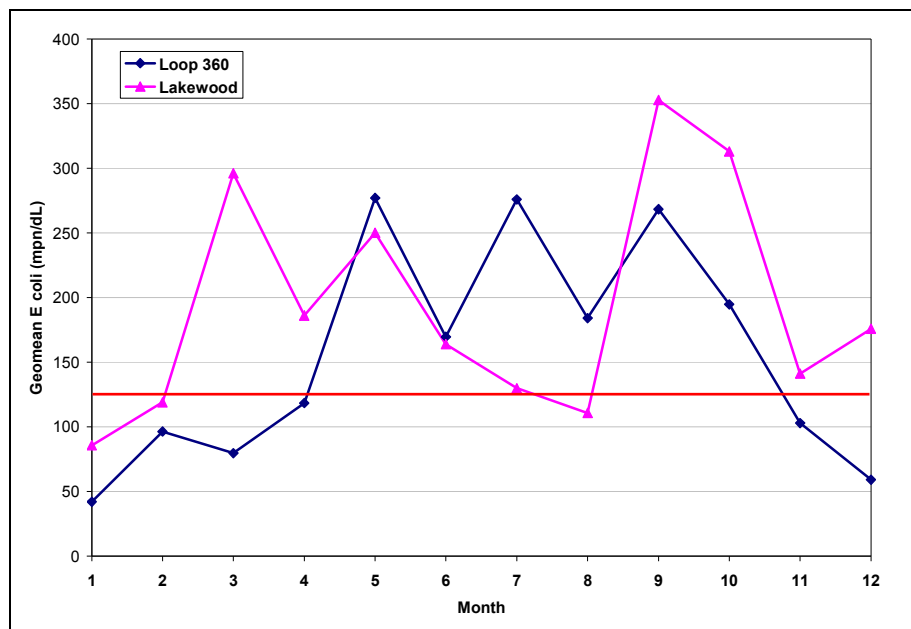
Figure 10. Monthly geometric mean *E. coli* for all data. The red line represents the Texas contact recreation standard of 126 mpn/dL.

There is no clear pattern in average monthly *E. coli* geometric means at the Lakewood or Loop 360 sites (Figure 10). January yielded the lowest overall monthly geometric means at both sites. The Lakewood site may yield higher geometric mean *E. coli* during the spring and summer months although the Loop 360 site may yield higher summer geometric mean *E. coli* values.

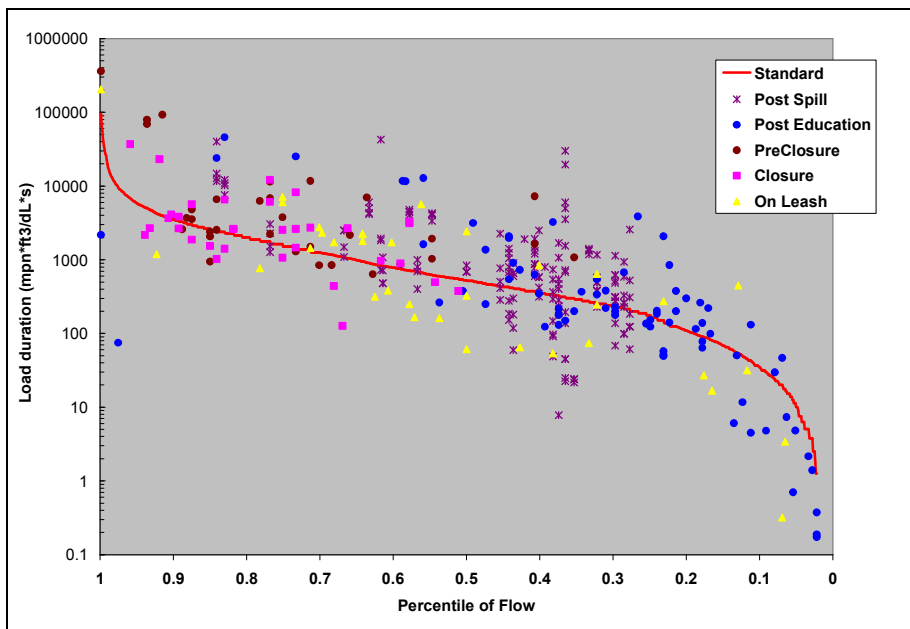
Figure 11. Load duration curve for the Lakewood site by time period calculated using mean daily flows from the USGS gauge at Loop 360 (08154700). The horizontal axis represents the percentile of flow, with the largest recorded flow values at the left of the graph. The red line represents the Texas contact recreation standard, and values above the line exceed the standard.

Load duration curves are recognized tools for non-point or point-source determination in Total Maximum Daily Load assessments (EPA 2007). Load duration curves characterize water quality under different flow regimes to visualize the frequency and magnitude of standard exceedances. Impairments observed under low flow regimes typically indicate point source impacts while impairments observed under high flow regimes typically indicate non-point source impacts. Load duration curves were calculated for the Lakewood (Figure 11) and Loop 360 (Figure 12) sites by following EPA methodology using the mean daily flows from the USGS flow gauge at Loop 360 (08154700) without including a margin of safety in the contact recreation standard as the curves are not being used for actual TMDL apportionment.

Exceedances of the standard occurred across the range of flow regimes at the Lakewood site, suggesting a combination of point and non-point source impacts. There are clear differences in the post-spill periods before education began between the Loop 360 and Lakewood sites, with few exceedances at Loop 360 but consistent exceedances at Lakewood. The post-spill, pre-education time period was consistent with historical monitoring at Loop 360. The reduction in bacteria levels during the on-leash period occurred primarily after the flooding of Tropical Storm Hermine (Figure 13).

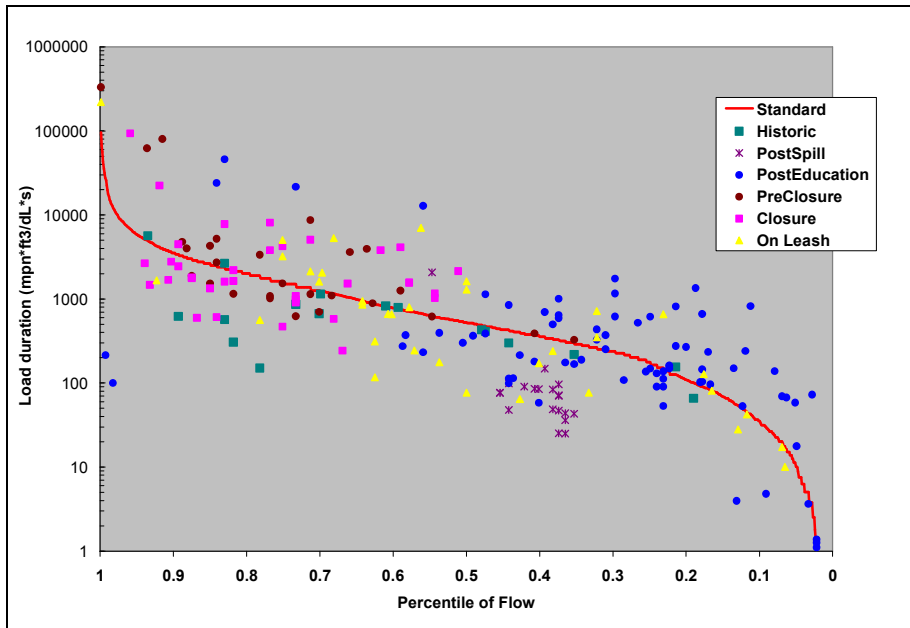
Figure 12. Load duration curve for the Loop 360 site by period using mean daily flows from the USGS gauge at Loop 360 (08154700). The horizontal axis represents the percentile of flow, with the largest recorded flow values at the left of the graph. The red line represents the Texas contact recreation standard, and values above the line exceed the standard.

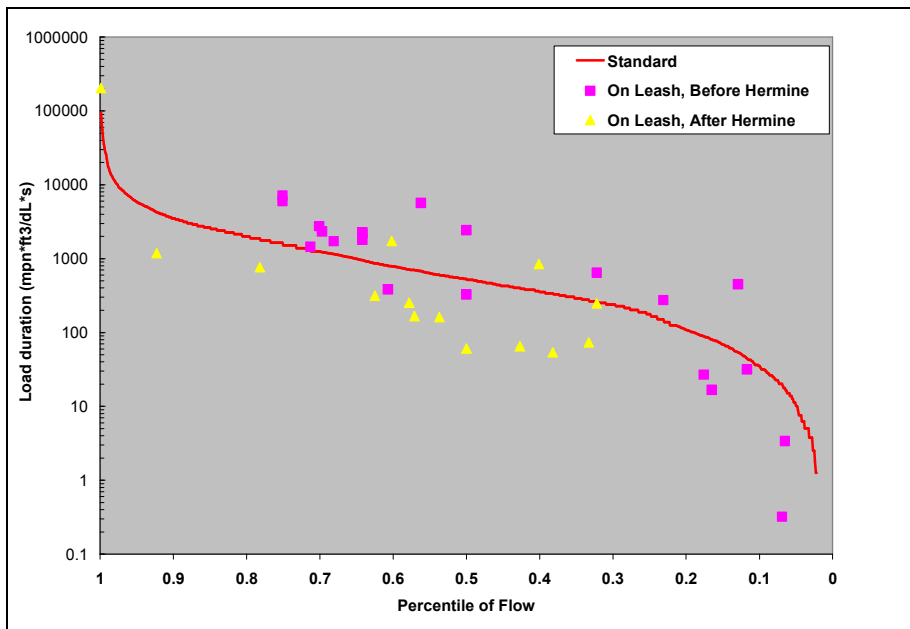
Figure 13. Load duration curve for the Lakewood site during the on-leash period with data separated before and after Tropical Storm Hermine. The horizontal axis represents the percentile of flow, with the largest recorded flow values at the left of the graph. The red line represents the Texas contact recreation standard, and values above the line exceed the standard.

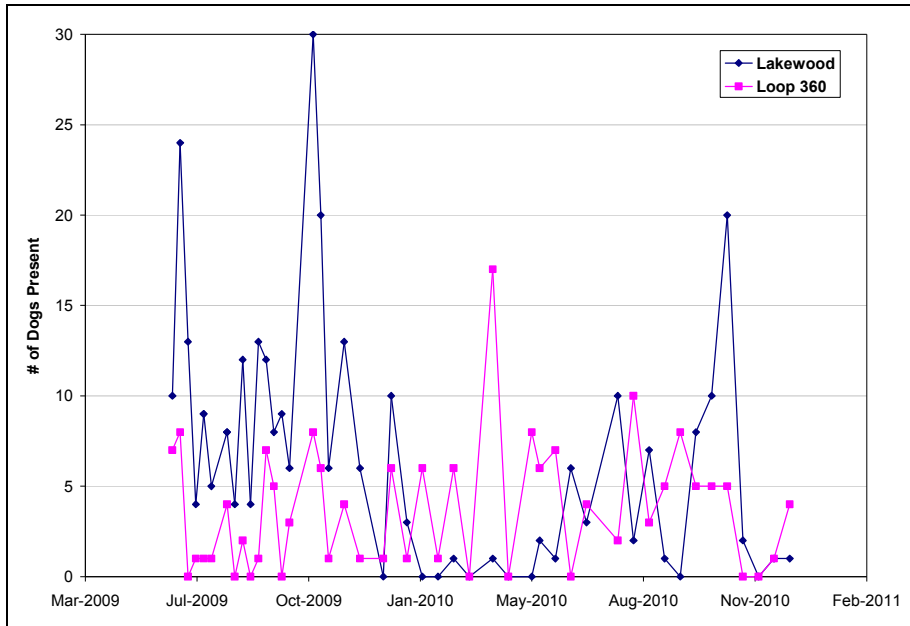
Figure 14. Number of dogs present at weekend sampling events.

The number of dogs (Figure 14) and people (Figure 15) present are counted instantaneously by WPD staff during weekend sampling events at the Loop 360 and Lakewood sites, typically performed in the early afternoon hours on a Sunday. There is no statistically significant

correlation with time by Kendall's tau-B analysis for the number of people or number of dogs present at the Loop 360 site for the period of record. There is a negative correlation of the number of dogs present ( $\text{tau-B} = -0.32$ ,  $n=48$ ,  $\text{Pr} > \text{tau} = 0.0019$ ) at the Lakewood site over time for the period of record, but no significant correlation with time in number of people present at the Lakewood site.

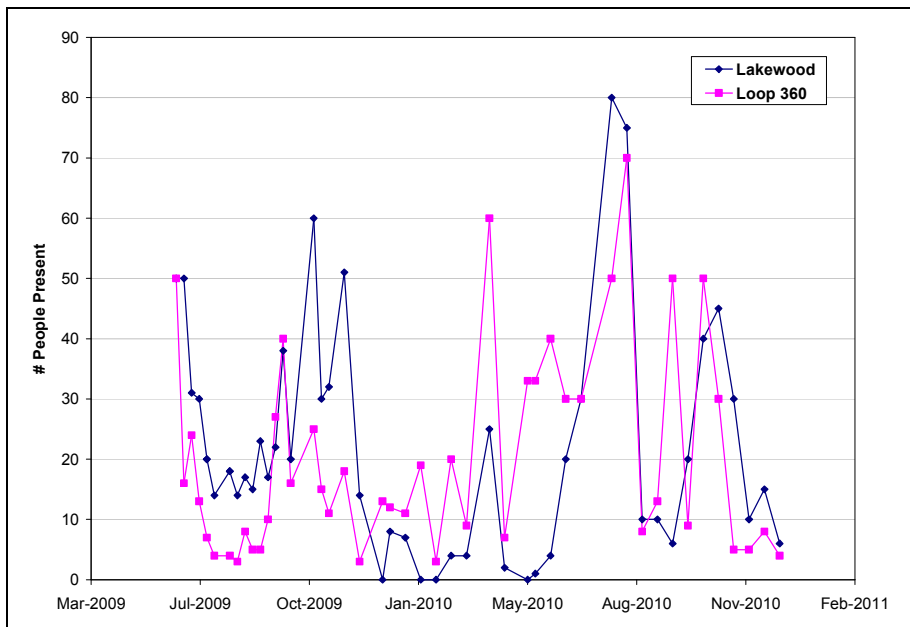
Figure 15. Number of people present at weekend sampling events.

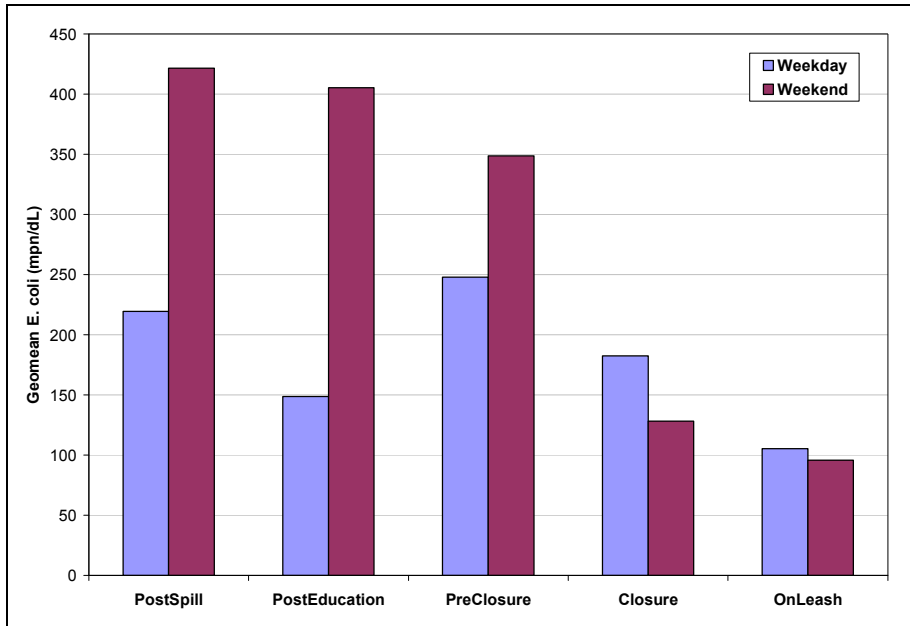
Figure 16. Geometric mean *E. coli* on weekdays (blue, left) and weekends (red, right) at the Lakewood site.

Previous analyses (COA 2008) noted a strong increase in *E. coli* concentrations on weekend days relative to weekdays, suggesting that park usage which is generally higher on weekends is correlated to indicator bacteria. The increased *E. coli* geometric mean on weekend pattern was maintained at the Lakewood site until the park was closed in December 2009 for restoration (Figure 16), although the difference in mean *E. coli* on weekends was only significant by the non-parametric Wilcoxon rank-sum test in the post-spill and post-education periods. A similar pattern of higher *E. coli* on weekends was never observed at the Loop 360 site (Figure 17). There is no significant difference by Wilcoxon rank-sum test between weekend and weekday *E. coli* at Loop 360 in any time period.

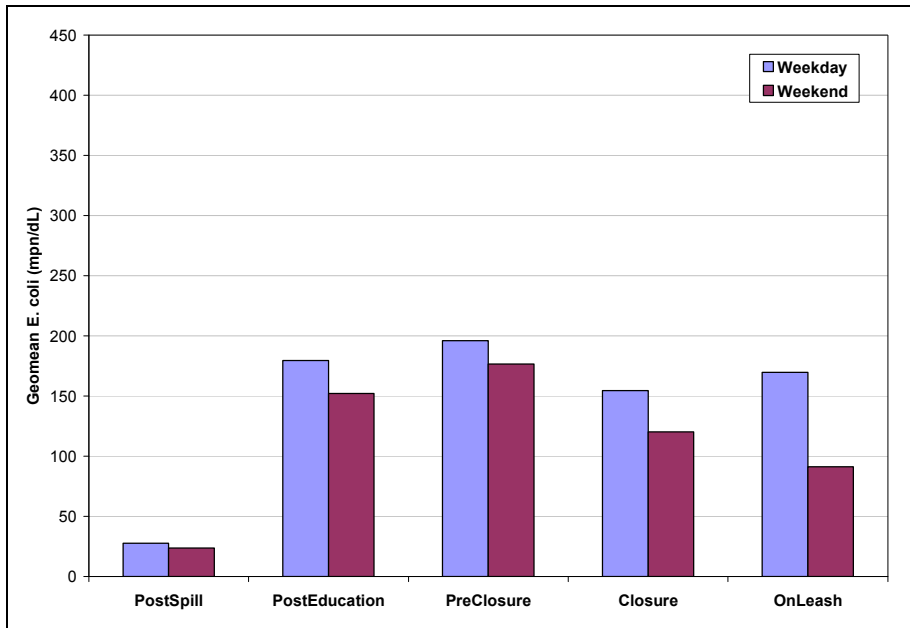
Figure 17. Geometric mean *E. coli* on weekdays (blue, left) and weekends (red, right) at the Loop 360 site.
