Barton Springs Pool *General Grounds Improvements Plan - East Entry Concept*

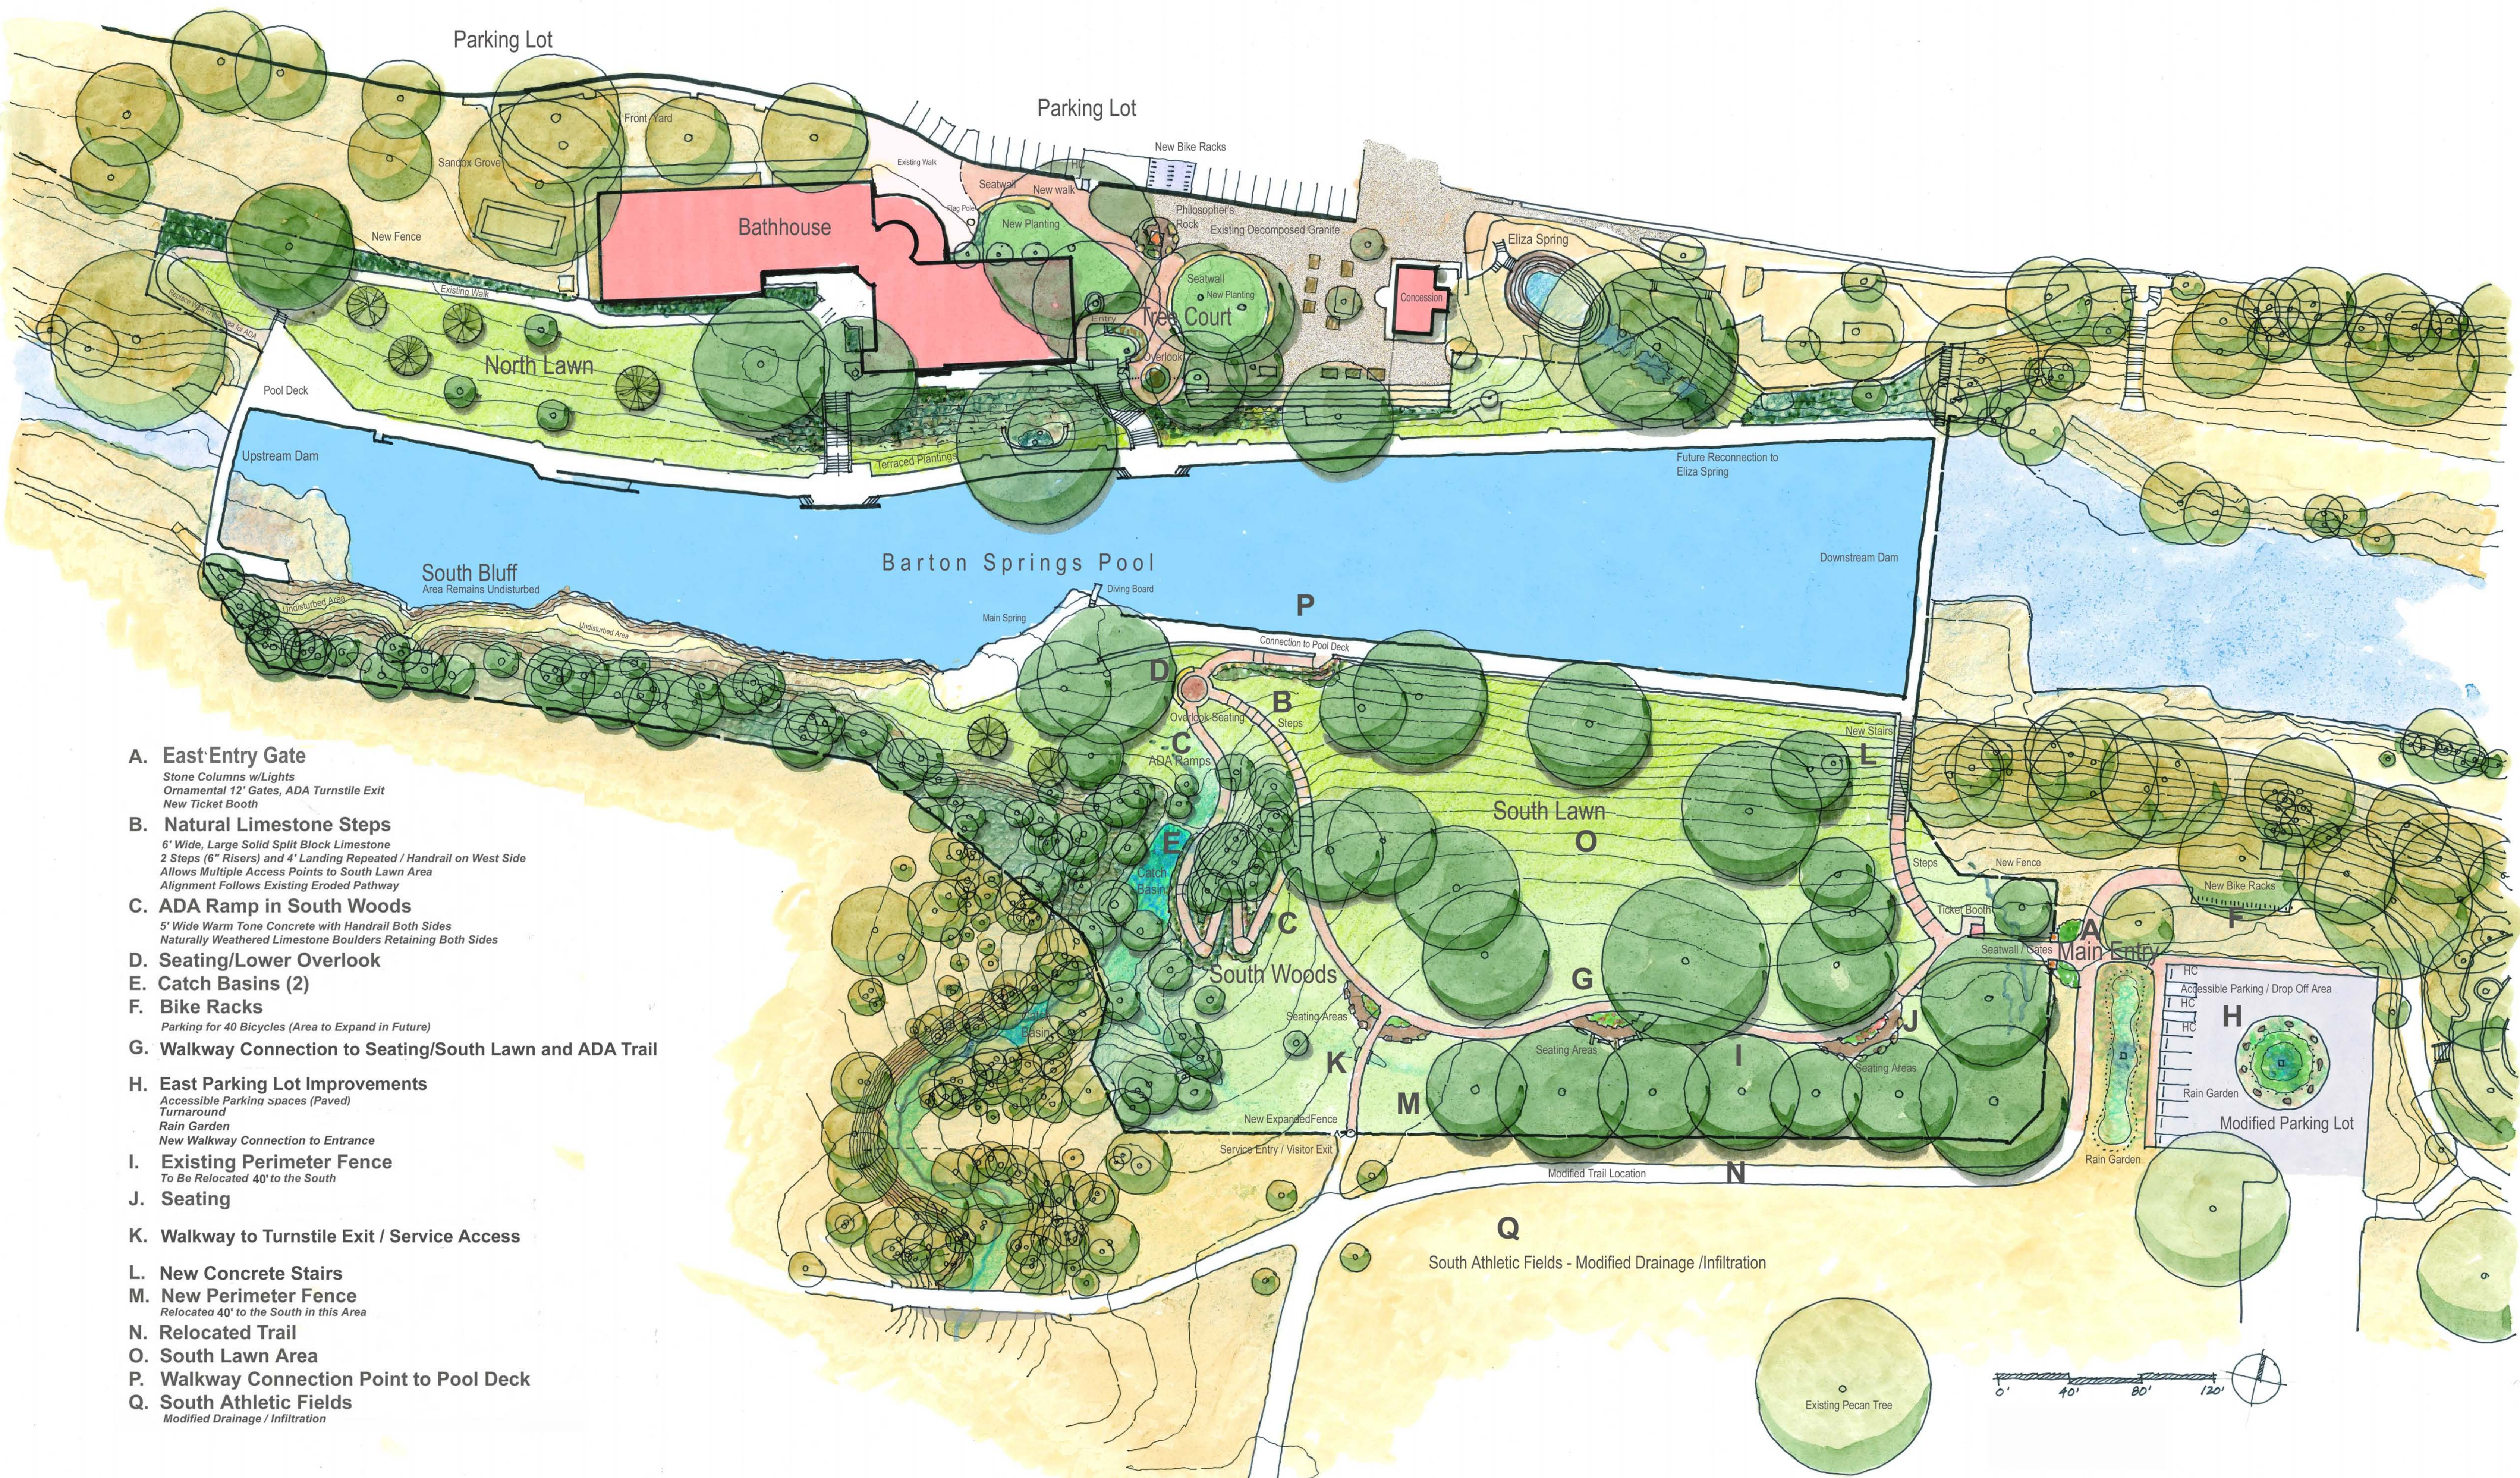
- A. East Entry Gate**
Stone Columns w/Lights
Ornamental 12' Gates, ADA Turnstile Exit
New Ticket Booth
- B. Natural Limestone Steps**
6" Wide, Large Solid Split Block Limestone
2 Steps (6" Risers) and 4" Landing Repeated / Handrail on West Side
Allows Multiple Access Points to South Lawn Area
Alignment Follows Existing Eroded Pathway

- C. ADA Ramp in South Woods**
5' Wide Warm Tone Concrete with Handrail Both Sides
Naturally Weathered Limestone Boulders Retaining Both Sides
- D. Seating/Lower Overlook**

- E. Catch Basins (2)**
- F. Bike Racks**
Parking for 40 Bicycles (Area to Expand in Future)
- G. Walkway Connection to Seating/South Lawn and ADA Trail**

- H. East Parking Lot Improvements**
Accessible Parking Spaces (Paved)
Turnaround
Rain Garden
New Walkway Connection to Entrance
- I. Existing Perimeter Fence**
To Be Relocated 40' to the South

- J. Seating**
- K. Walkway to Turnstile Exit / Service Access**
- L. New Concrete Stairs**
- M. New Perimeter Fence**
Relocated 40' to the South in this Area

- N. Relocated Trail**
- O. South Lawn Area**
- P. Walkway Connection Point to Pool Deck**
- Q. South Athletic Fields**
Modified Drainage / Infiltration
