Mabel Davis Pond Algae Bloom, Summer 2010

Staryn Wagner
Environmental Scientist Associate
Environmental Resource Management Division
Watershed Protection & Development Review Department
City of Austin

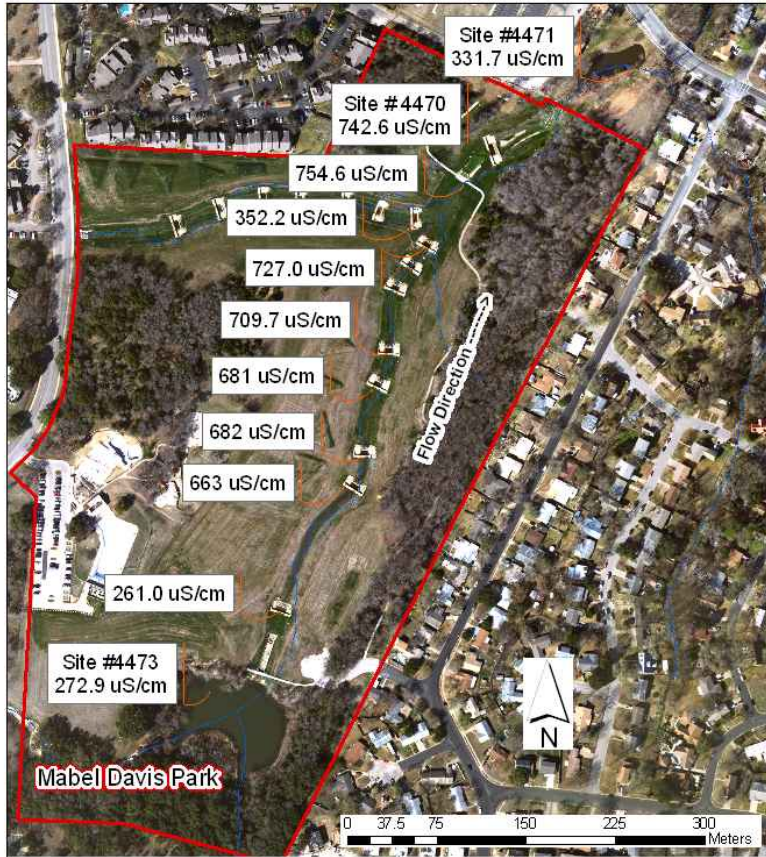
Metcalf pond had a relatively normal specific conductivity value of 331.7 µS/cm but the stream flowing into the downstream pond had a specific conductivity of 747.1 µS/cm. Following the water upstream (Figure 1) the specific conductivity was found to decrease slowly reaching the lowest level of 361 µS/cm in one of the upper drop structures in the park, ~200' below Mabel Davis pond. Mabel Davis pond had a specific conductivity of 272.9 µS/cm and did not visibly contribute to flow in the stream.

Figure 1 The Specific Conductivity increases with downstream flow until below the pathway at site 4470.
