**RESULTS OF 2002 GROUNDWATER DYE TRACING STUDY,
BARTON SPRINGS SEGMENT OF THE EDWARDS AQUIFER,
ONION CREEK, HAYS COUNTY, TEXAS**

Dye Tracing Recharge Features Under High-flow Conditions, Onion Creek, Barton Springs Segment of the Edwards Aquifer, Hays County, Texas

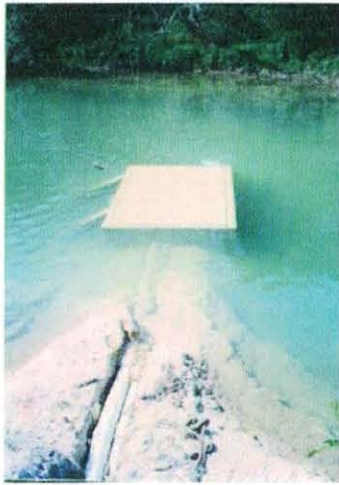
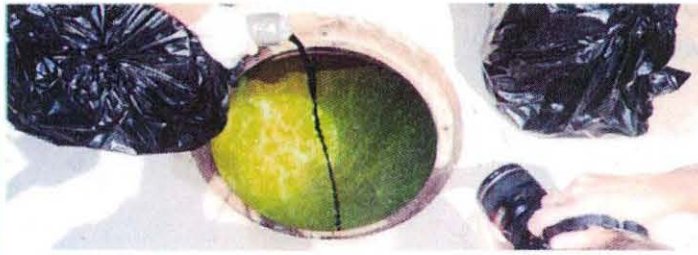
Figure 2: (left) Concrete vault and valve system above Antioch Cave within Onion Creek. (above) Sodium fluorescein dye being poured into the top of the vault.

Twenty-five pounds of sodium fluorescein were injected into Antioch Cave on August 2, 2002. Dye was injected by pouring the dye mixture directly into the top of the vault while the side valve was open, allowing recharge into the structure and cave (**Figure 2**). Thirty-five pounds of eosine were injected into Cripple Crawfish Cave on August 6, 2002. The BSEACD and COA injected dye into Cripple Crawfish Cave through a PVC pipe inserted into the feature from the bank (**Figure 3**).

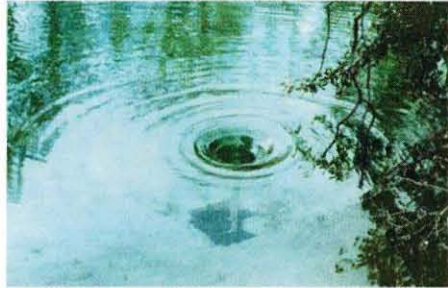
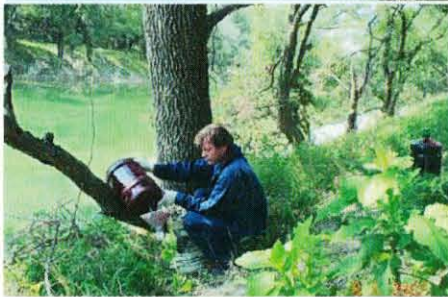
Figure 3: Vortex formed above Cripple Crawfish Cave (top). Nico Hauwert pouring eosine into a pipe inserted into Cripple Crawfish Cave on Onion Creek.

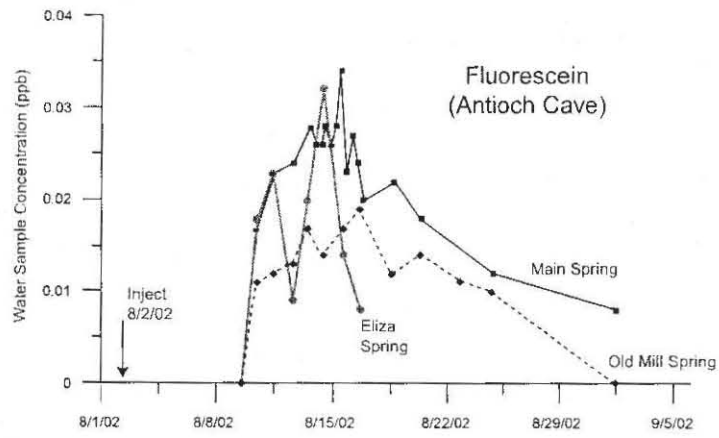
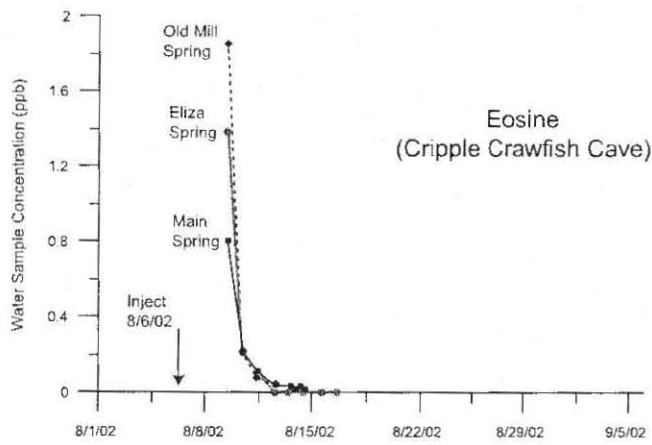
Figure 7: Breakthrough curves of sodium fluorescein and eosine at Barton Springs.

Breakthrough curves were prepared from the laboratory results, from which the initial travel time, duration, and peak concentrations were calculated. Breakthrough curves, which are graphs displaying dye concentrations over time, were evaluated to characterize the dye response at the springs (**Figure 7**).

Breakthrough concentrations peak soon after initial arrival, suggesting an aquifer system strongly influenced by conduit (rapid, pipe-like) flow rather than diffuse (slow) flow. Several sodium fluorescein breakthrough peaks on **Figure 7** suggest arrival of dye via different (conduit) pathways.
