501 CONGRESS - EXISTING PHOTOS

**STREAM
REALTY**

501 CONGRESS - RENDERING

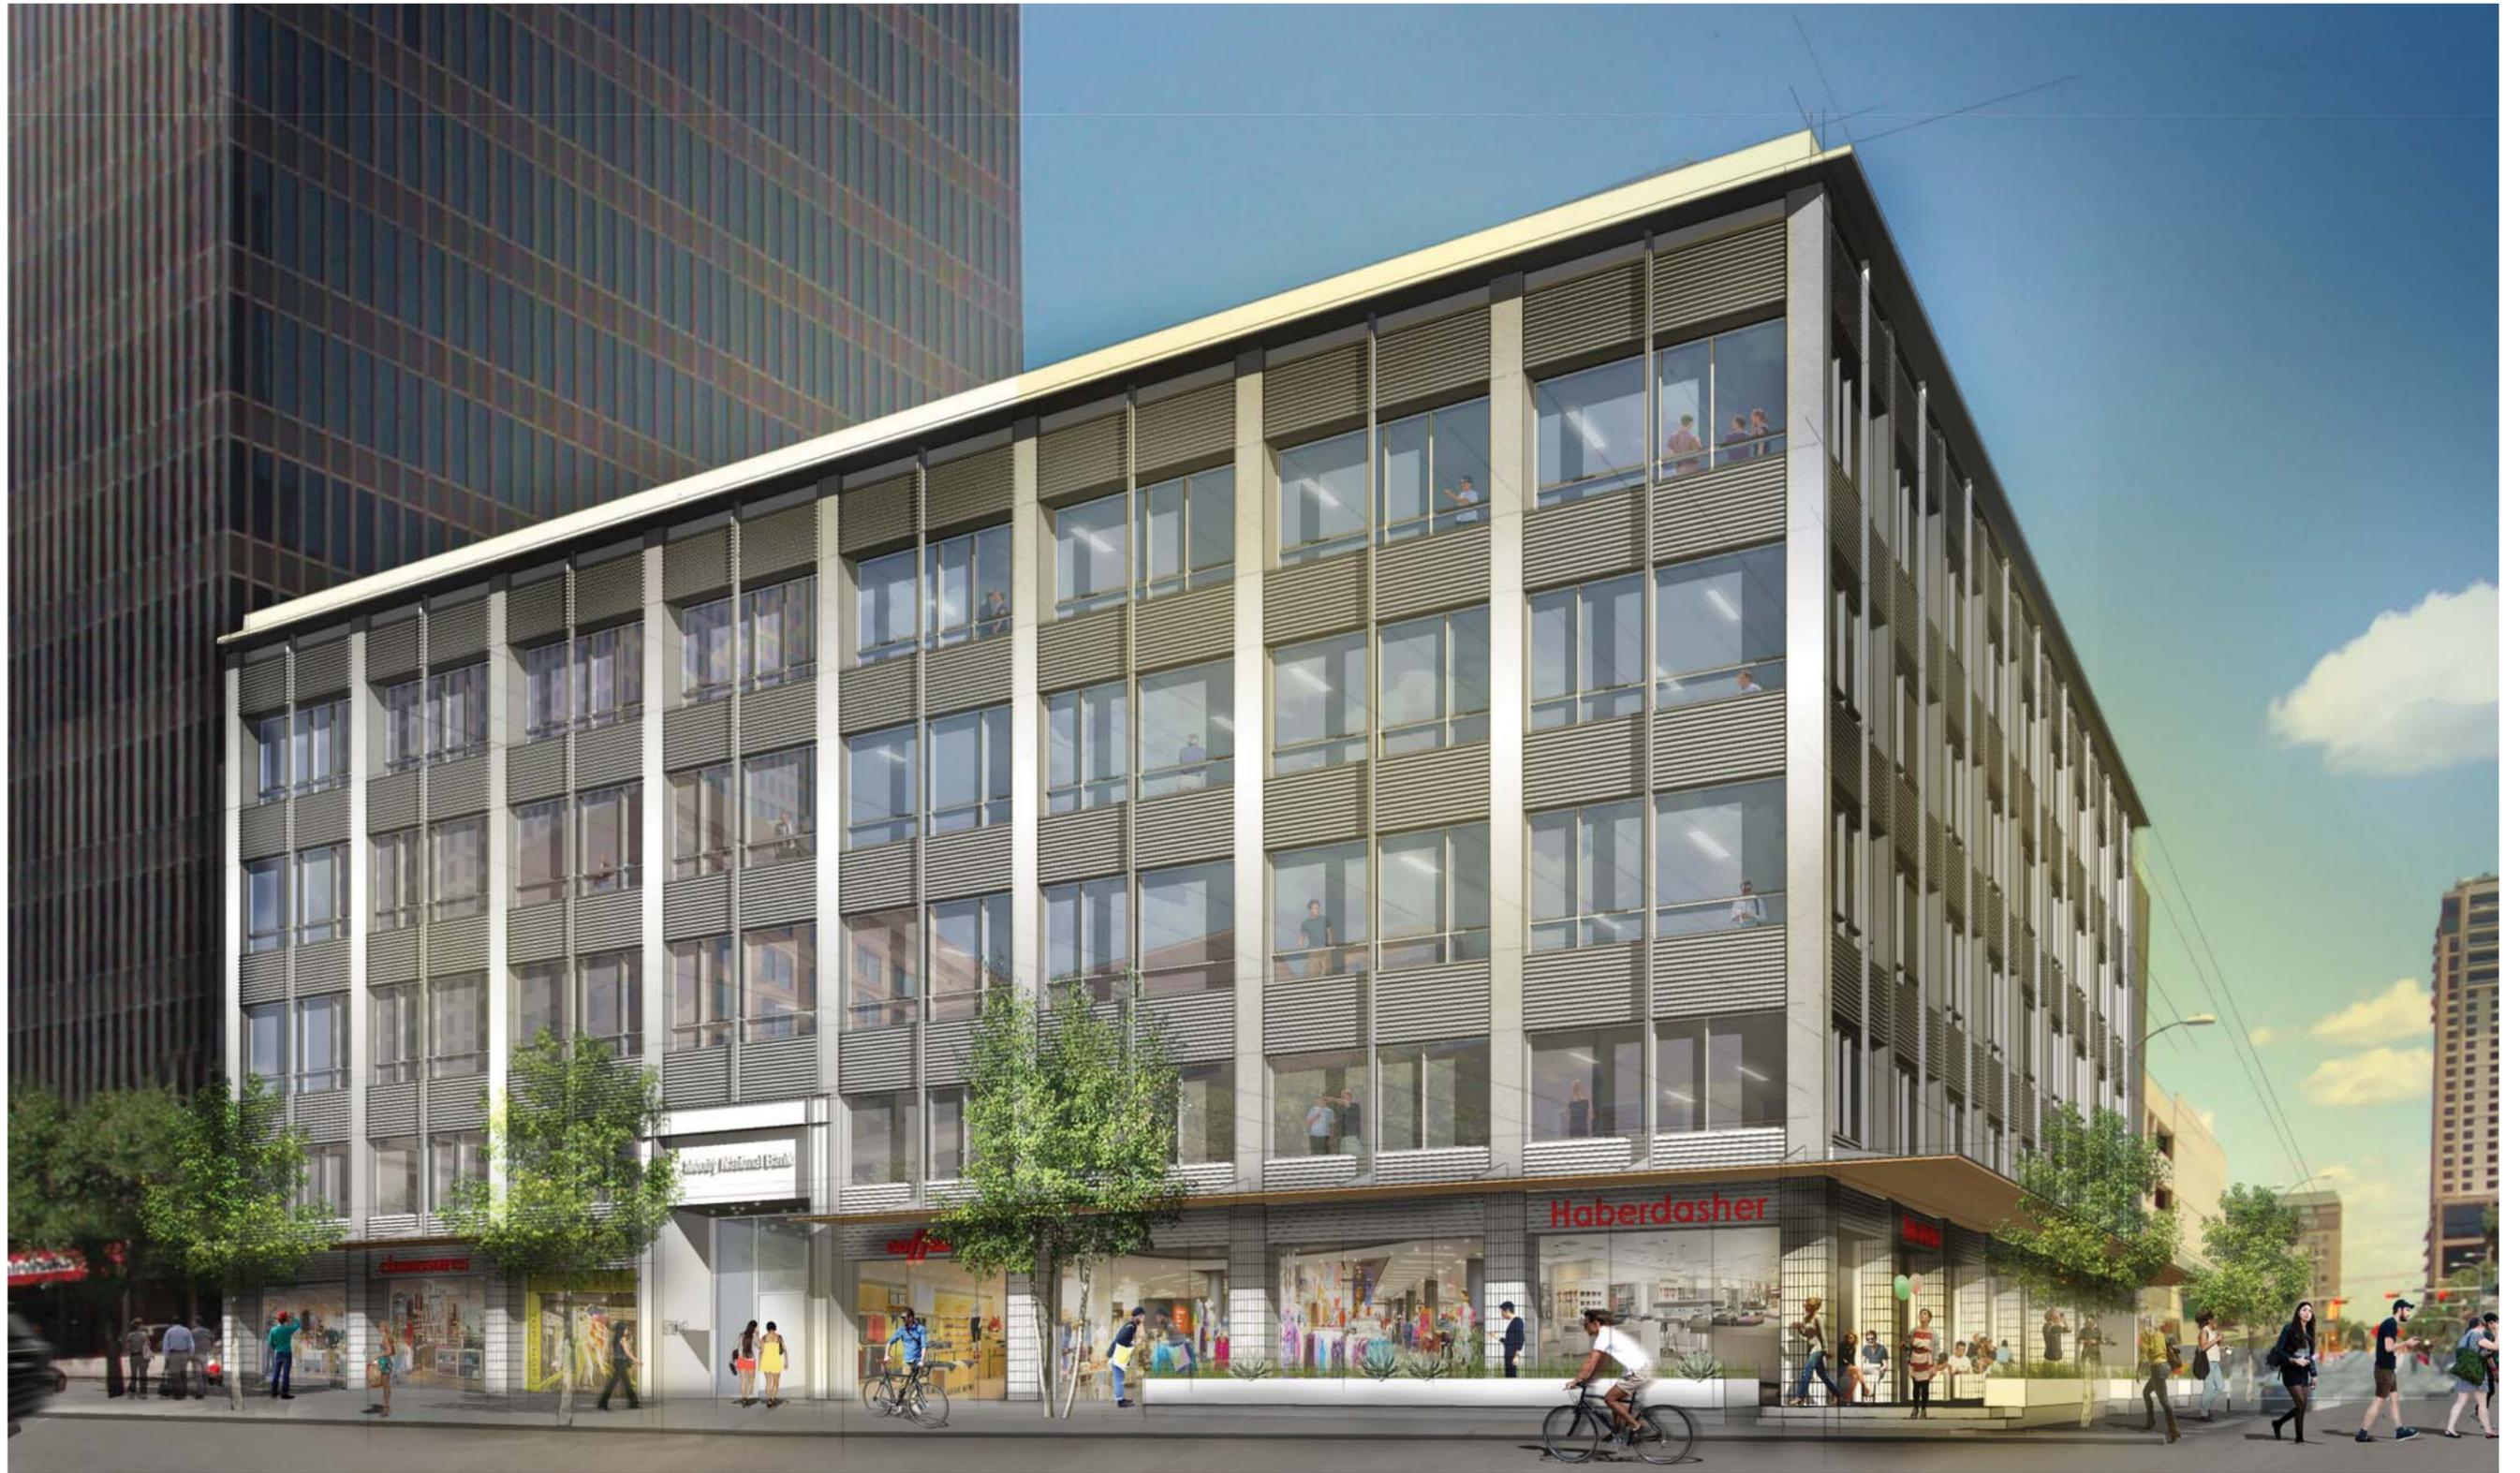
COMPOSITE ALUMINUM PANELS OVER
STRUCTURAL STEEL TUBES AT VERTICAL
AND HORIZONTAL SURFACE OF TOP CAP

GAP B/W CORRUGATED METAL PANEL & TOP CAP

CORRUGATED METAL PANEL

COMPOSITE ALUMINUM PANELS AT
EXISTING STRUCTURAL COLUMNS

ALUMINUM MULLION W/ DOUBLE EDGE
-REFER TO DETAIL XX/A6.02

ALUM. FRONT SET RIBBON WINDOW SYSTEM

CORRUGATED METAL PANEL
OVER EXISTING SPANDREL, TYP.

STEEL PLATE CANOPY W/ WOOD SOFFIT

BUTT GLAZED WINDOW SYSTEM

GLAZED BRICK VENEER APPLIED
TO EXISTING CONCRETE COLUMNS
