1 AN ORDINANCE REZONING AND CHANGING THE ZONING MAP TO  
2 ESTABLISH THE BLUEBONNET HILLS HISTORIC DISTRICT LOCALLY  
3 KNOWN AS THE AREA ROUGHLY BOUNDED BY ANNIE STREET TO THE  
4 NORTH, EAST SIDE DRIVE TO THE EAST, LELAND STREET TO THE  
5 SOUTH, AND BRACKENRIDGE STREET TO THE WEST IN THE SOUTH  
6 RIVER CITY NEIGHBORHOOD PLAN AREA.

# BLUEBONNET HILLS HISTORIC DISTRICT

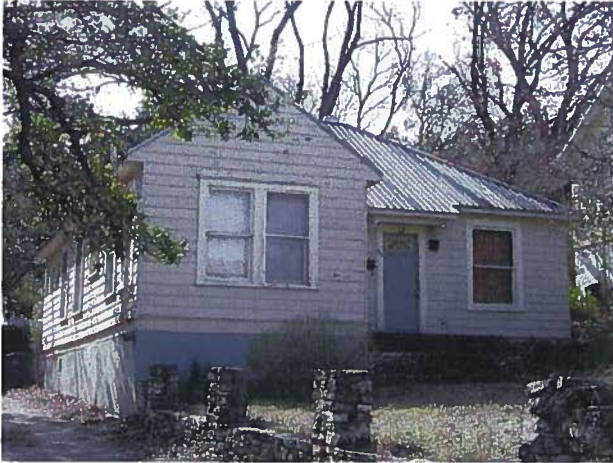
L-Plan House (515 Annie St.)

Most L-plan houses were constructed after the arrival of the railroad using milled lumber with prefabricated decorative elements. These houses typically are one or one-and-a-half stories in height with an L-shaped floor plan and a cross-gabled roof form. Historic additions to the rear of the building are typical. L-plan houses are usually set back with a front yard. Wood or cast iron fences may be present. Original barns or sheds may be present. Although not original, detached garages may have been added within the district's period of significance.

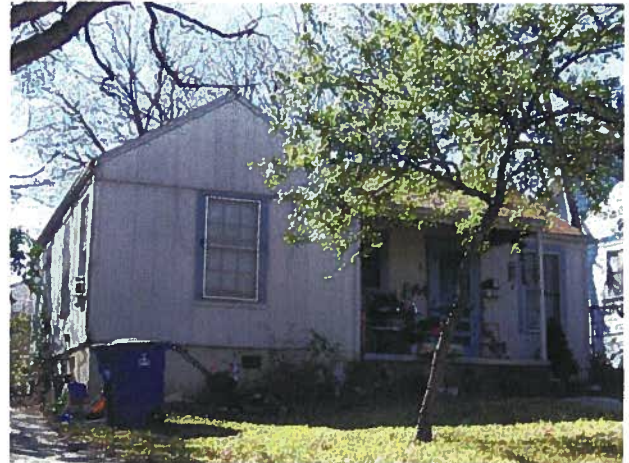
L-Plan House with Porch (509 Lockhart Dr.)

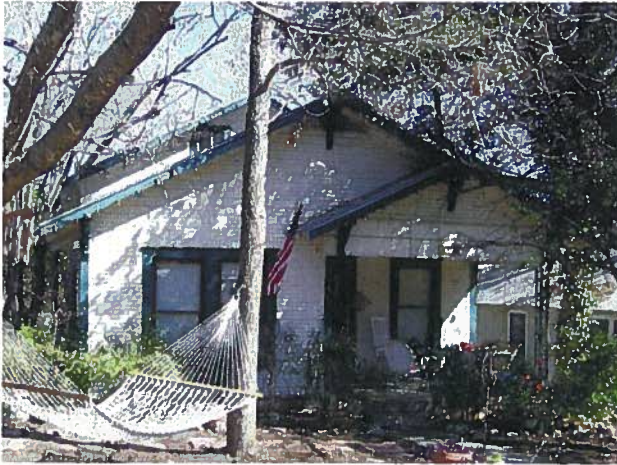
Front-gabled Bungalow (502 Lockhart Dr.)

The bungalow is a nationally popular house form that was always constructed after the arrival of the railroad, and typically constructed after local popularization of the automobile. Bungalow plans were standardized, often distributed through lumber companies. Bungalows are usually one-story in height, but sometimes one-and-a-half or two-stories. Floor plans usually are organized with the living room, dining room, and kitchen aligned on one side of the house, and the bedrooms aligned on the other side, so that corridor space is minimized. In Austin, bungalows typically are set back from the street, with a front yard. Concrete sidewalks or driveway runners may be present. Because bungalows often were constructed after the advent of the automobile, a detached garage may be associated with the house, and/or a porte cochere attached to a side of the house.

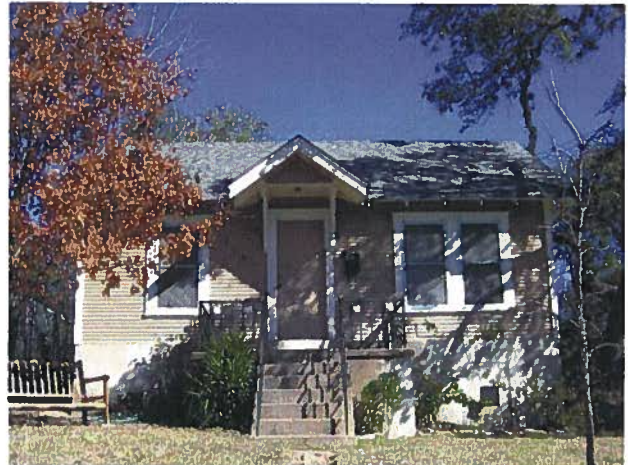
Side-gabled Bungalow (310 Leland St.)

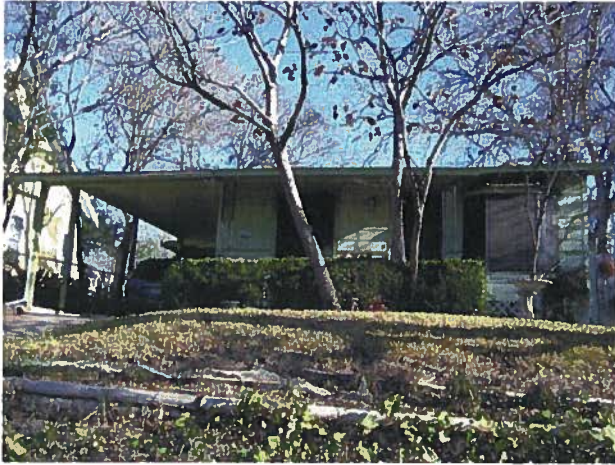
Compact Ranch Form (510 Terrace Dr.)

The Ranch house probably is the most common house form found in Austin. These houses were constructed nationwide beginning ca. 1940 and continuing with the post-World War II housing boom. Ranch houses were constructed using prefabricated building materials, and often standardized plans were repeated within subdivisions. The Ranch house form is nearly always one-story. The footprint may be rectangular, L-plan, rambling and irregular, or even split-level. The interior floor plan of a Ranch house is open, with free-flowing living, dining, and kitchen spaces, many of which open out to outdoor spaces, such as courtyards or patios. Ranch houses typically lack applied architectural ornament, and instead feature details integral to the design of the house that are influenced by the Ranch Style, Modern Style, or Contemporary Style. In Austin, neighborhoods of Ranch houses include typically suburban landscape patterns, with houses set back from the street with a front yard. Concrete sidewalks and driveways are often present. Garages or carports are integral to the overall form and design of the Ranch house, and most examples include an attached carport or one- or two-car garage.

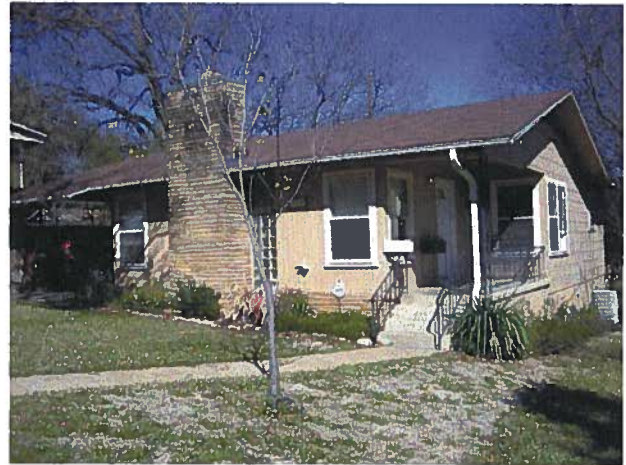
Ranch Form with Large Front Chimney (510 Lockhart Dr)

- Doors: Typically wood, often with geometric glazing or relief patterns.
- Chimneys: When present, often wide, constructed of Roman brick or flagstone masonry, and set asymmetrically on front façade.

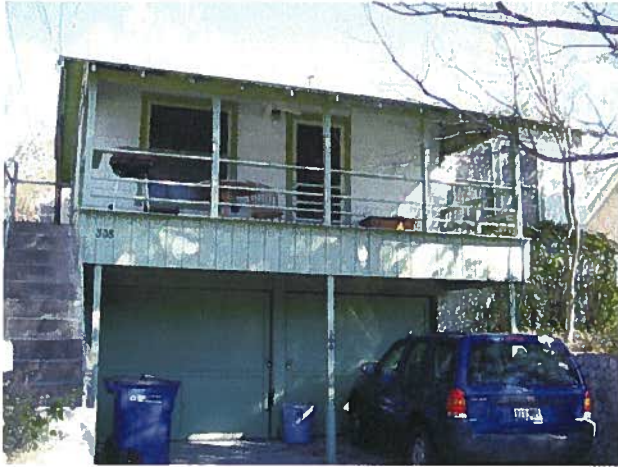
Detached Garage Apartment (308 Leland St)

The detached garage is the overwhelmingly most common historic domestic outbuilding found in Austin. Detached garages typically are one-story in height with a rectangular footprint and a single, open interior space. Garage apartments may be two stories in height, with an open garage space on the ground floor and a living space above. Some domestic properties retain agricultural outbuildings, such as barns or sheds, which pre-date the residential development of the surrounding neighborhood. Domestic outbuildings typically are sited at the rear of the lot, behind the main house.

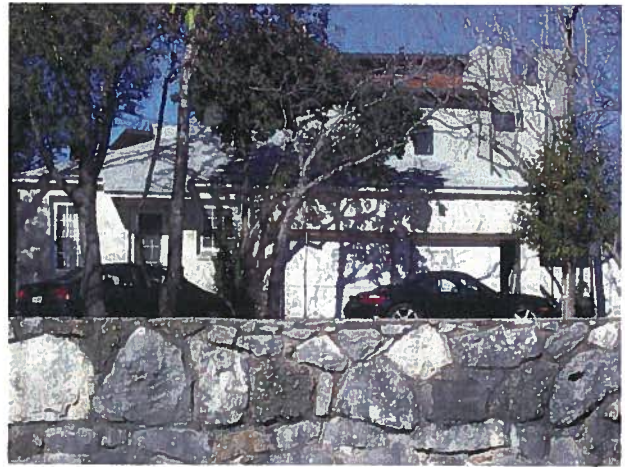
Detached Secondary Dwelling (1926 Newning Ave.)

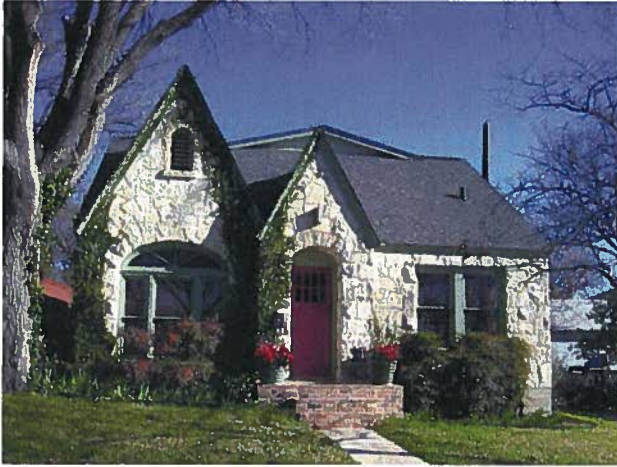
Tudor Revival House (514 Terrace Dr.)

- Building Form: Bungalow, L-plan, or irregular.
- Exterior Walls: Usually brick masonry in varying colors, patterns, and textures, with exaggerated mortar joints, sometimes seeping. Sometimes stucco. Faux half-timbering often adorning gable-ends. Wing walls or buttresses sometimes accenting front façade.
- Foundation: Usually skirted with brick.
- Porches: If present, sometimes include low-sloped Gothic arches supported by brick piers.
- Roofs: Gable-on-hip or front gabled. Often complex. Eaves sometimes swept.
- Windows: Usually double-hung wood sash. Window openings sometimes feature low-sloped Gothic arches. Sometimes feature picture windows with leaded glass in a lattice pattern.
- Doors: Round-arched wood doors with small lites.
- Chimneys: Prominent brick chimneys, often on front façade. Sometimes feature chimney caps with corbelling or crenellations.

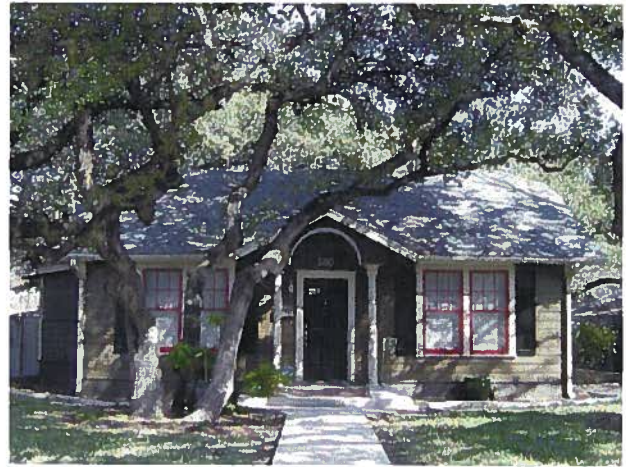
Colonial Revival House (500 Mary St.)

- Building form: American four-square, two-story center-passage, or bungalow.
- Exterior walls: Typically red brick.
- Foundations: Typically pier and beam skirted with brick.
- Porches: Often lack porches. Sometimes include front-gabled or arched awnings over the main entrance, supported by brackets. If present, porches usually partial-width, with front-gabled roof supported by white wood or stone columns.
- Roofs: Side-gable. Wood cornice and enclosed eaves, often painted white.
- Windows: Typically double-hung wood sash, painted white. Often flanked by wood shutters.
- Doors: Typically wood, sometimes topped with fanlights. Commonly include sidelights, ornate door surrounds, pediments, etc.
- Chimneys: Typically red brick.

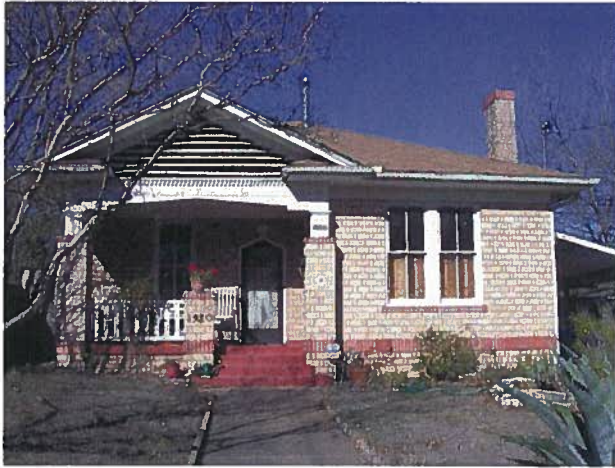
Prairie Style House (1920 Newning Ave.)

- Building Form: American four-square, L-plan or bungalow.
- Exterior Walls: Typically brick or stone, with wood trim details .
- Foundation: Typically skirted with wood, stone or brick.
- Porches: Partial-width or full-width, often with front-gabled roof, typically supported by tapered wood or massive square stone or brick columns.
- Roofs: Low-sloped hipped or gabled, with deep eaves, often with clean, boxed ends.
- Windows: Typically double-hung wood sash, often with decorative transoms and wood screens with geometric detail.
- Doors: Typically wood with glazing, sometimes with transoms and sidelights.
- Chimneys: Brick, sometimes with corbelling or stone coping.

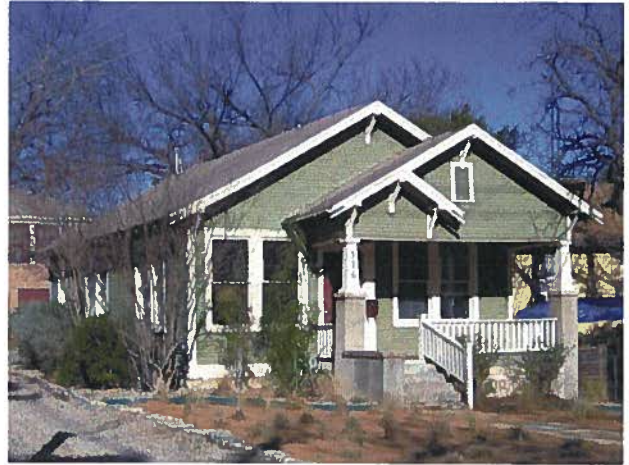
Craftsman House (516 Leland St.)

- Building Form: L-plan or bungalow.
- Exterior Walls: Typically wood siding or asbestos shingle, sometimes brick. Sometimes feature wood shingle detailing.
- Foundation: Typically skirted with wood or brick. Skirt walls sometimes battered.
- Porches: Partial-width or full-width, often with front-gabled roof, typically supported by tapered wood or stone columns but sometimes supported by decorative metal posts.
- Roofs: Low-sloped hipped or gabled, with deep eaves, often with exposed rafter ends.
- Windows: Typically double-hung wood sash, often with wood screens with geometric detail.
- Doors: Typically wood with glazing, sometimes with transoms and sidelights.
- Chimneys: Brick, sometimes with corbelling or stone coping.

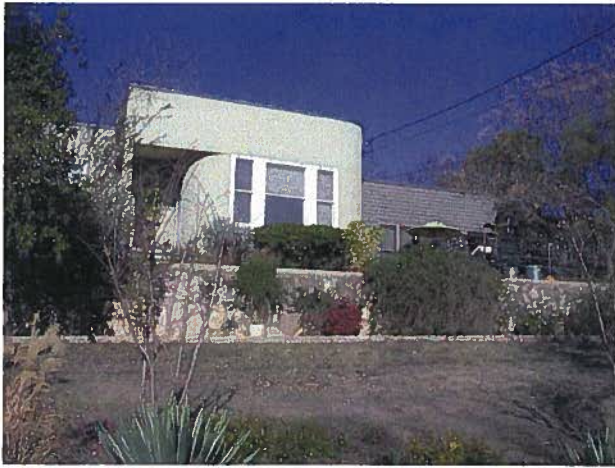
Modernistic House (1928 Newning Ave.)

- Building Form: Split-Level or irregular.
- Exterior Walls: Often smooth stucco, sometimes with brick detailing
- Foundation: Concrete slab.
- Porches: If present, typically a small stoop or recessed assymmetrically.
- Roofs: Flat with parapet, sometimes with small coping at roof line
- Windows: Steel fixed and casement frames, also often round “porthole” windows and glass brick; windows often wrap corners
- Doors: Wood, often with small simple square or circular lites.
- Chimneys: If present, broad and simple stuccoed brick or stone.

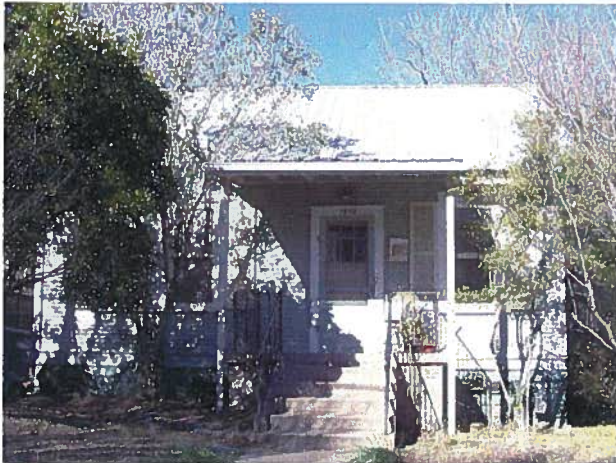
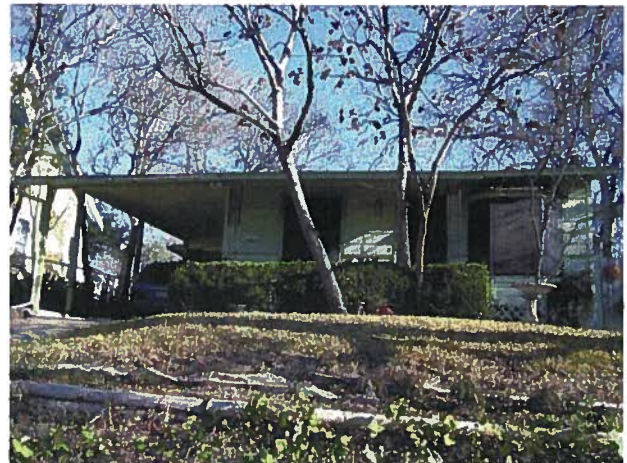
#### MINIMAL TRADITIONAL

- Building Form: L-plan, modified L-plan, bungalow, or ranch.
- Exterior walls: Wood siding or asphalt shingle. Decorative wood shingles, board-and-batten, or waney-edge siding sometimes present at gable ends. Brick or stone veneer sometimes present at water table.
- Foundation: Pier and beam with wood skirt, or concrete slab.
- Porches: Typically partial-width, supported by simple wood posts, geometric wood posts, or decorative metal posts.
- Roofs: Cross-gabled or gable-on-hip.
- Windows: Casement or double-hung, wood or metal sash. Fixed picture windows sometimes present at front façade. Decorative wood shutters common.
- Doors: Wood, often with small lites in geometric patterns.
- Chimneys: If present, simple brick or stone.

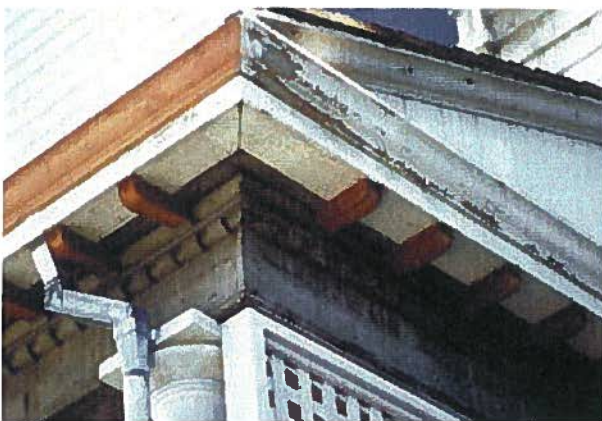
Damaged exterior wall materials can be repaired or replaced in kind, as in this example of a replaced fascia board. —  
[http://www.cr.nps.gov/hps/tps/standguide/preserve/preserve\\_wood.htm](http://www.cr.nps.gov/hps/tps/standguide/preserve/preserve_wood.htm)

- a. Repair damaged exterior wall materials, details, and ornamentation to the greatest extent possible. Replace only those sections that are deteriorated beyond repair. Replace deteriorated wall materials, details, and ornamentation in kind, to match existing wall materials.

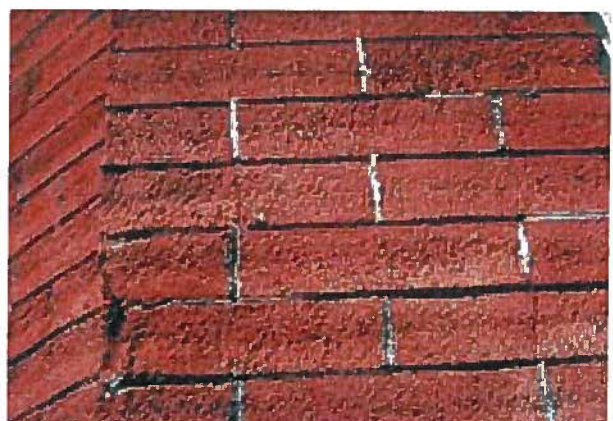
Sandblasting and other abrasive cleaning methods can permanently damage exterior building materials. Clean masonry surfaces with the gentlest method possible, such as low pressure water and detergents, using natural bristle brushes.—  
[http://www.cr.nps.gov/hps/tps/standguide/rehab/rehab\\_masonry.htm](http://www.cr.nps.gov/hps/tps/standguide/rehab/rehab_masonry.htm)

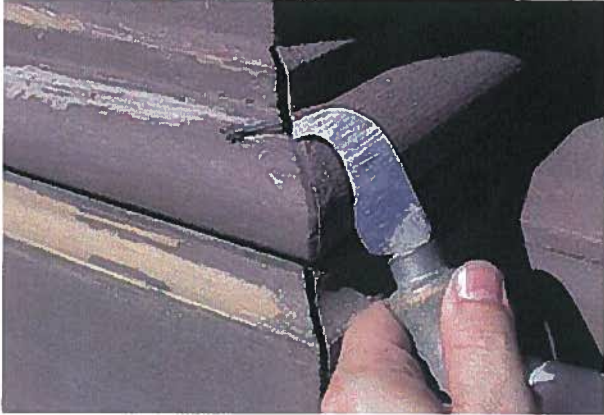
Cracks and unpainted wood on porch elements can lead to decay due to water seepage. Proper caulking and painting can help preserve these elements.—  
<http://www.nps.gov/tps/how-to-preserve/briefs/45-wooden-porches.htm>

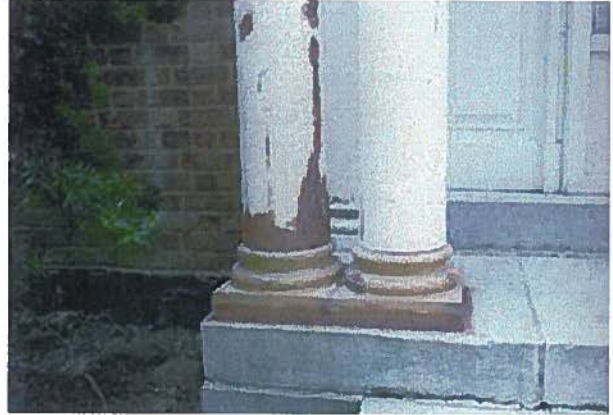
Deteriorated wood porch elements can be repaired in place with epoxy consolidants and fillers. —  
<http://www.nps.gov/tps/how-to-preserve/briefs/45-wooden-porches.htm>

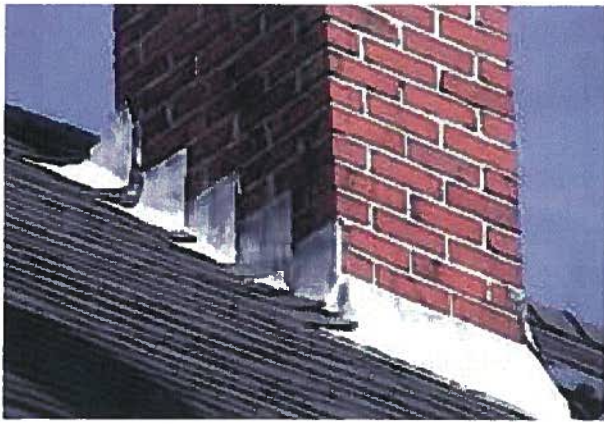
Protect and maintain a roof by cleaning the gutters and downspouts and replacing deteriorated flashing.—  
[http://www.cr.nps.gov/hps/tps/standguide/rehab/rehab\\_roofs.htm](http://www.cr.nps.gov/hps/tps/standguide/rehab/rehab_roofs.htm)

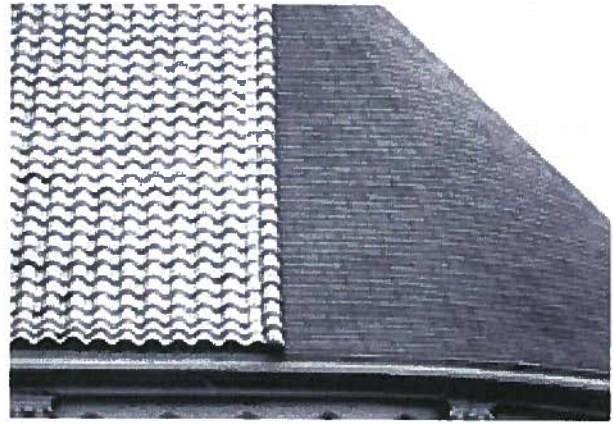
Asphalt shingles are an incompatible replacement substitute for the original Spanish clay tiles.—  
[http://www.cr.nps.gov/hps/tps/standguide/rehab/rehab\\_roofs.htm](http://www.cr.nps.gov/hps/tps/standguide/rehab/rehab_roofs.htm)

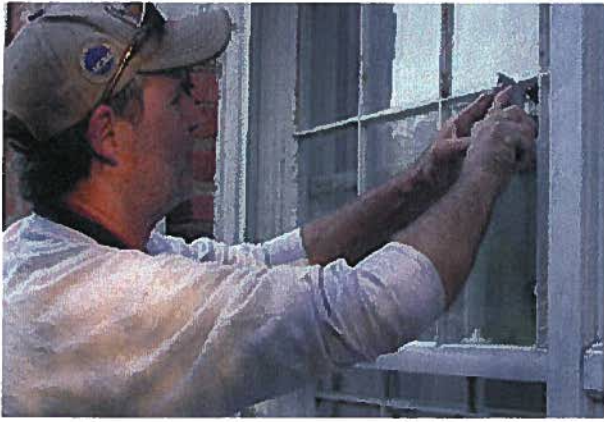
Glazing putty on historic windows should be maintained in sound condition to prevent unwanted air infiltration and water damage.—<http://www.nps.gov/tps/how-to-preserve/briefs/47-maintaining-exteriors.htm>

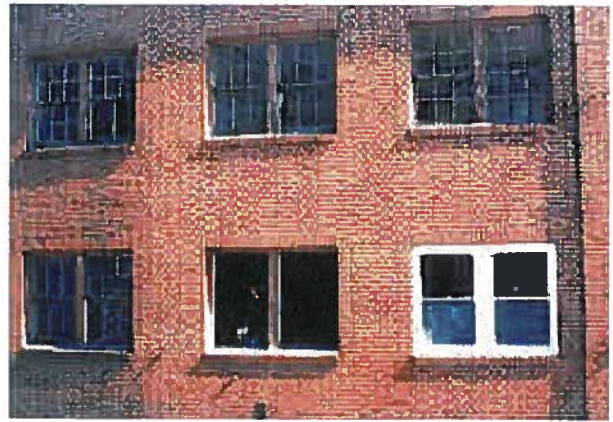
Do not replace historic windows with new windows that do not convey the same visual appearance.—  
[http://www.cr.nps.gov/hps/tps/standguide/rehab/rehab\\_windows.htm](http://www.cr.nps.gov/hps/tps/standguide/rehab/rehab_windows.htm)

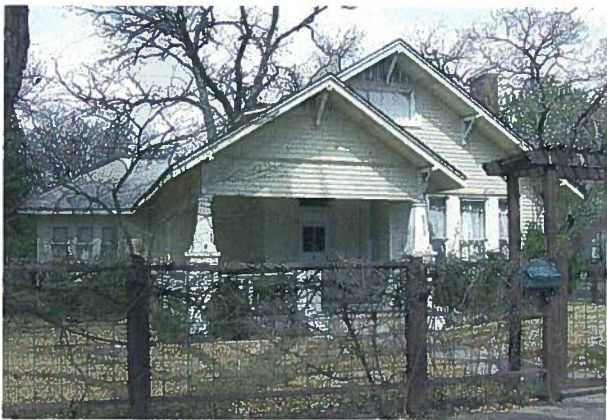
This side addition (to the left) is compatible because it is set back from the front of the house.

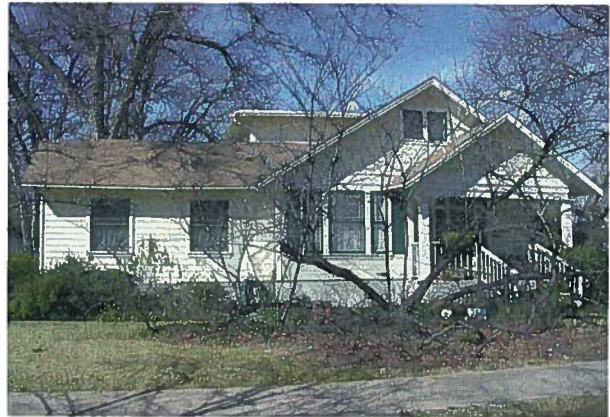
This side addition is incompatible because it is flush with the front of the house.

- f. Do not locate an addition flush with the original front façade or projecting beyond width of the original front façade. If the historic building has a side-gabled, hipped, or pyramidal roof form, the addition shall be set back behind the ridgeline of the original roof. If the original historic building has a front-gabled or flat roof form, the addition should be set no closer to the front facade than half the width of the facade. For example, if the front façade is thirty feet (30') wide, than the addition shall be set back from the front façade by at least fifteen feet (15').

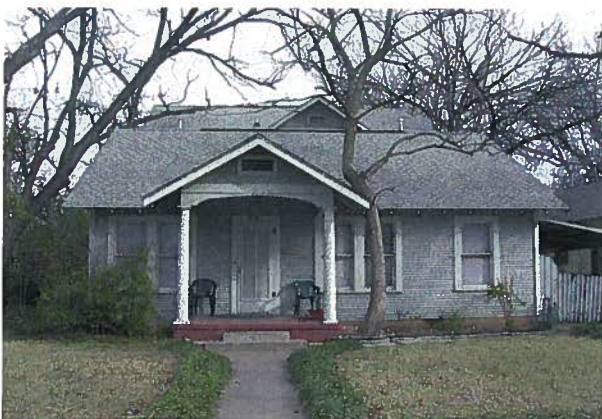
This rear addition is compatible because it is subordinate to the main house

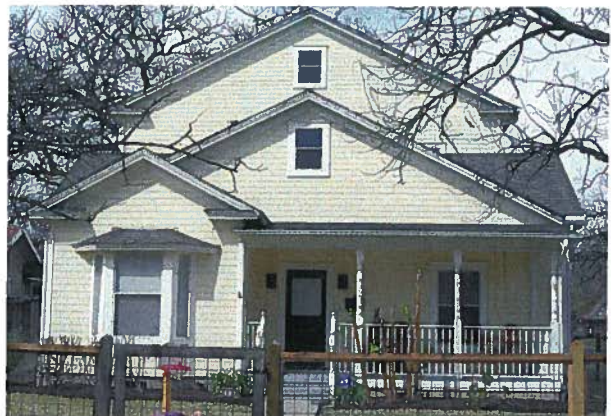
This rear addition is incompatible because it is too dominant compared to the main house.

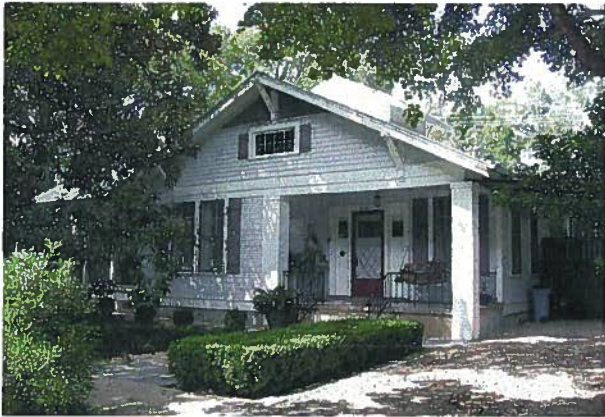
This roof pop-up is compatible because it is located near the back the house and is subordinate in design to the house.

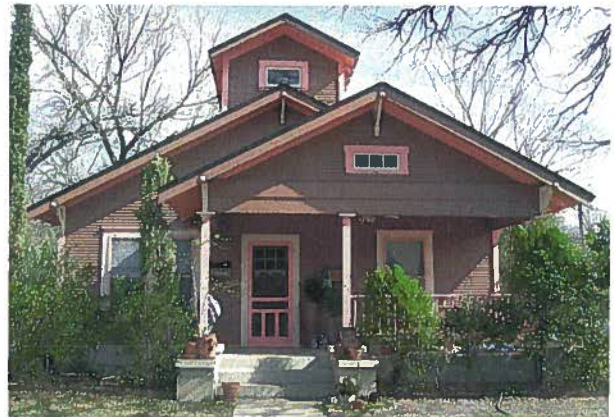
This roof pop-up is not compatible because it is set too far forward and dominates the design of elements on the original house.

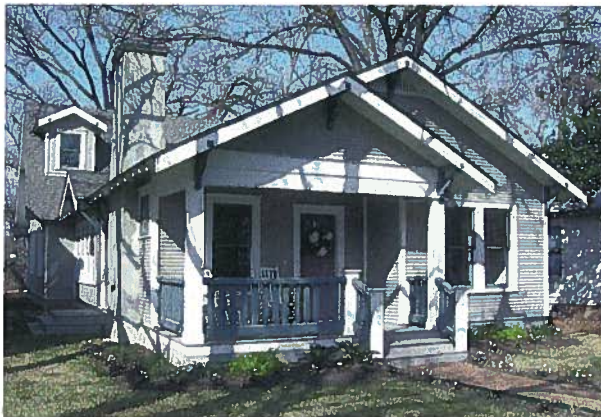
Even though this rear addition has as a potentially-dominant front facing dormer, it is compatible because it is set back far from the front of the house.

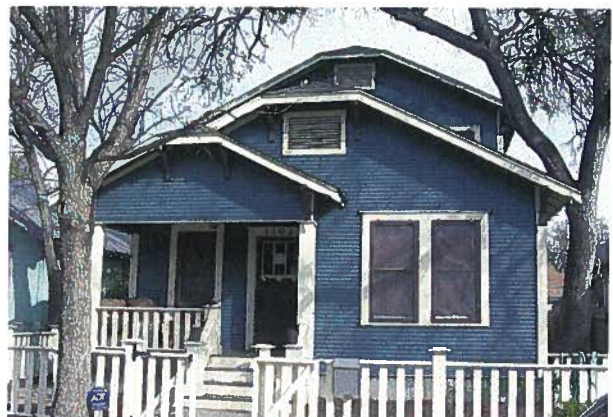
This rear addition is questionably compatible. It is set back from the front of the house but it might be too high and its design might not be differentiated enough. This proposal would need further review.

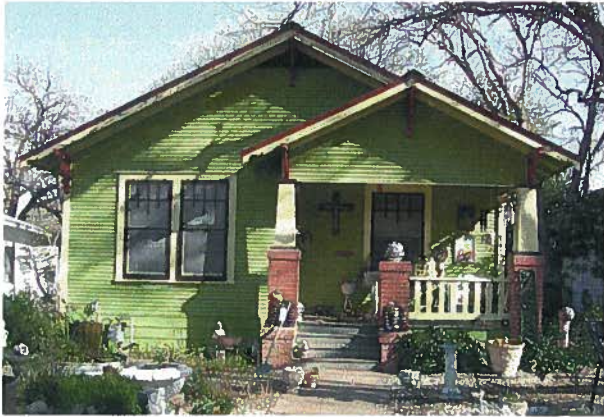
This house has a very compatible two-story rear addition. It is not visible from the street.

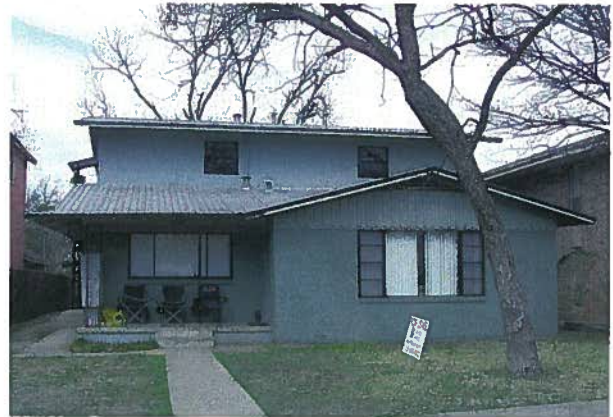
This second story addition is not compatible because it is highly visible from the street.

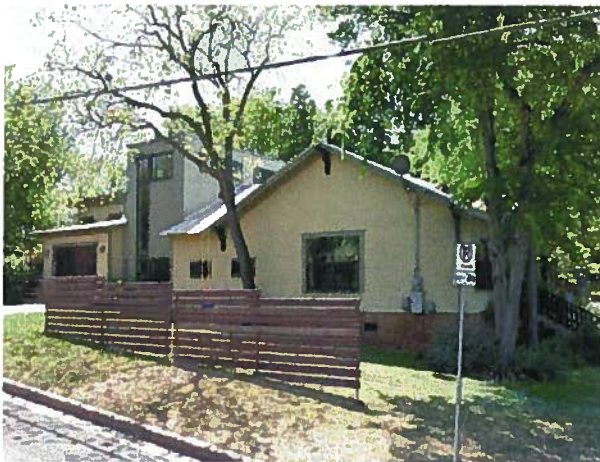
The contemporary two-story addition behind this house is compatible because it is located in the rear of the property and is subordinate in scale to the main house

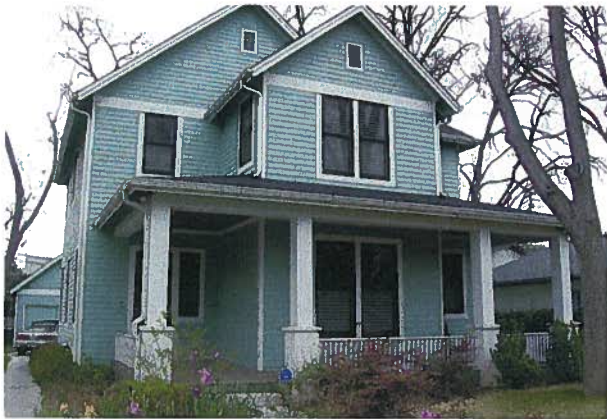
This 2004 house is compatible with the district because it places its garage at the rear of the parcel.

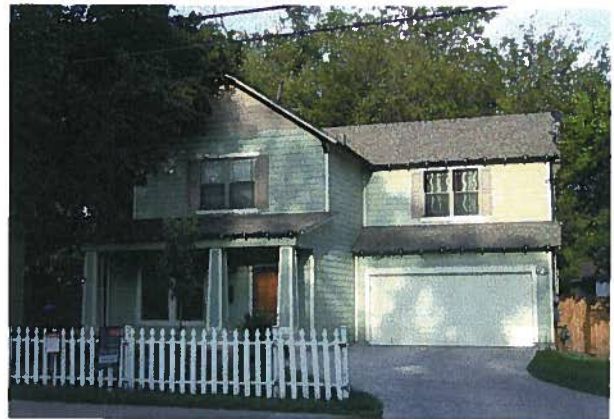
This 2006 house is not compatible because its garage is situated too close to the front of the house.

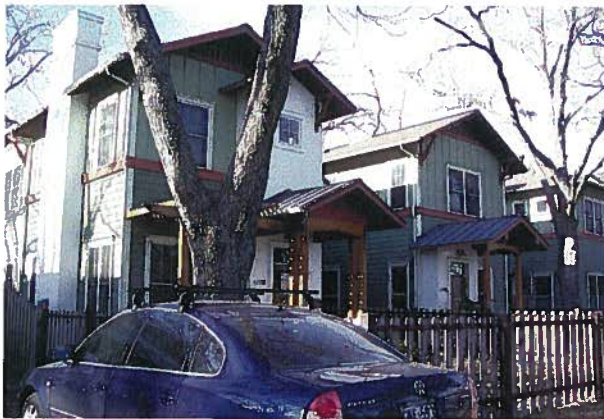
This new multiple dwelling development is compatible because each unit is a separate building facing the street. The units are compatible in scale and design.

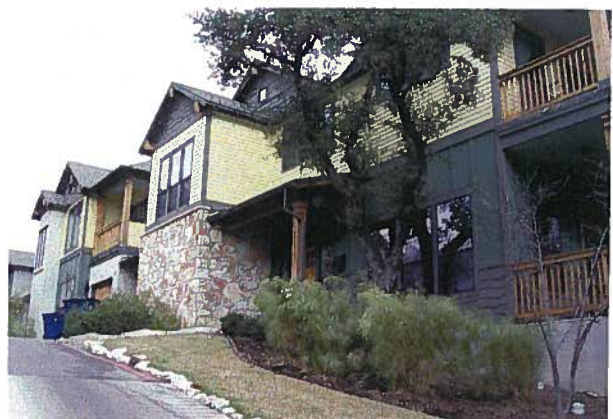
This new multiple dwelling development is not compatible because it is a single large building that faces an internal driveway instead of the public street.
