## ZILKER PARK IMPROVEMENTS AT THE BATHHOUSE ZONE

# BATHHOUSE KEY FINDINGS

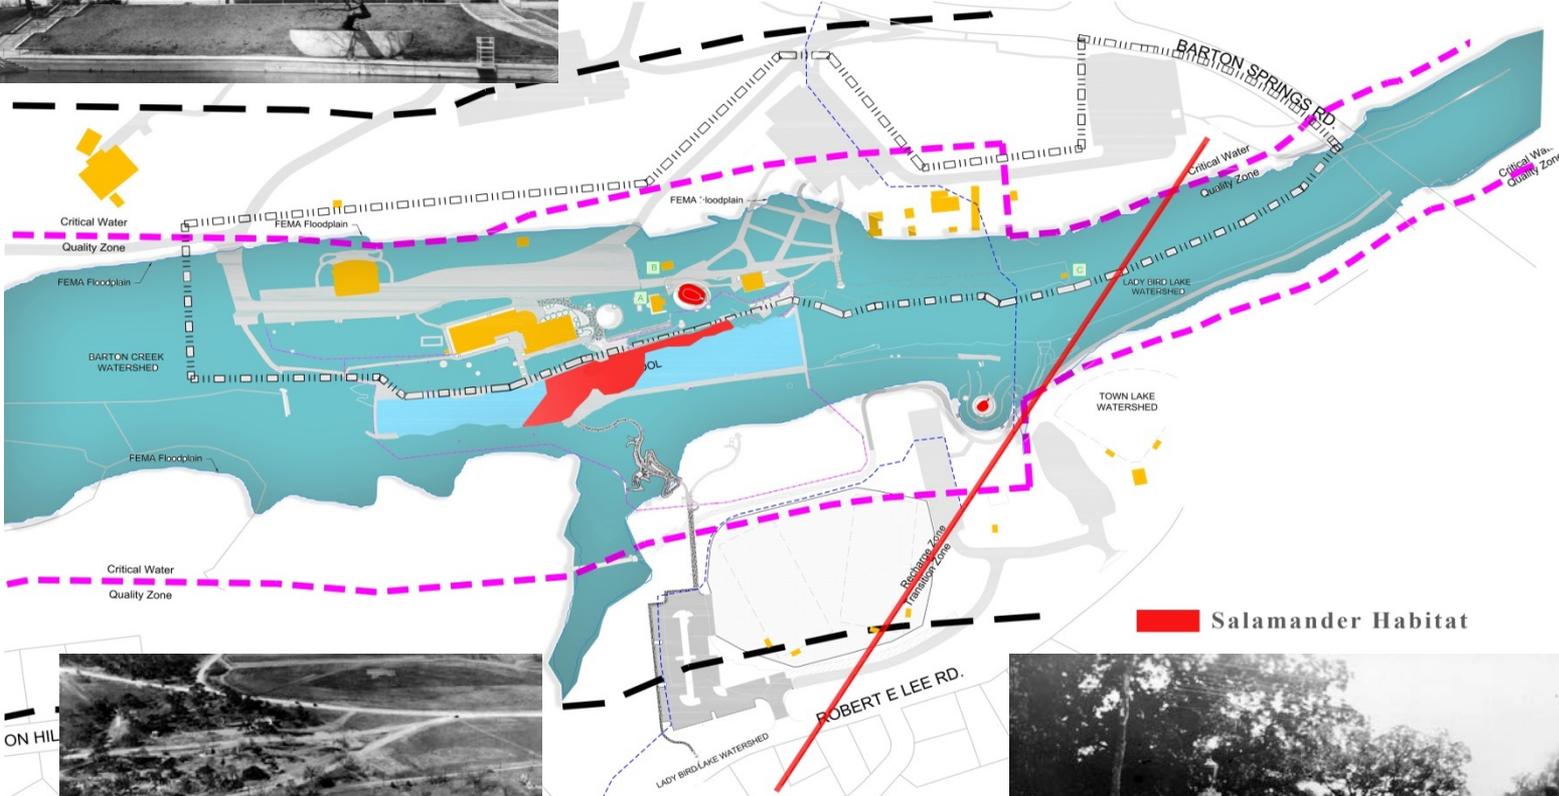
# CONSTRAINTS

- Barton Springs Master Plan
- Public safety
- Major facilities in flood zone
- Critical species habitat and corresponding educational commitments
- Impervious cover at limit
- Inadequate water quality elements
- Historical designations
- Heritage trees

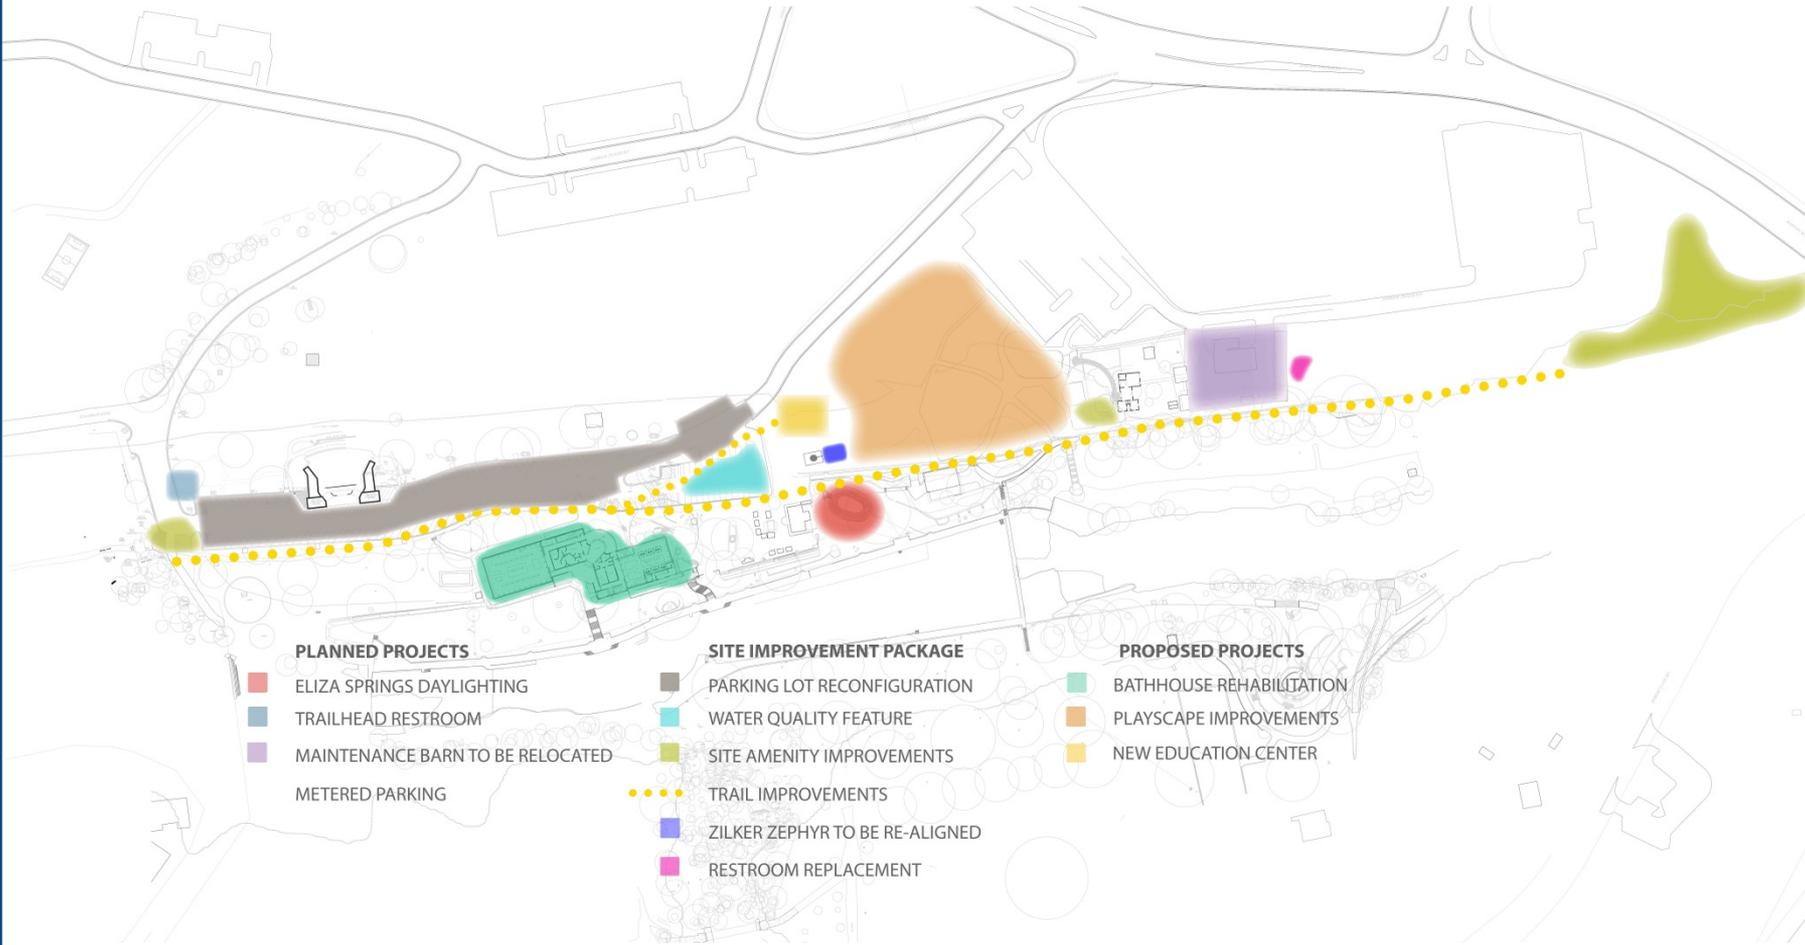
# SITE PLAN RECOMMENDED PROJECTS

- ELIZA SPRINGS DAYLIGHTING
- TRAILHEAD RESTROOM
- MAINTENANCE BARN TO BE RELOCATED
- METERED PARKING

- PARKING LOT RECONFIGURATION
- WATER QUALITY FEATURE
- SITE AMENITY IMPROVEMENTS
- TRAIL IMPROVEMENTS
- ZILKER ZEPHYR TO BE RE-ALIGNED
- RESTROOM REPLACEMENT

- BATHHOUSE REHABILITATION
- PLAYSCAPE IMPROVEMENTS
- NEW EDUCATION CENTER

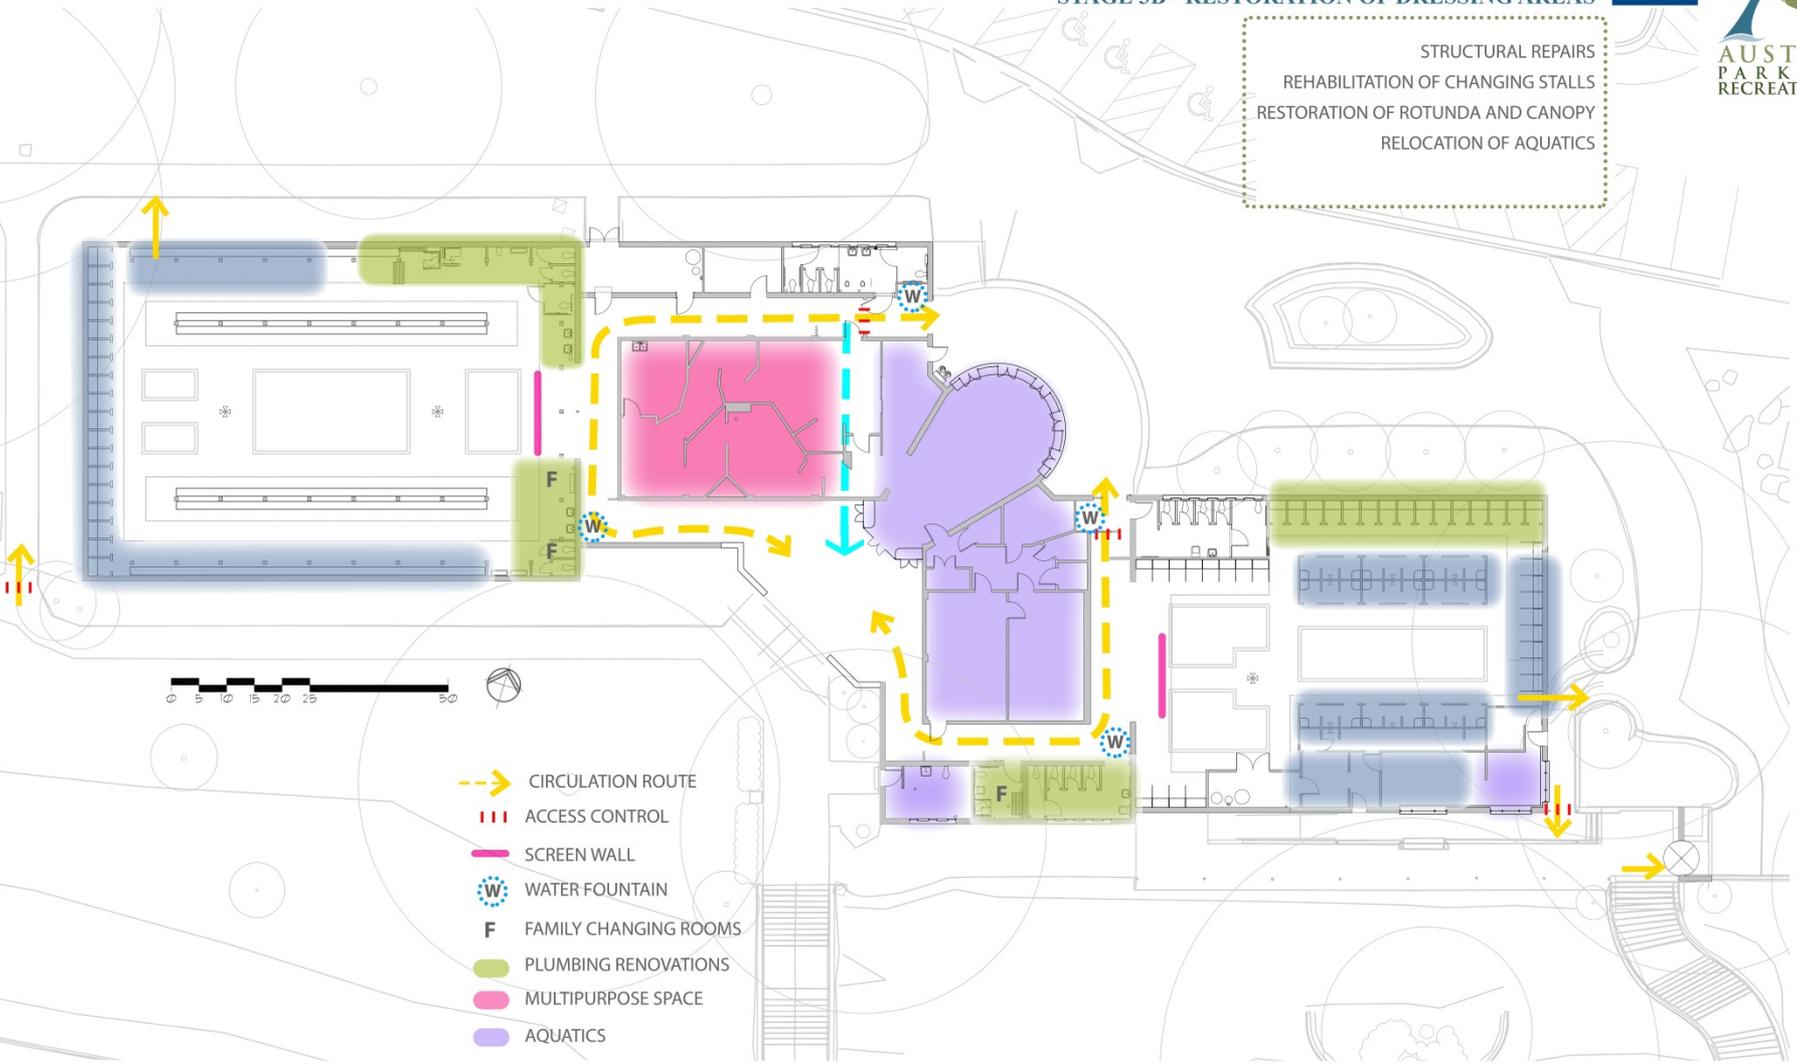
## STAGE 3B - RESTORATION OF DRESSING AREAS

STRUCTURAL REPAIRS  
REHABILITATION OF CHANGING STALLS  
RESTORATION OF ROTUNDA AND CANOPY  
RELOCATION OF AQUATICS

- CIRCULATION ROUTE
- ACCESS CONTROL
- SCREEN WALL
- W WATER FOUNTAIN
- F FAMILY CHANGING ROOMS
- PLUMBING RENOVATIONS
- MULTIPURPOSE SPACE
- AQUATICS
- DRESSING ROOM RESTORATIONS
- ALTERNATE ROUTE

- Ingress/egress needs improvement
- Bathhouse facilities need extensive rehabilitation
  - Plumbing systems should be replaced
  - Dressing stalls need major repair/restoration
  - Rotunda and canopy require restoration
- Sheffield/Splash! must remain in vicinity
  - They are non-conforming use and construction
  - Visitor/information function needs better location
- Aquatics facilities are inadequate
