HISTORIC LANDMARK COMMISSION
JANUARY 23, 2017
APPLICATION FOR A CERTIFICATE OF APPROPRIATENESS
LHD-2016-0017
806 Blanco Street
Castle Hill Historic District

Remove existing windows on the side of the house and install new windows; demolish the rear wall of the house and replace with a wall of glass.

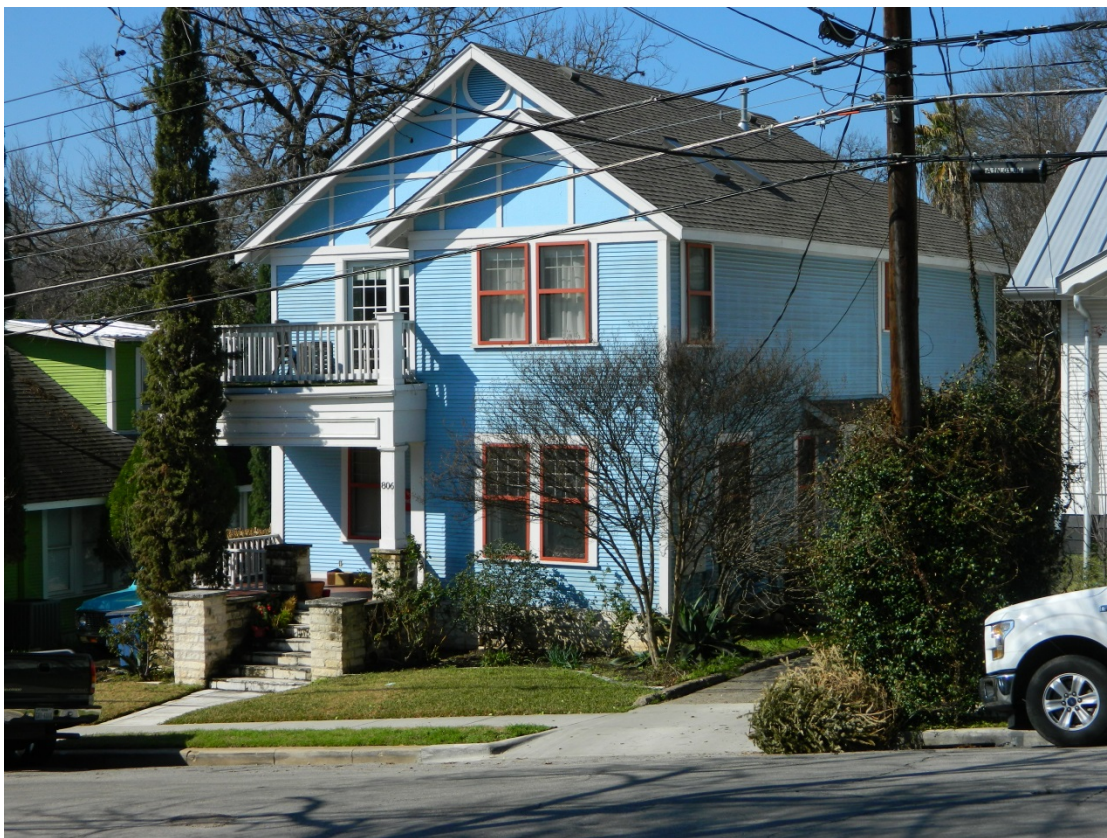
View of the house from W. 9th Street, showing the north side of the house.

The applicant proposes to remove one pair of windows from the ground floor of the south side of the house, one window from the ground floor of the north side of the house, and one window from the second story of the north side of the house. The ground floor window on the north side of the house will be replaced with a larger window; two windows will be added to the second story of the north side of the house, and the pair of windows on the south side of the house will be replaced with a smaller window. All of the new proposed windows will be in the same style and materials as the existing windows.
