**SITE PLAN REVIEW SHEET  
ENVIRONMENTAL VARIANCE REQUEST ONLY**

**CASE:** SP-2016-0420D

**PROJECT NAME:** Bulkhead for 2200 Lauranne Lane

**SUBJECT:** Bulkhead for 2200 Lauranne Lane  
Case No. SP-2016-0420D

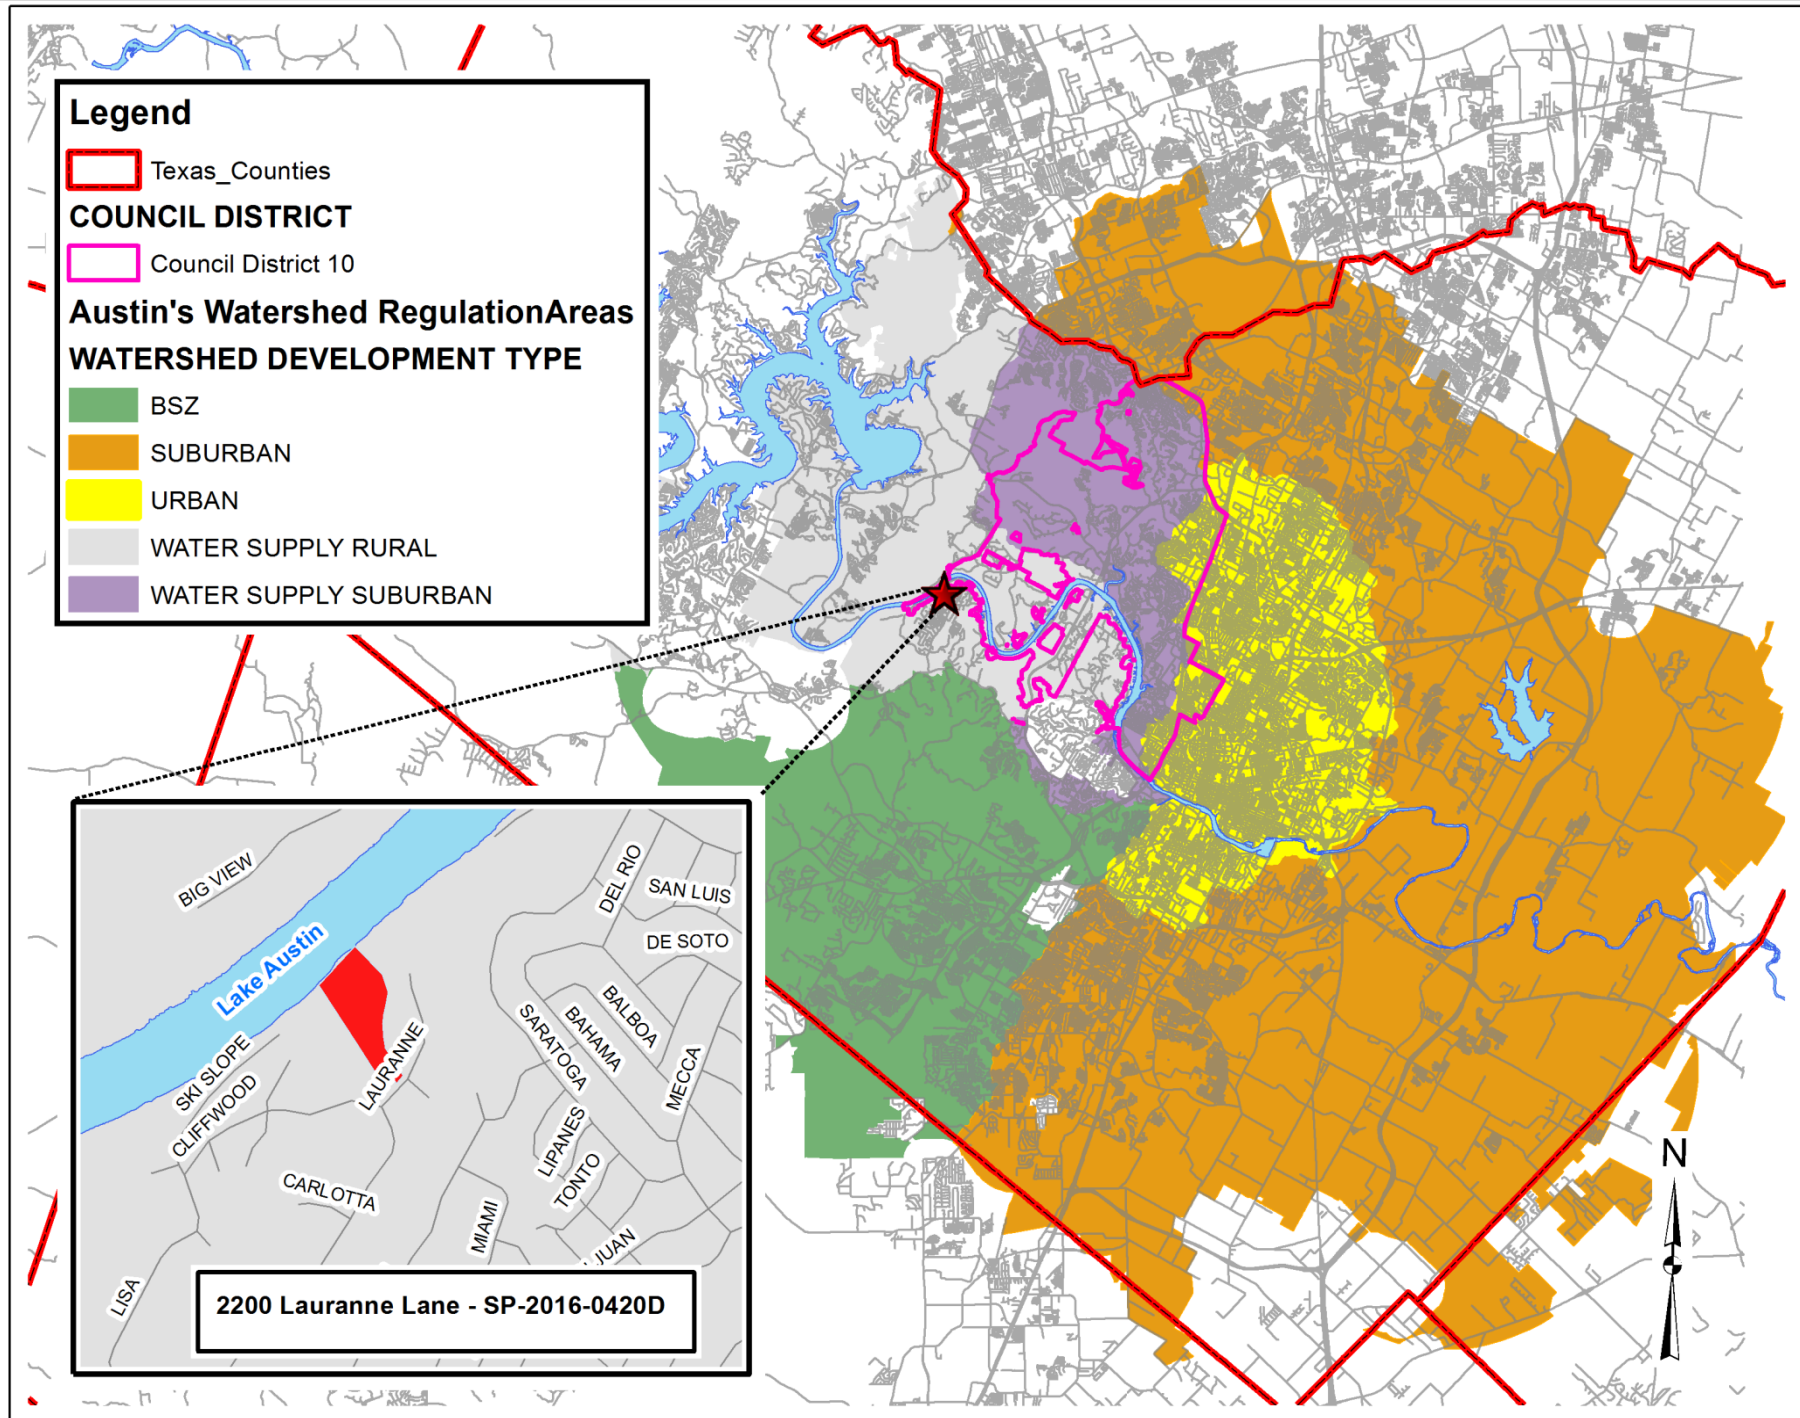
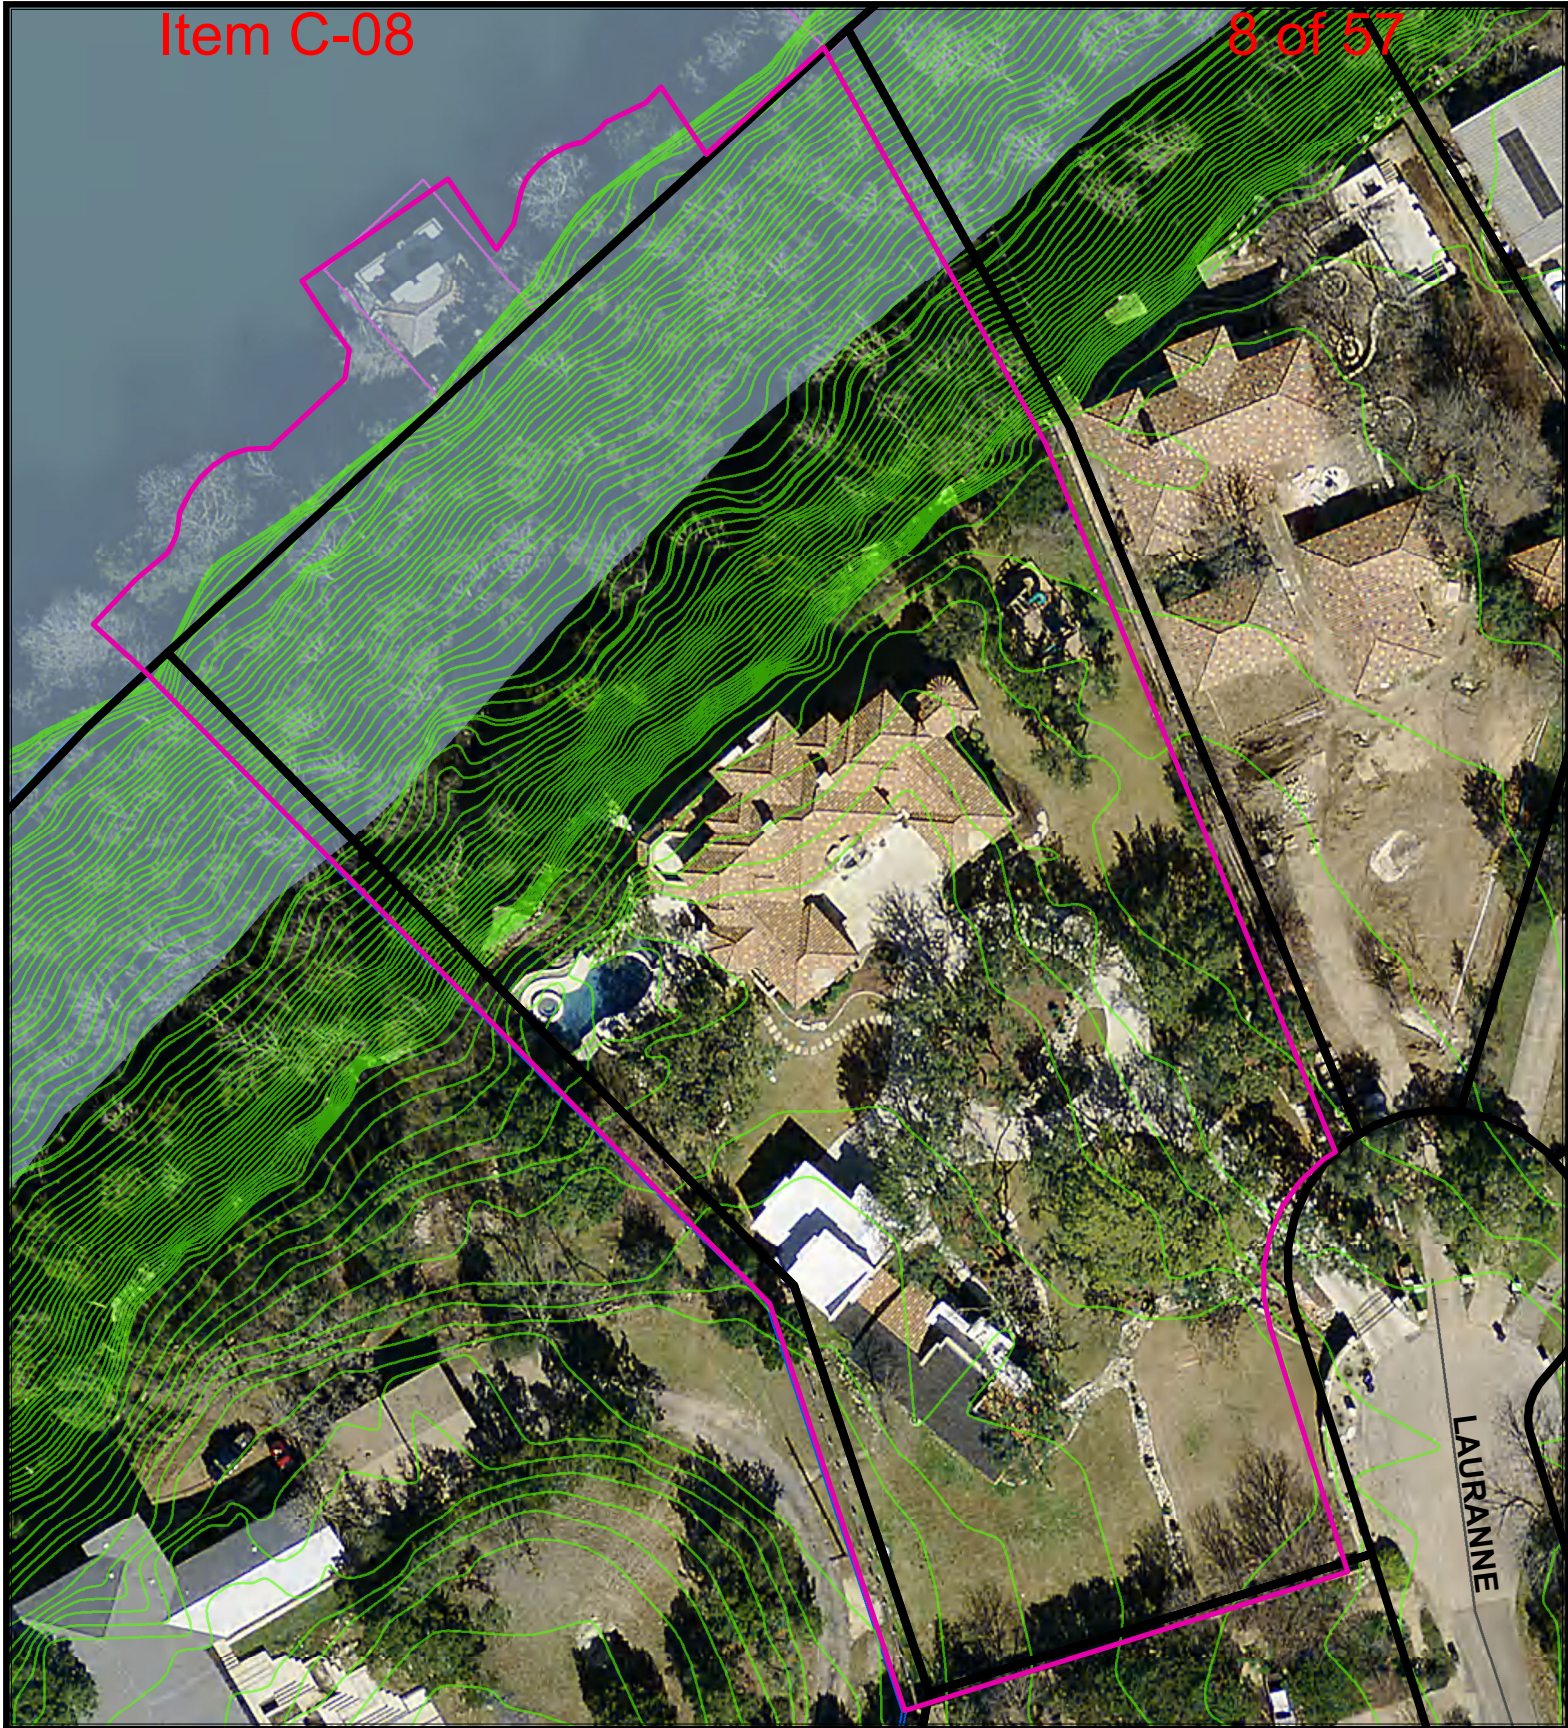
*Exhibit 1*  
*CWQZ & Topography*  
*Bulkhead for 2200 Lauranne Ln.*  
*SP-2016-0420D*

Critical Water Quality Zone
-

2-ft. Contours

A Critical Water Quality Zone associated with Lake Austin extends onto the property (Memo Exhibit 1 – Critical Water Quality Zone and Topography Map). The property is located within the Lake Austin Watershed, which is classified as a Drinking Water Protection and Water Supply Rural Watershed. The property is not located within the Edwards Aquifer Recharge Zone. The property fronts Lake Austin, and surface water drains northwest to Lake Austin.

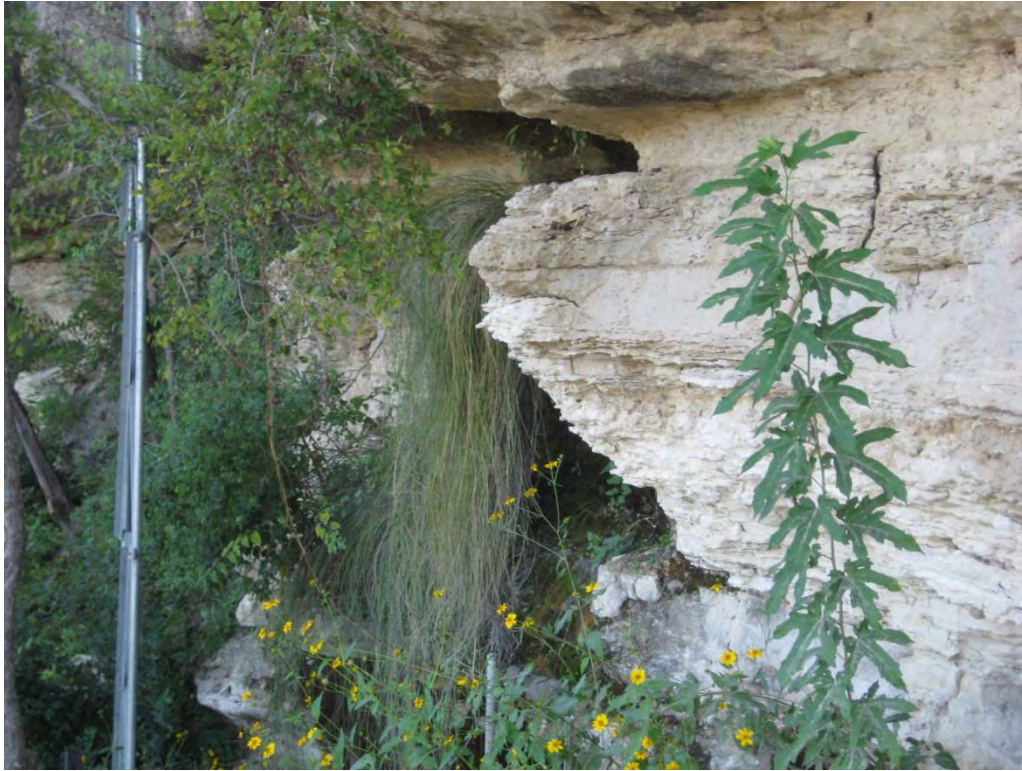
Photo 1 S-1/B-1 seep and bluff CEF

During the site investigation, no additional surface waters were observed on-site. A bluff and seep CEF (B-1 and S-1) were observed below the on-site residence and a wetland CEF (W-1) was observed near the existing boat dock along the bank of Lake Austin. Additionally, two non-CEF voids (C-1 and C-2) were observed in the northeastern portion of the site. The identified features are mapped on Exhibit 2 in Appendix B.

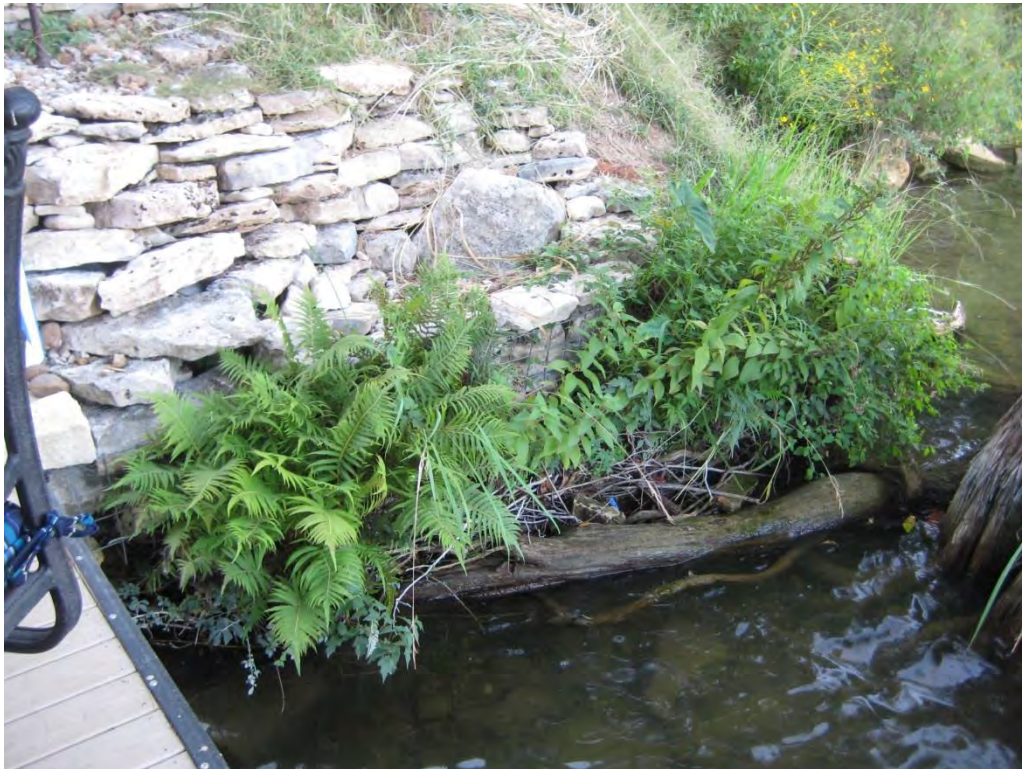
Photo 2 W-1 wetland CEF

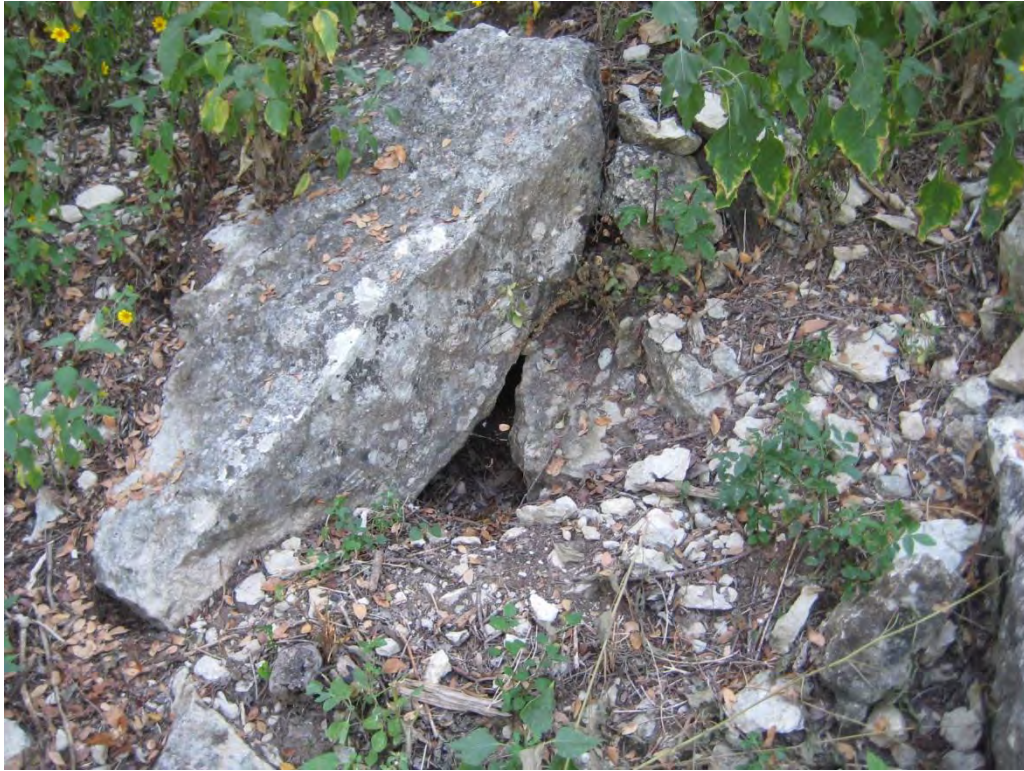
Photo 3 C-1 non-CEF void

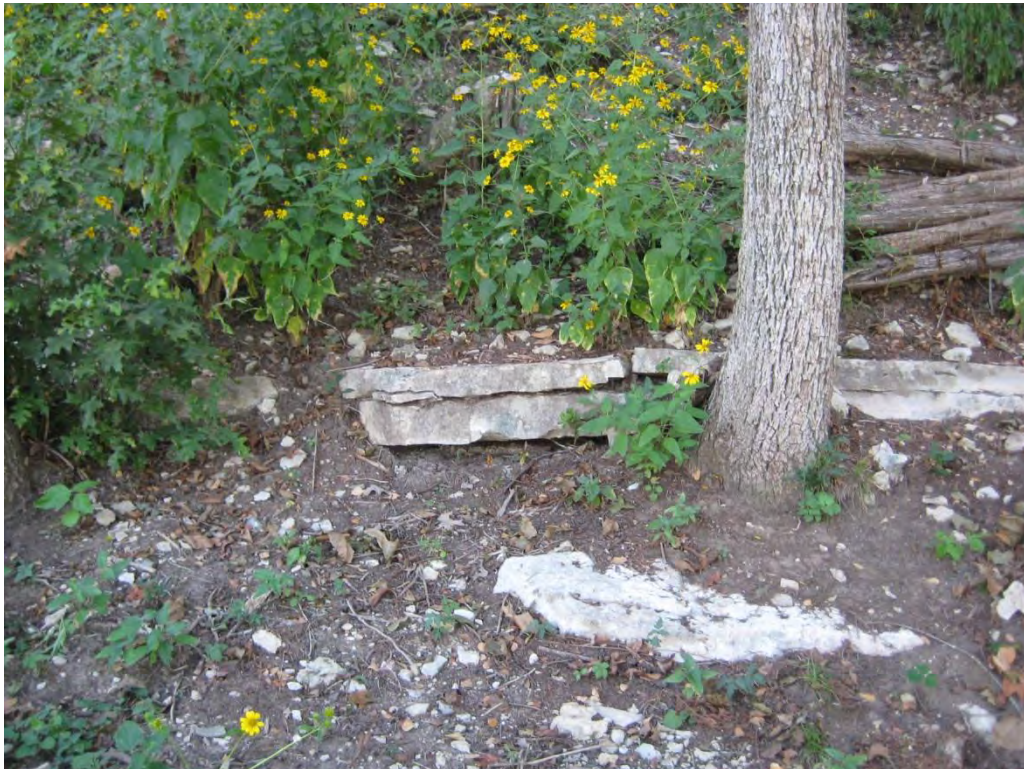
Photo 4 C-2 non-CEF void

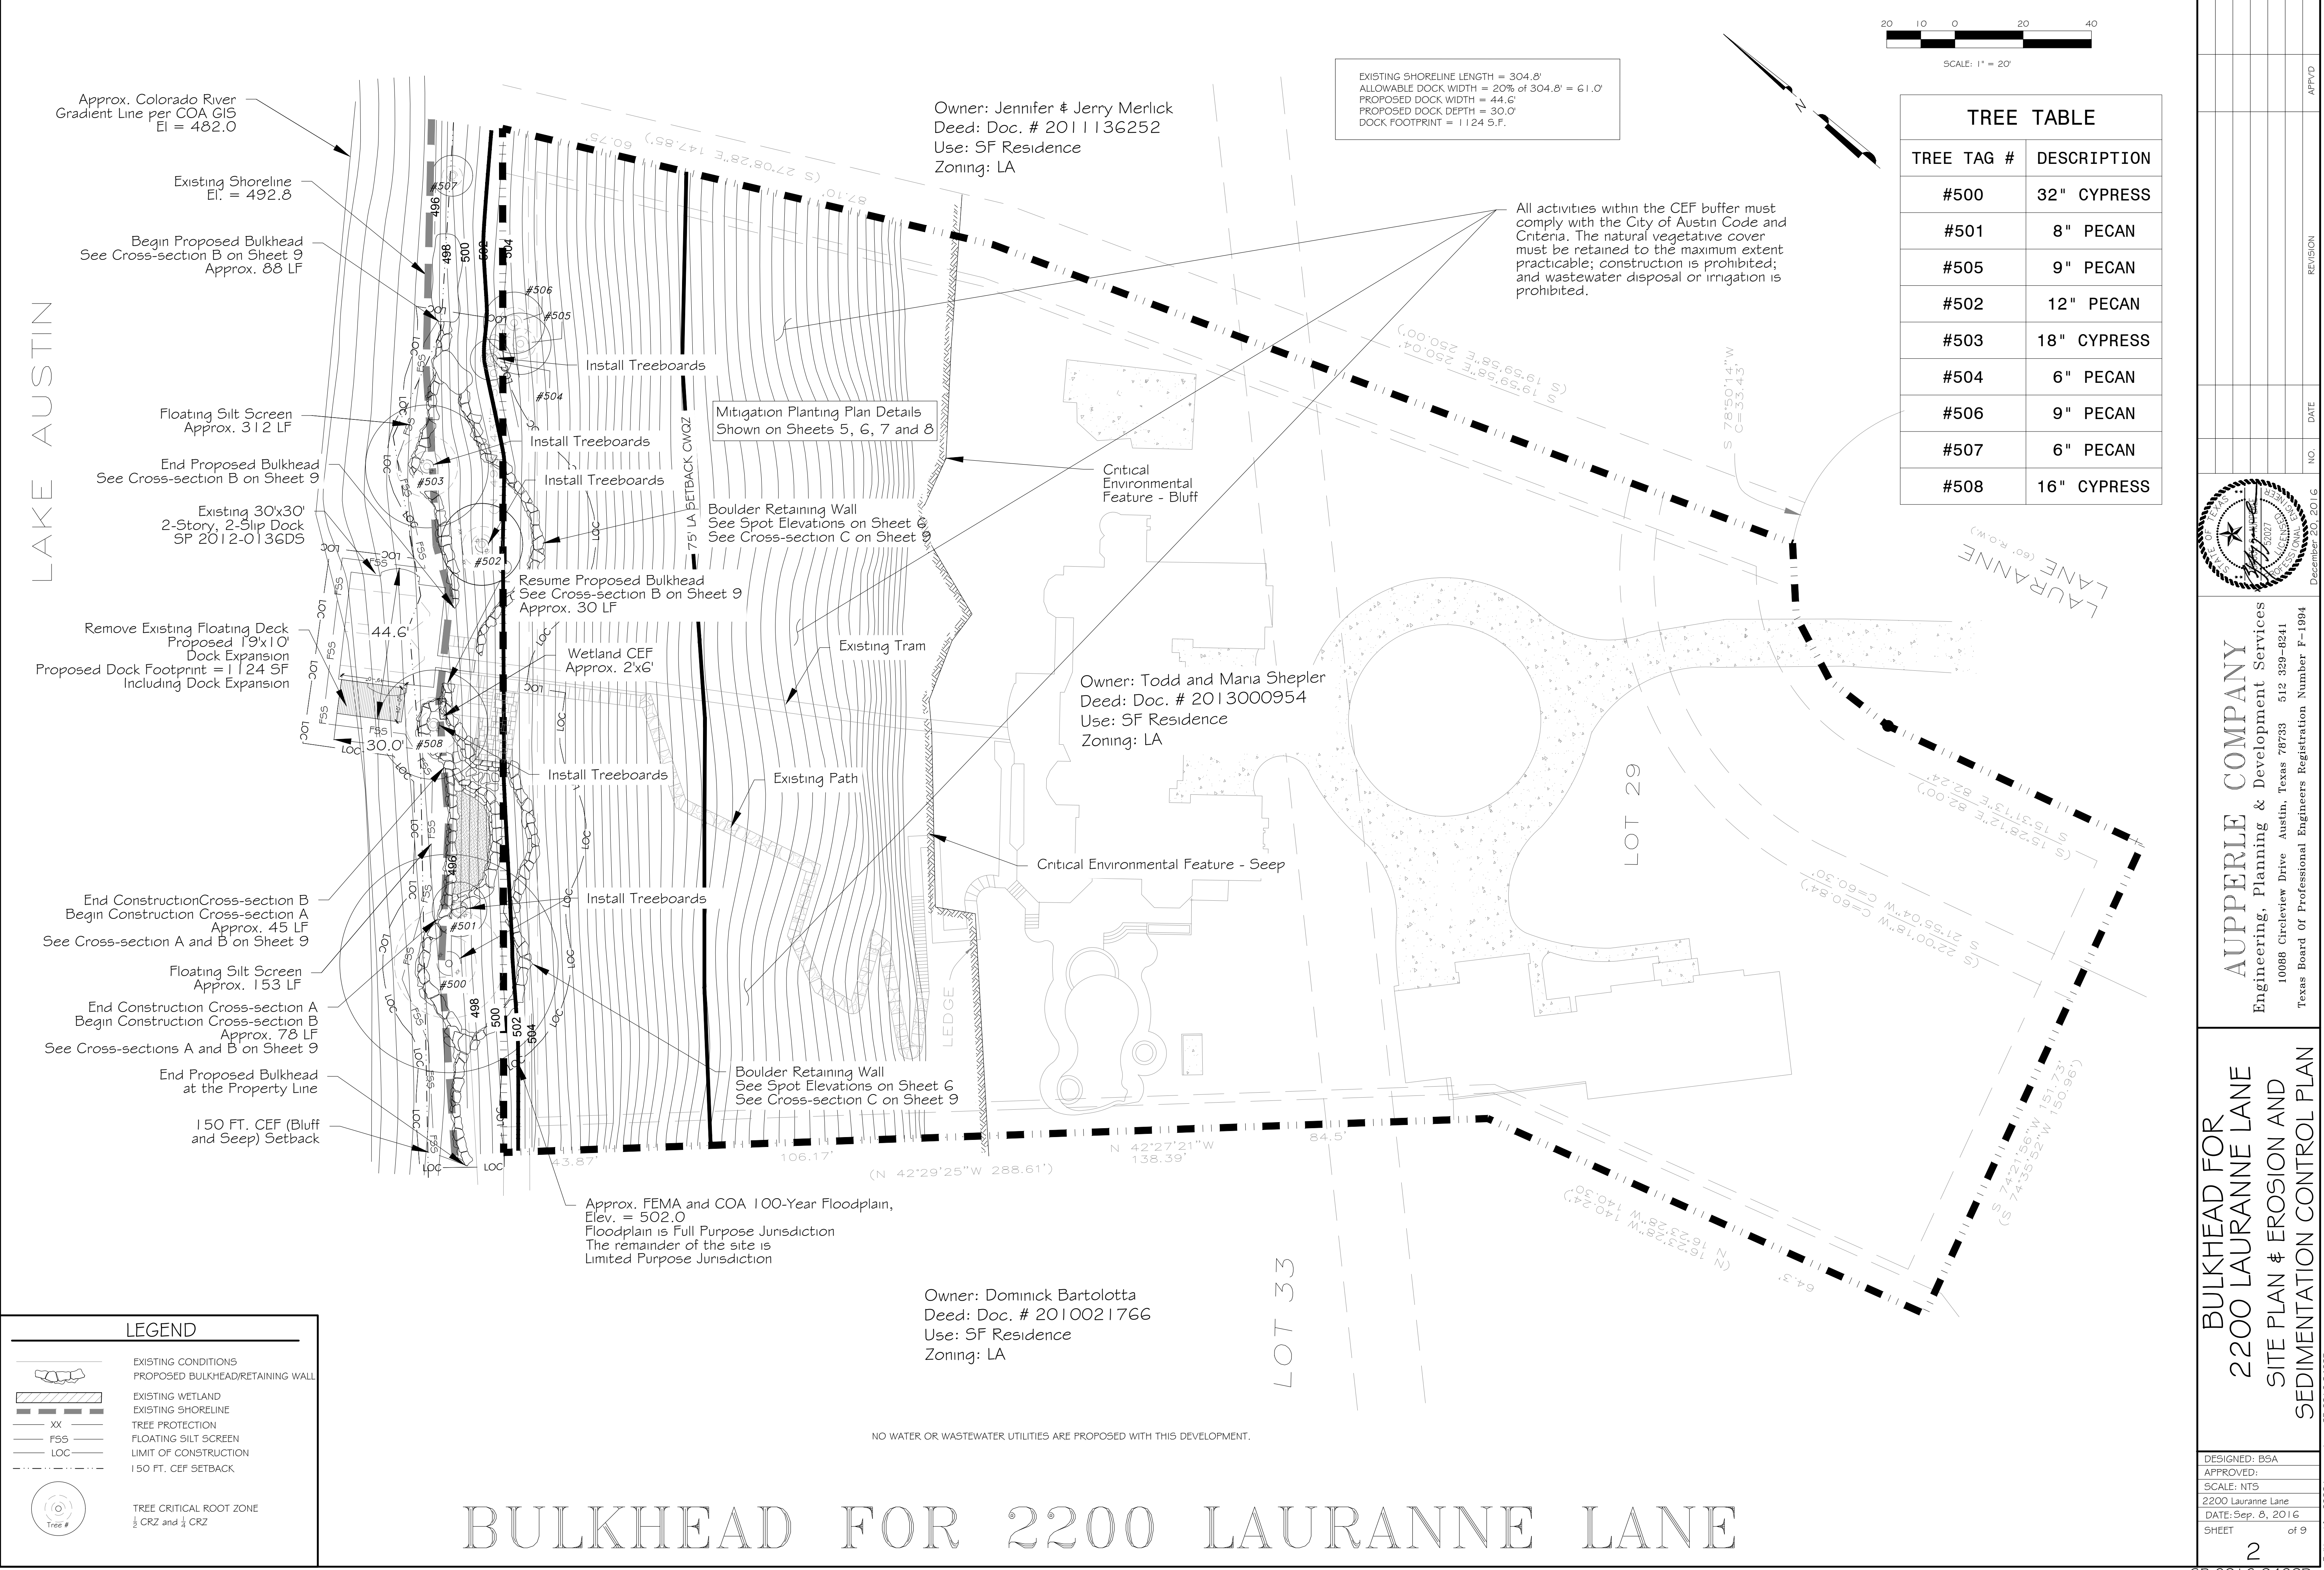
EXHIBIT 3  
SITE PLAN  
BULKHEAD FOR 2200 LAURANNE LANE

TREE TABLE	
TREE TAG #	DESCRIPTION
#500	32" CYPRESS
#501	8" PECAN
#505	9" PECAN
#502	12" PECAN
#503	18" CYPRESS
#504	6" PECAN
#506	9" PECAN
#507	6" PECAN
#508	16" CYPRESS

EXISTING CONDITIONS  
PROPOSED BULKHEAD/RETAINING WALL  
EXISTING WETLAND  
EXISTING SHORELINE  
TREE PROTECTION  
FLOATING SILT SCREEN  
LIMIT OF CONSTRUCTION  
150 FT. CEF SETBACK  
TREE CRITICAL ROOT ZONE  
1/2 CRZ and 1/2 CRZ

The proposed project, consisting of tiered, limestone and riprap walls, is downhill of and within the 150' setback of the rimrock and seep. The project is necessary to stop erosion along the bank that is threatening multiple trees and is designed to protect the trees. At the point closest to the rimrock and seep, the wall is 111 feet downhill from the CEF.
