1405 W. 10TH STREET  
AUSTIN, TEXAS 78703  
512/751-1374

BALL PERRY HOUSE

610 BAYLOR STREET, AUSTIN, TEXAS 78703

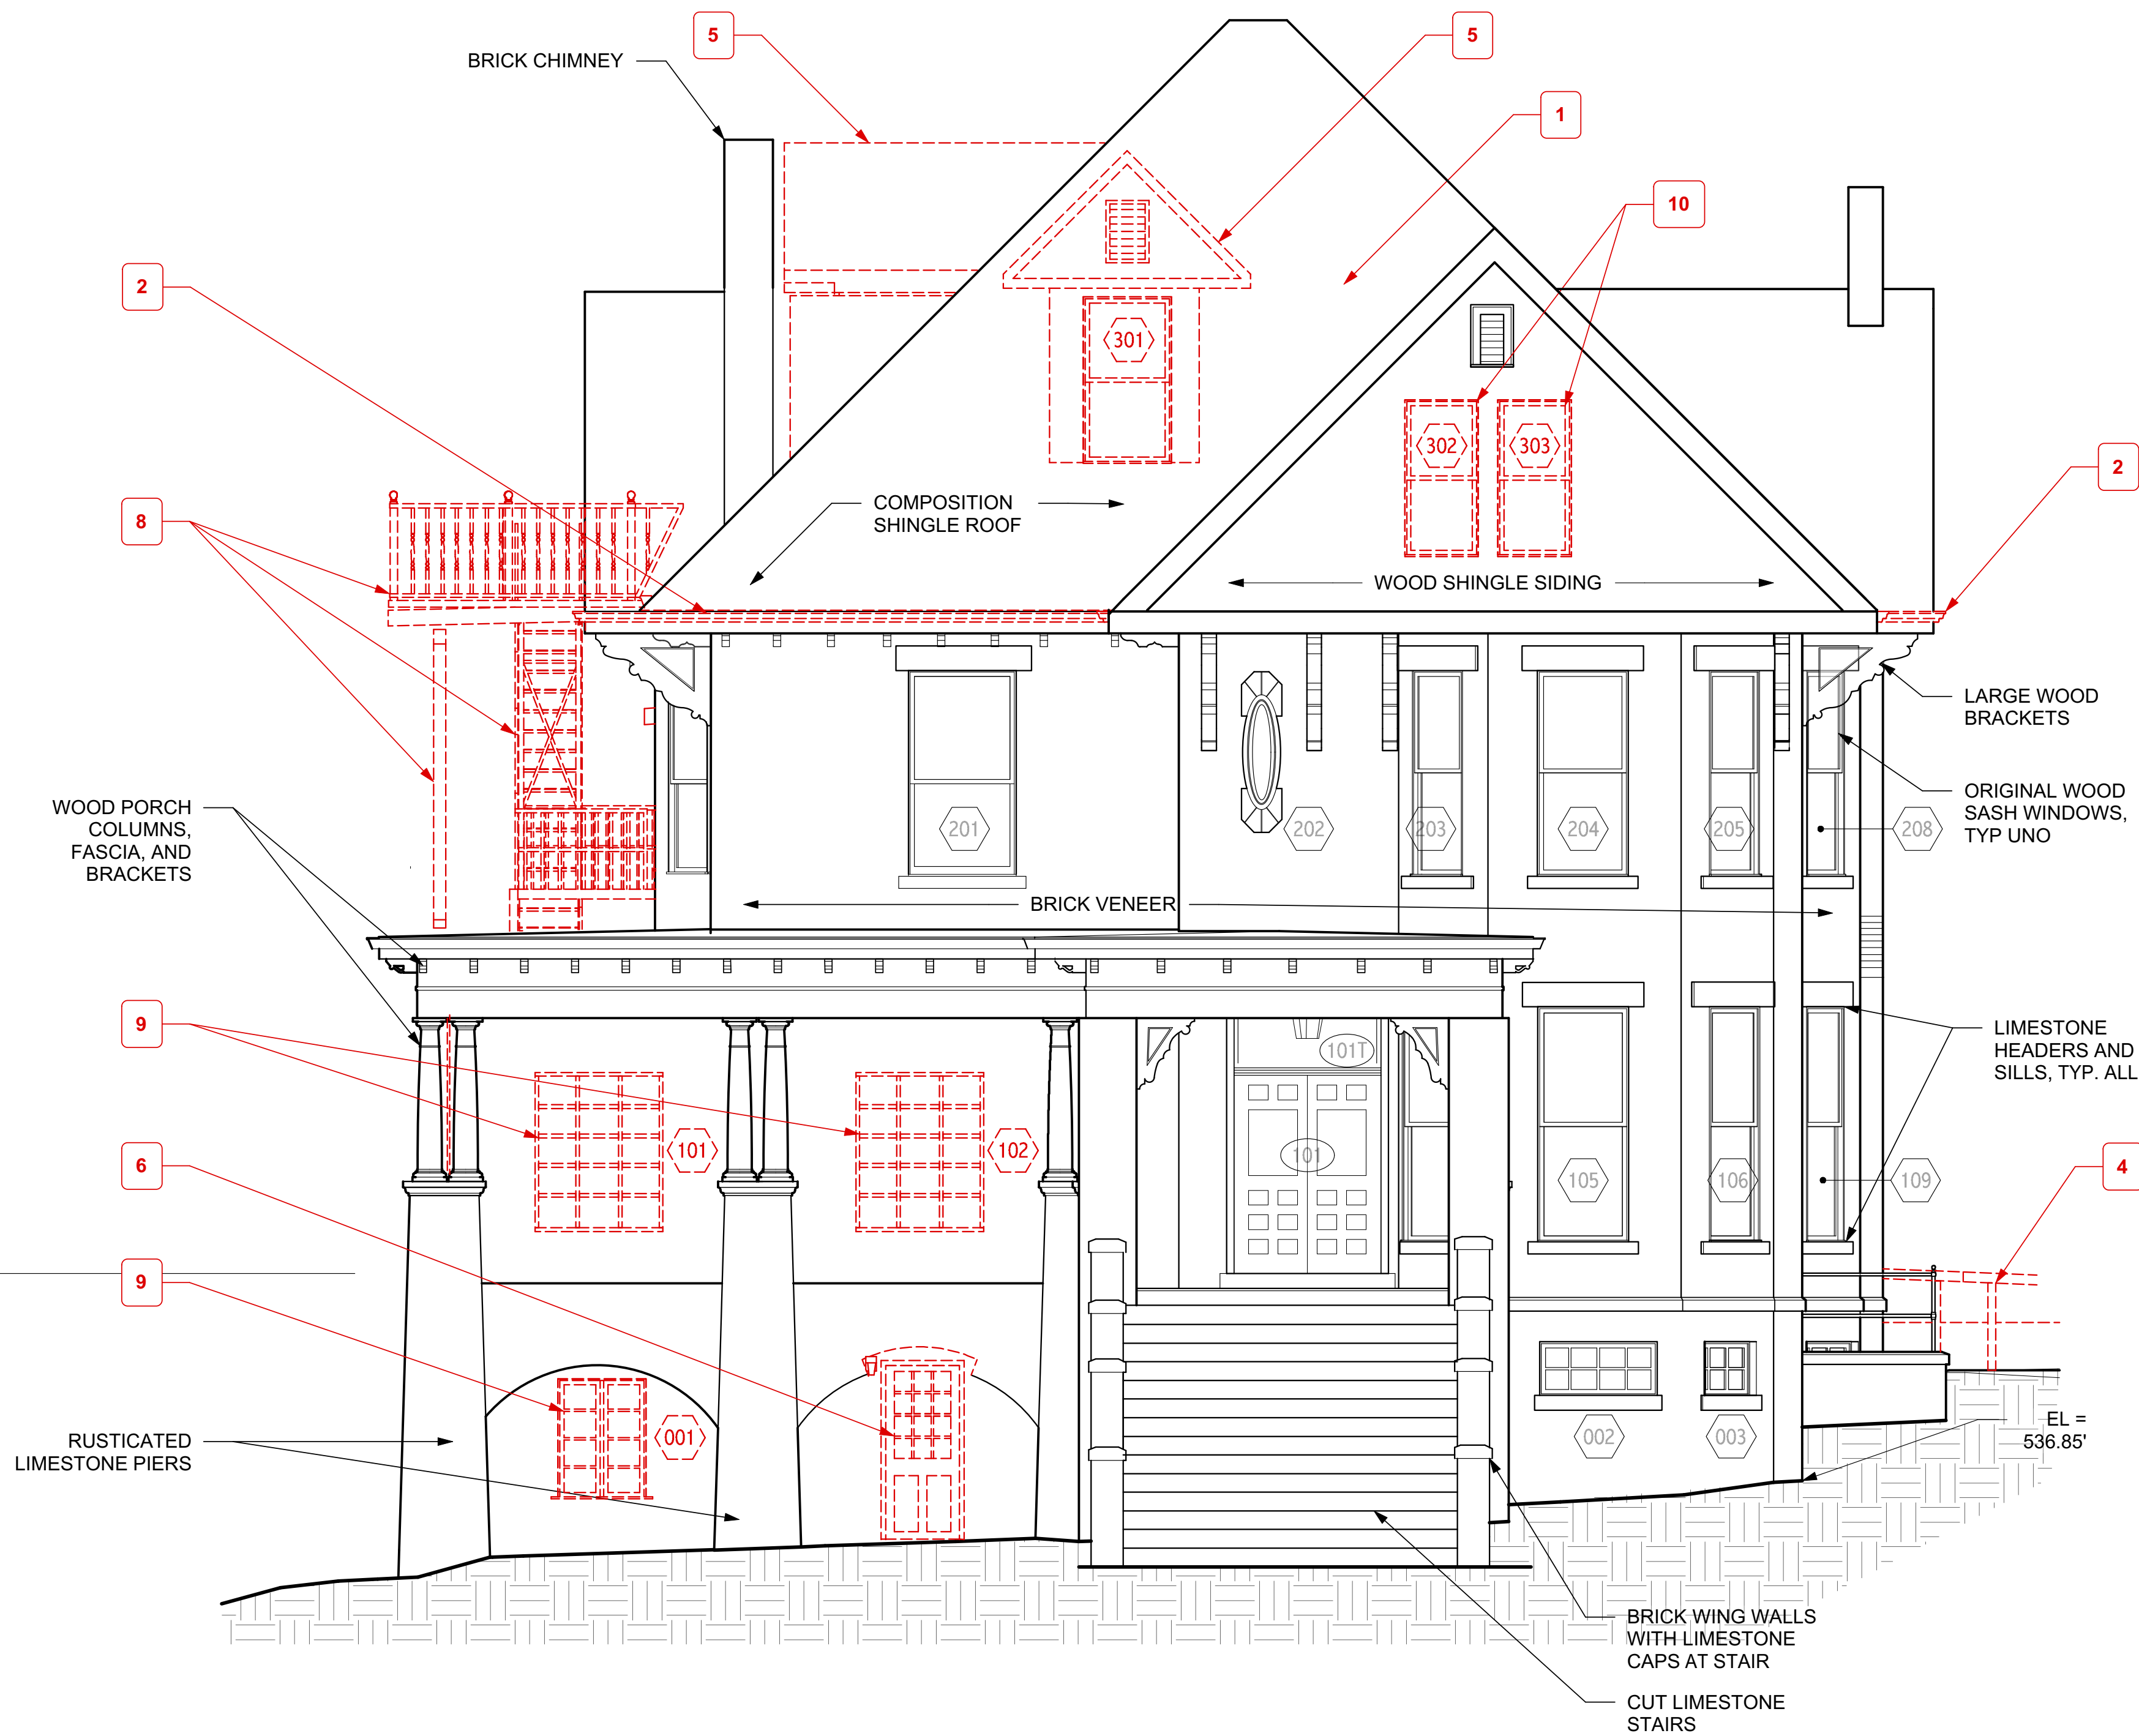
1 EAST ELEVATION DEMOLITION  
Scale: 1/4" = 1'-0"

1. REMOVE AND REPLACE COMPOSITION SHINGLE ROOF
2. REMOVE AND REPLACE GUTTERS
3. REMOVE AND SALVAGE WINDOW
4. REMOVE AWNING
5. REMOVE DORMER AND REPLACE WITH NEW TO MATCH ORIGINAL DESIGN
6. REMOVE NON-ORIGINAL DOOR AND INFILL
7. REMOVE NON-ORIGINAL DORMER
8. REMOVE NON-ORIGINAL METAL-FRAMED UPPER DECK AND FIRE ESCAPE
9. REMOVE NON-ORIGINAL PORCH INFILL AND WINDOW
10. REMOVE NON-ORIGINAL WINDOWS AND PREPARE FOR RESTORATION
11. REMOVE WOOD-FRAMED STAIR AND RAILS
12. REMOVE CONCRETE BULKHEAD
13. REMOVE BACK PORCH IN ENTIRETY AND PREPARE FOR REPLACEMENT
14. CLEAR VINES FROM AREA, TYP
15. REMOVE ELECTRIC METERS AND TELEPHONE BOXES IN THIS AREA
16. REMOVE EXPOSED CAST IRON PIPE

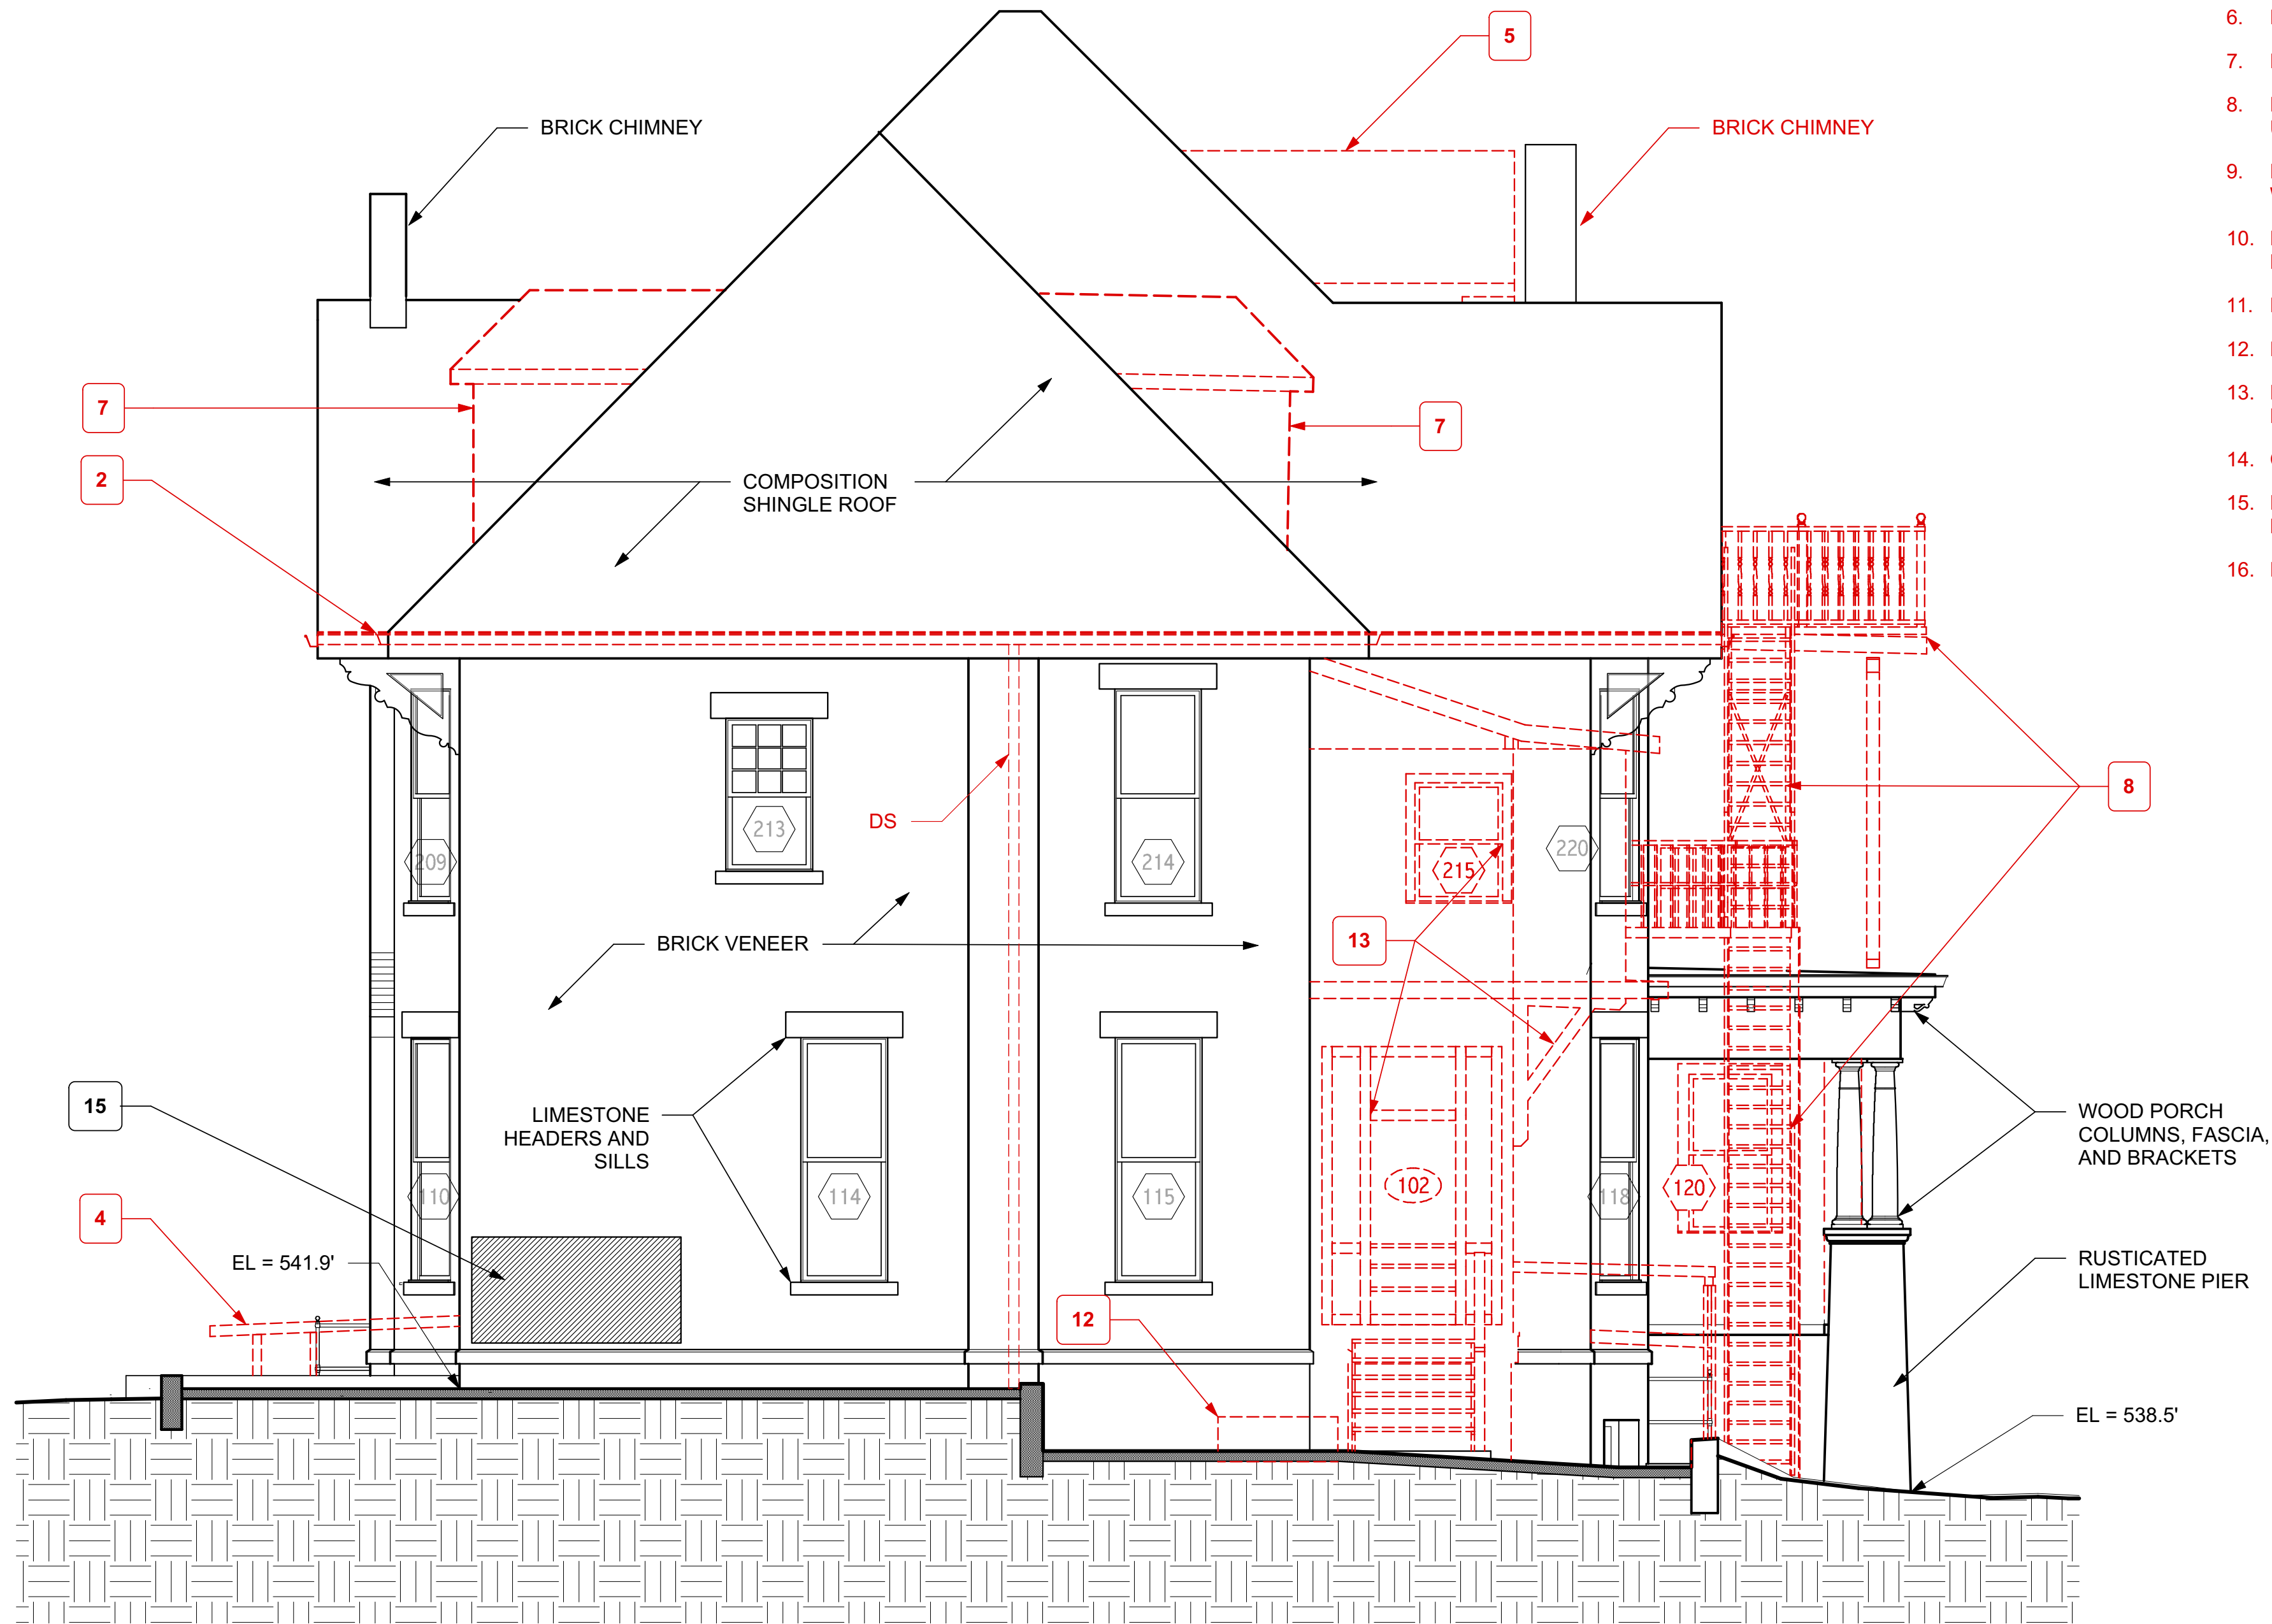
1 WEST ELEVATION DEMOLITION  
Scale: 1/4" = 1'-0"

1. REMOVE AND REPLACE COMPOSITION SHINGLE ROOF
2. REMOVE AND REPLACE GUTTERS
3. REMOVE AND SALVAGE WINDOW
4. REMOVE AWNING
5. REMOVE DORMER AND REPLACE WITH NEW TO MATCH ORIGINAL DESIGN
6. REMOVE NON-ORIGINAL DOOR AND INFILL
7. REMOVE NON-ORIGINAL DORMER
8. REMOVE NON-ORIGINAL METAL-FRAMED UPPER DECK AND FIRE ESCAPE
9. REMOVE NON-ORIGINAL PORCH INFILL AND WINDOW
10. REMOVE NON-ORIGINAL WINDOWS AND PREPARE FOR RESTORATION
11. REMOVE WOOD-FRAMED STAIR AND RAILS
12. REMOVE CONCRETE BULKHEAD
13. REMOVE BACK PORCH IN ENTIRETY AND PREPARE FOR REPLACEMENT
14. CLEAR VINES FROM AREA, TYP
15. REMOVE ELECTRIC METERS AND TELEPHONE BOXES IN THIS AREA
16. REMOVE EXPOSED CAST IRON PIPE

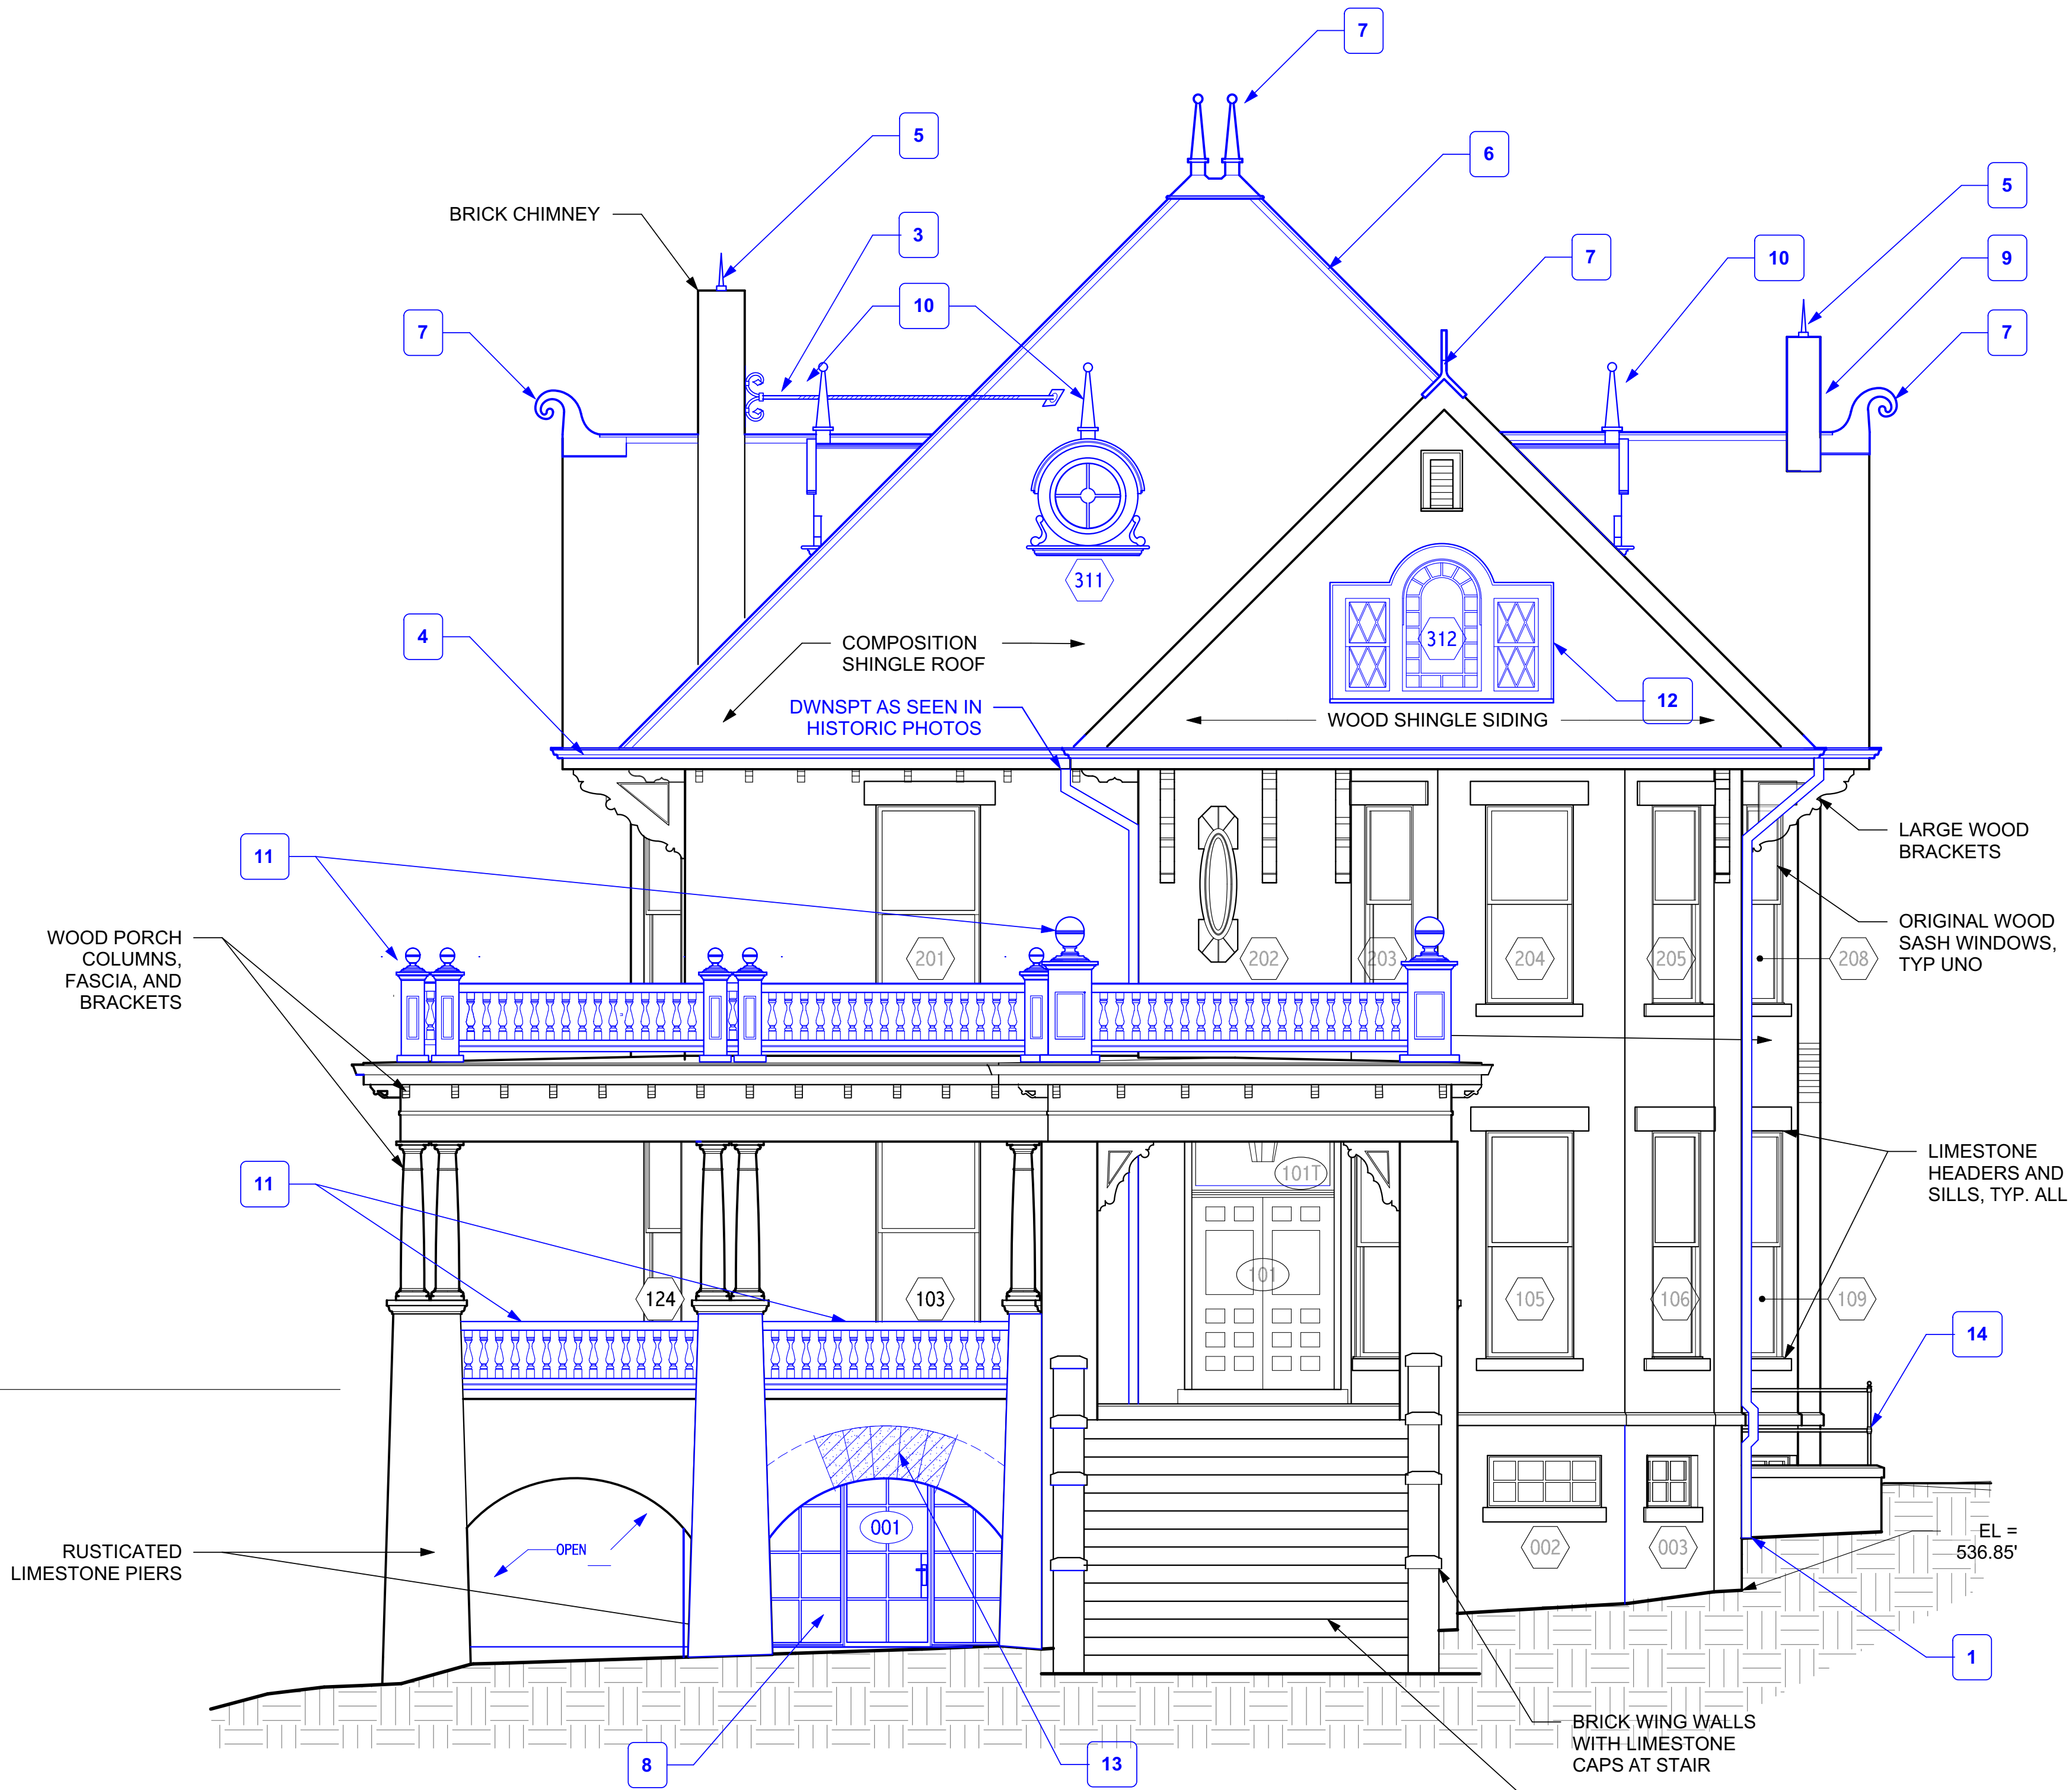
1 EAST ELEVATION RESTORATION  
Scale: 1/4" = 1'-0"

WOOD PORCH  
COLUMNS AND  
RAILS

BRICK WING  
WALLS WITH  
LIMESTONE  
CAPS AT STAIR

BRICK CHIMNEY

COMPOSITION  
SHINGLE ROOF

WOOD BARGE  
BOARD

LARGE WOOD  
BRACKETS

BRICK VENEER

LIMESTONE  
HEADERS AND  
SILLS

LIMESTONE  
BELTCOURSE

EXISTING RETAINING  
WALLS TO REMAIN

1. CONNECT DOWNSPOUT TO NEW SUBGRADE DRAINAGE SYSTEM, TYP ALL
2. INSTALL DUTCHMAN REPAIR AT DAMAGED MASONRY
3. INSTALL NEW CHIMNEY BRACE PER HISTORIC PHOTOGRAPH
4. INSTALL NEW GUTTERS AND DOWNSPOUTS
5. LIGHTNING PROTECTION
6. METAL RIDGE CAP
7. NEW FINIAL AND INTEGRATED LIGHTNING PROTECTION
8. NEW METAL-FRAMED ENTRY DOOR AND WINDOWS INFILL OPENING BEYOND. REF: PLAN AND DETAILS
9. RECONSTRUCT MISSING BRICK CHIMNEY
10. RECONSTRUCT MISSING ROUND DORMER AND FINIAL
11. RECONSTRUCT ORIGINAL BALCONY RAIL AND PIERS
12. RECONSTRUCT WINDOWS TO MATCH ORIGINAL DESIGN
13. REPLACE DAMAGED MASONRY AT ARCH TO MATCH ORIGINAL
14. RESTORE ORIGINAL RAILING
15. RECONSTRUCT WINDOW OPENING FROM NON-ORIGINAL DOOR OPENING, INCLUDING NEW STONE WINDOW SILL

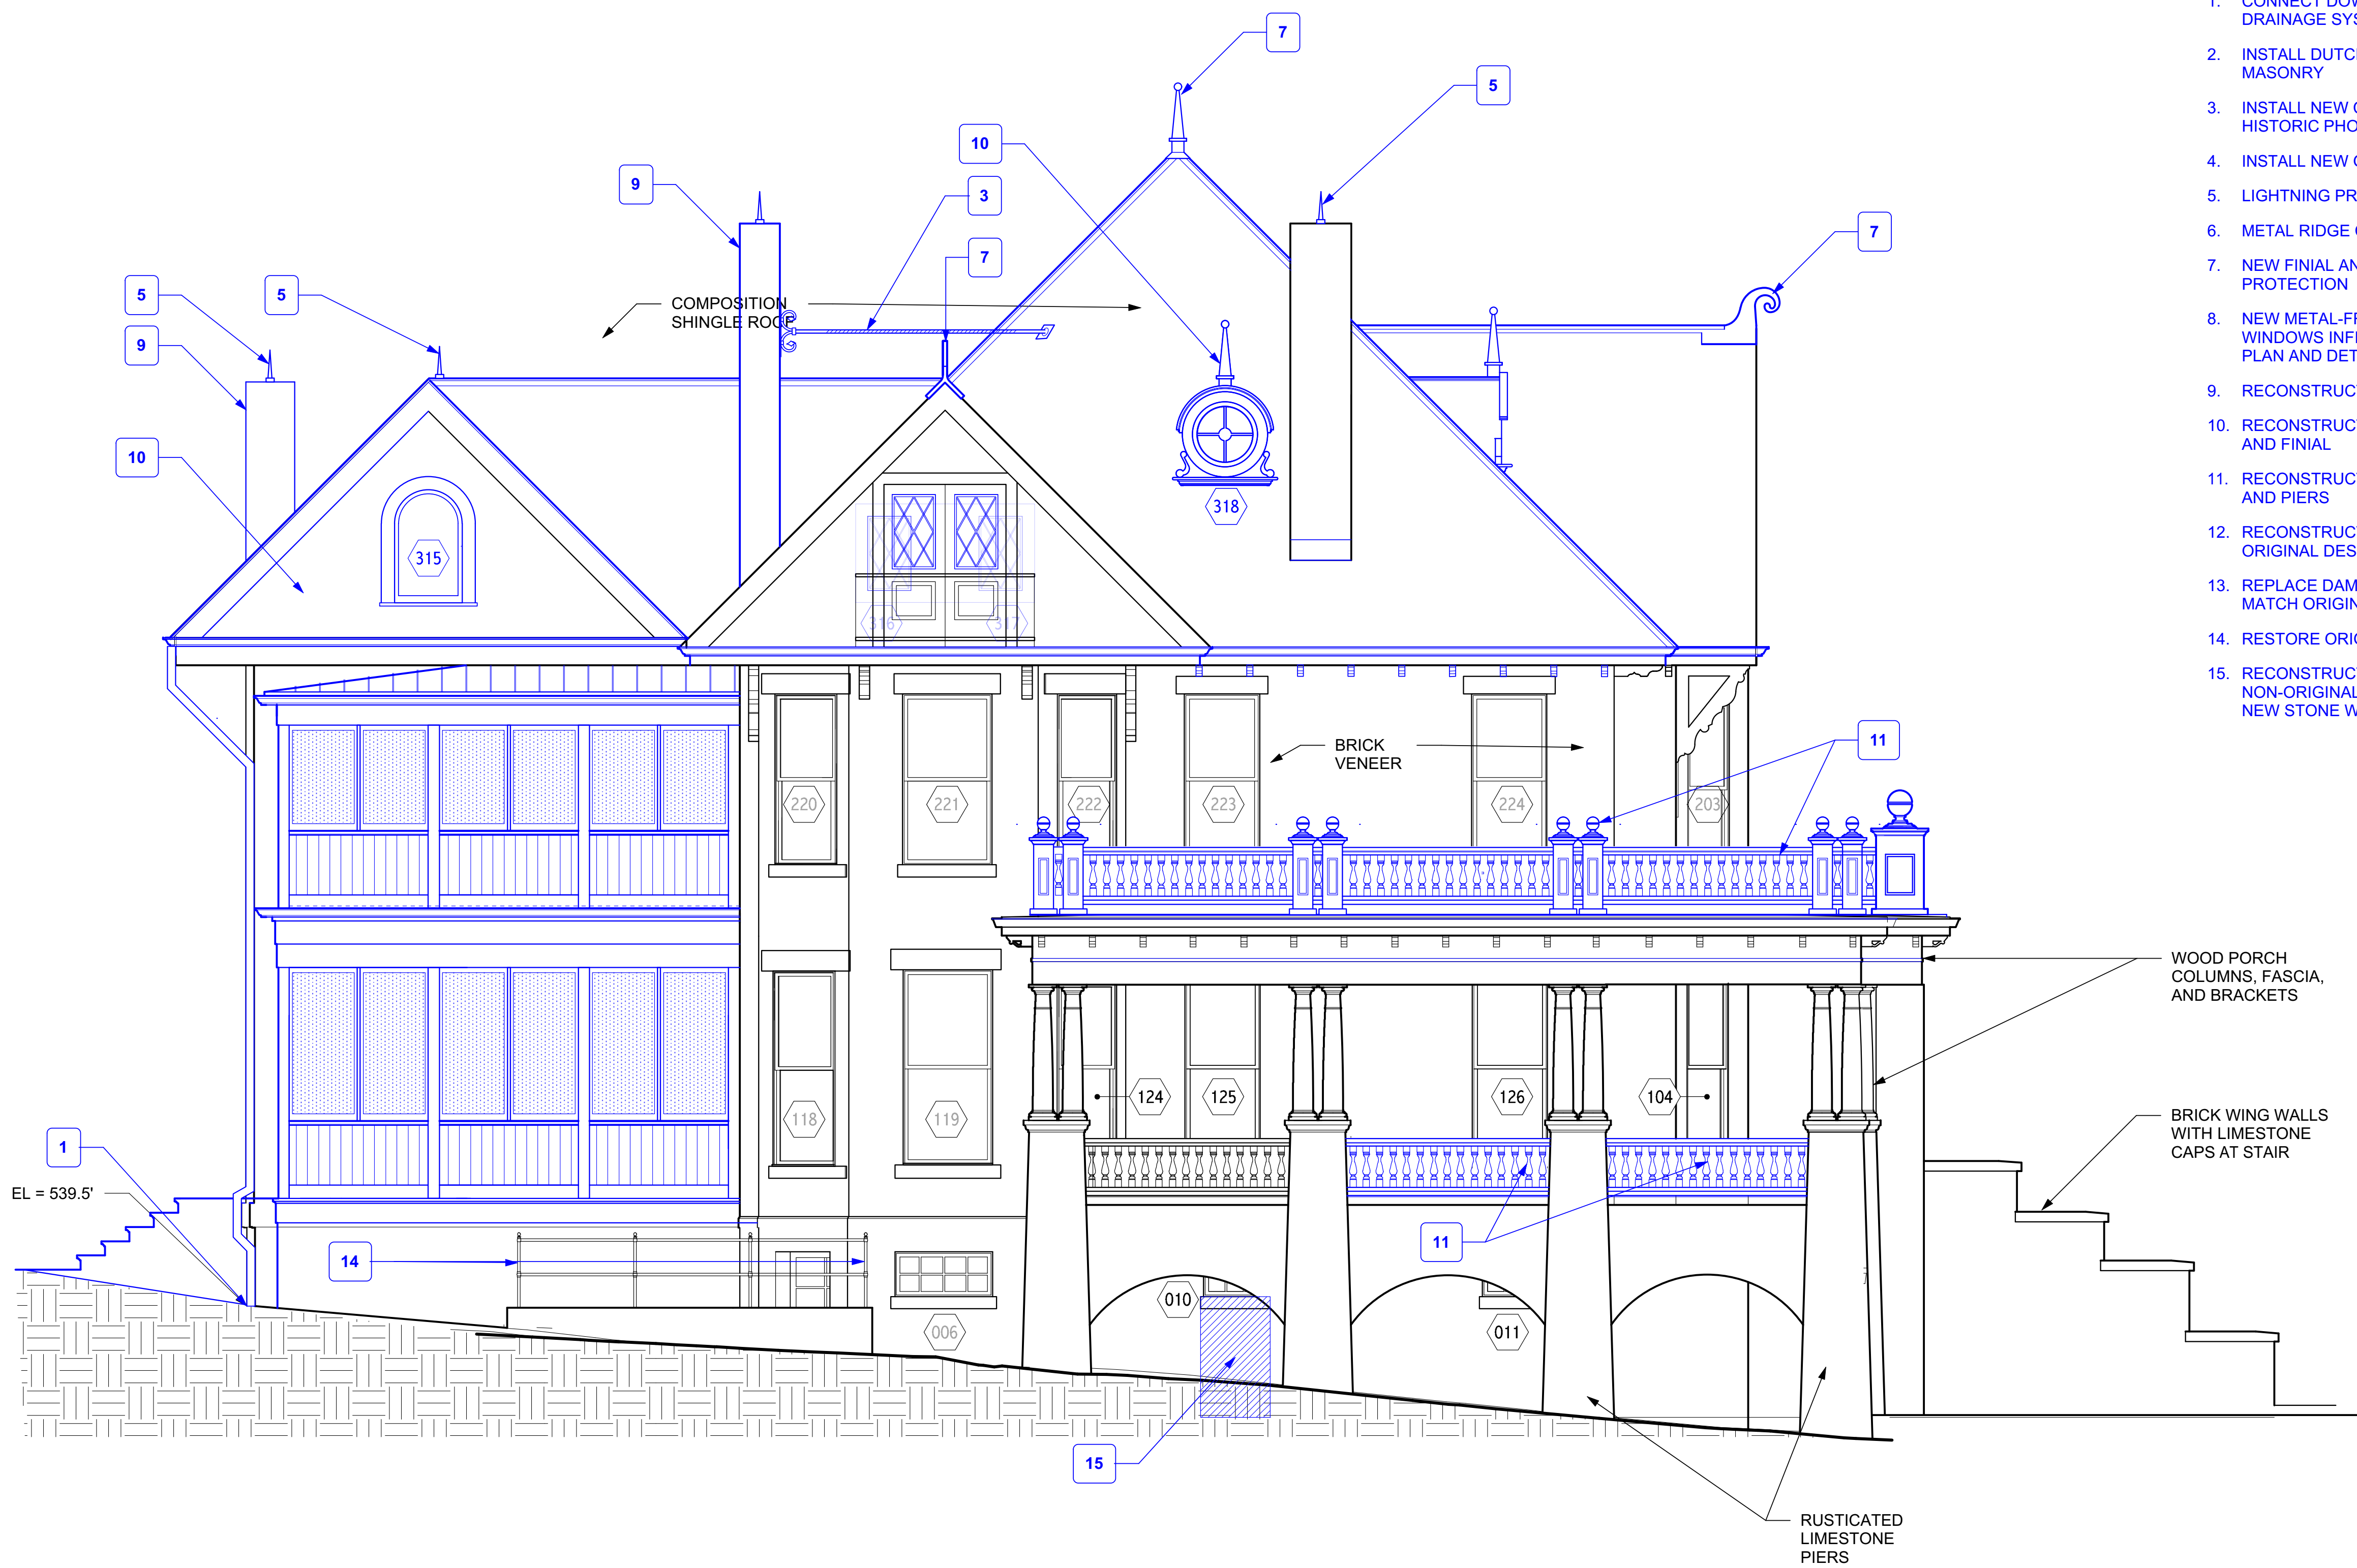
1 WEST ELEVATION RESTORATION  
Scale: 1/4" = 1'-0"

1. CONNECT DOWNSPOUT TO NEW SUBGRADE DRAINAGE SYSTEM, TYP ALL
2. INSTALL DUTCHMAN REPAIR AT DAMAGED MASONRY
3. INSTALL NEW CHIMNEY BRACE PER HISTORIC PHOTOGRAPH
4. INSTALL NEW GUTTERS AND DOWNSPOUTS
5. LIGHTNING PROTECTION
6. METAL RIDGE CAP
7. NEW FINIAL AND INTEGRATED LIGHTNING PROTECTION
8. NEW METAL-FRAMED ENTRY DOOR AND WINDOWS INFILL OPENING BEYOND. REF: PLAN AND DETAILS
9. RECONSTRUCT MISSING BRICK CHIMNEY
10. RECONSTRUCT MISSING ROUND DORMER AND FINIAL
11. RECONSTRUCT ORIGINAL BALCONY RAIL AND PIERS
12. RECONSTRUCT WINDOWS TO MATCH ORIGINAL DESIGN
13. REPLACE DAMAGED MASONRY AT ARCH TO MATCH ORIGINAL
14. RESTORE ORIGINAL RAILING
15. RECONSTRUCT WINDOW OPENING FROM NON-ORIGINAL DOOR OPENING, INCLUDING NEW STONE WINDOW SILL
