**PROPOSAL / CONTRACT**

Subject: Exterior Building Repairs

Job Name: Blue Cross Blue Shield – 206 W 13<sup>th</sup> St., Austin, TX 78701

**BASE BID: THE BOTTOM 16 FEET OF THE WEST ELEVATION (Approximately 1000 sf.)**

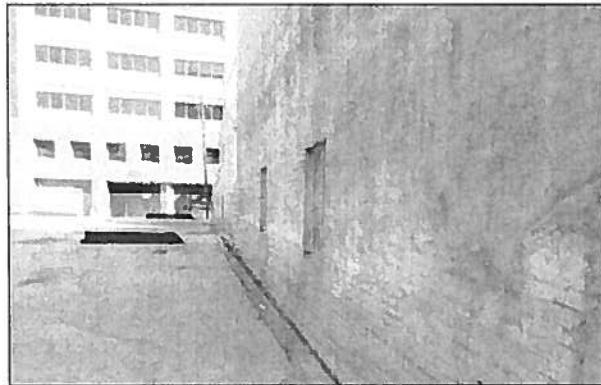
- (3) The previously painted brick surfaces shall have as much of the existing paint removed from the surface as possible by use of chemical paint strippers and pressurized water. The chemical strippers shall be applied to the surface, allowed to dwell and rinsed in accordance with the manufacturer's specifications. This proposal includes **two (2)** applications of the paint stripper. Additional paint stripping applications shall be handled on a unit price basis at a rate of **\$3.00** per square foot, per application.

- (4) All mortar joints shall be carefully inspected and those found to have voids, cracks or openings greater than 1/64th inch in width or those found to be eroded more than 1/4-inch in depth, shall be cut back to a depth of two times the joint width, but in no case deeper than 1-inch, and shall then be cleaned of all loose and foreign debris with air and/or water pressure.

- (5) Defective mortar joints that have been cut and cleaned shall then be pointed (filled and tightly packed) with a non-staining, non-shrinking, Type "N" masonry pointing mortar, colored and tooled to match the adjacent joints in appearance as closely as possible.

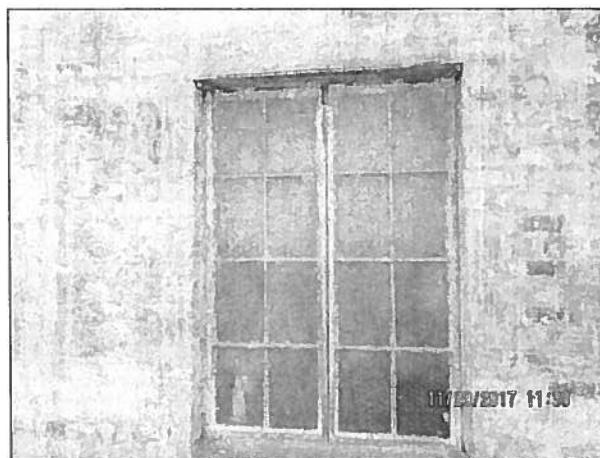
- (6) The two (2) existing window openings shall be infilled with CMU block and a brick veneer to match the adjacent surfaces as closely as possible. The existing window frames shall be removed and disposed of, unless directed otherwise. The new brick and block infill shall be placed in the same plane as the original wall.
