### **ITEM FOR ENVIRONMENTAL COMMISSION AGENDA**

**NAME & NUMBER OF PROJECT:** 3801 Westlake  
SP-2019-0243DS

**REQUEST:** Variance request is as follows:  
Request to vary from LDC 25-8-281(C)(2)(b) to allow construction  
of a boat dock and shoreline access within a 150-foot Critical  
Environmental Feature (CEF) buffer for a Rimrock CEF.

3801 WESTLAKE DRIVE  
PROPOSED CONDITIONS SITE PLAN  
AND EROSION CONTROLS SHEET

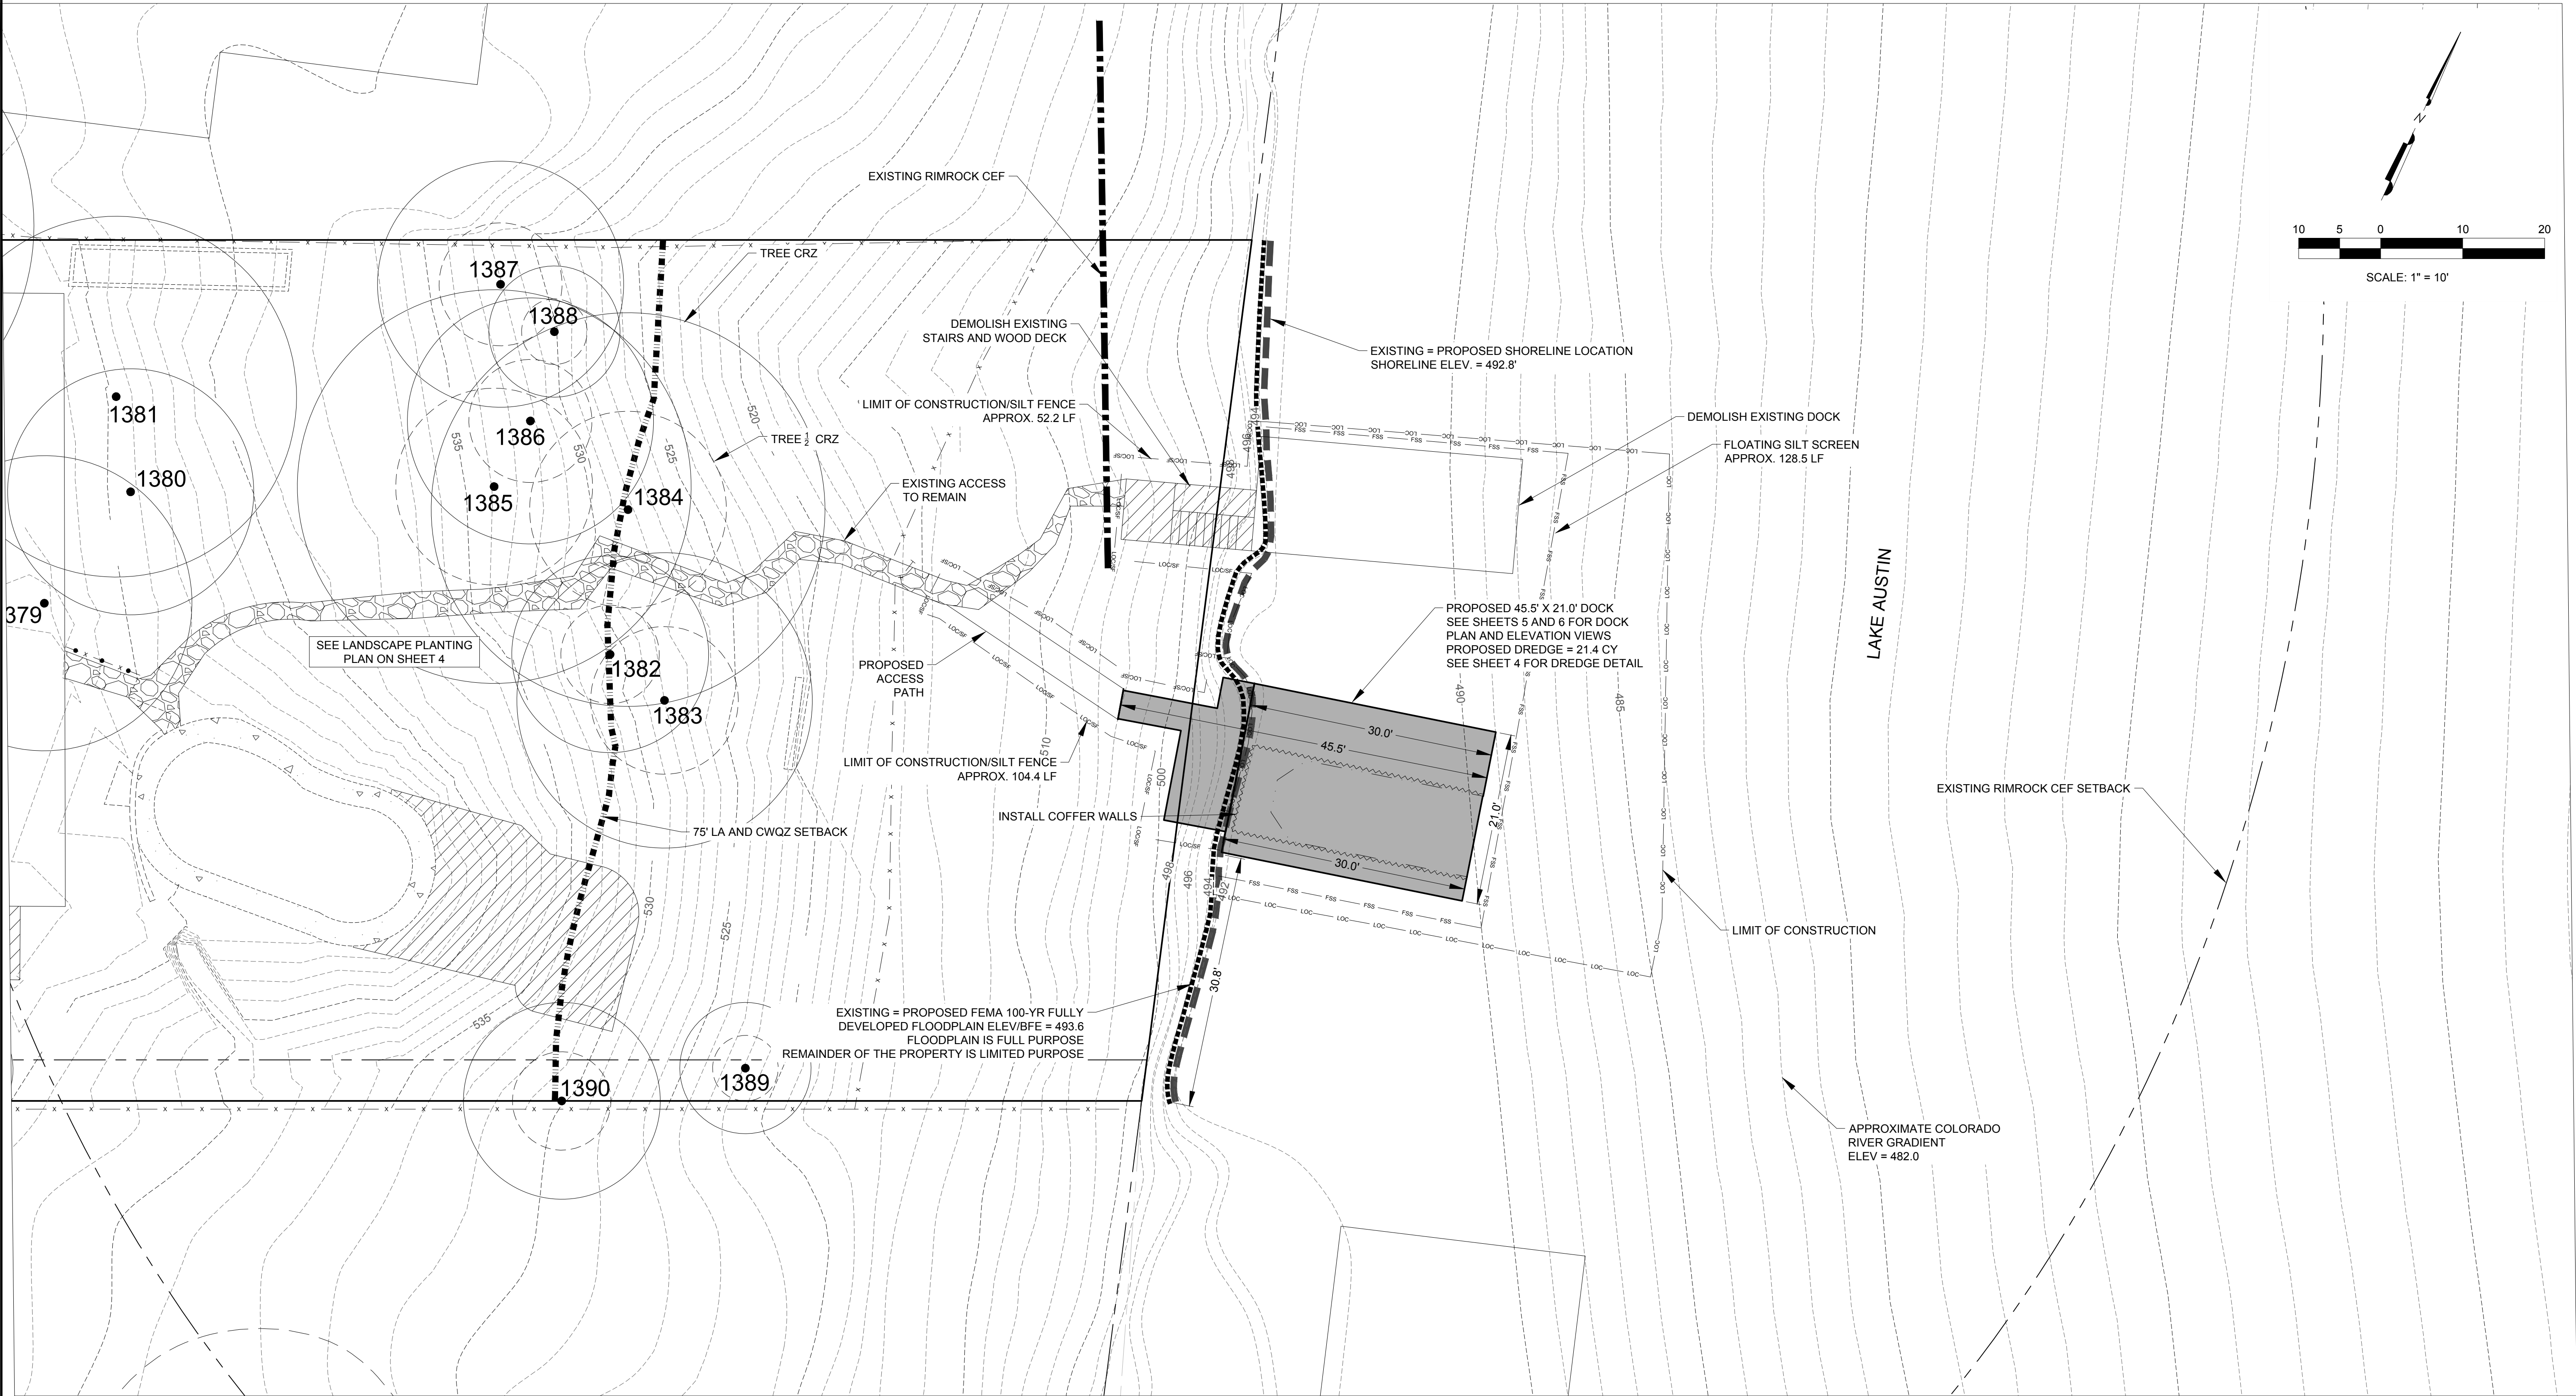
PROPOSED SITE PLAN

1. ALL WORK SHALL OCCUR WITHIN THE LIMITS OF CONSTRUCTION AS SHOWN ON THE PLAN. ALL MATERIALS WILL BE TRANSPORTED TO THE SITE FROM WATER. ALL CONSTRUCTION ACTIVITY, INCLUDING STAGING AND SPOIL STORAGE, WILL BE COMPLETED BY WATER.

5. NO WATER OR WASTEWATER UTILITIES ARE PROPOSED WITH THIS DEVELOPMENT.
6. DOCK SHALL BE AT LEAST 66% OPEN.
7. PILINGS SHALL BE 6-5/8" DIAMETER STEEL PIPE.

EXISTING SHORELINE LENGTH = 108.6'  
ALLOWABLE DOCK WIDTH = 20% OF 108.6' = 21.7'  
PROPOSED DOCK WIDTH = 21.0' = 19.3%  
PROPOSED DOCK DEPTH = 48.5'  
DOCK FOOTPRINT = 783.7 SF

| Clearly indicate in what way the proposed project does not comply with current Code (include maps and exhibits) | <i>This project proposes to demolish an existing dock and its access and construct a new dock and access route farther away from a rimrock. The demolition of the dock and access as well as the construction of the new dock and access are within 150 ft. of the rimrock. Please see Attachment 1 for the Proposed Conditions Site Plan and Erosion Controls Sheet.</i> |

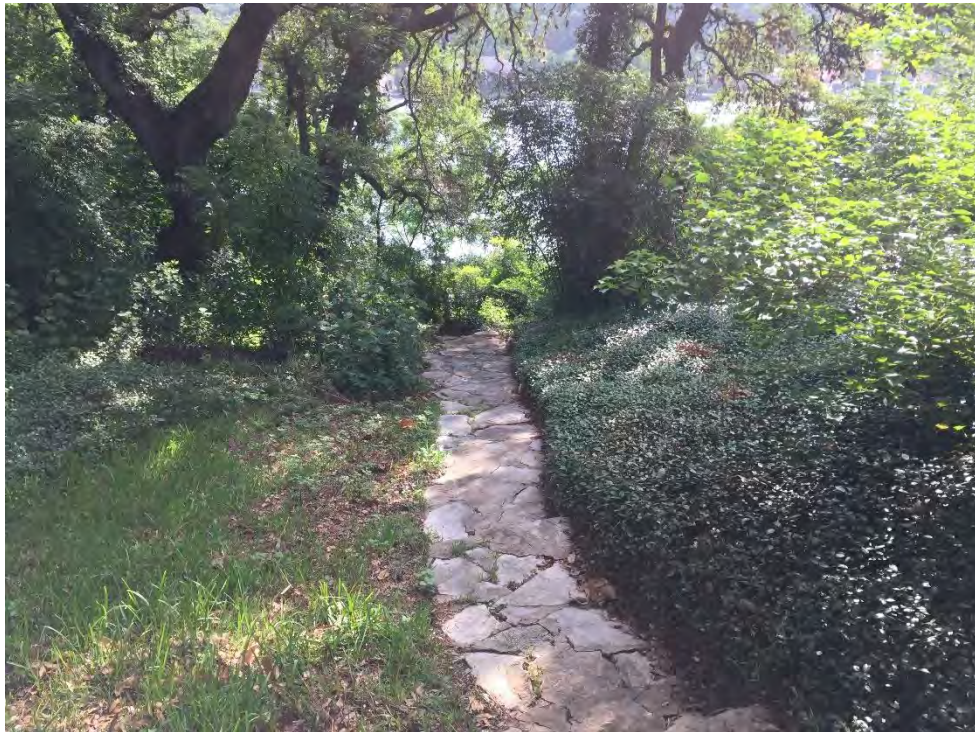
**Photo 6: Path from residence down to the dock. Photo is facing the east northeast.**

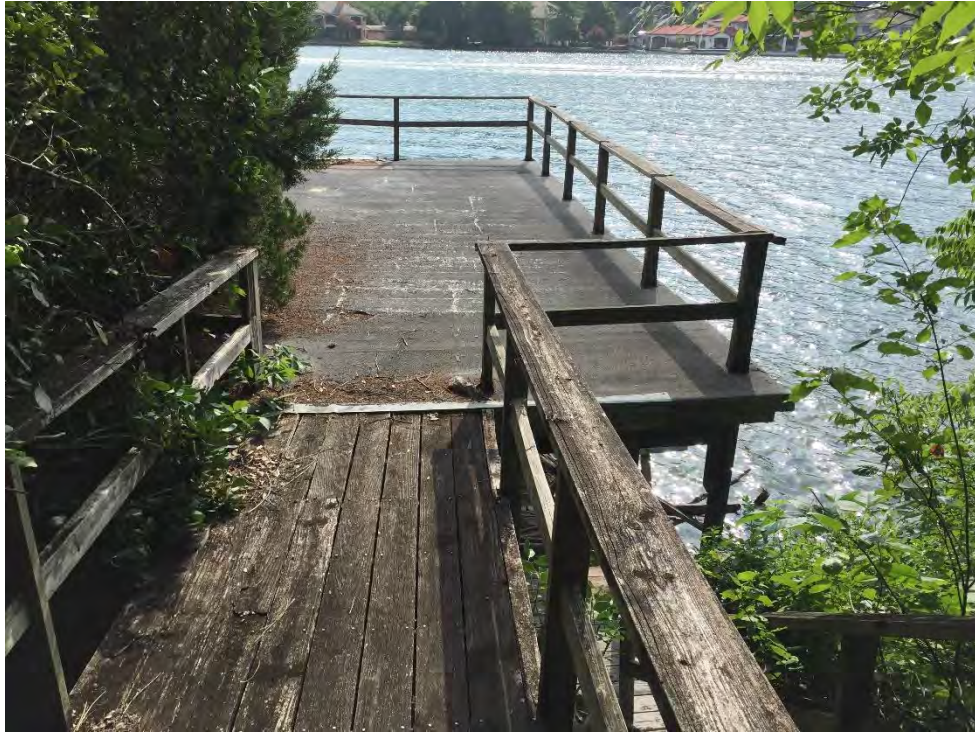
**Photo 7: Dock over Lake Austin. Photo is facing the east northeast.**

**YES. The entire shoreline is within the CEF setback. The existing dock is rotting; it's unsafe and unusable; and the stairs and gangway to the dock cross the rimrock. The replacement dock will be built as far away as possible from the rimrock while making maximum use of the existing access route from the house in order to minimize the disturbance on the shoreline. Runoff from the limit of construction will not flow toward the rimrock.**

**YES. The existing dock and access are crumbling with tar paper sloughing off of the roof of the dock into the lake. The structures are unsound, and it's not possible to construct a dock without the variance. All disturbed areas will be revegetated per the 609s specification.**

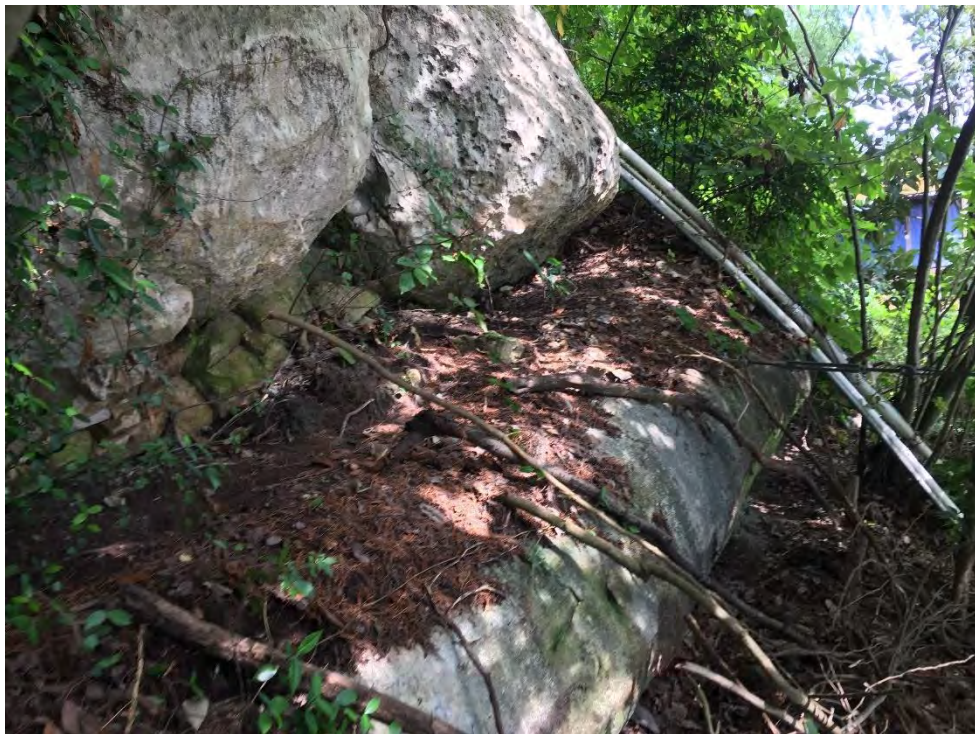
**Photo 8: Canyon rimrock (CEF) adjacent to Lake Austin along the eastern boundary of the property. Photo is facing the north northwest.**

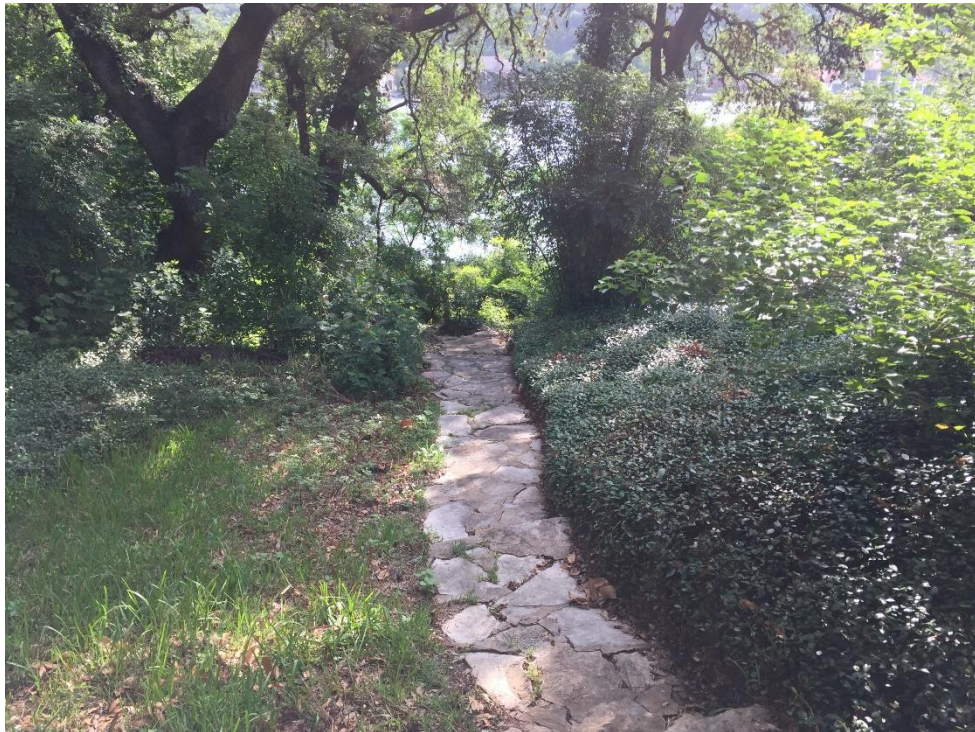
**Photo 6: Path from residence down to the dock. Photo is facing the east northeast.**

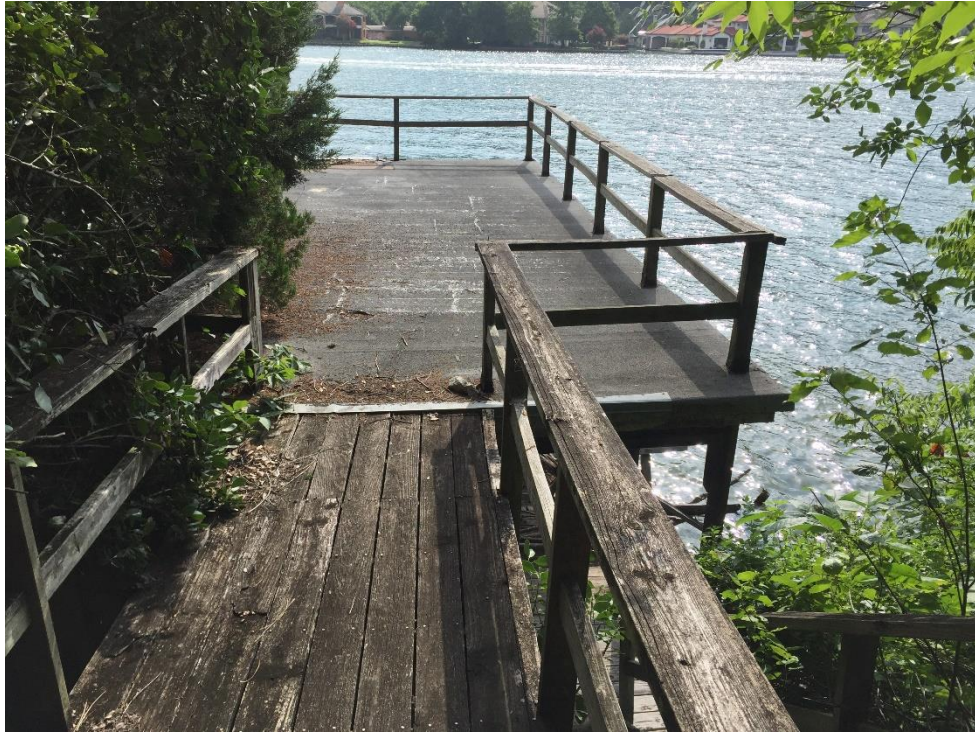
**Photo 7: Dock over Lake Austin. Photo is facing the east northeast.**

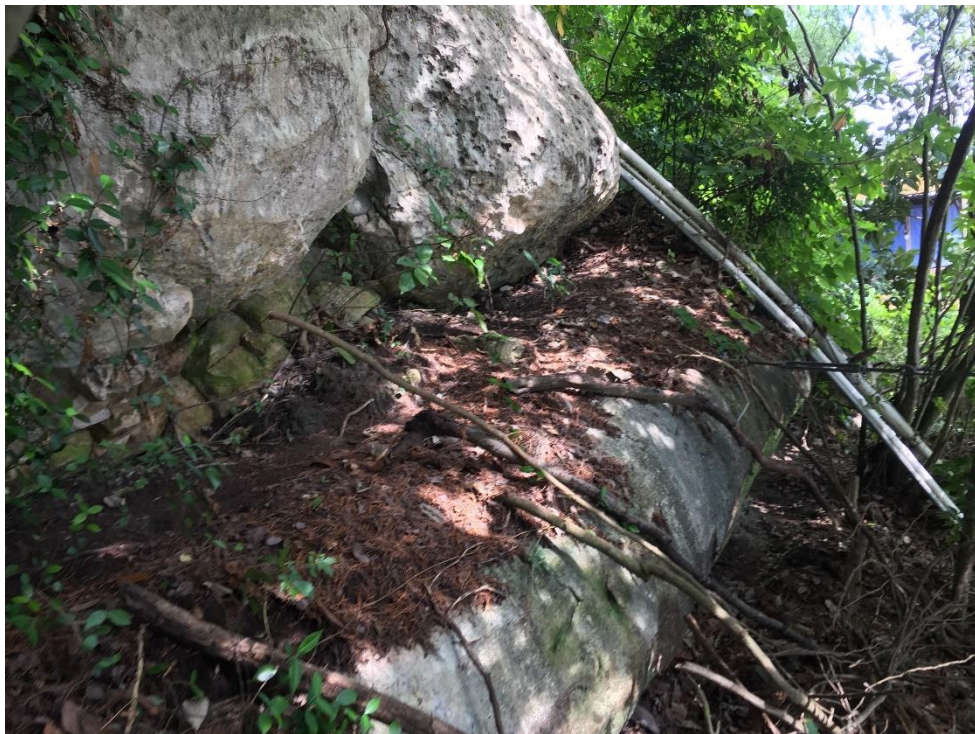
**Photo 8: Canyon rimrock (CEF) adjacent to Lake Austin along the eastern boundary of the property. Photo is facing the north northwest.**
