PROPOSAL

Construct an apartment complex around the Judge Sebron G. Sneed House ruins erected circa 1857-1860.

PROJECT SPECIFICATIONS

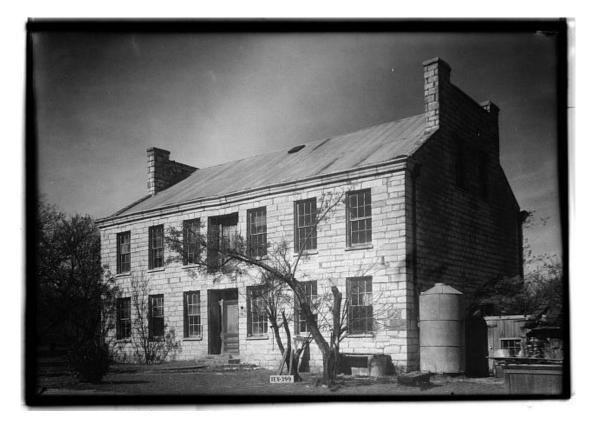
Historic American Buildings Survey, Arthur W. Stewart, Photographer November 27, 1936 SOUTHEAST ELEVATION. - Judge Sebron G. Sneed House, Route I-35 & Bluff Springs Road, Austin, Travis County, TX https://www.loc.gov/pictures/item/tx0291.photos.156361p/

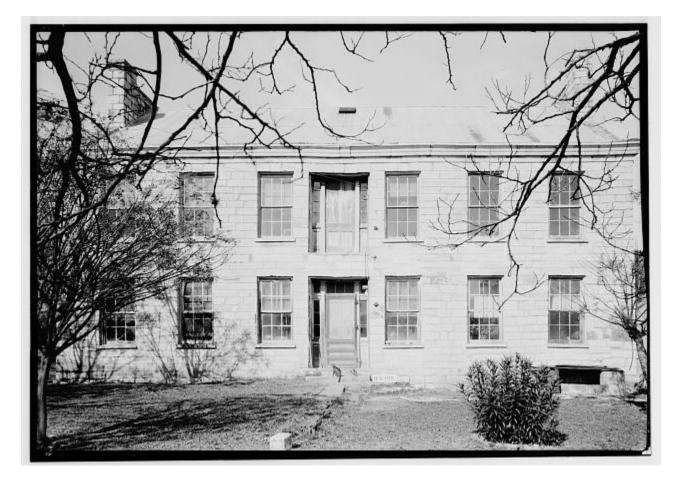
https://www.loc.gov/pictures/item/tx0291.photos.156360p/resource/

Historic American Buildings Survey, Arthur W. Stewart, Photographer November 27, 1936 SOUTH ELEVATION (FRONT). - Judge Sebron G. Sneed House, Route I-35 & Bluff Springs Road, Austin, Travis County, TX

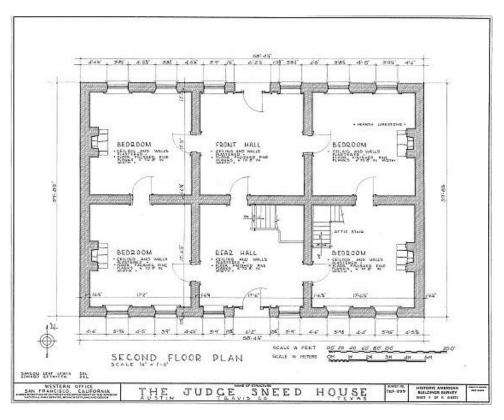
https://www.loc.gov/pictures/item/tx0291.sheet.00002a/resource/

HABS TEX,227-AUSTIN.V,1- (sheet 2 & 3 of 8) - Judge Sebron G. Sneed House, Route I-35 & Bluff Springs Road, Austin, Travis County, TX

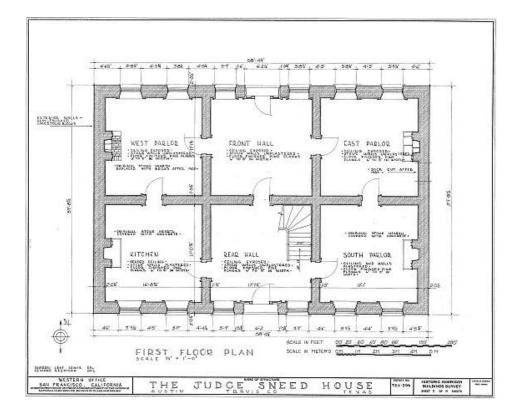
Sebron G. Sneed House Ruins: "photos" (Historic Review Application, 2022)

In 2015, HLC reviewed a proposal to tuck point the remaining limestone walls of the ruined house and clean the site of debris. After the restoration work was completed, two steel fencing rings were erected to prevent intrusions into the ruins. A protective epoxy sealant was proposed to be applied to the top of the walls to prevent further deterioration from water penetration.
