# 1400 GARDEN STREET

## GARDEN STREET ELEVATIONS

# 1400 GARDEN STREET NAVASOTA STREET ELEVATIONS

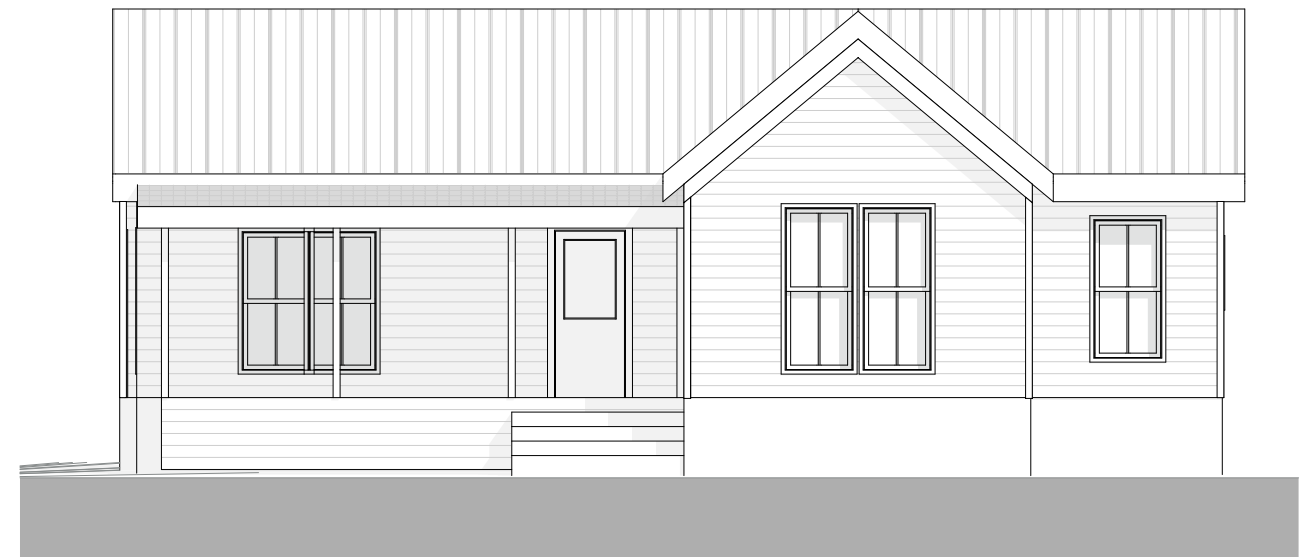
REVISED GARDEN ST. ELEVATION - 08/03

- KEEP DOUBLE WINDOW PATTERN FOUND CURRENTLY ON HOUSE.
- SLIGHTLY LARGER WINDOWS THAN EXISTING - APPROPRIATELY SCALED FOR PERIOD CORRECT ARCHITECTURE.
- REPLACE ROTTING SIDING WITH NEW WOOD SIDING TO MATCH EXISTING; PAINT TO MATCH EXISTING WHITE
- REPAIR EXISTING PORCH AS NEEDED, DESIGN AND DIMENSIONS TO REMAIN.
- REPLACE AGING SHINGLE ROOF WITH MORE PERIOD CORRECT GALVANIZED METAL ROOF.

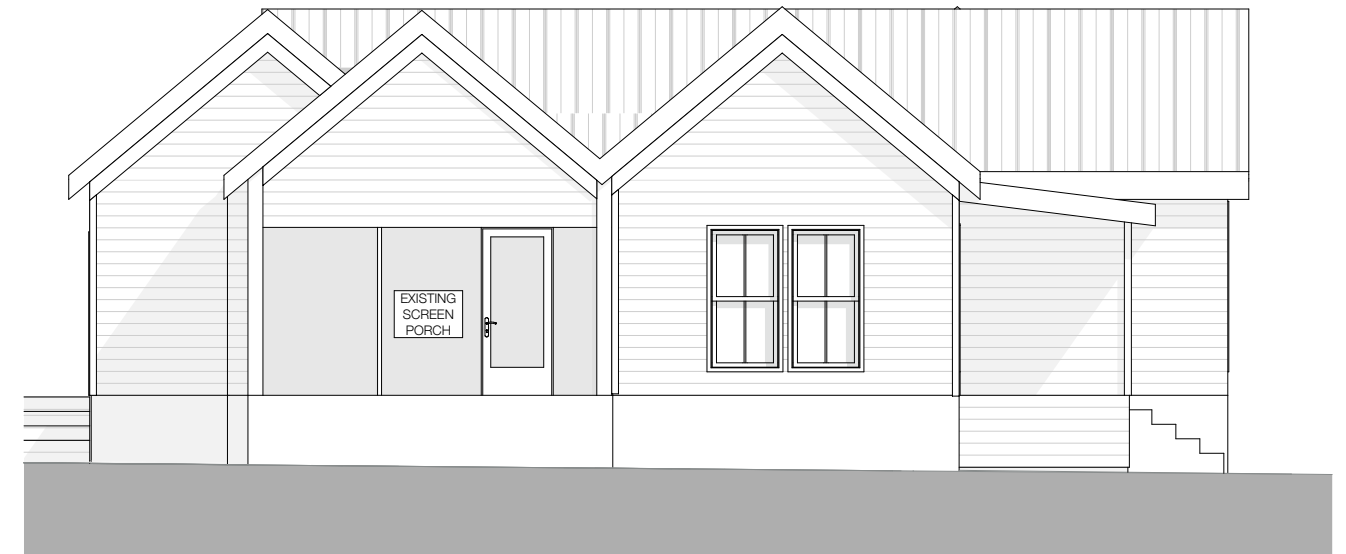
REVISED NAVASOTA ELEVATION - 08/03

- KEEP DOUBLE WINDOW PATTERN FOUND CURRENTLY ON HOUSE.
- SLIGHTLY LARGER WINDOWS THAN EXISTING - APPROPRIATELY SCALED FOR PERIOD CORRECT ARCHITECTURE.
- REPLACE ROTTING SIDING WITH NEW WOOD SIDING TO MATCH EXISTING; PAINT TO MATCH EXISTING WHITE
- REPAIR EXISTING PORCH AS NEEDED, DESIGN AND DIMENSIONS TO REMAIN.
- REPLACE AGING SHINGLE ROOF WITH MORE PERIOD CORRECT GALVANIZED METAL ROOF.

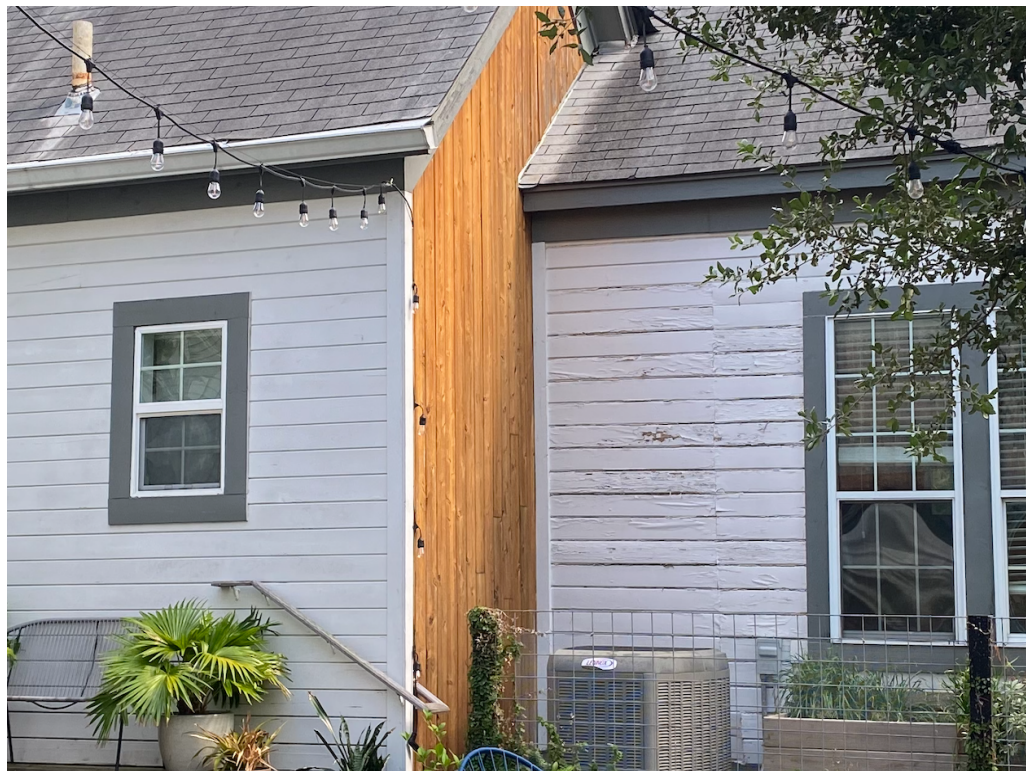
NEW VS. EXISTING ROTTEN SIDING AT 1400 GARDEN ST.

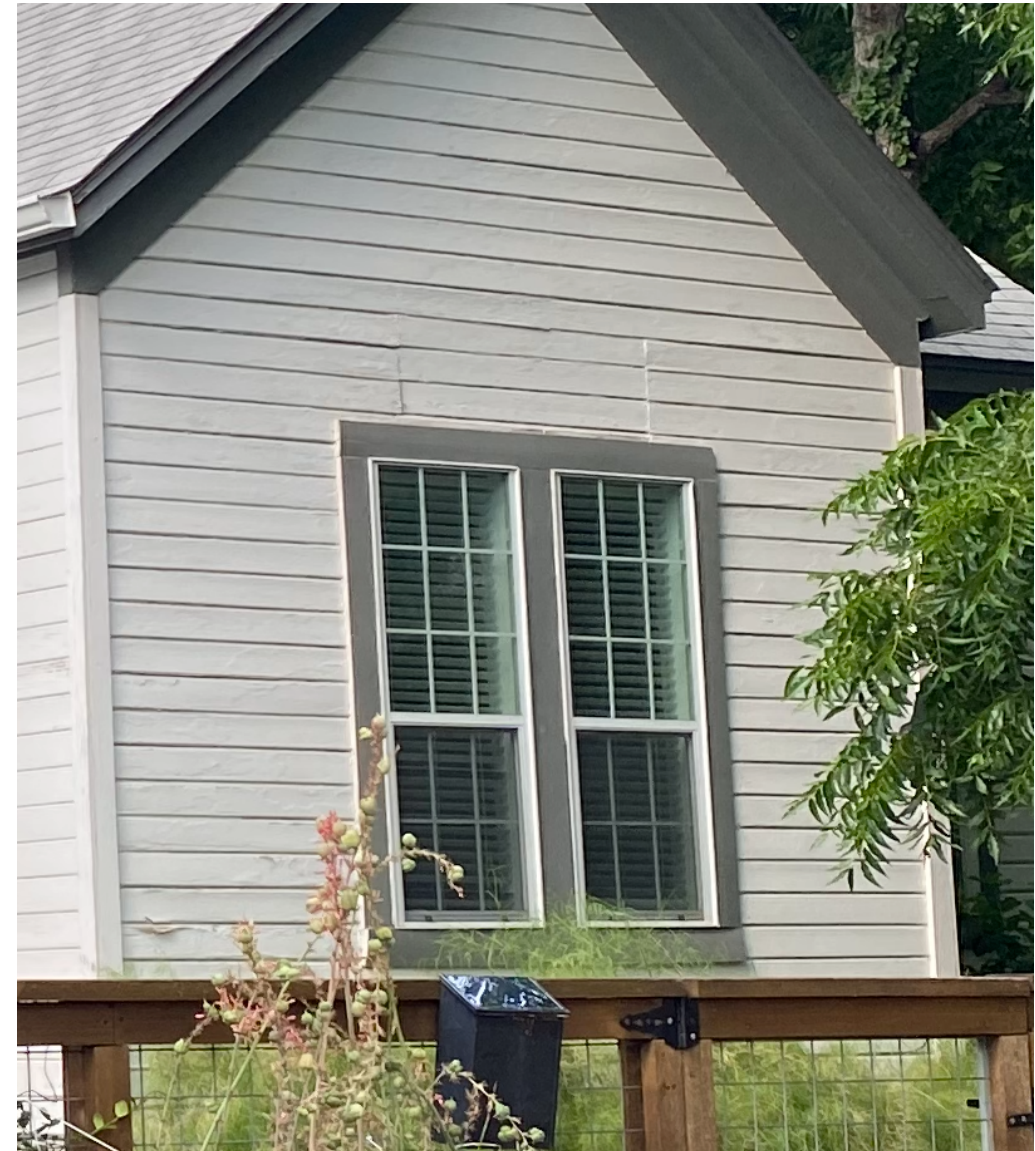
DETAIL SHOWING PATCHED SIDING / NON ORIGINAL WINDOWS AT 1400 GARDEN ST.
