Section 11 Neighborhood Park

Mueller Commission Presentation August 9, 2022

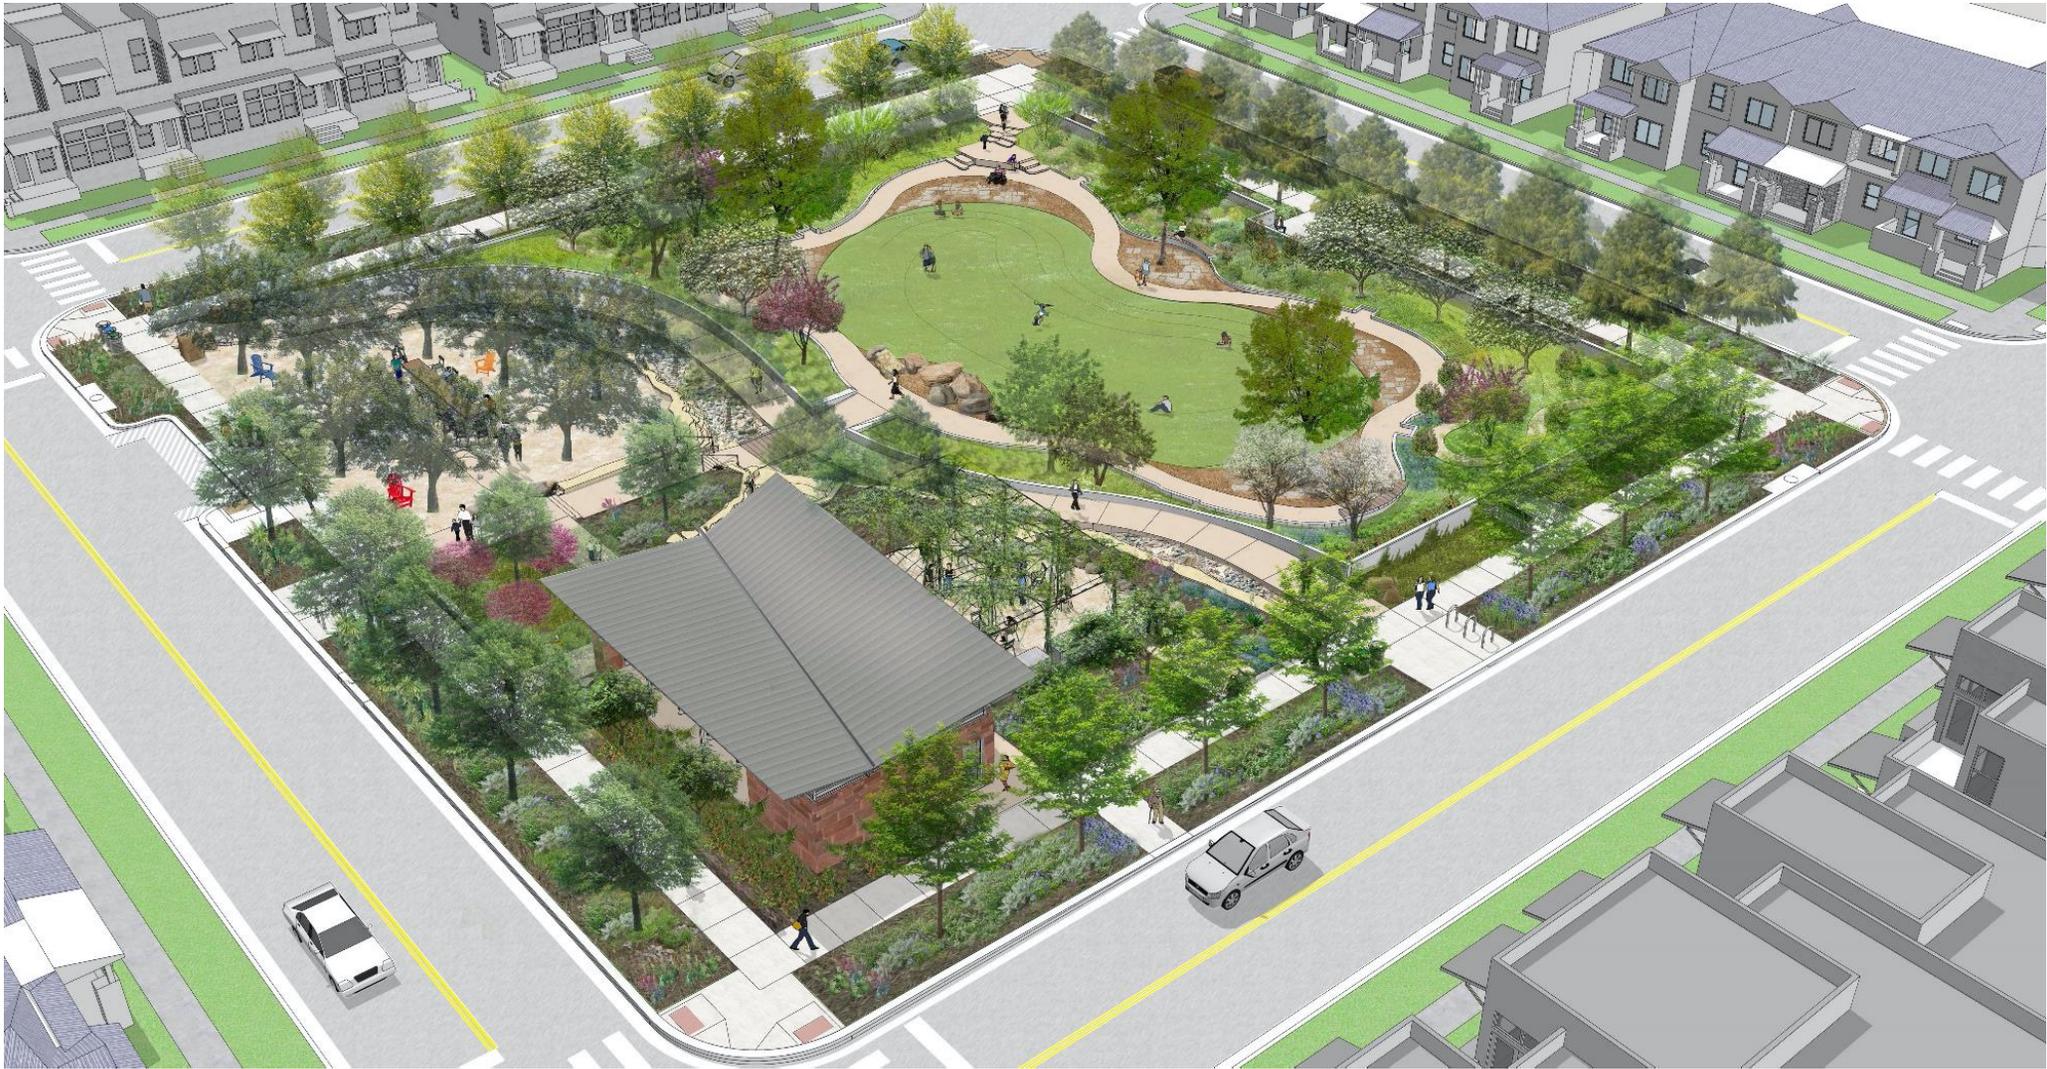
Bird's-Eye View of Park from Northwest corner looking to Southeast

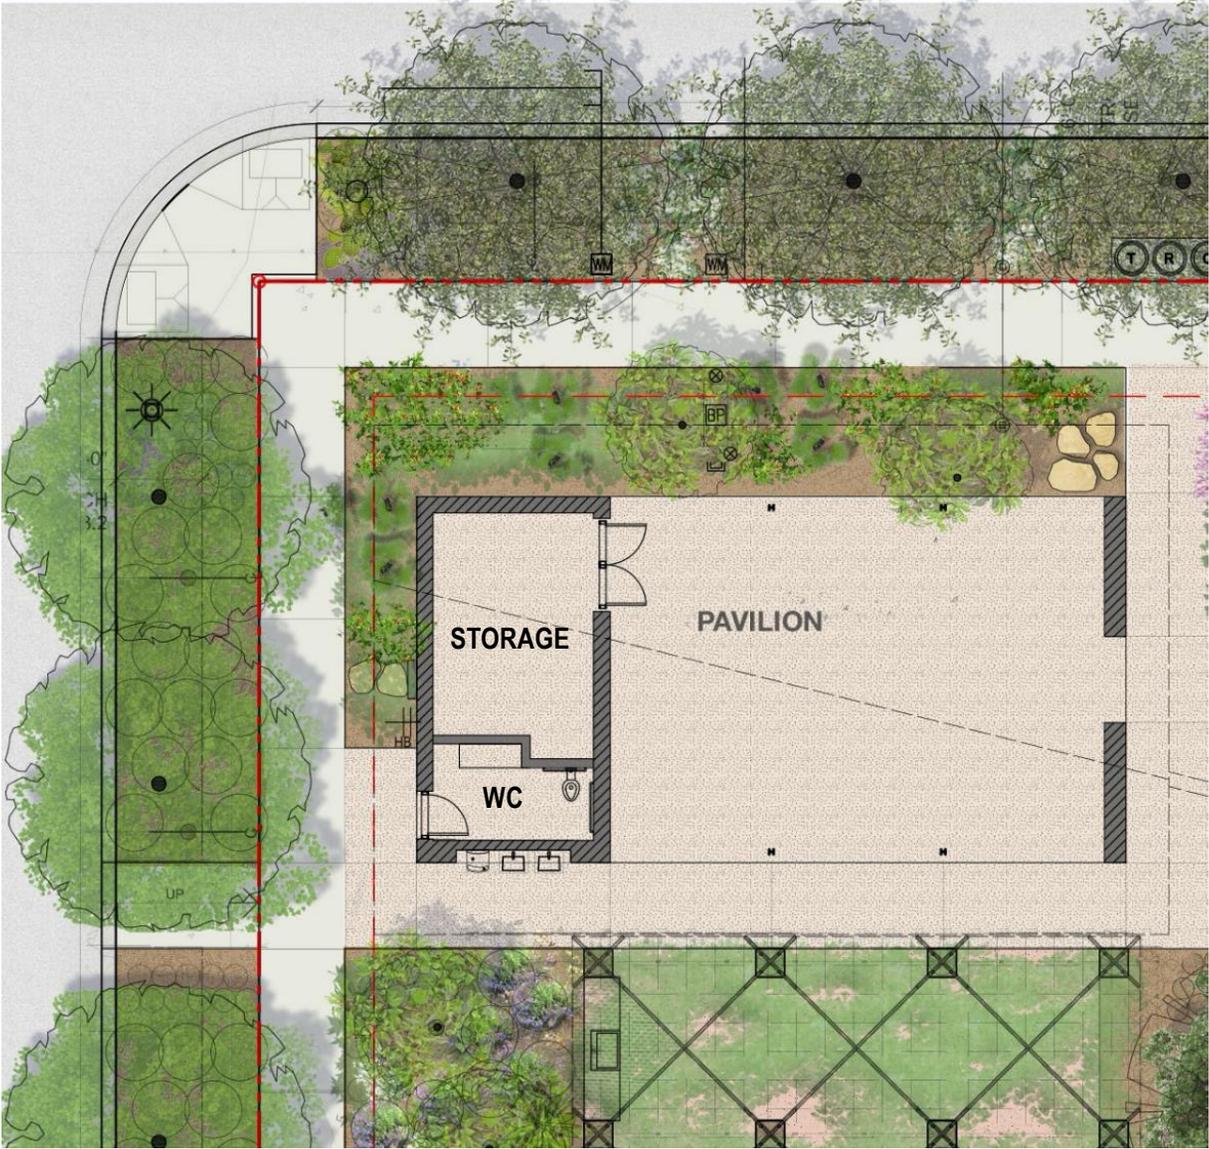
Pavilion Plan

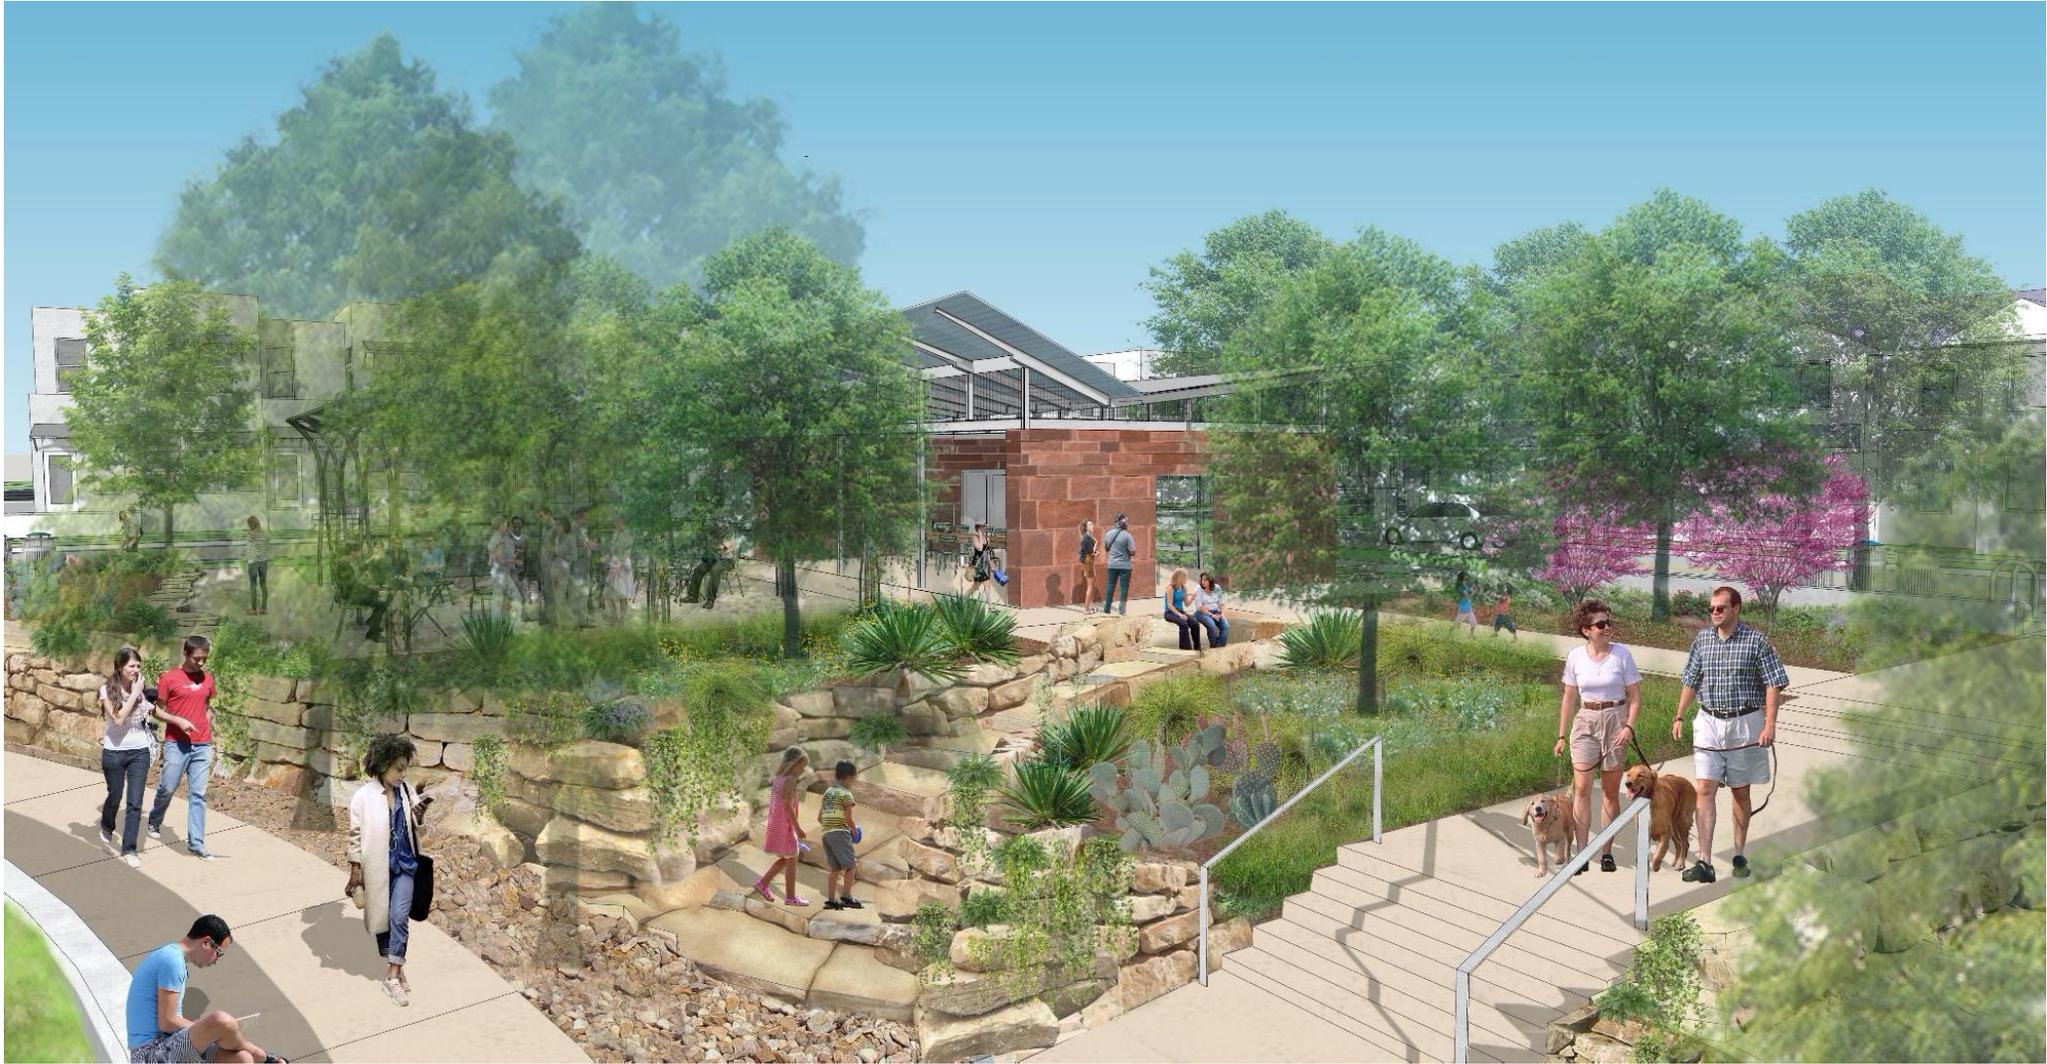
View of Dry Creek, Stacked Stone Wall, Vine Trellis-Covered Terrace and Pavilion

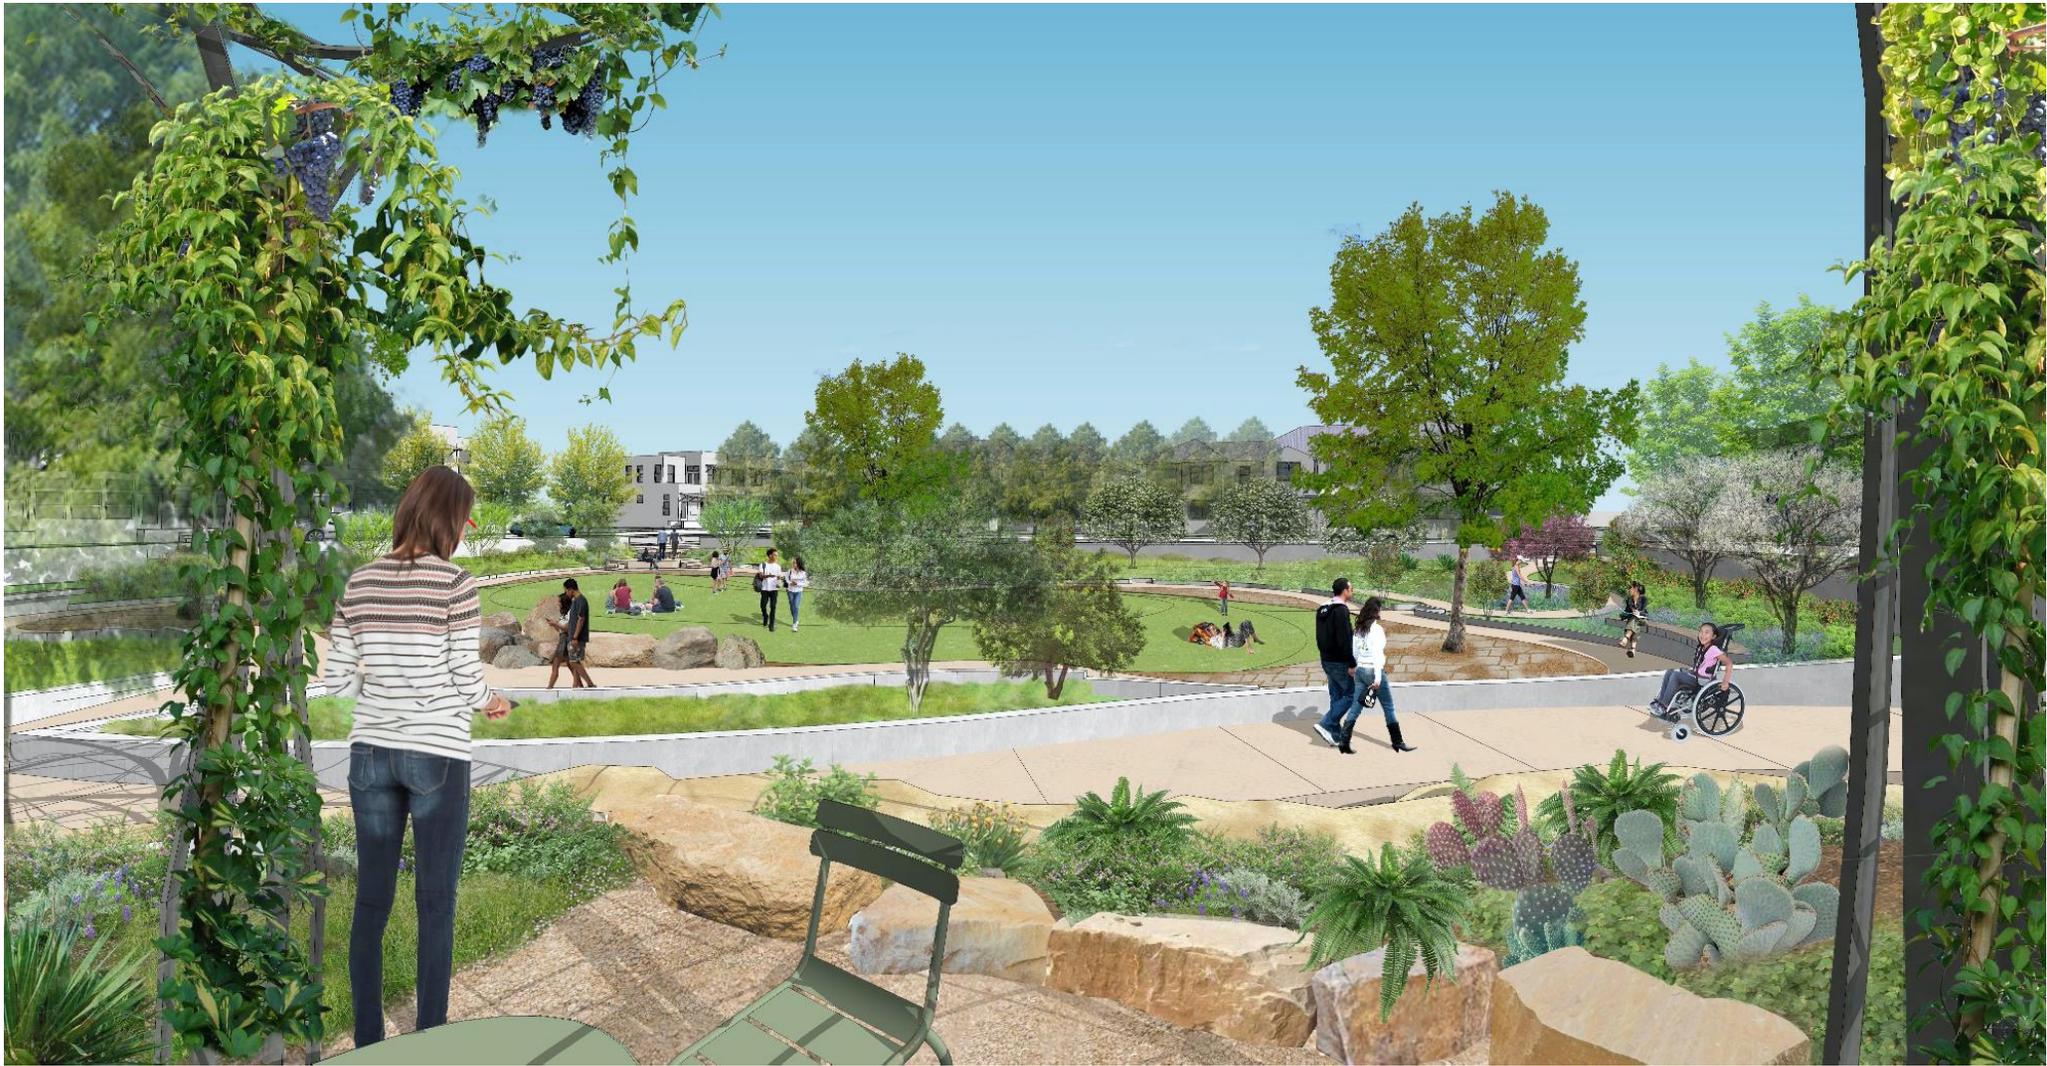
View from Vine Trellis-Covered Terrace to Open Lawn Area

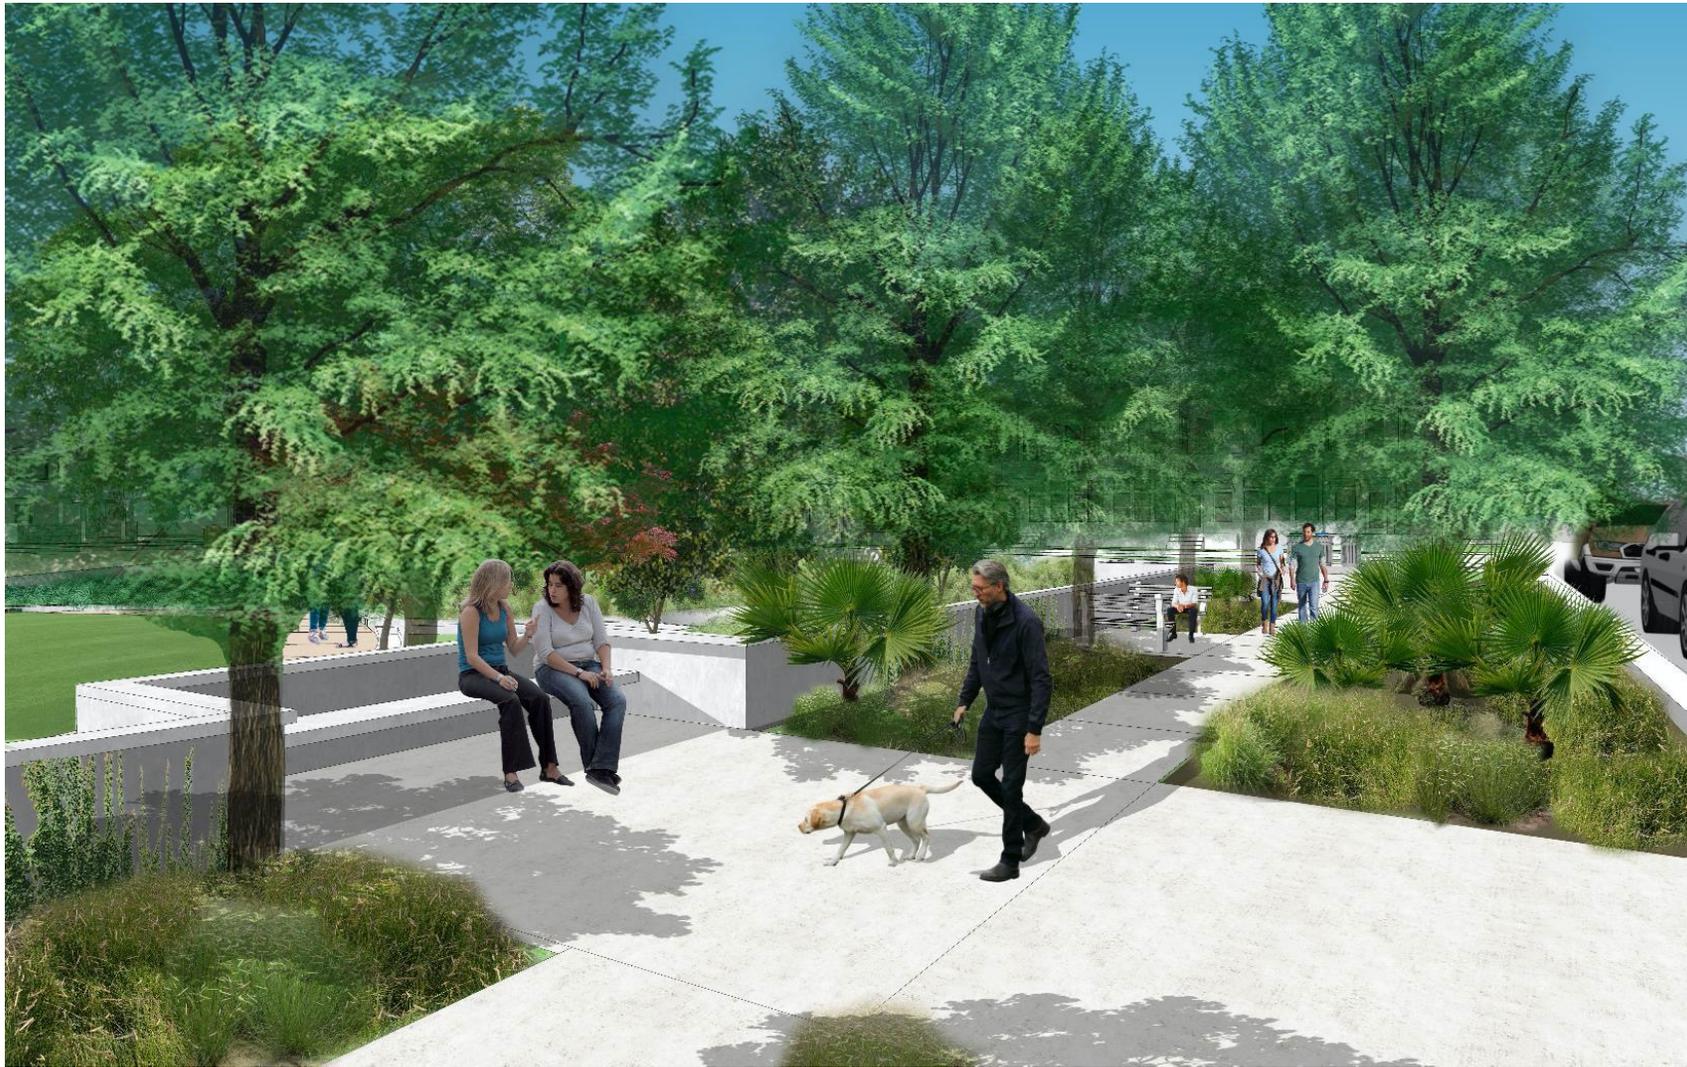
View of Chennault St Streetscape at Mid-Block Seating

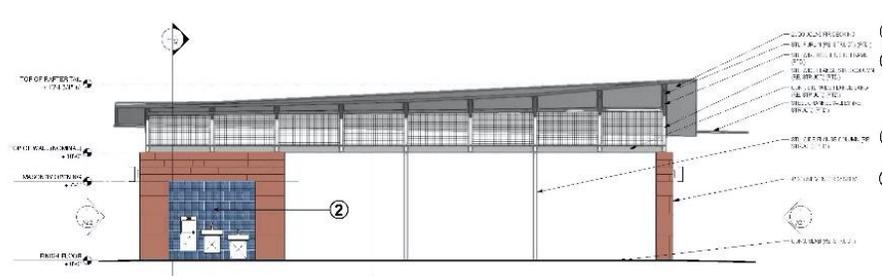
SOUTH ELEVATION: PARK-FACING FACADE

EXTERIOR WALL

- Pacos Red Sandstone
- Random broken/chopped lengths
- Natural color variations
- Size: 4" thickness x random lengths and graduating heights

BACK OF ALCOVE WALL SURFACE

- Trikeenan Tile, Affinity Series
- Running bond
- Color: "Blue Jay"
- Size: 6" x 9"

STRUCTURAL STEEL MEMBERS

- Bands, Columns, Joists, Purlins
- Painted Gray / Silver

ROOF DECK

- 2x6 Tongue & Groove
- Douglas Fir or Pine
- Painted pale blue

ROOF

- Standing seam metal
- 16" ribs
- Paint grip finish

Pavilion Color and Materials (Steel of Trellis will be allowed to weather.)

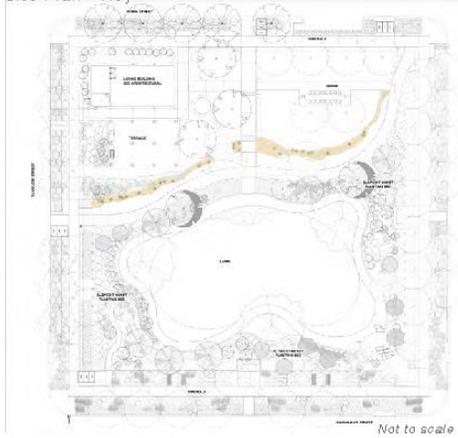
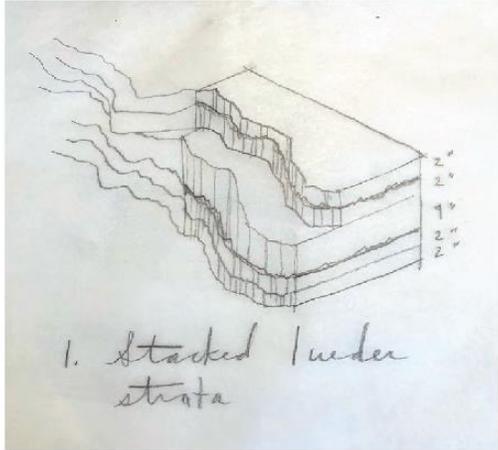
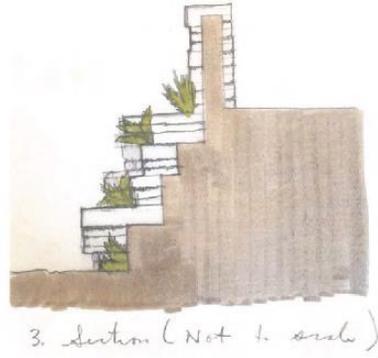
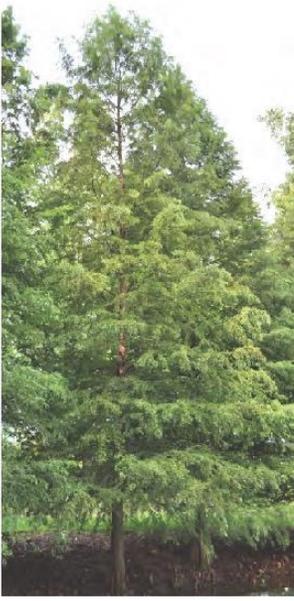
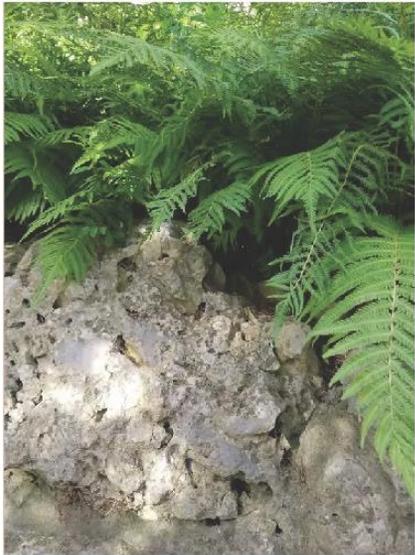
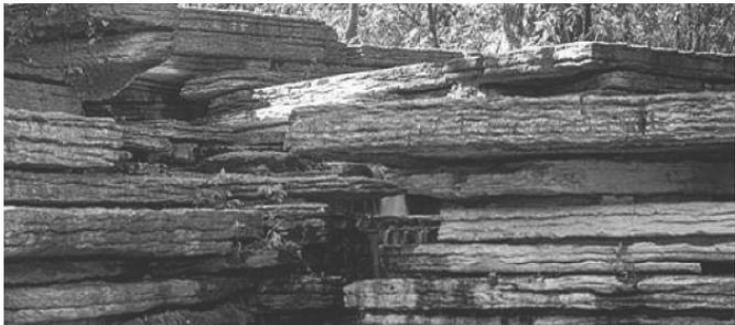
STACKED STONE WALL
