Winter Storm Mara

Restoration and Recovery

March 20, 2023

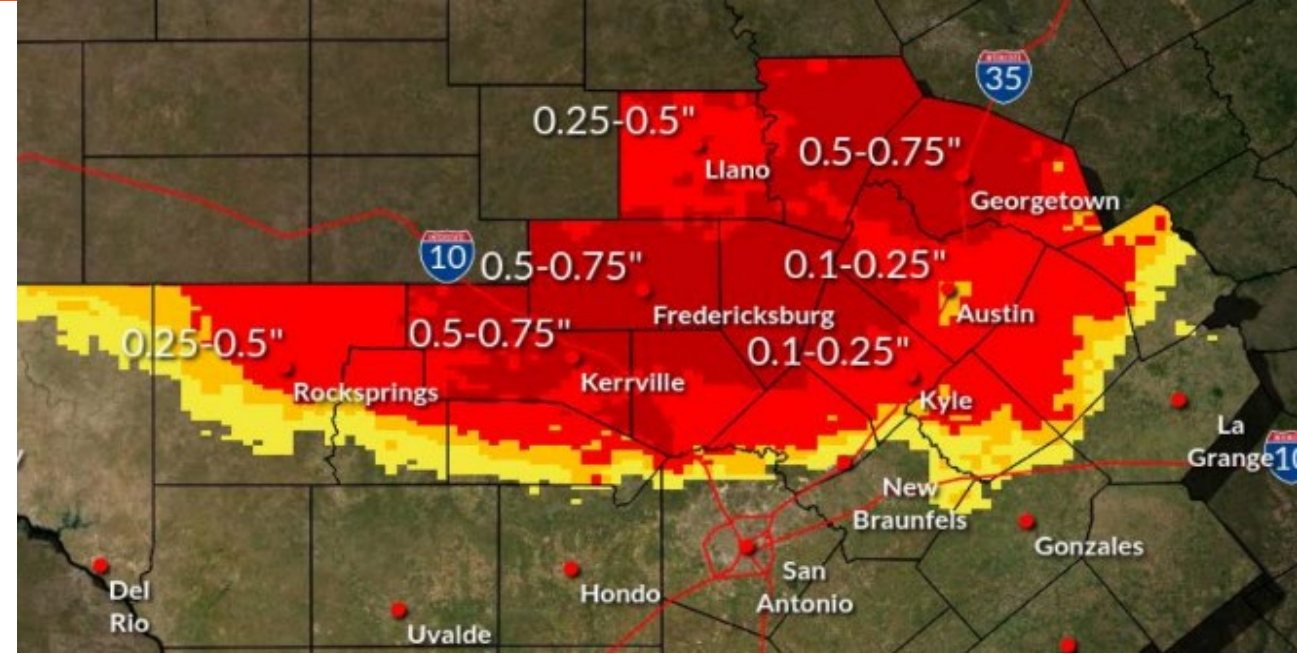
National weather service forecast issued Jan 30, 2023

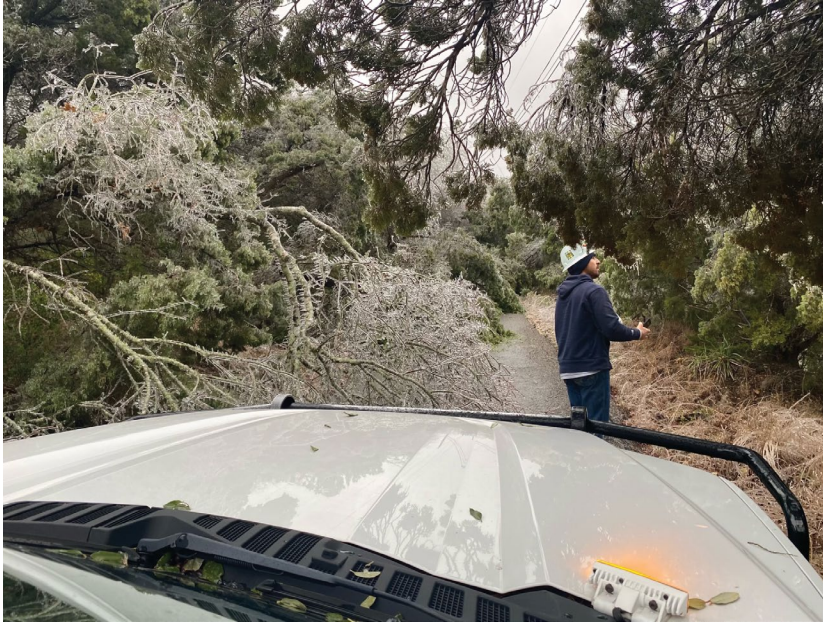
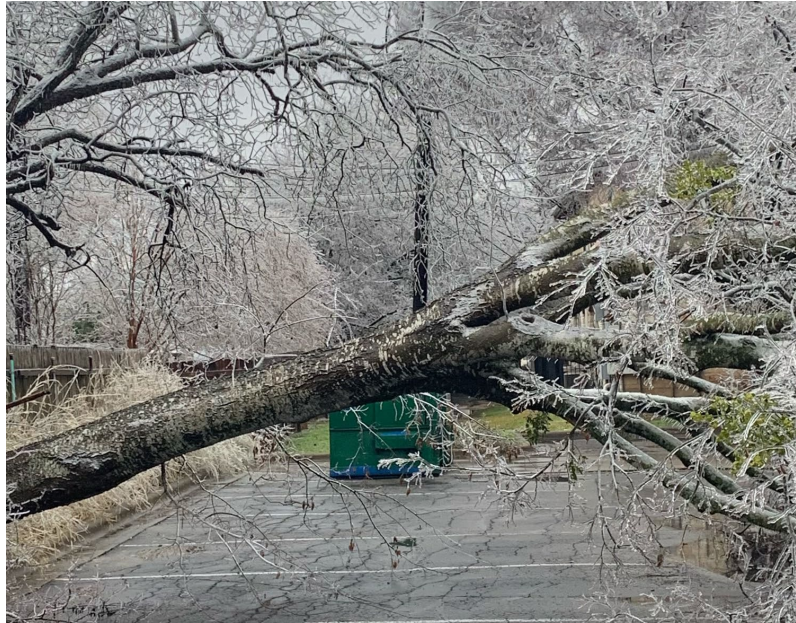
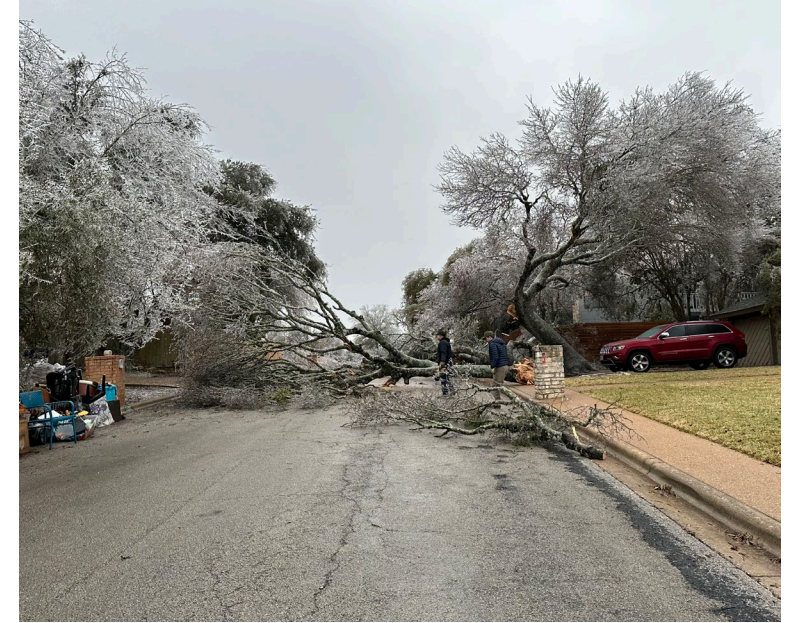
Phase 1: Restoration Challenges

Hazardous road conditions, icy equipment

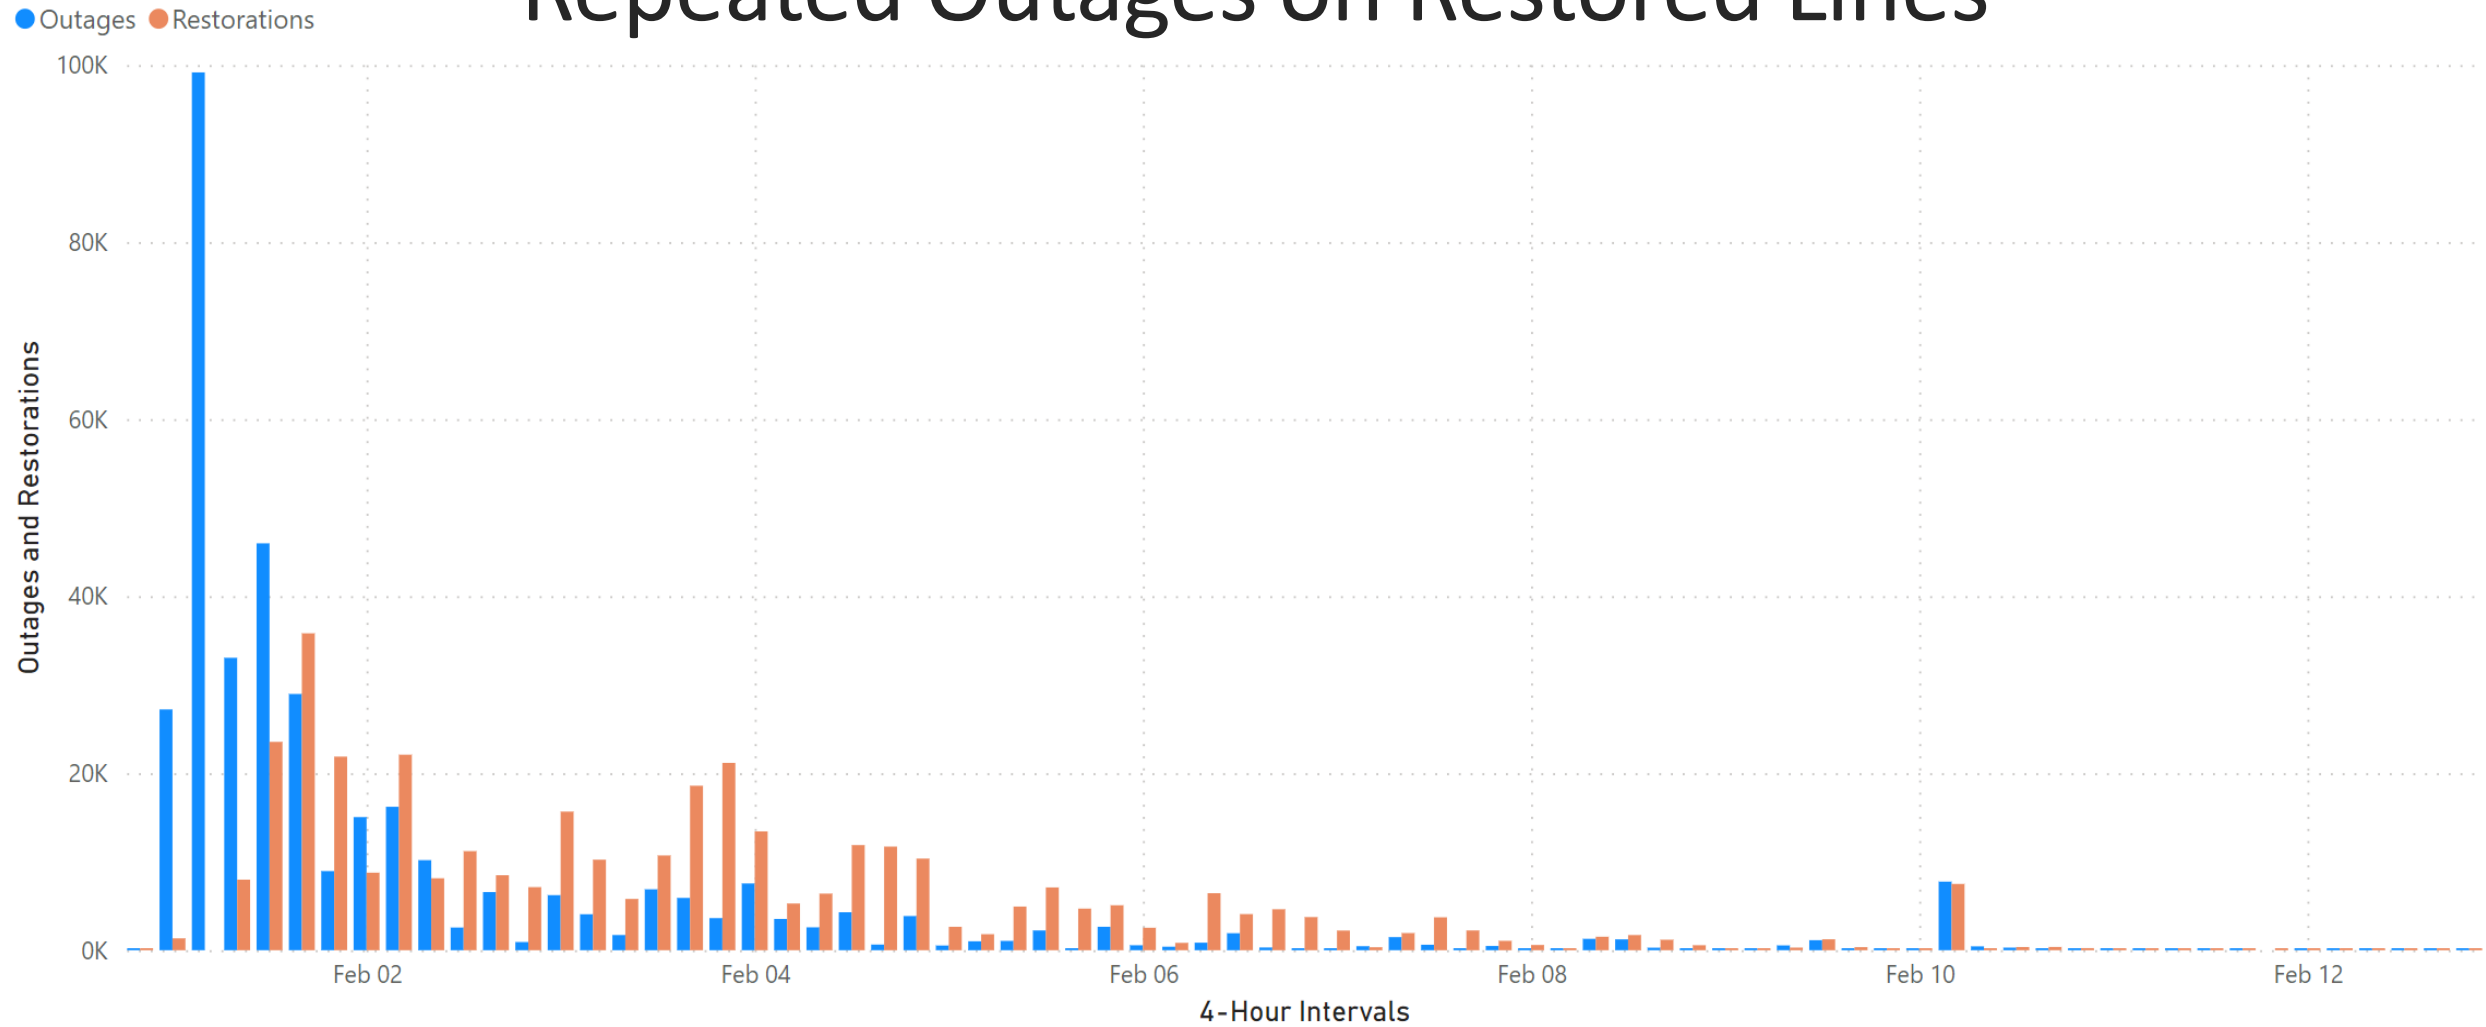
AE Customer 4-Hour Interval Outages/Restorations
Winter Ice Storm Mara - 2023

Repeated Outages on Restored Lines

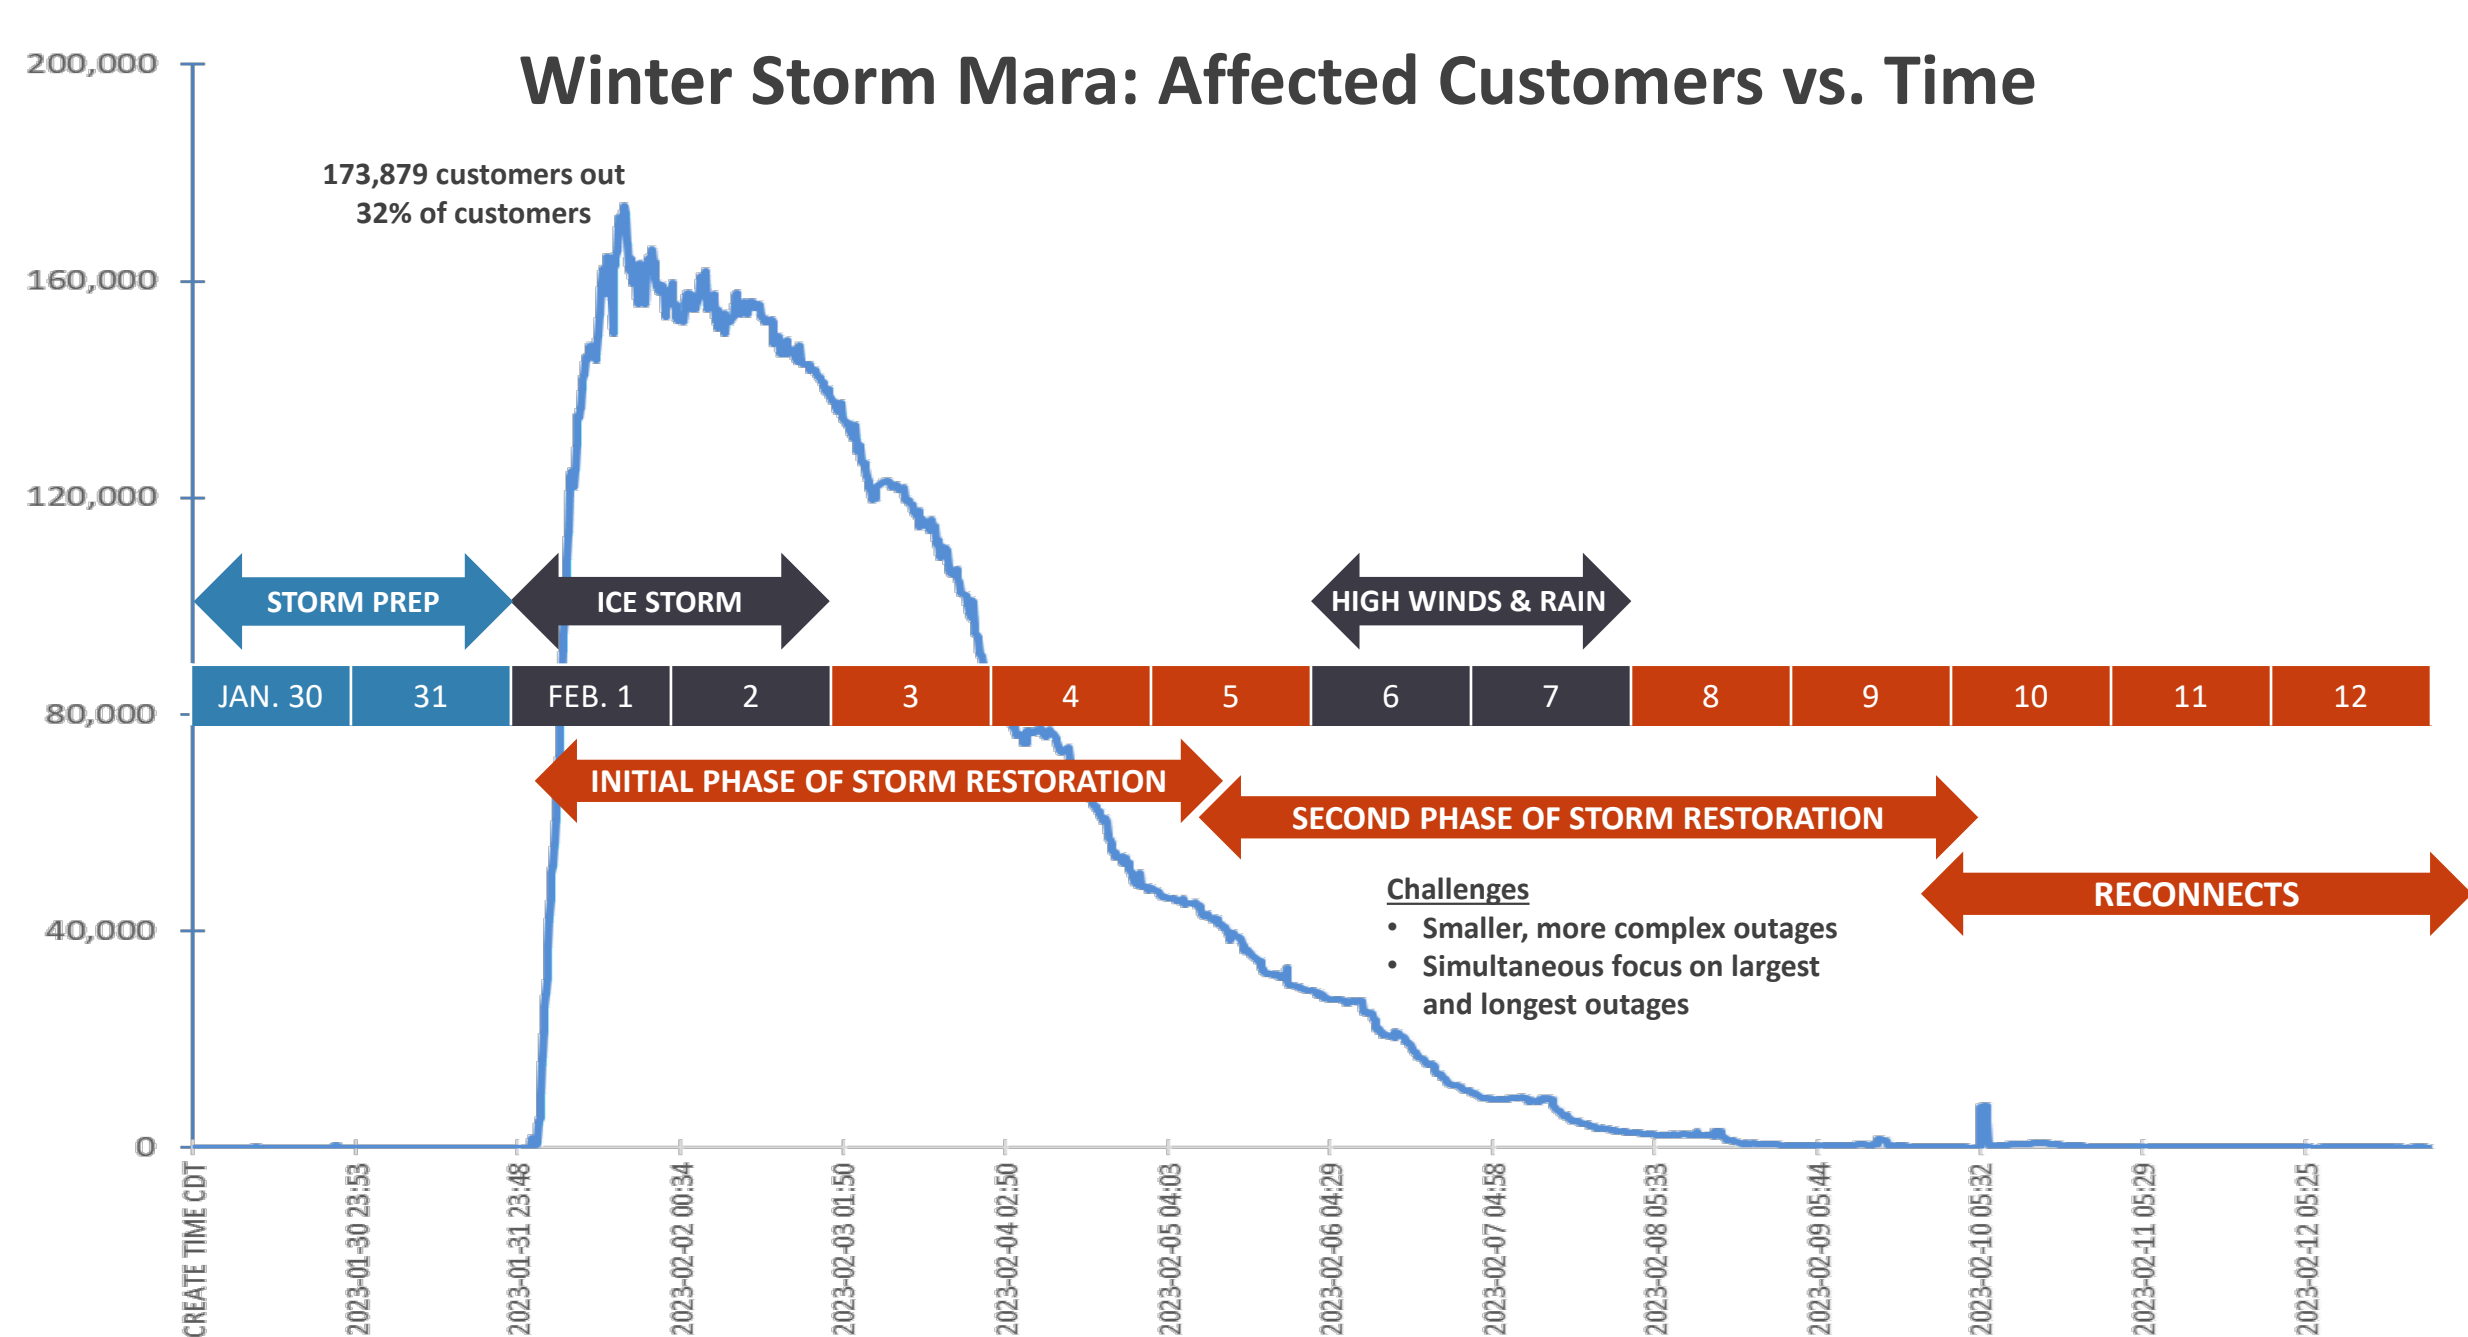
Winter Storm Mara: Affected Customers vs. Time

*Customers who are able to receive power

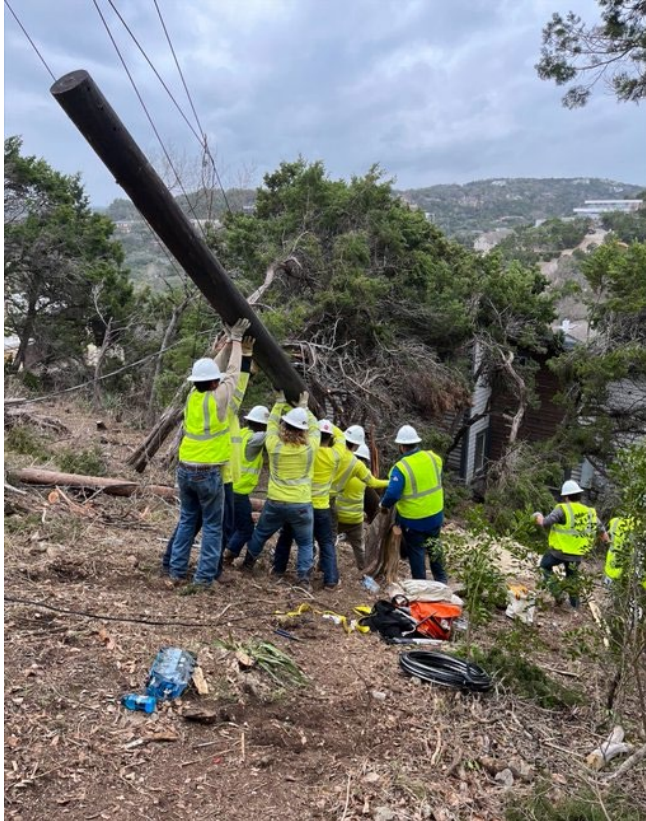
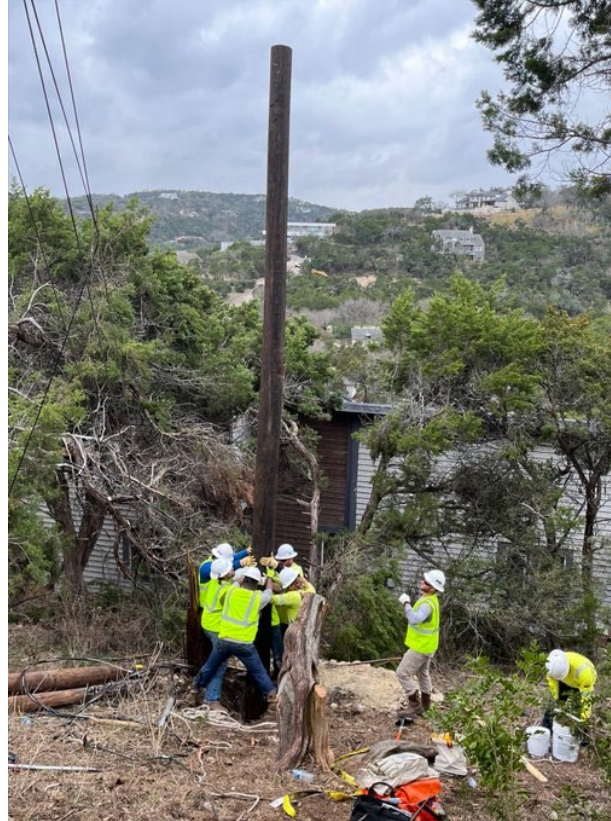
Phase 2: Restoration Challenges

Smaller, more complex restoration process

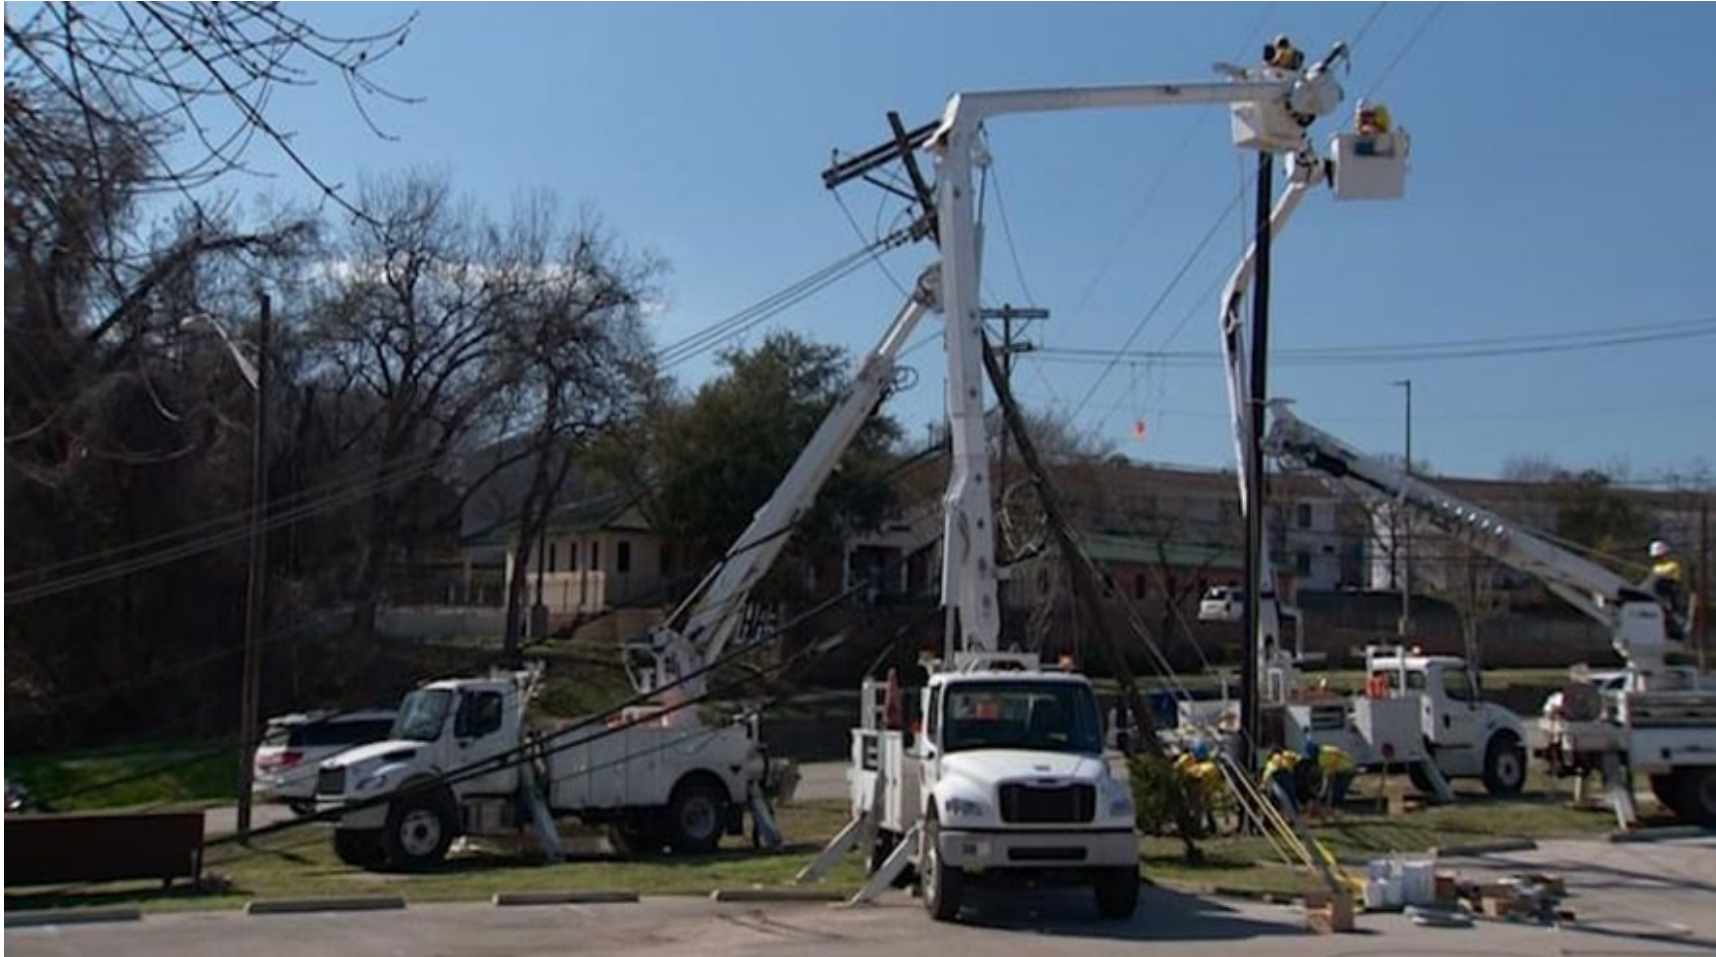
Phase 2: Restoration Challenges

Smaller, more complex restoration process

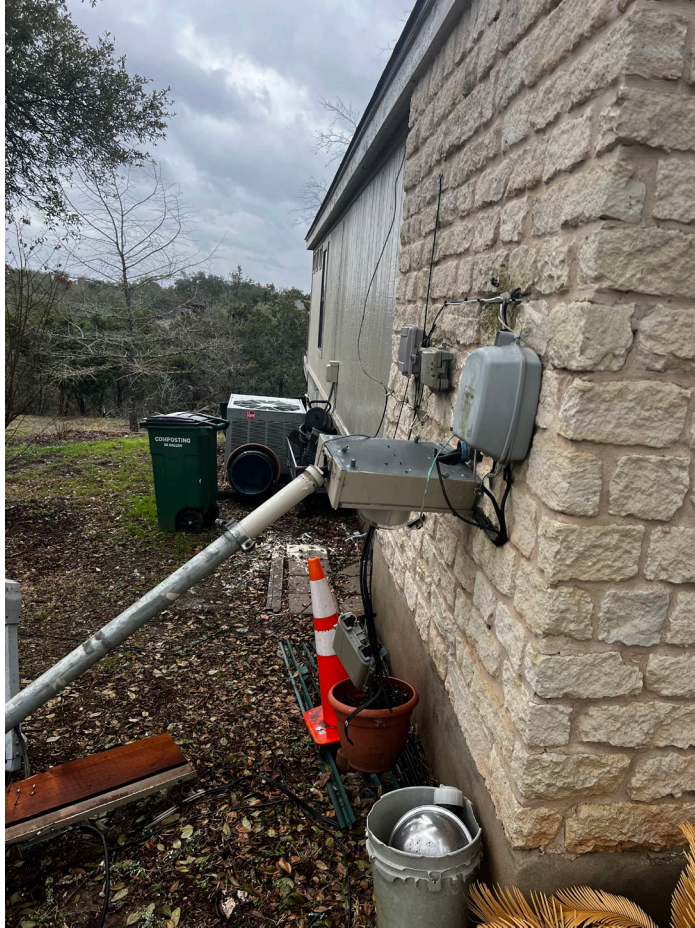
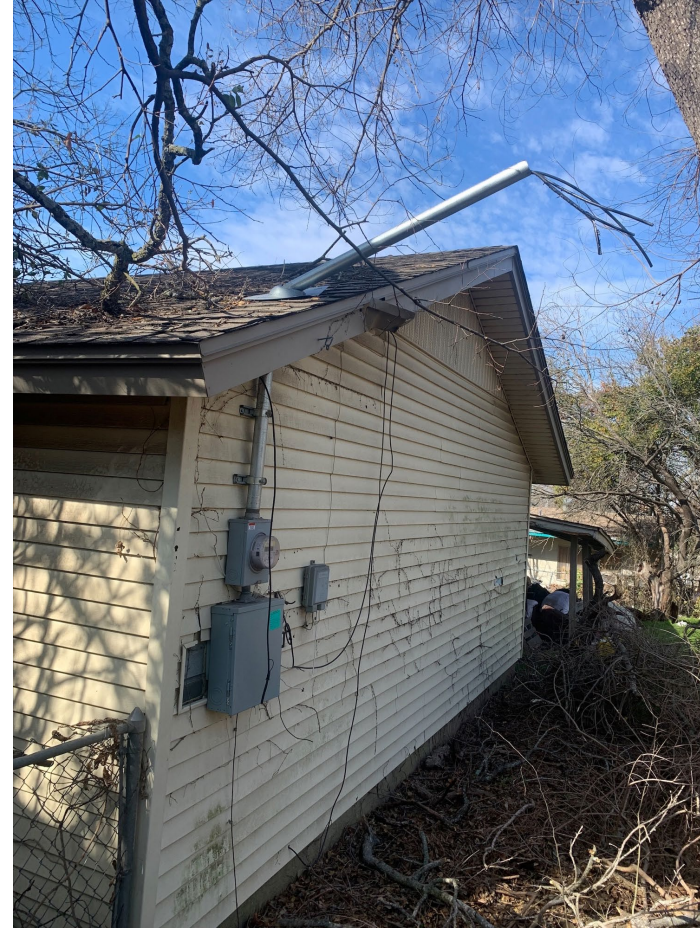
Phase 3: Restoration Challenges

Damage to customer-owned or maintained equipment

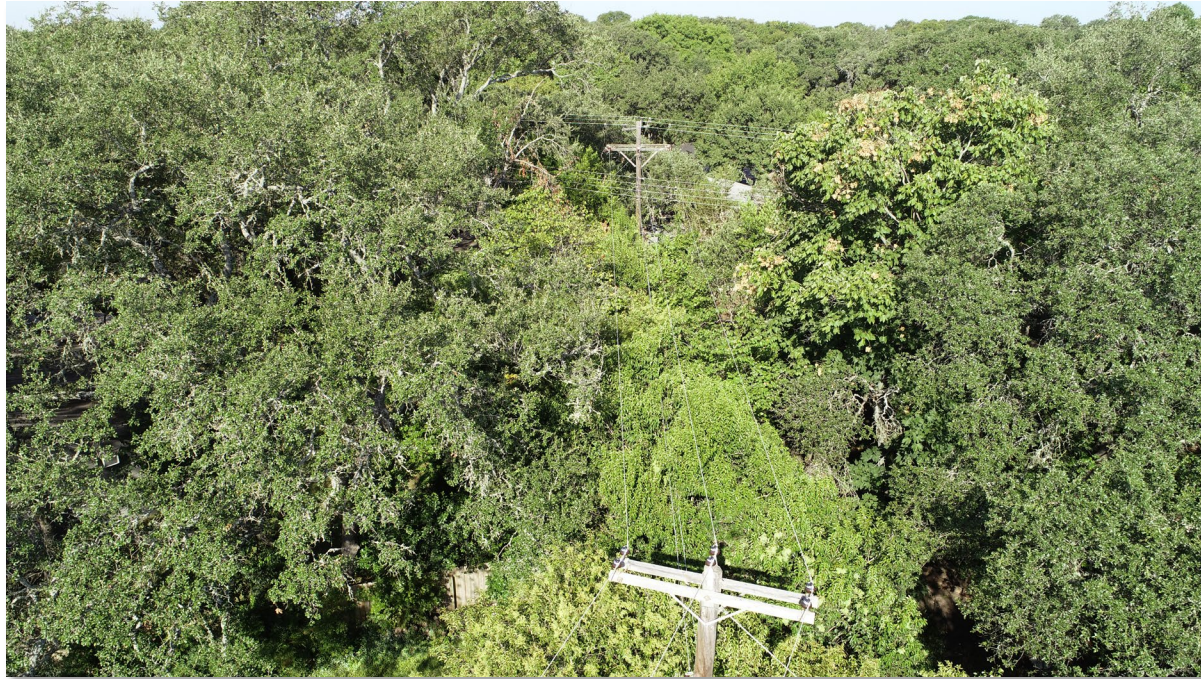
Before - 2019

Sample High-Level Visual Perspective
