Picture of front elevation (east side) of German Free School
circa 1918

Timeline

Historic Photos c. 1940
Double-gallery porch and staircase

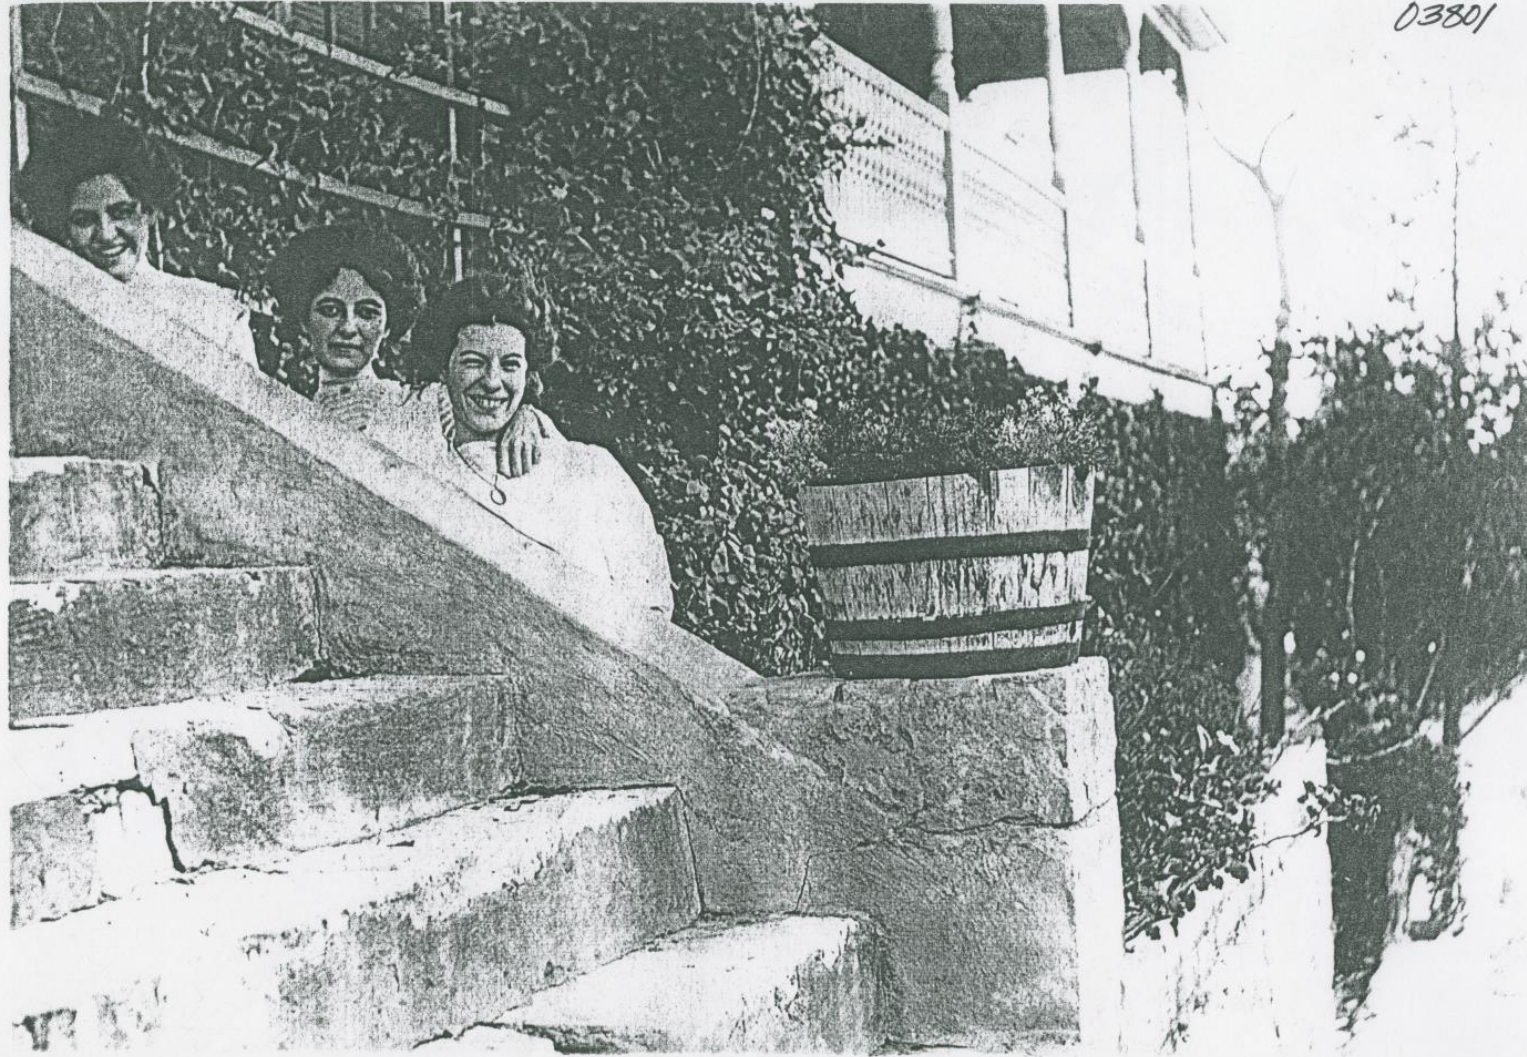
Historic Photo c. 1918

Double-gallery porch and staircase

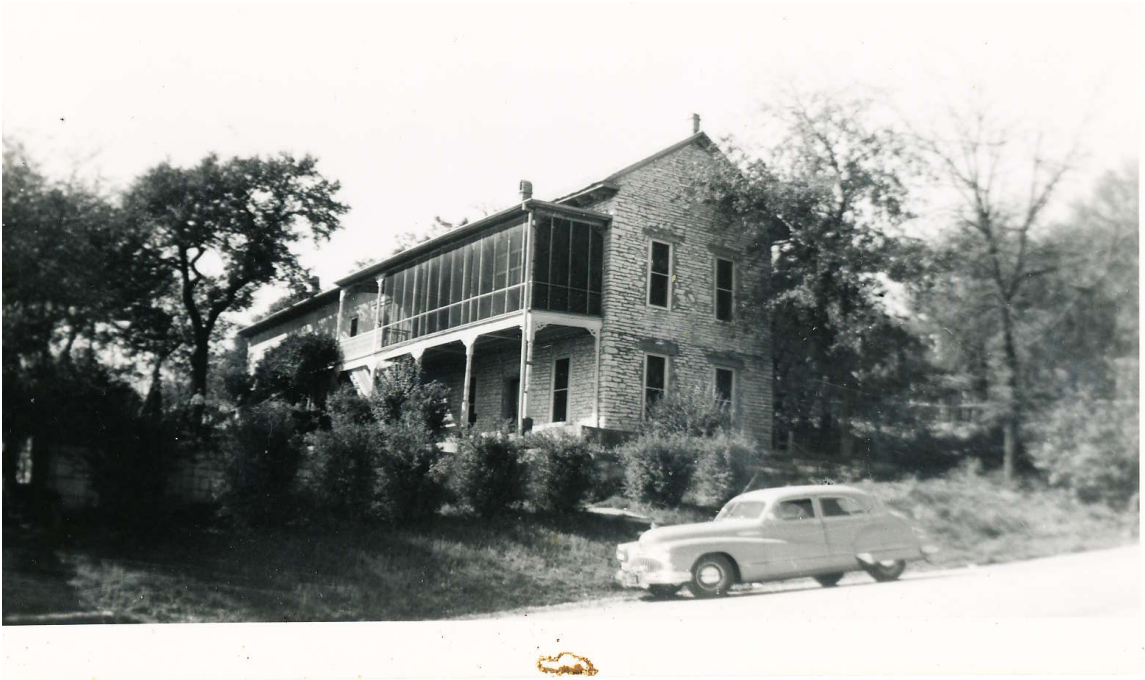
The double gallery porch was constructed circa 1901, and screened-in 1921. It was removed in the 1948 renovation of the property by owner Kelly Stevens.

The photo to the right shows two different patterns of turned balusters: one at the upper gallery, and one at the stair

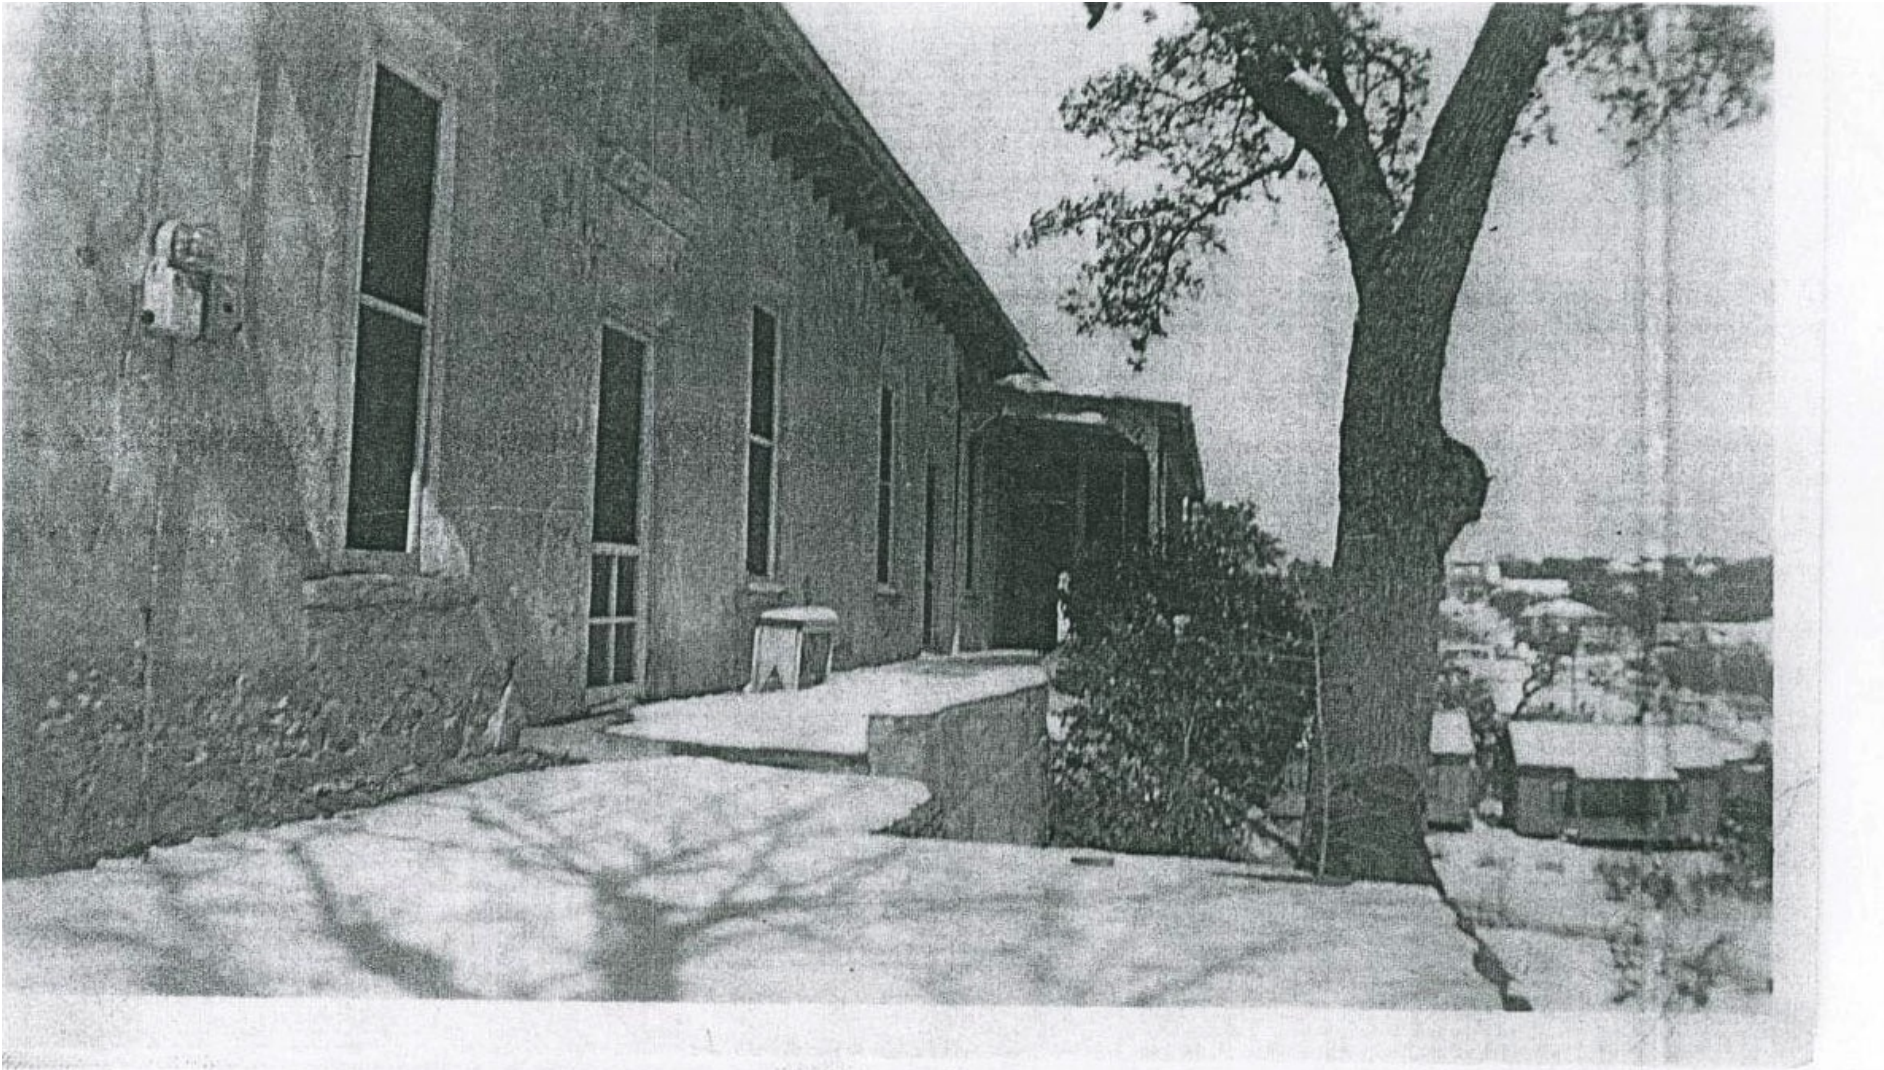
Photo c. 1948

This picture was taken in 1948; view of the German Free School second story elevation, east side of structure.

Original building in foreground, original porch still in place at 1872 addition

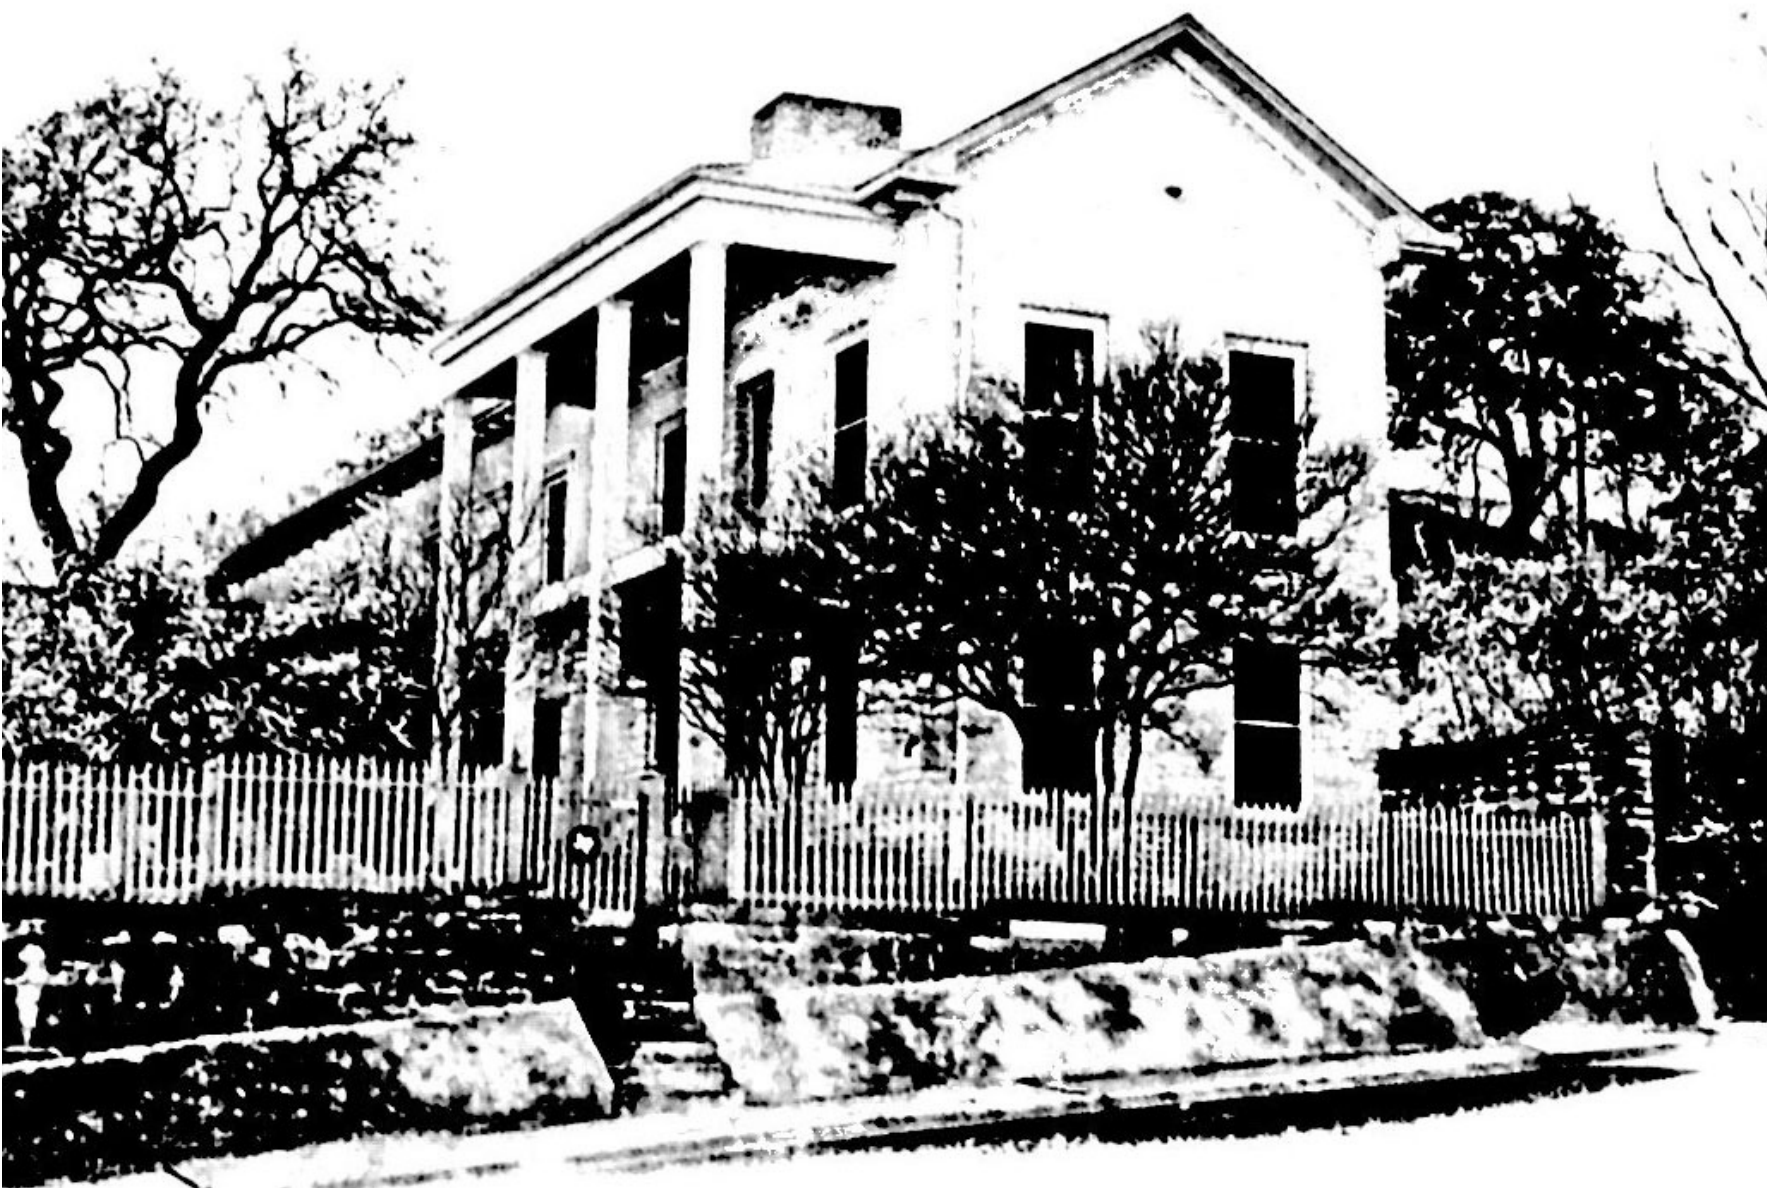
Photo c. 1971

Greek Revival porch
constructed ca. 1948
no railings present

State marker on fence

1949: Porch removed and replaced with existing Greek Revival-styled porch

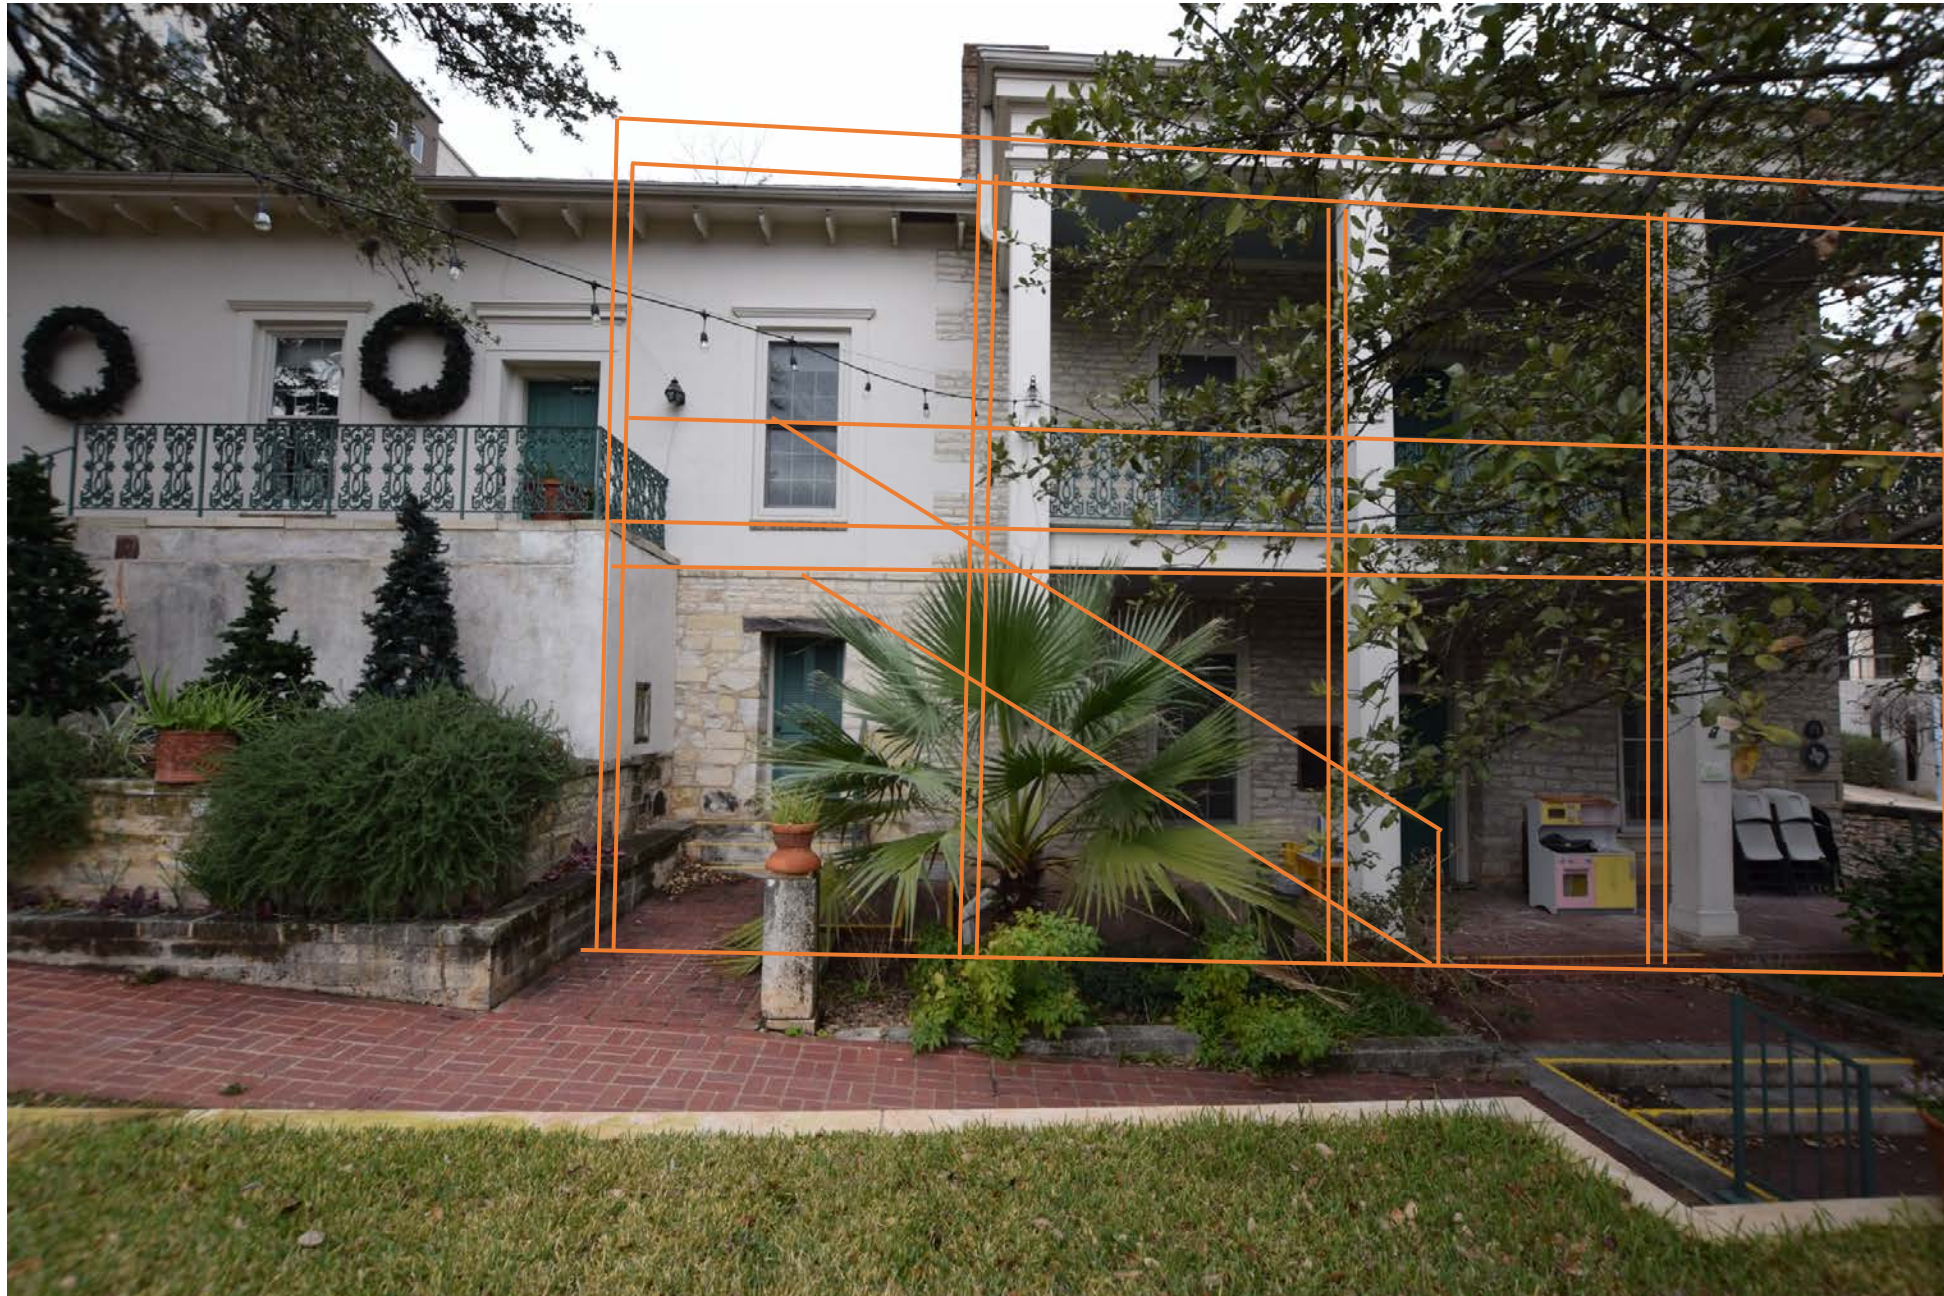
EAST ELEVATION, 2022

Rough outline of
proposed reconstructed
porch

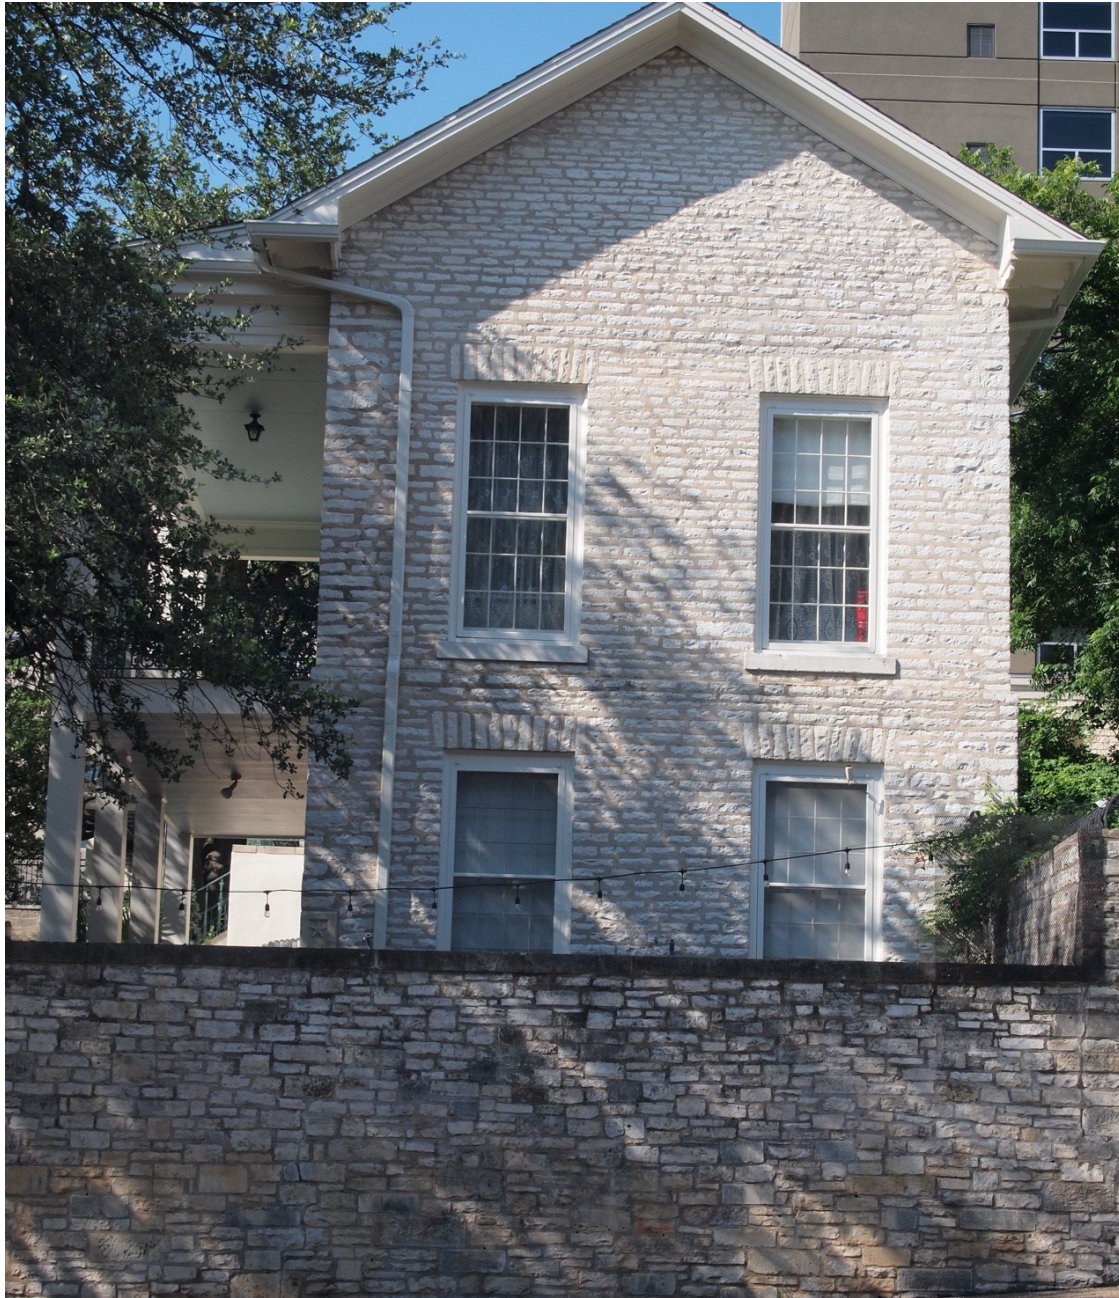
NORTH ELEVATION, 2022 As seen from 10th Street
