Date: 2024.04.22
Residence Address: 803 River Rd
Austin, TX 78734

Dear Historic Landmark Commission,

Please see supplemental materials including: site observation notes, photos, and survey for 803 River Road. No existing plans were found or made available to LaRue Architects.

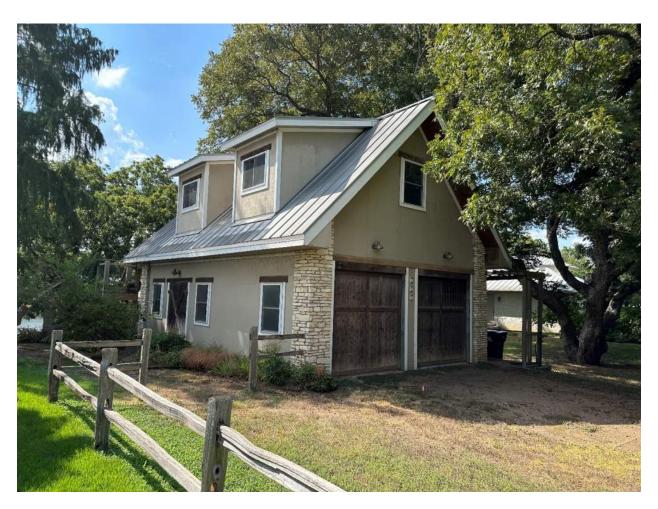
Northwest Elevation – Garage (Front/Side)

- 2-Story residence with contrasting door, window, and exterior material palette.
- Double-hung window units are seen at the first floor, while sliding windows are seen at the second floor (attic) level.
- Rustic wood, possibly salvaged, is used for accessible barn doors and sectional garage doors.
- Stucco siding and newer limestone with a coursed ashlar pattern is used at the corners of the first floor.
