# General Summary

**Customer**  
STOUSE DESIGN

**Address**  
1602 Alta Vista Avenue  
Austin TX 78704

Prepared Using HomeGauge <http://www.HomeGauge.com> : Licensed To Roel Marroquin TREC #3690

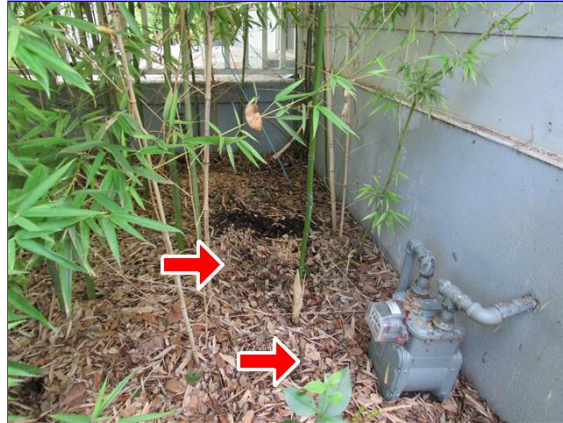
Excessive moisture was present at the front soiled area of the crawlspace. This is a sign of improper grading towards the home. The front yard area of the home is severely sloped towards the home. A swell 10 feet beyond the foundation of the home is recommended to slow or divert water run-off towards the foundation. All grades should terminate away from the structure at a rate of 6 inches per 10 feet. Unfortunately, removal of the front shrubbery will be required to improve the grading.

Front yard graded towards the home

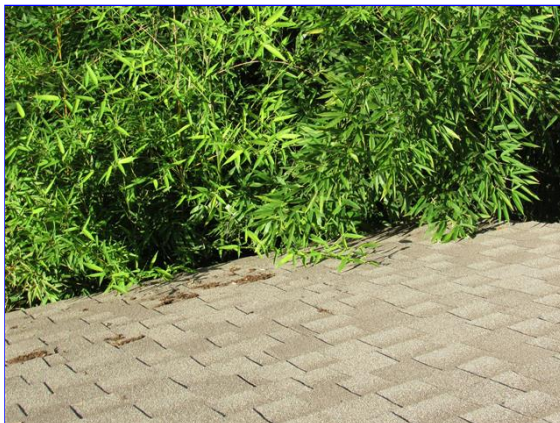
The tree limbs that are in contact with roof and/or hanging near roof. Limb contact can promote pest infestation. Trimming back of all limbs a minimum to 3 feet from the roofing surfaced and re-evaluation of the roofing tabs at these areas is recommended.

Tree limbs in contact with the roof

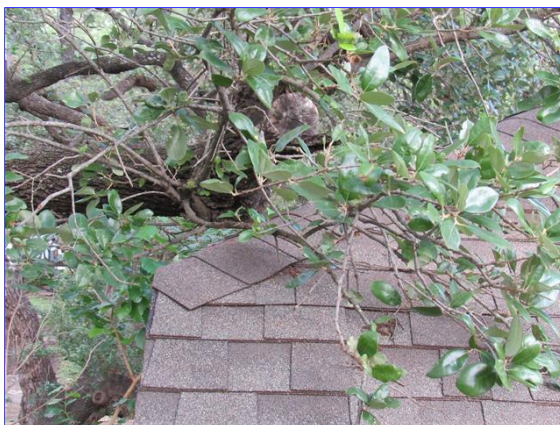
Tree limbs in contact with the roof

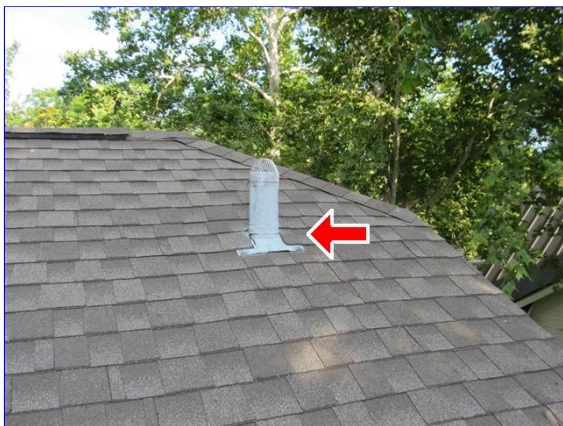
Properly saddled vent

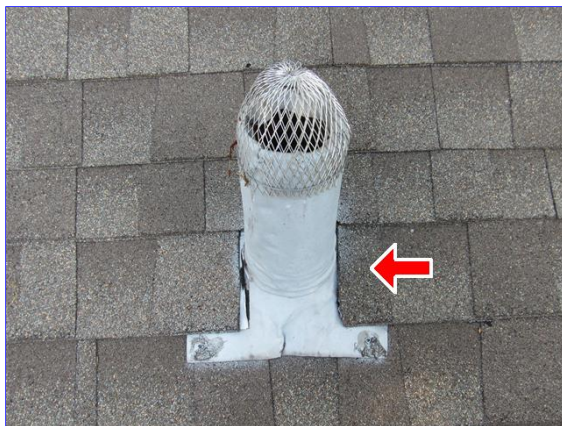
Properly saddled vent

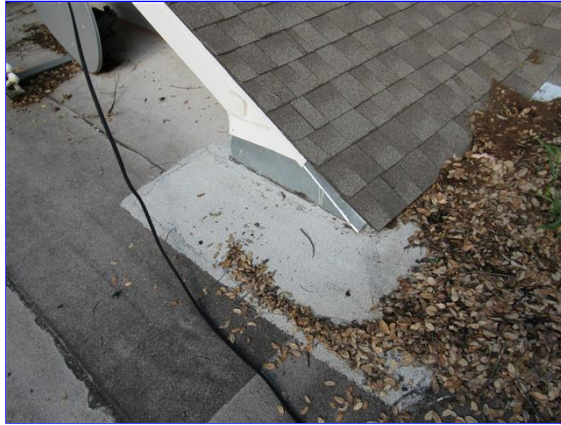
Roofing surface has been patched at several locations. This may be a sign of future failure. Reevaluation by a Roofing Contractor is recommended.

Patched roofing surface

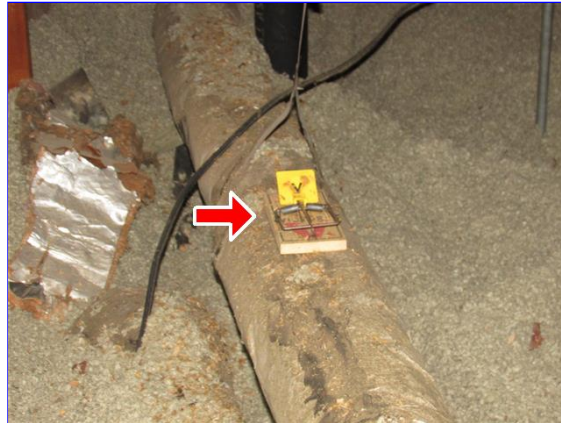
Signs of rodent infestation was visible at various attic locations. It is unknown as to whether this is a current issue or past issue. If not tended to, rodent activity can cause damage to HVAC ducting, Electrical wiring and damage to other building materials. Further consultation with the sellers over this matter is recommended.

Rodent activity

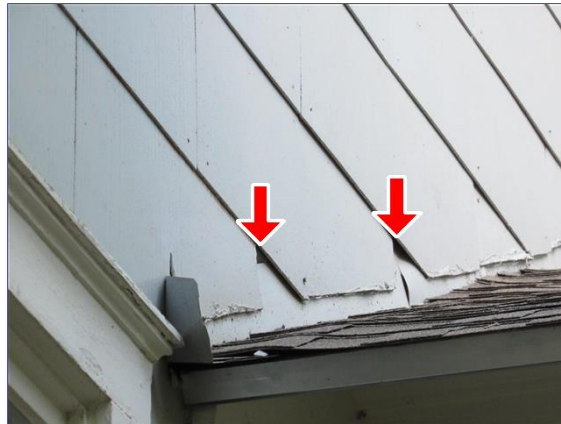
Exterior cladding is damaged near the flashing area of the home. Cladding is gapped at the flashing and is in need of repair.

Gapped cladding at flashing

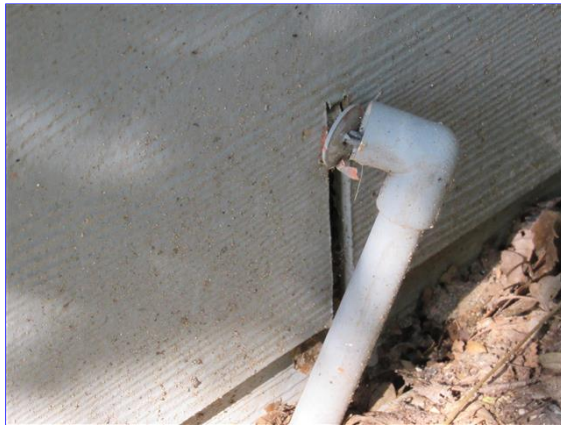
Electrical conduit at the garage wall is gapped. Gapped conduit allows moisture to penetrate the housing of the wiring. Sealing of the conduit to the mortar wall is recommended.

Gapped conduit

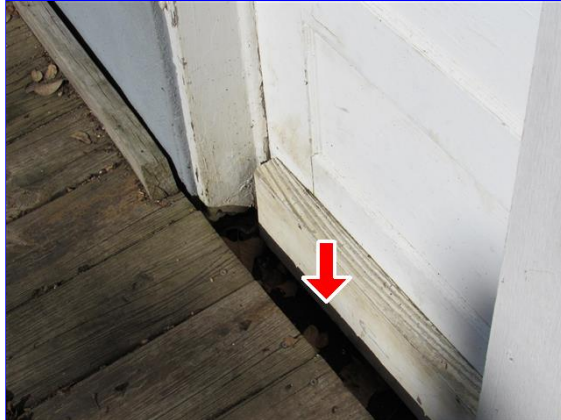
Deck higher than the Storage Entry

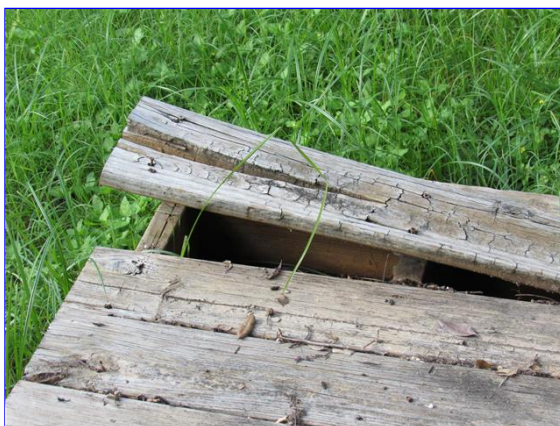
Raised decking

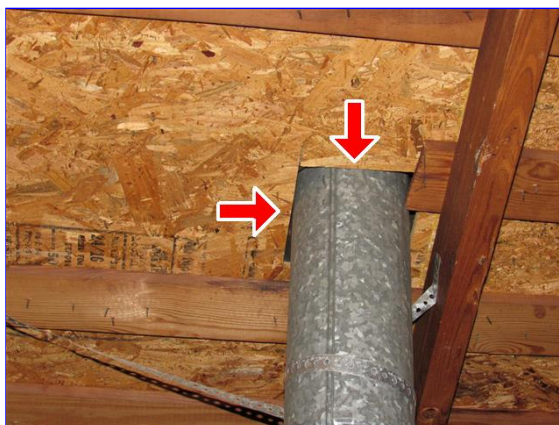
Insufficient clearance from roof decking

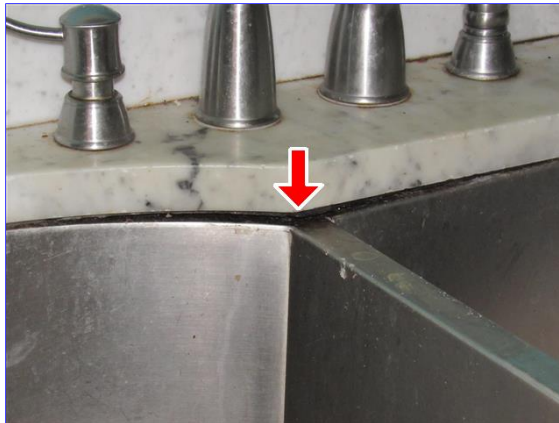
Sink gapped at counter-top
