**Austin 10/26/2020**

**Re: Existing Residential Foundation and Superstructure Assessment**

808 Avondale Rd, Austin, TX 78704

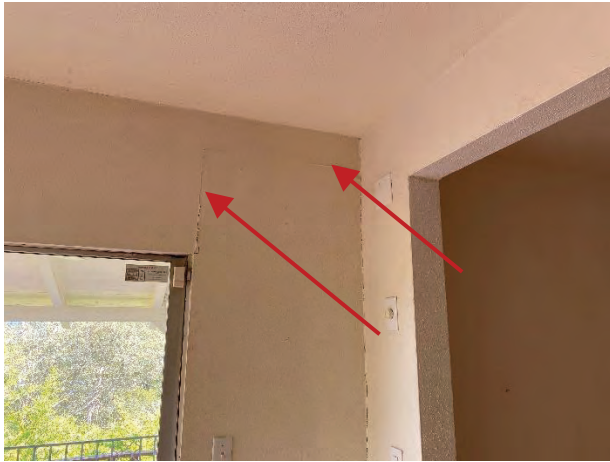
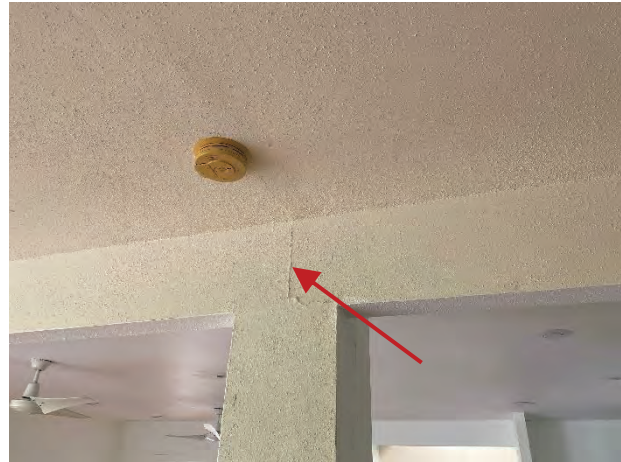
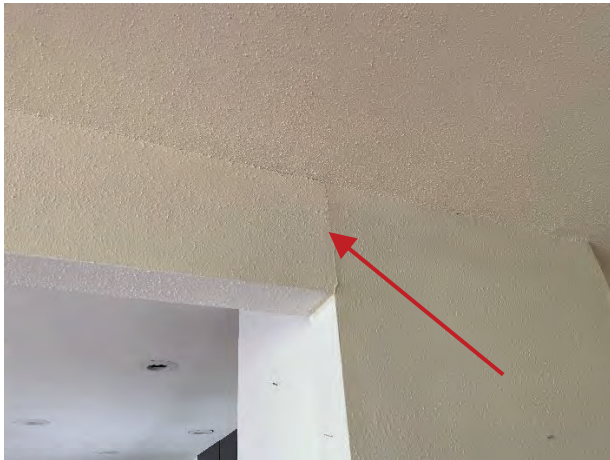
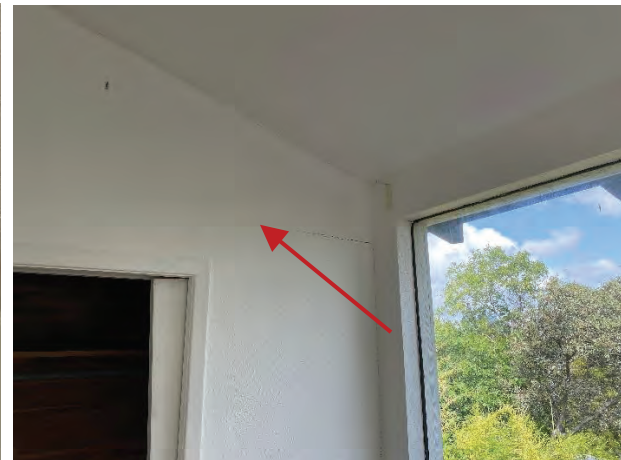
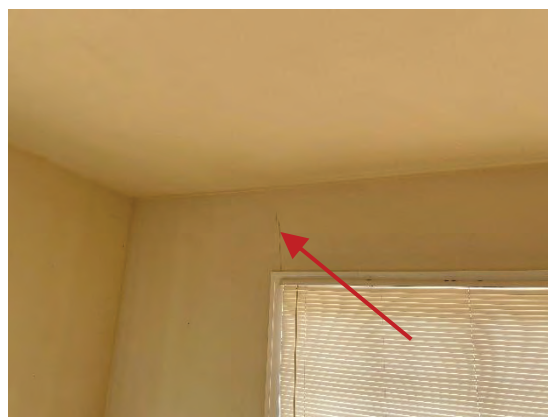
- Several stair-stepped, vertical and horizontal cracks on interior walls. These cracks are common indicators of foundation movement (Figure 3).

Figure 3. Cracks in walls and ceiling

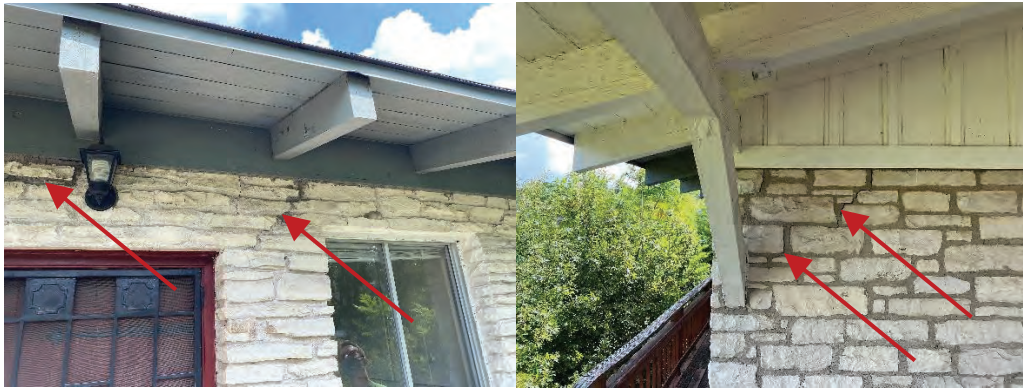
- Interior Floor elevations indicate that the floor is approximately 3” out of level (pier-and-beam). This indicates a high degree of foundation shifting/settlement. Most variations in elevation measurements inside particular rooms are equal or over 2”, pointing to excessive movement.
- Extensive cracking observed in the exterior stone veneer, another indication of an underperforming foundation. Figure 5.

Figure 5. Cracks in stove veneer.

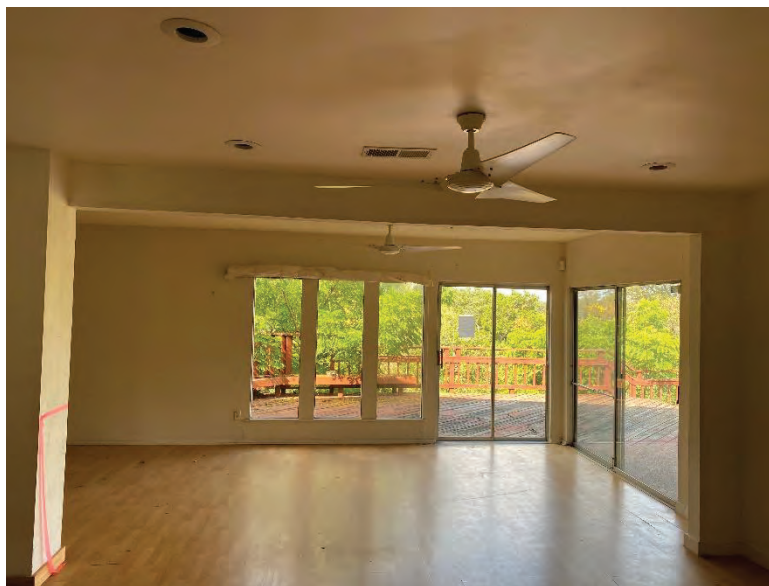
- Several cosmetic repairs still visible throughout the house. These repairs were likely necessary to cover extensive cracking on interior walls and ceiling. This reinforces the previous observation about out-of-tolerance foundation movement.
- Excessive deflection of framing members (Figure 6). Some floor and ceiling beams/headers are visibly undersized for the current span.

Figure 6. Excessive deflection of framing members.

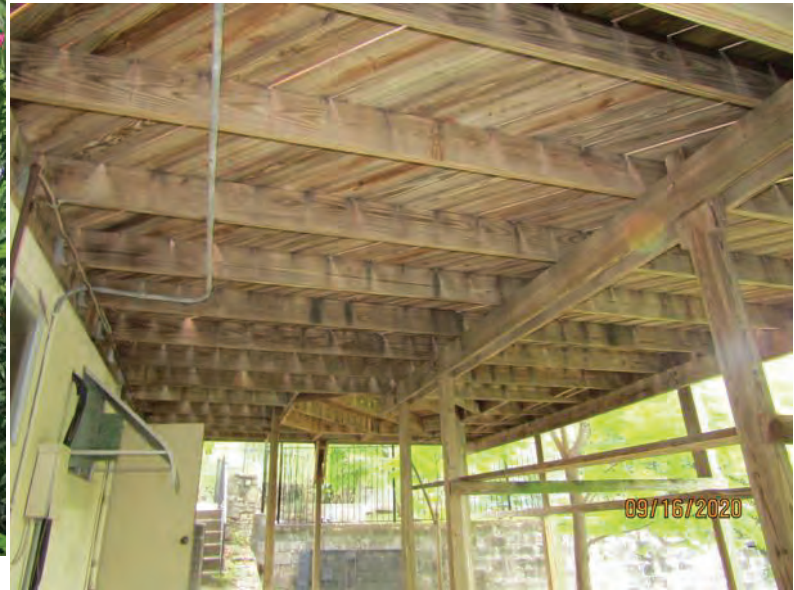
substandard and defective deck support structure conditions create the potential for catastrophic deck failure

underside deck photo

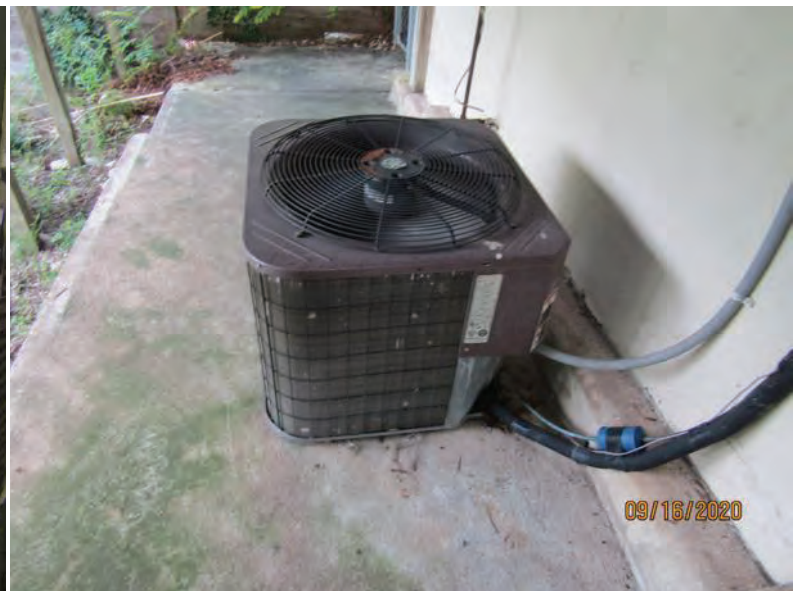
1993 Mfd. 2 ton capacity Ruud AC unit currently set up to cool entire house

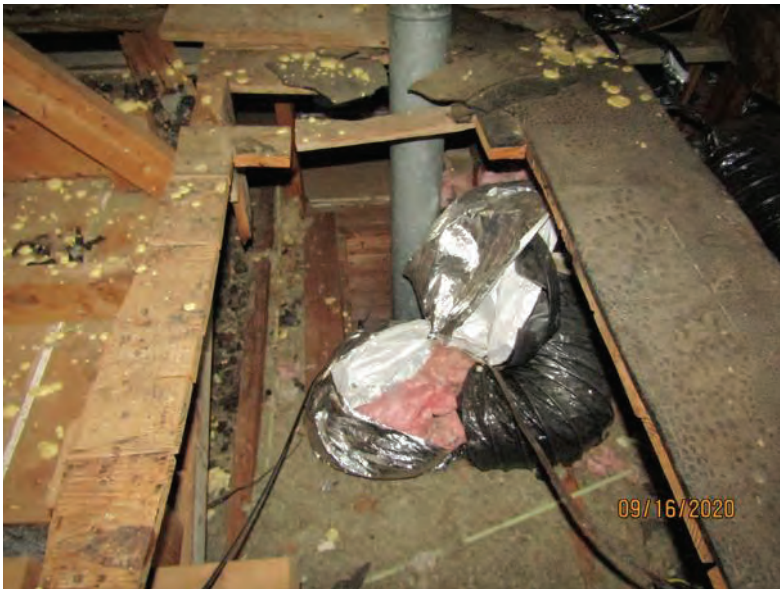
attic HVAC ducting destroyed by critters. Raccoon droppings point to culprits

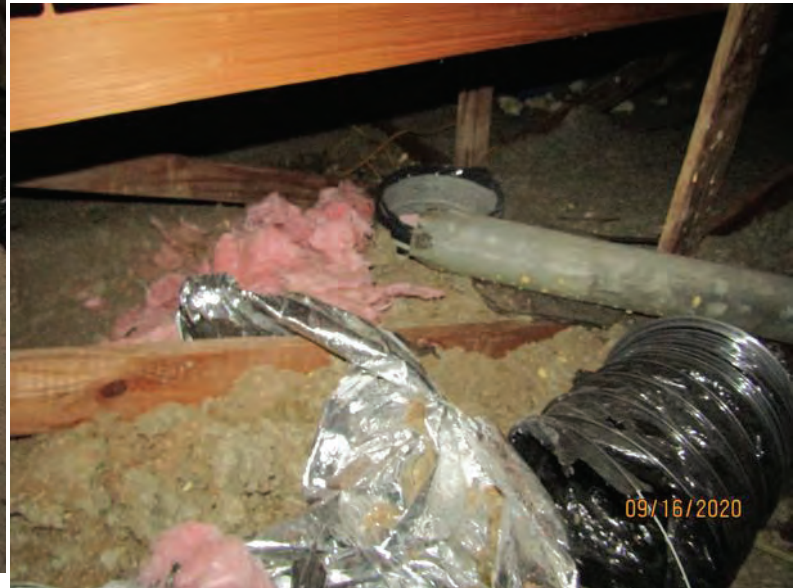
attic HVAC ducting destroyed by critters.

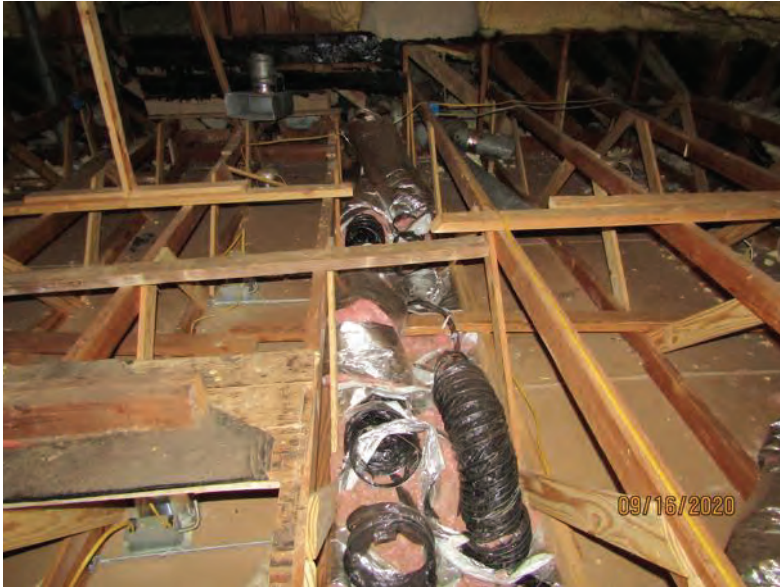
attic HVAC ducting destroyed by critters.

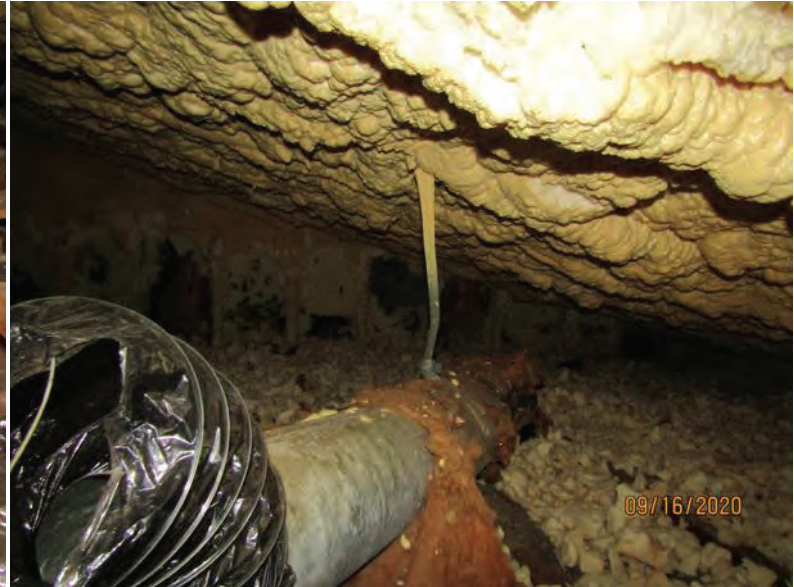
attic HVAC ducting destroyed by critters.

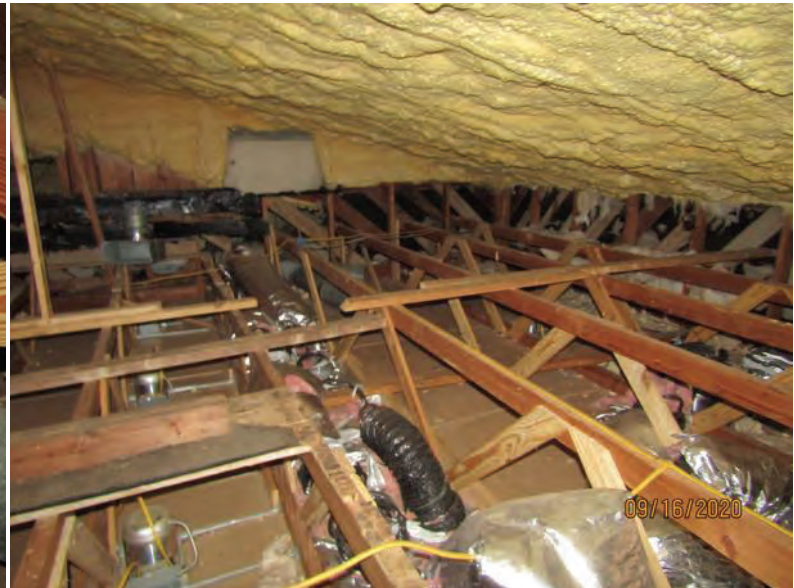
attic HVAC ducting destroyed by critters.

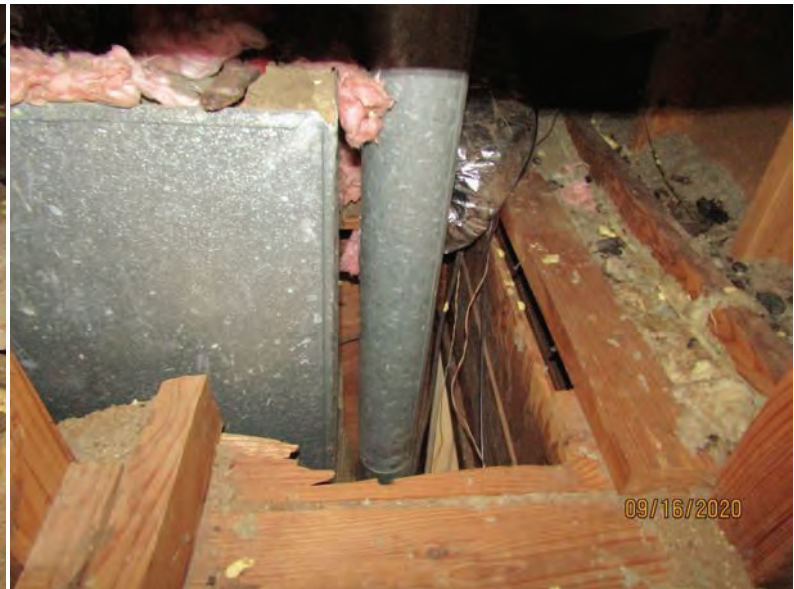
no required ceiling/firestopping over entry foyer furnace closet

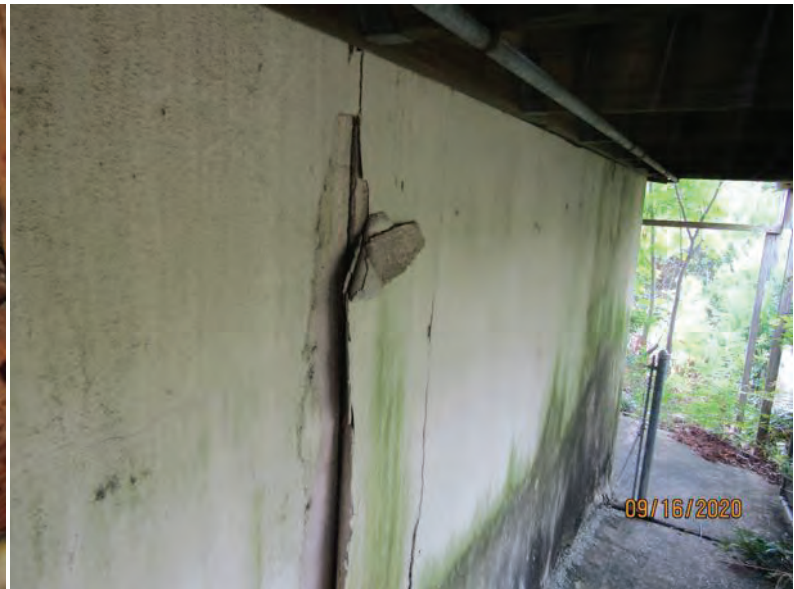
distress crack in plaster coating where back left concrete beam ties into foundation skirt wall

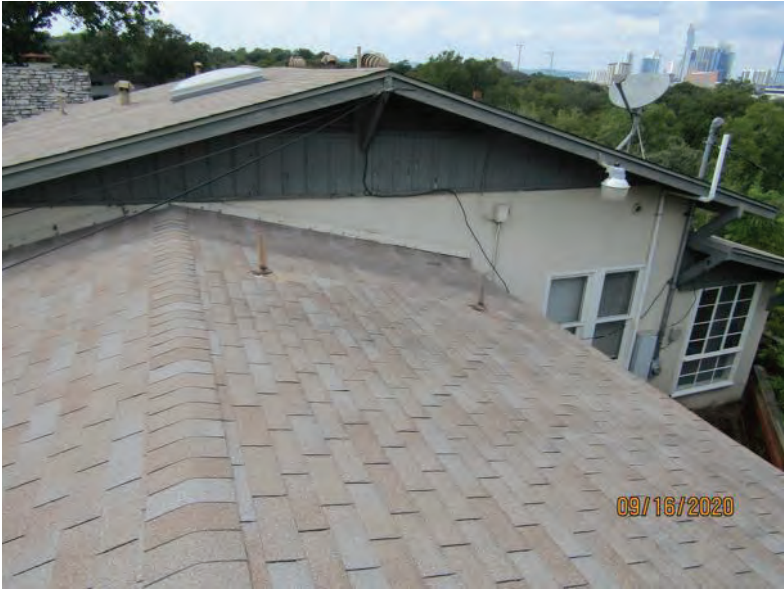
general roof photo

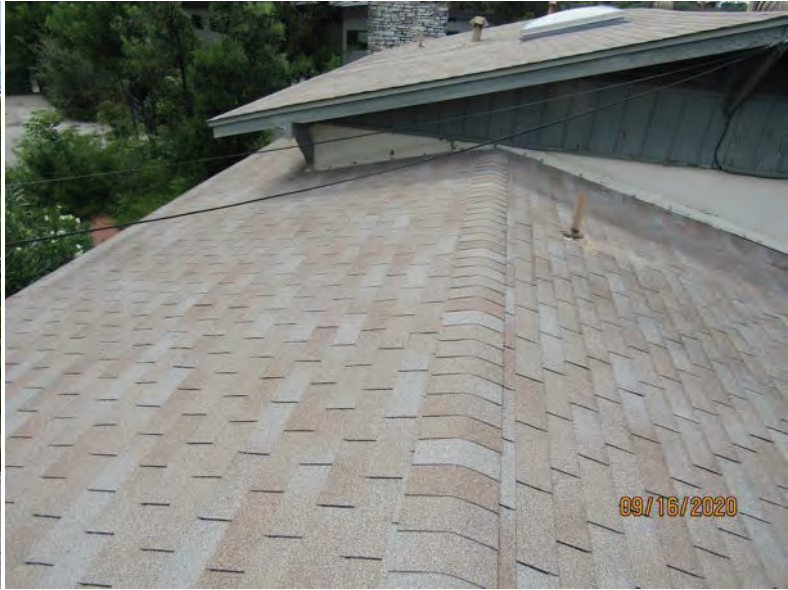
general roof photo

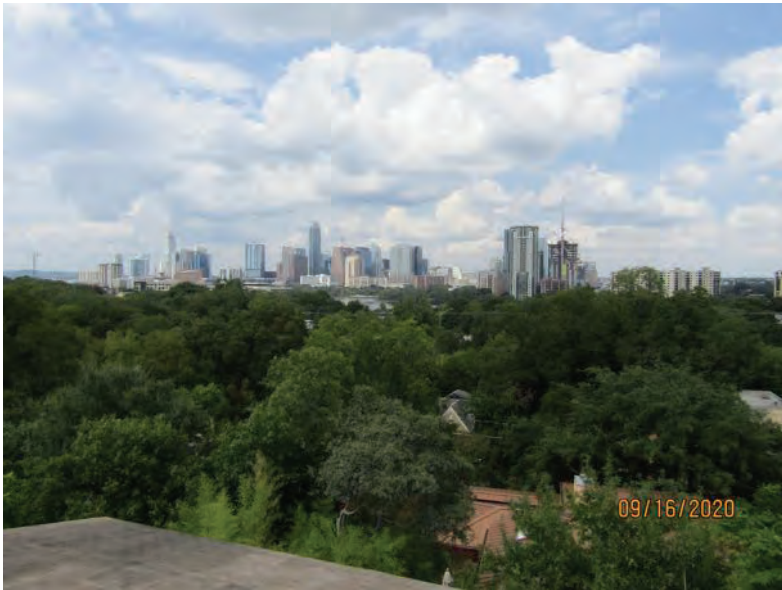
beautiful view of Austin skyline from roof vantage point

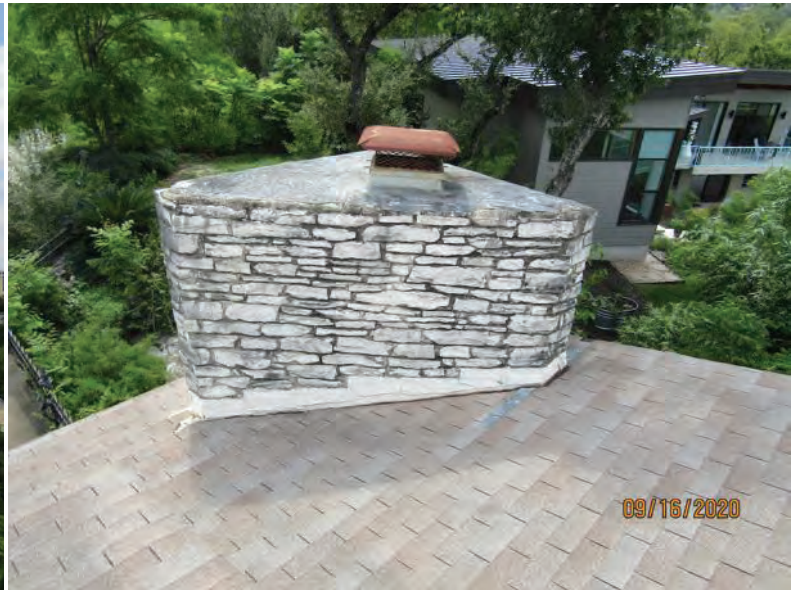
chimney

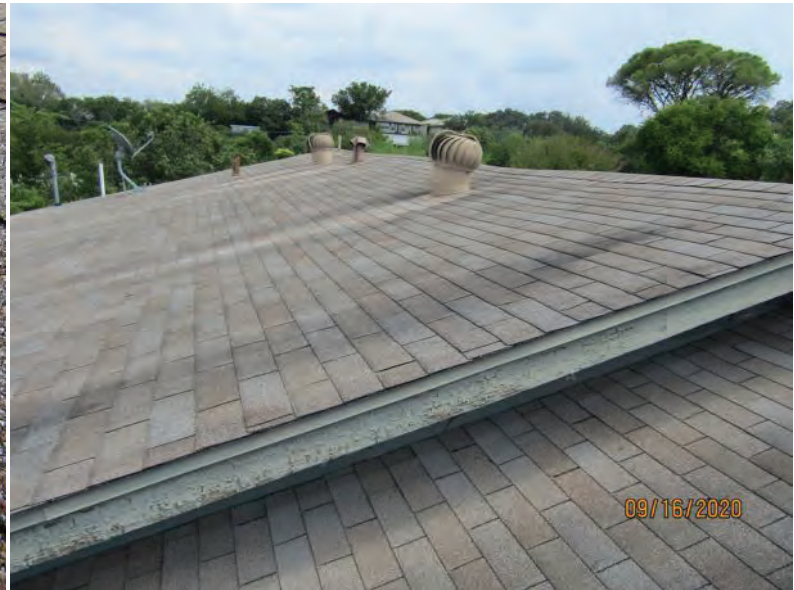
general roof photo

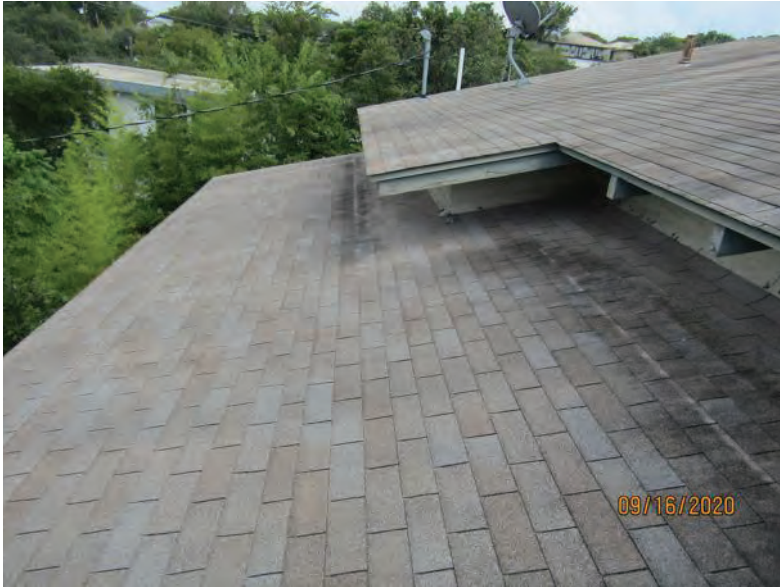
general roof photo

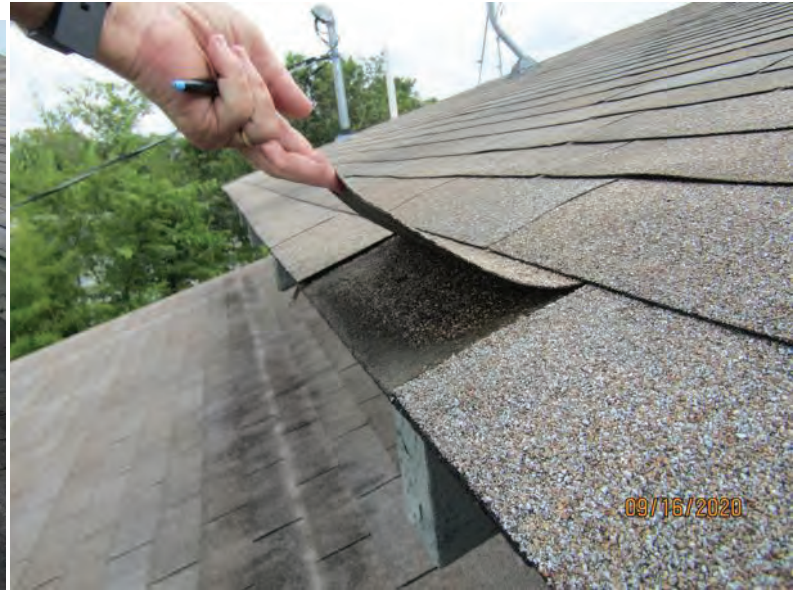
first course shingles not sealed down per roofing manufacturer's installation guidelines

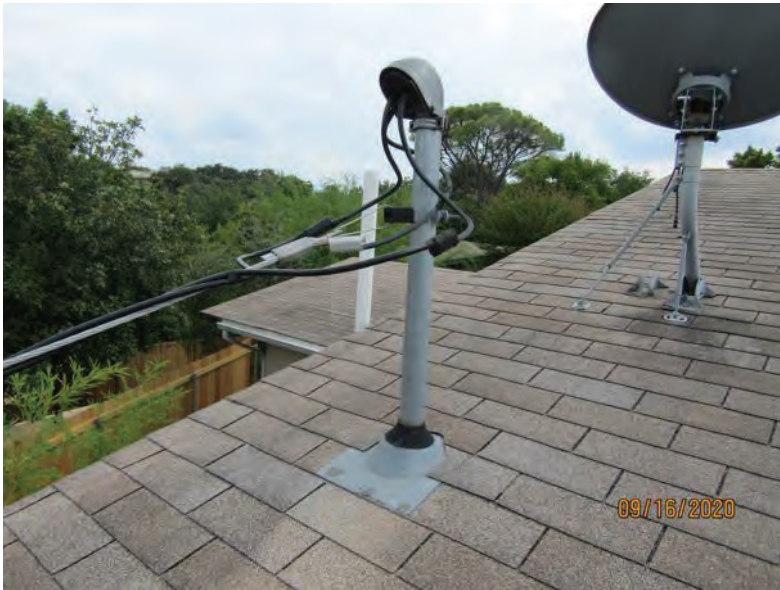
electric riser pipe and cable over roof

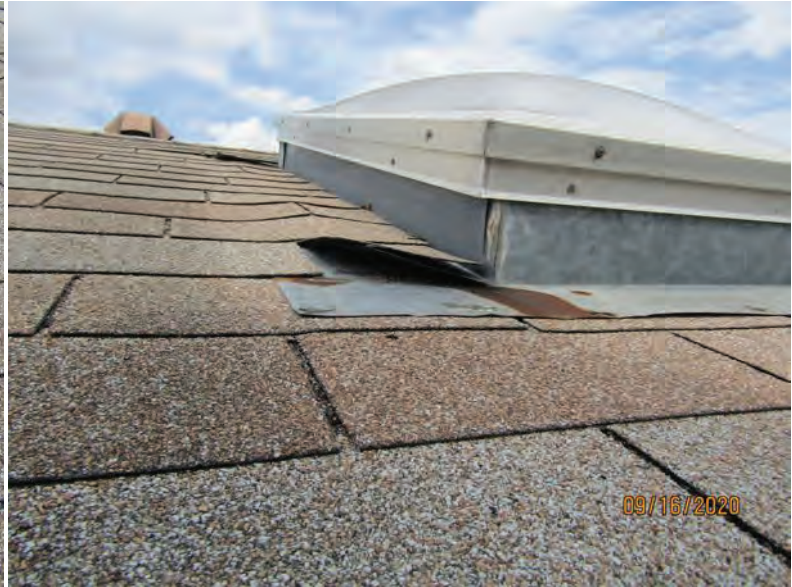
skylight flashing lifted

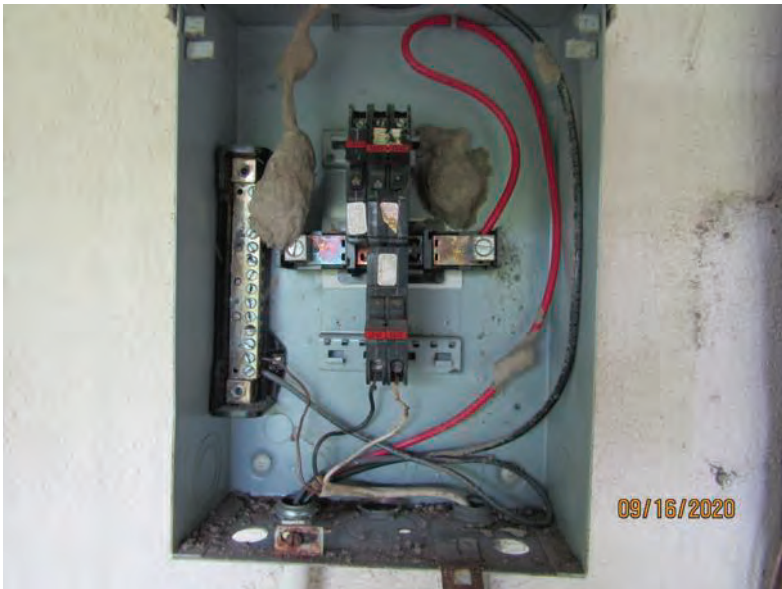
mud dauber nests in AC unit electrical disconnect box due to openings at bottom of box

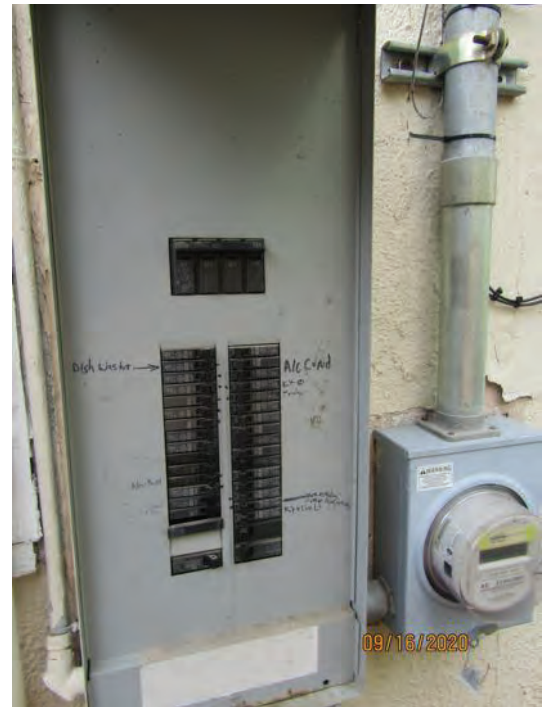
main 150 amp electrical disconnect panel at back right deck location

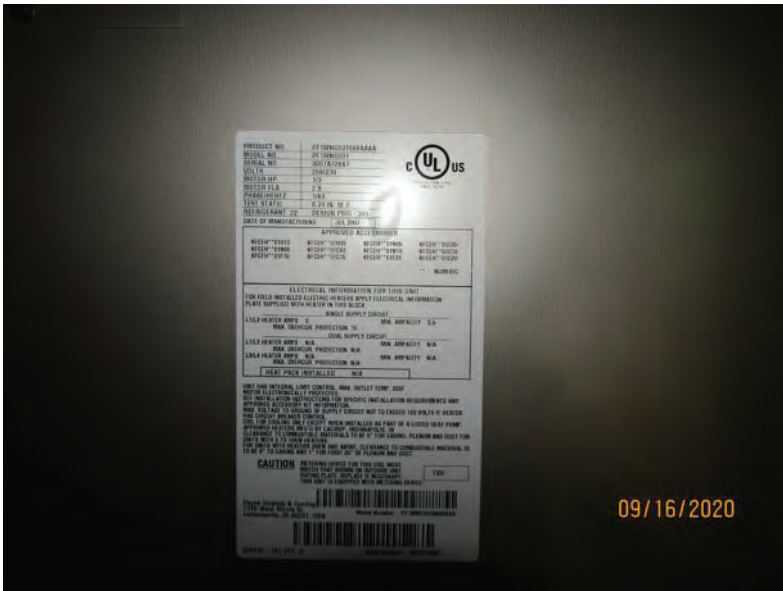
obsoleted 2007 Mfd. Payne HVAC data plate on crawl space unit

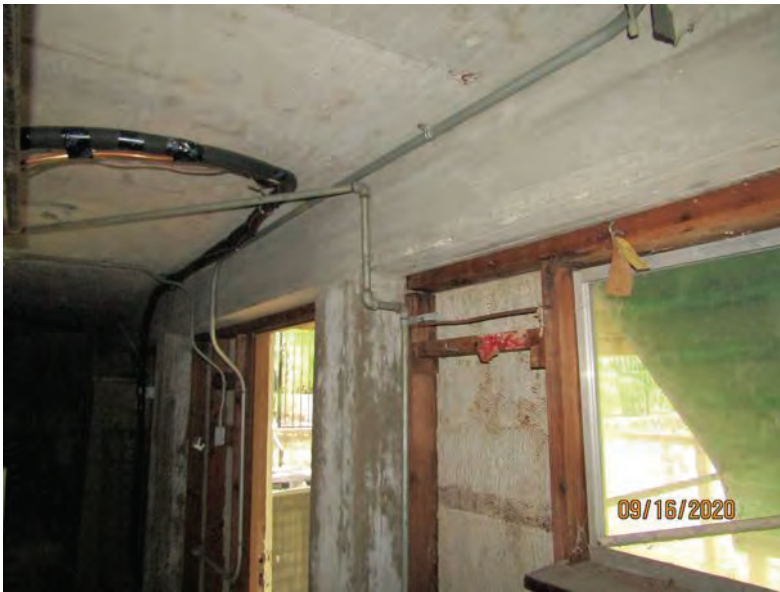
concrete columns and beams support cast-in-place suspended concrete floor slab in left side crawl space

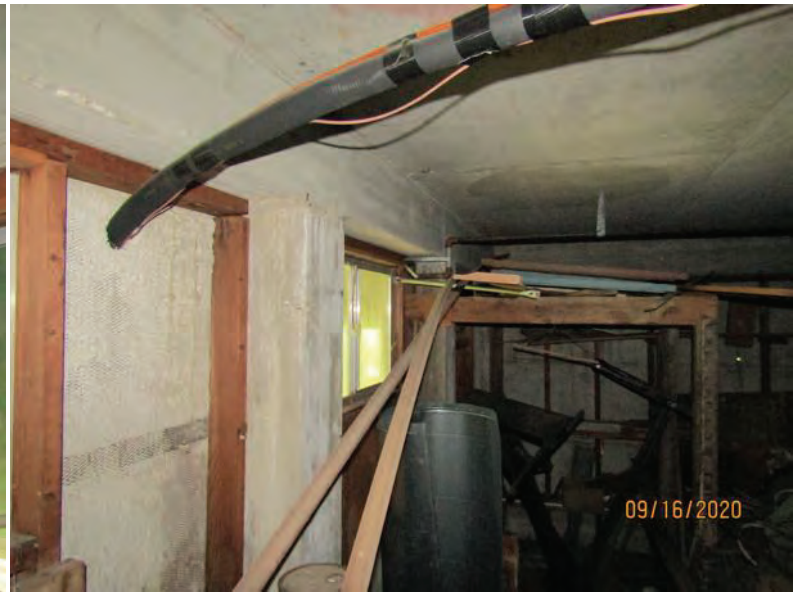
concrete columns and beams support cast-in-place suspended concrete floor slab in left side crawl space

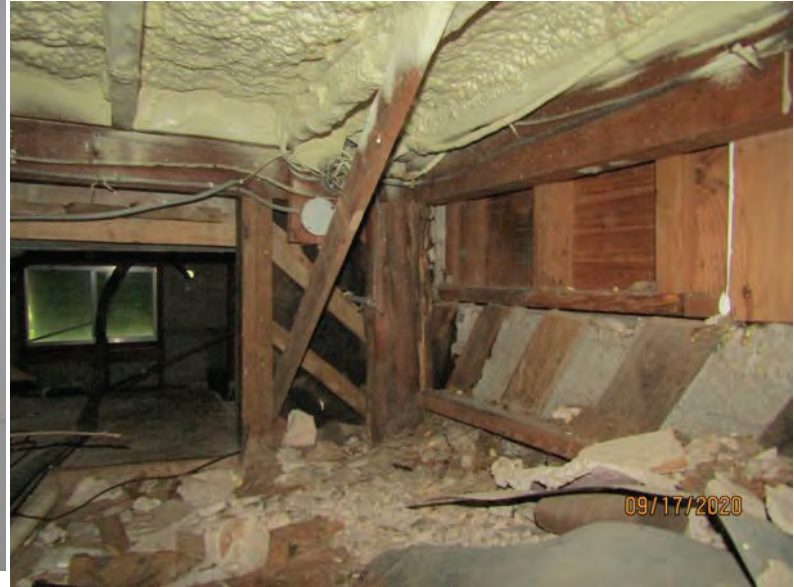
cedar pier in original house crawl space

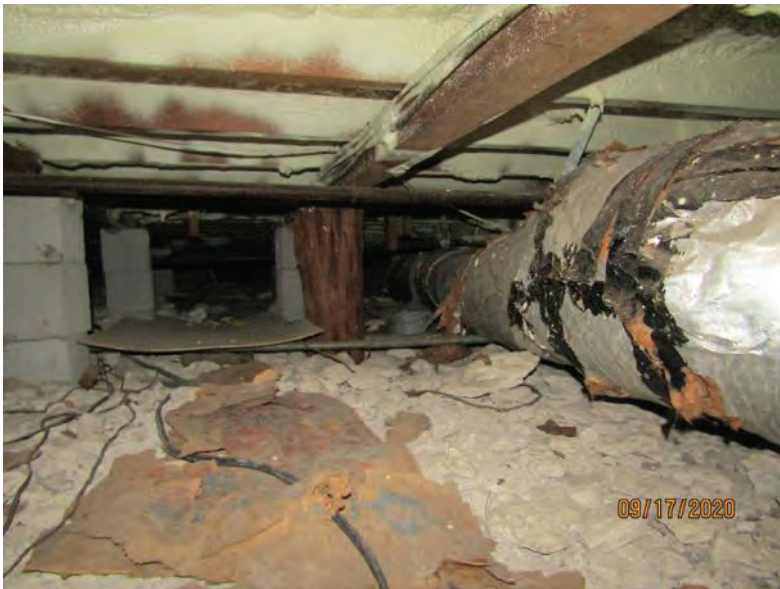
mix of concrete block and cedar piers in crawl space under house

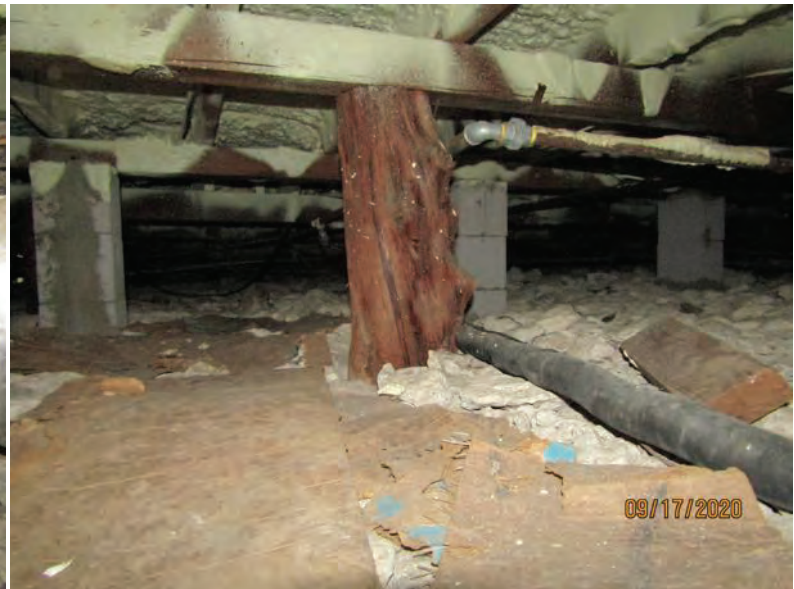
4x4 beam members are undersized per current minimum building code standards

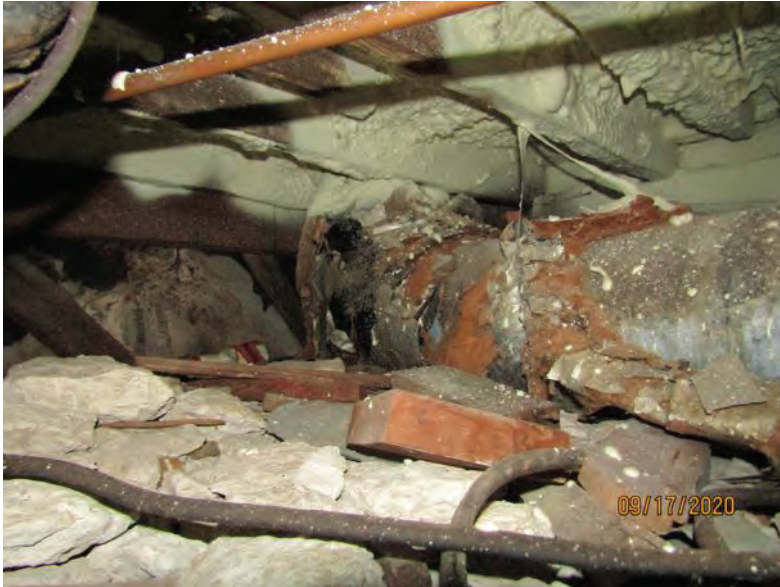
obsolete metal HVAC ducting in crawl space

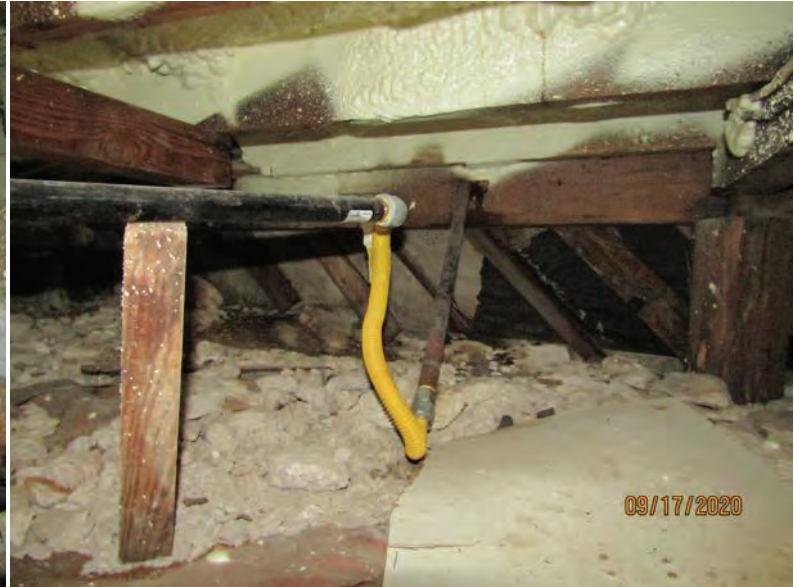
gas line in front left crawl area

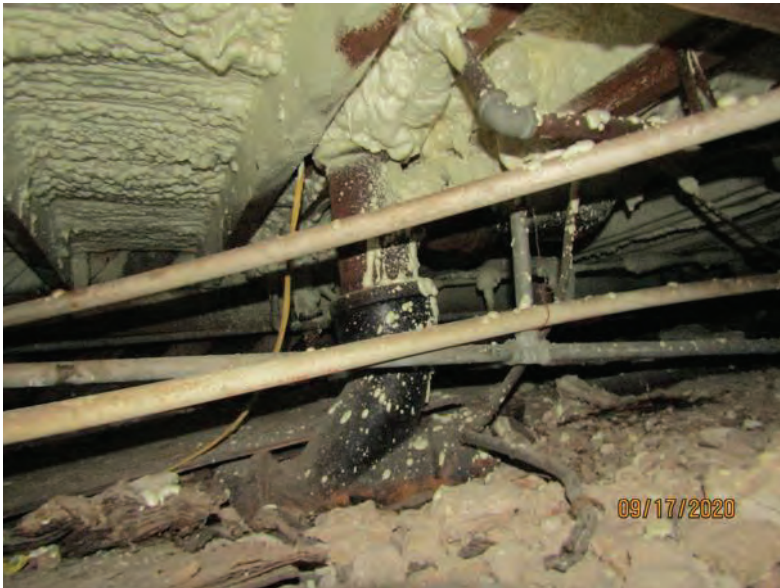
old cast iron sewer piping under bathroom toilet

A video camera inspection of the sanitary drain and sewer system was performed . The lines beneath the home consist of original cast-iron piping in poor and deteriorated condition. The camera could not pass through kitchen/utility drain lines due to severe build up and deterioration. The drain lines beneath the restrooms were partially restricted due to deterioration.

| DESCRIPTION | QTY | UNIT PRICE | AMOUNT |
|---|---|---|---|
| Excavate by exterior access to tunnel 60' below the foundation to replace deteriorated cast-iron drain lines using schedule 40 PVC. Install clevis hangers for pipe support. Backfill. City permit and Engineer backfill letter. | 1 | \$20,000.00 | \$20,000.00 |

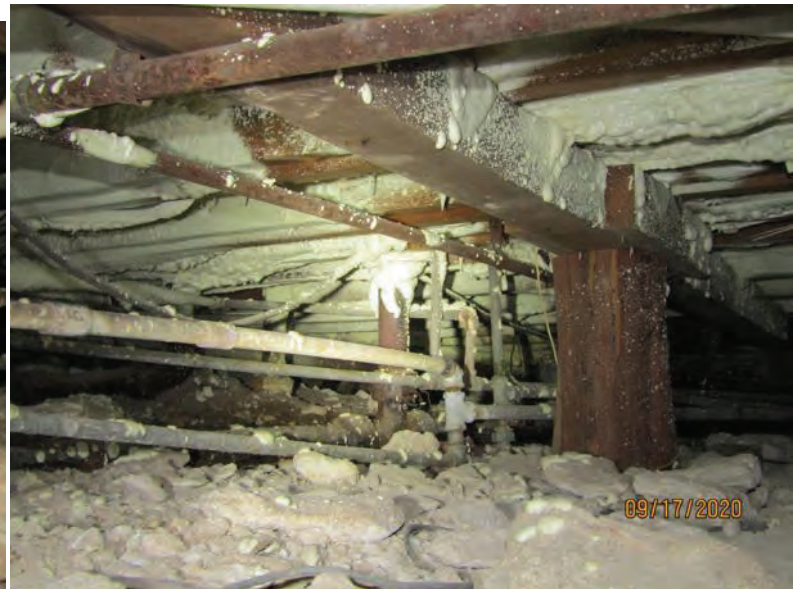
old galvanized steel water supply and cast iron sewer pipe under bathroom area

A water pressure test could not be performed due to multiple leaking fixtures . It appears that the water main from the meter to house (150'+) is galvanized piping that will likely need to be replaced. Water pressure exceeds 100 PSI.

| DESCRIPTION | QTY | UNIT PRICE | AMOUNT |
|---|---|---|---|
| Excavate by exterior trench through driveway and rock/soil from house to street to replace galvanized water main. Backfill | 1 | \$14,000.00 | \$14,000.00 |

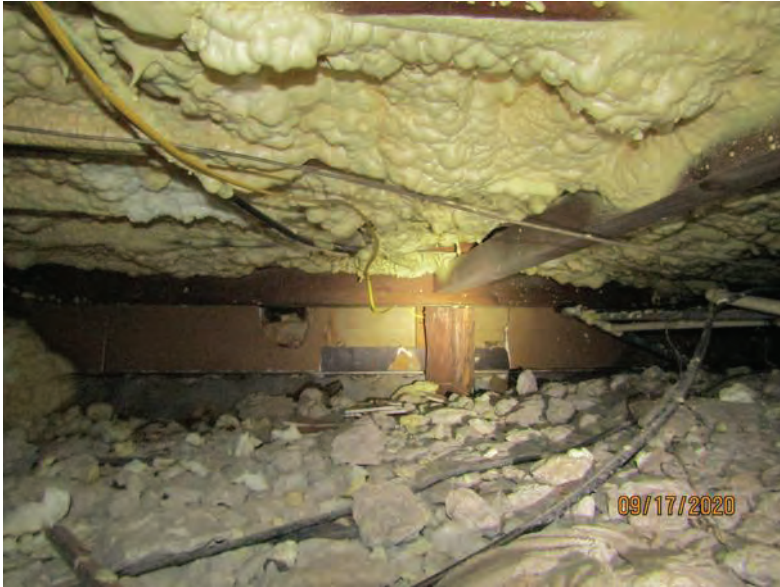
general crawl space photo

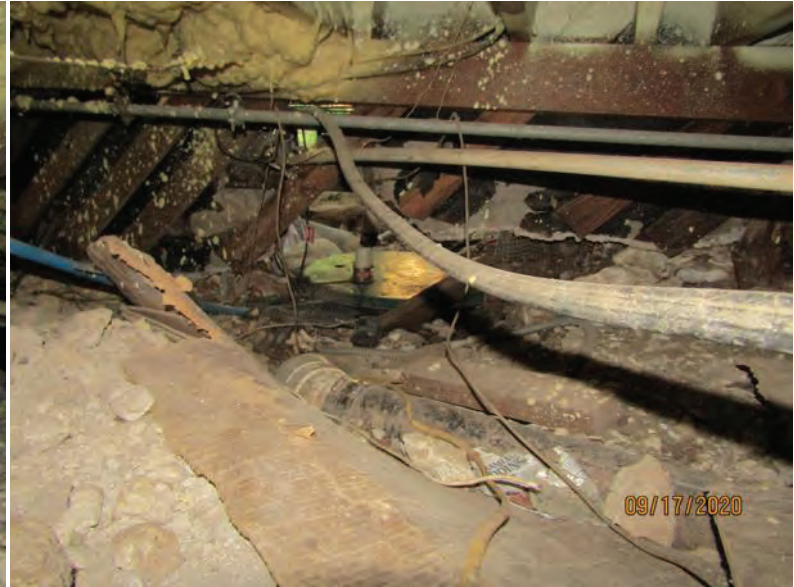
grinder pump equipment under back right deck

The original sewer line has been abandoned and a grinder tank/pump was installed beneath the rear deck. It appears that the grinder system is not functioning. The newer 2" pressure sewer line from tank to front yard is PVC piping. The 4" new gravity sewer line from front yard to street is also PVC with no problems observed.

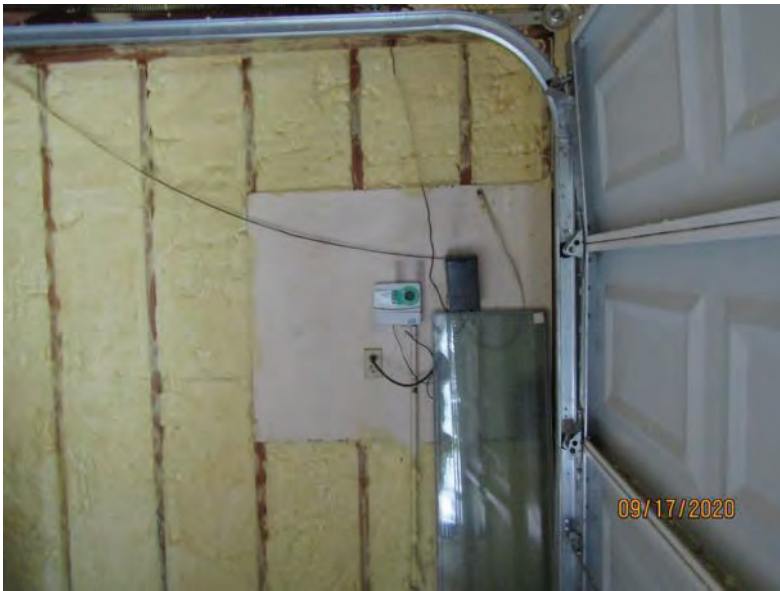
spray foam installed over garage underside roof surfaces and in stud wall space

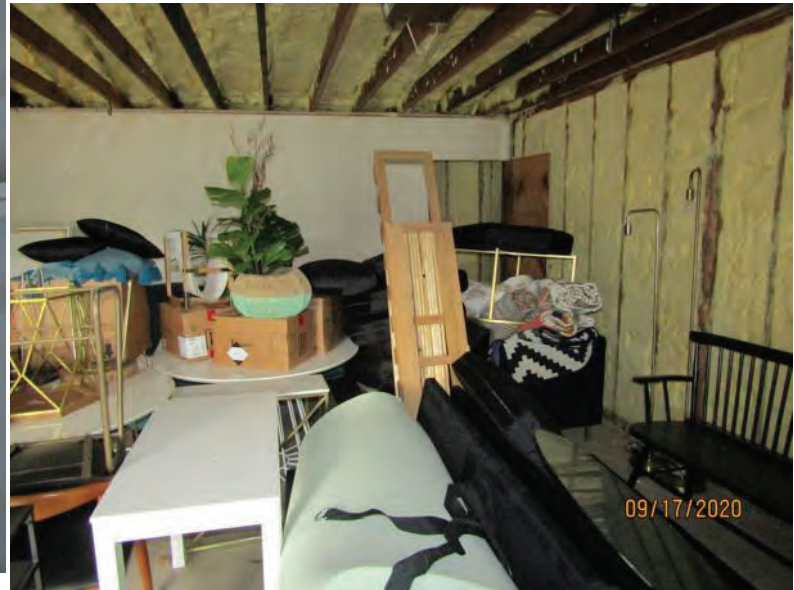
storage in garage

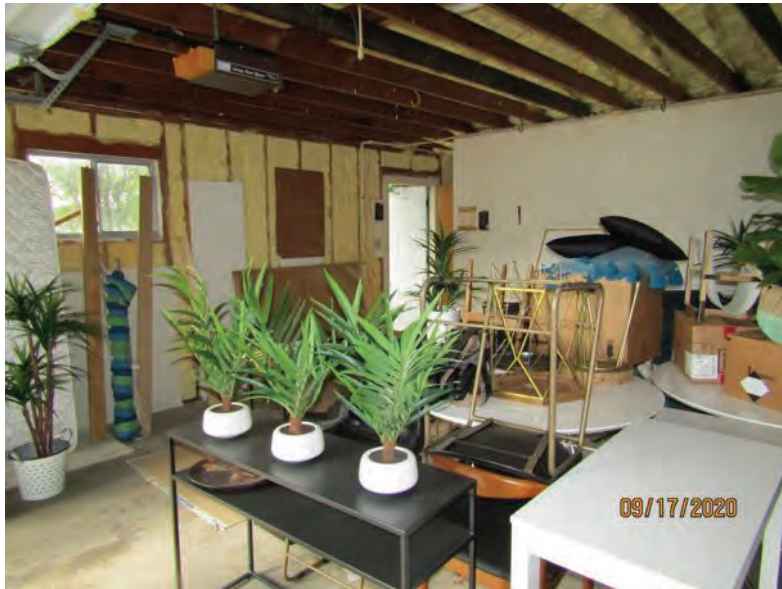
general garage photo
