Analysis of Existing Building at
1403 EAST CESAR CHAVEZ STREET
Historic Landmark Commission Hearing

MAY 04, 2022

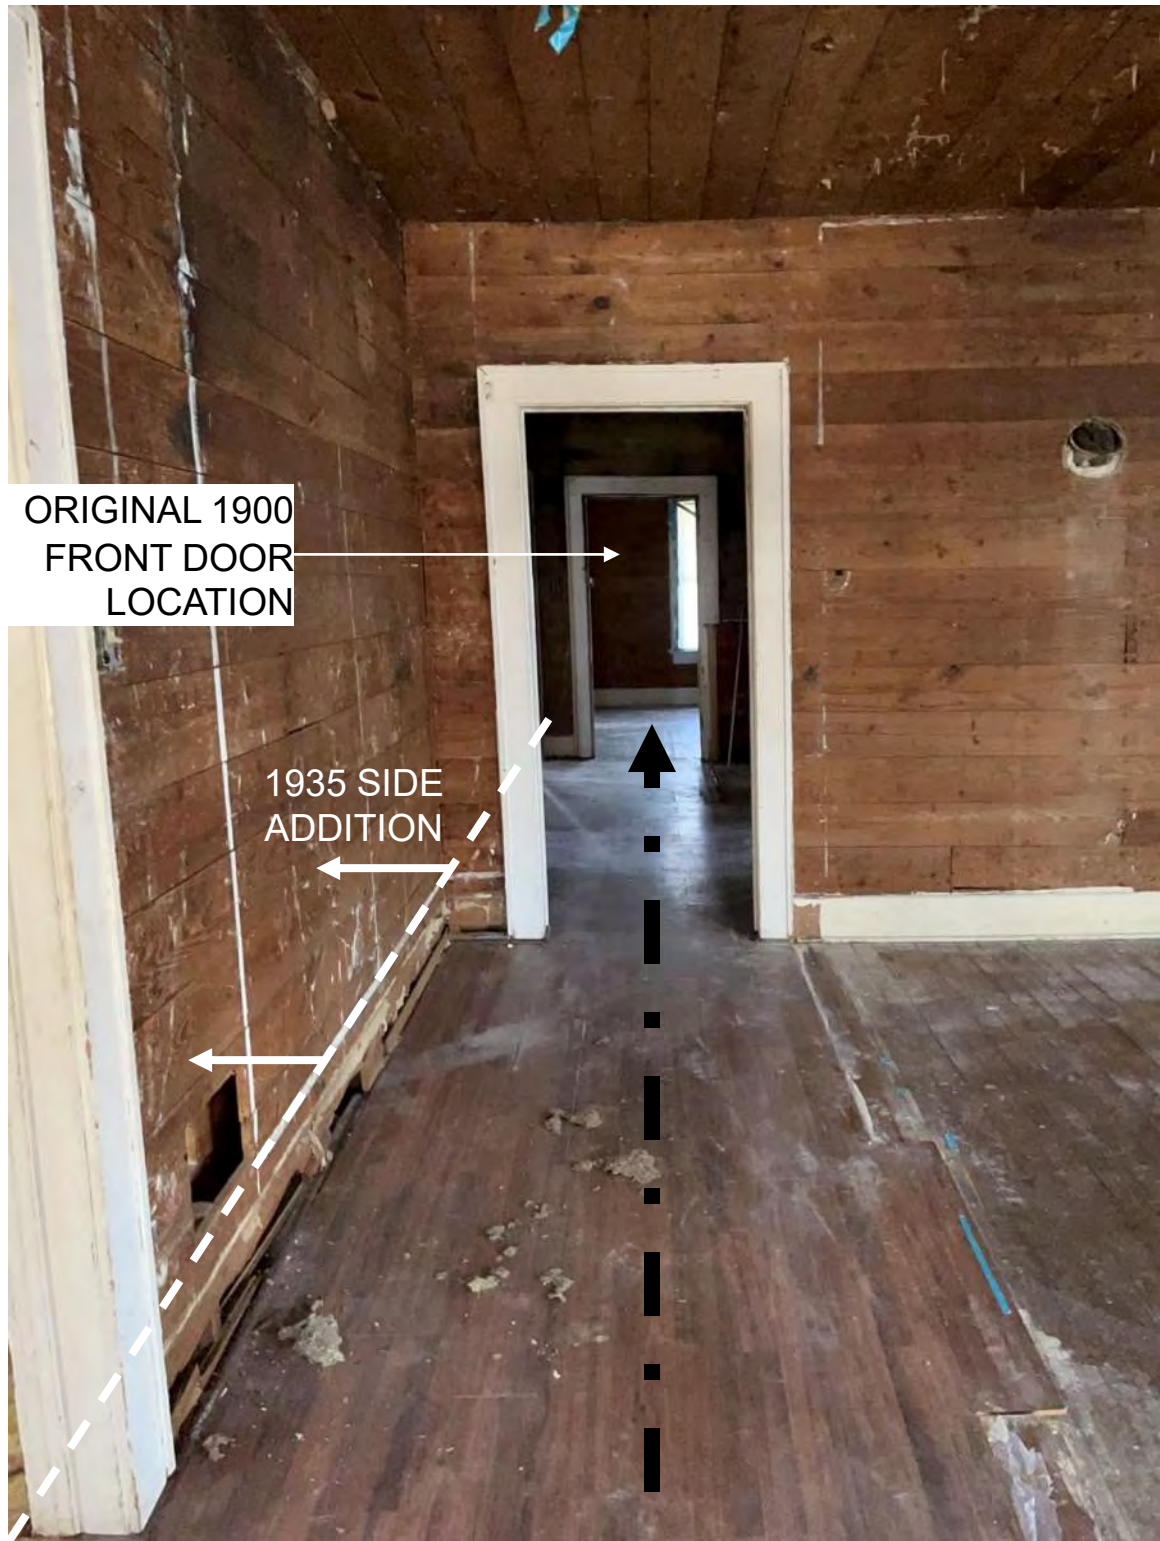
ALIGNMENT OF ORIGINAL 1900 DOORWAYS

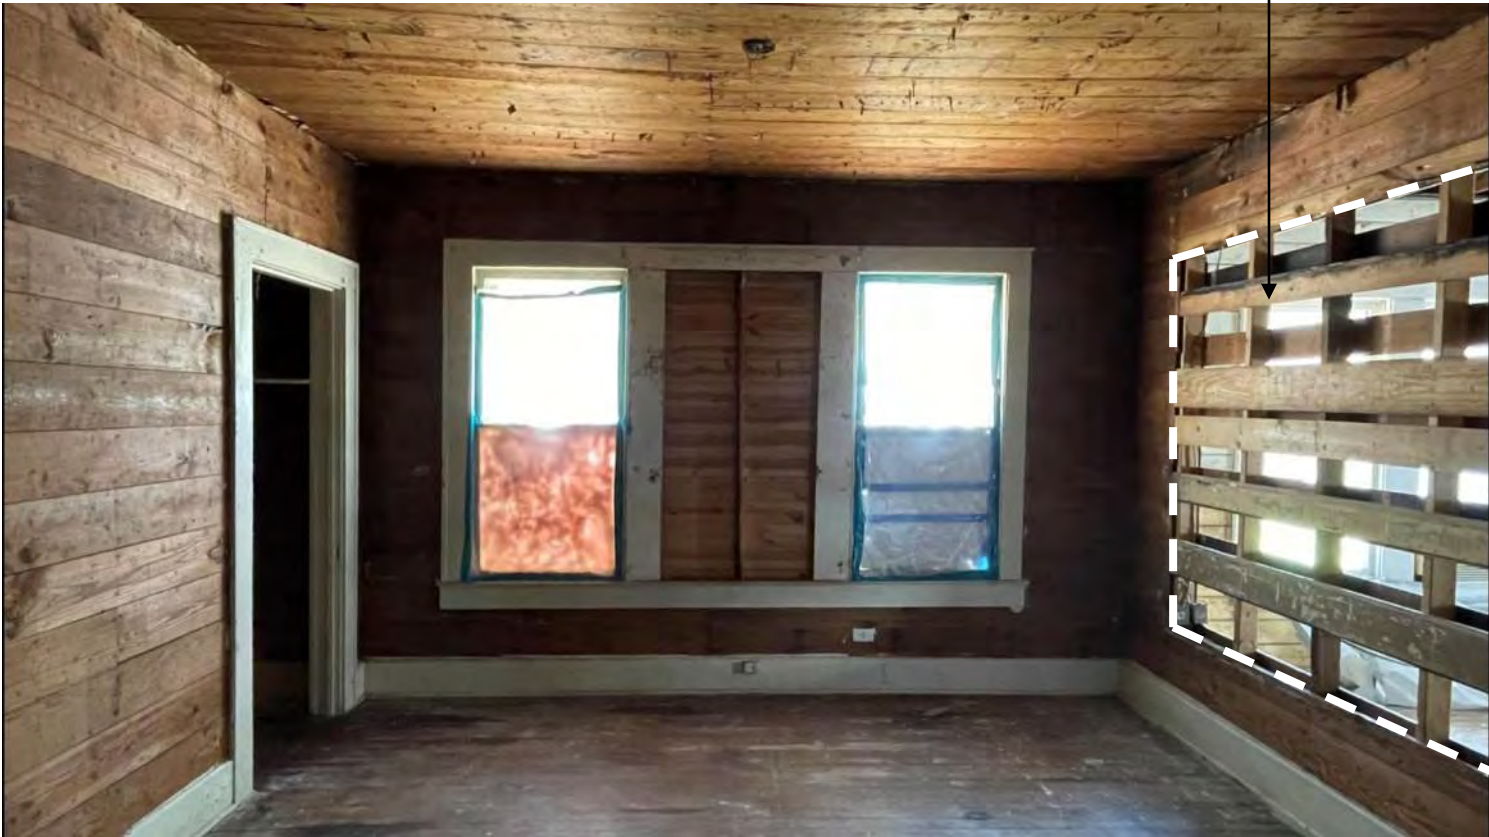
BACK ROOM – VIEW FACING EAST

ORIGINAL 1900 EXTERIOR
WINDOW LOCATION

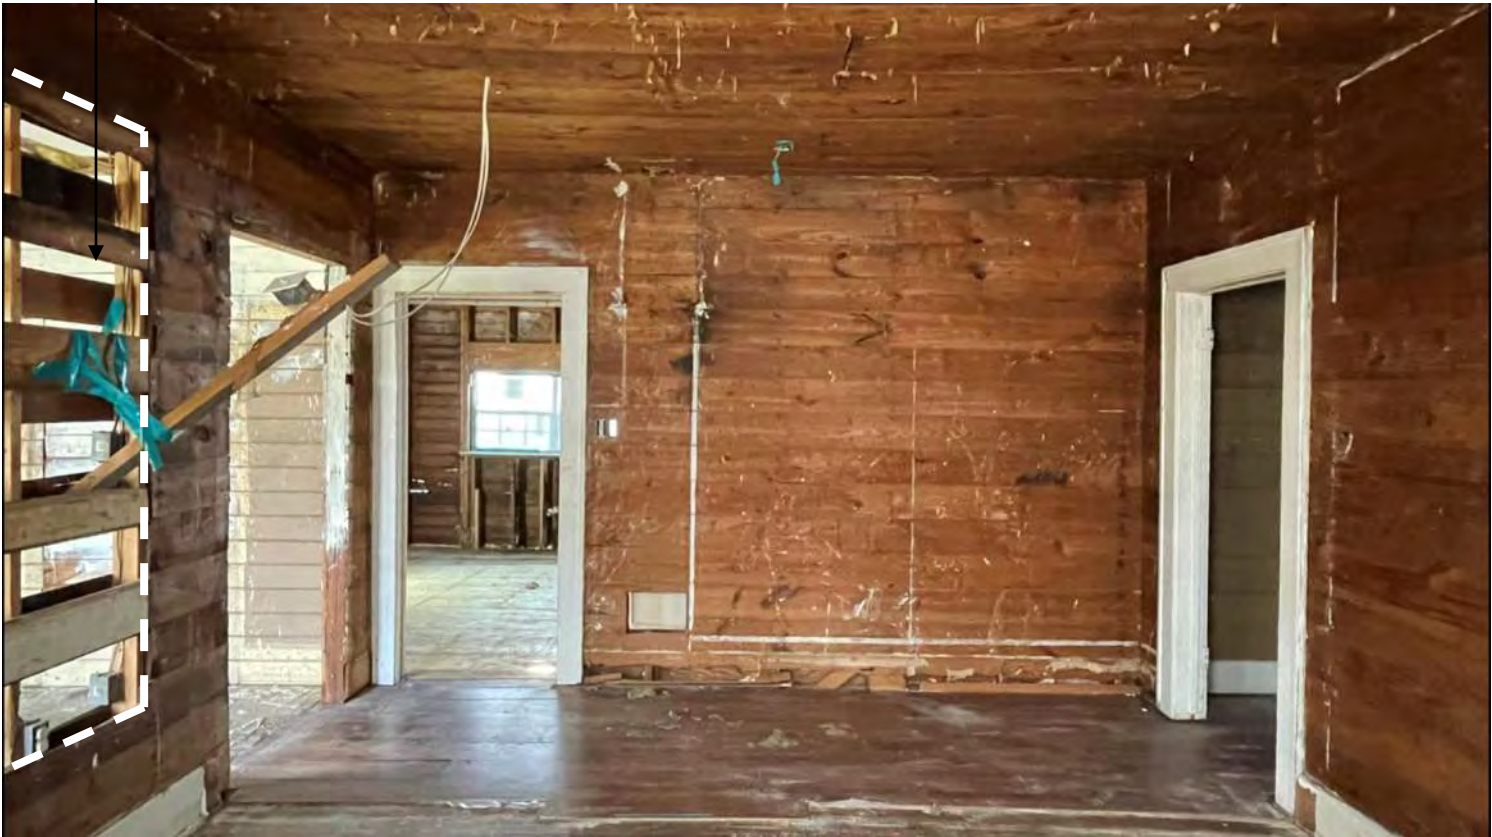
BACK ROOM – VIEW FACING WEST

ORIGINAL 1900 EXTERIOR
WINDOW LOCATION

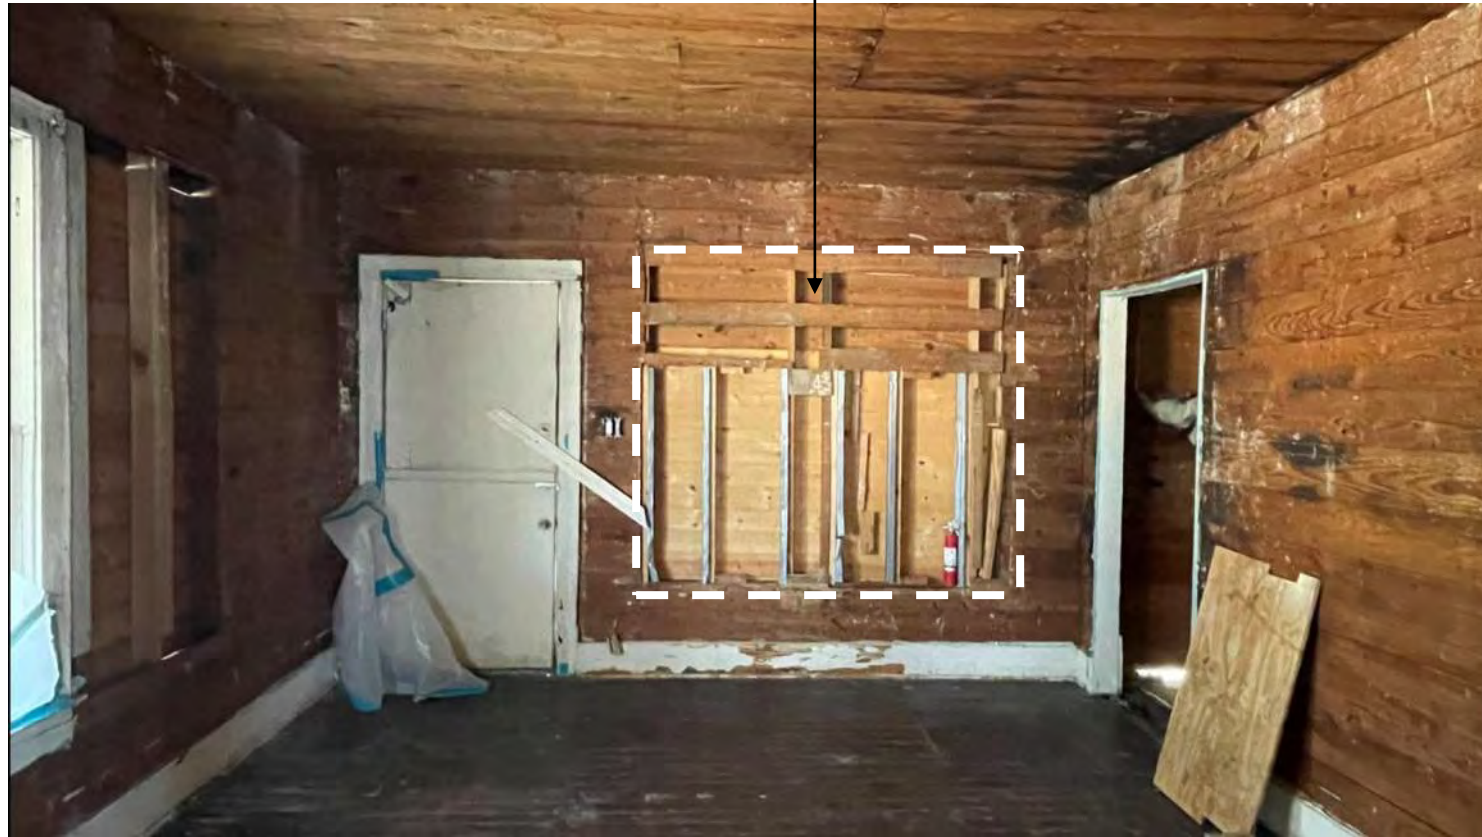
FRONT ROOM – VIEW FACING EAST

1935 WINDOW LOCATIONS
COVERED DURING RENOVATION
WITH CONTEMPORARY
FRAMING AND SHEATHING

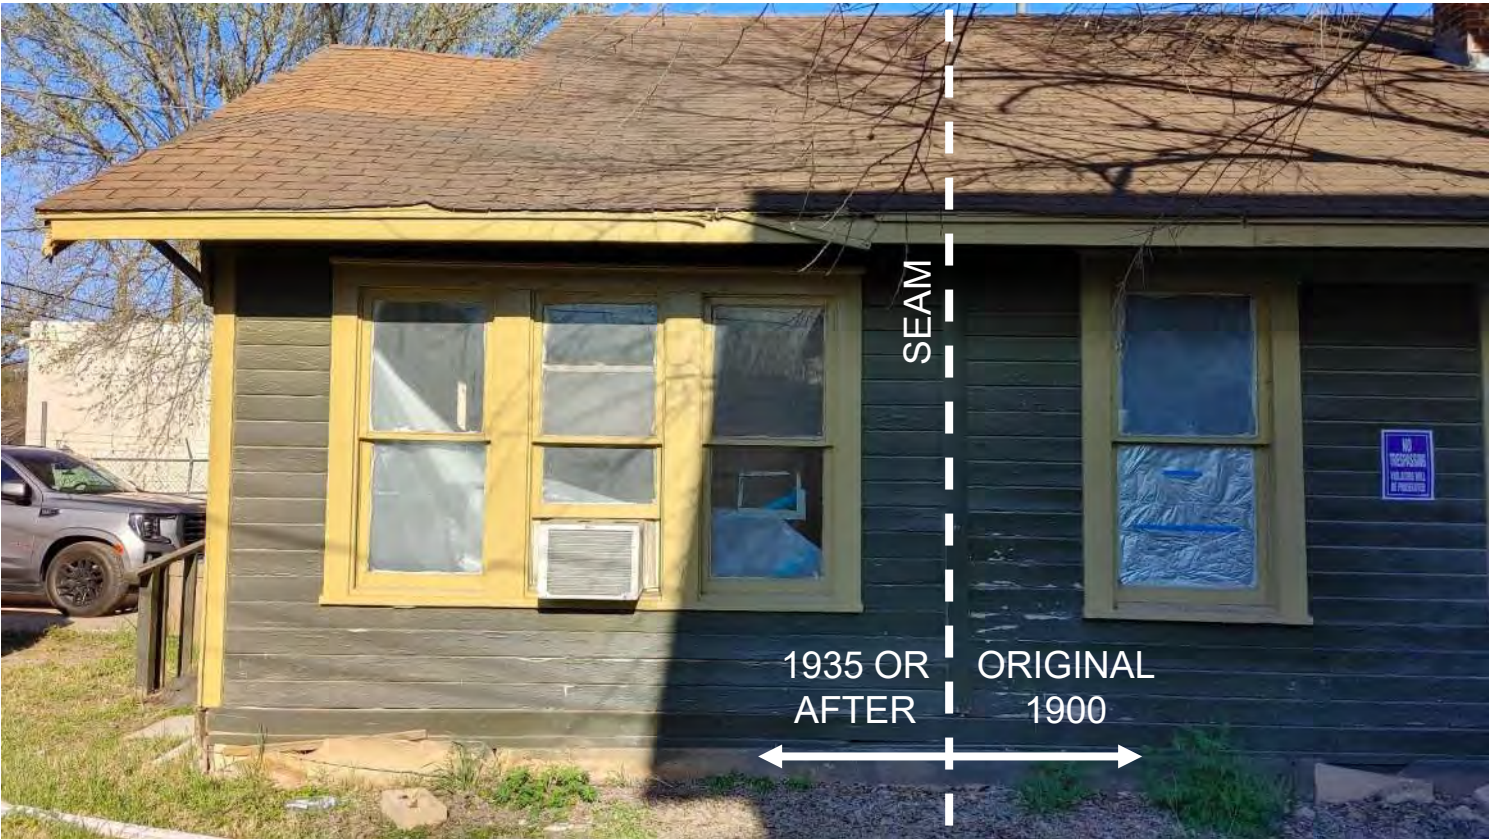
REAR ADDITIONS – VIEW FACING WEST

EXTERIOR SIDING
MISALIGNED ON
EITHER SIDE OF SEAM

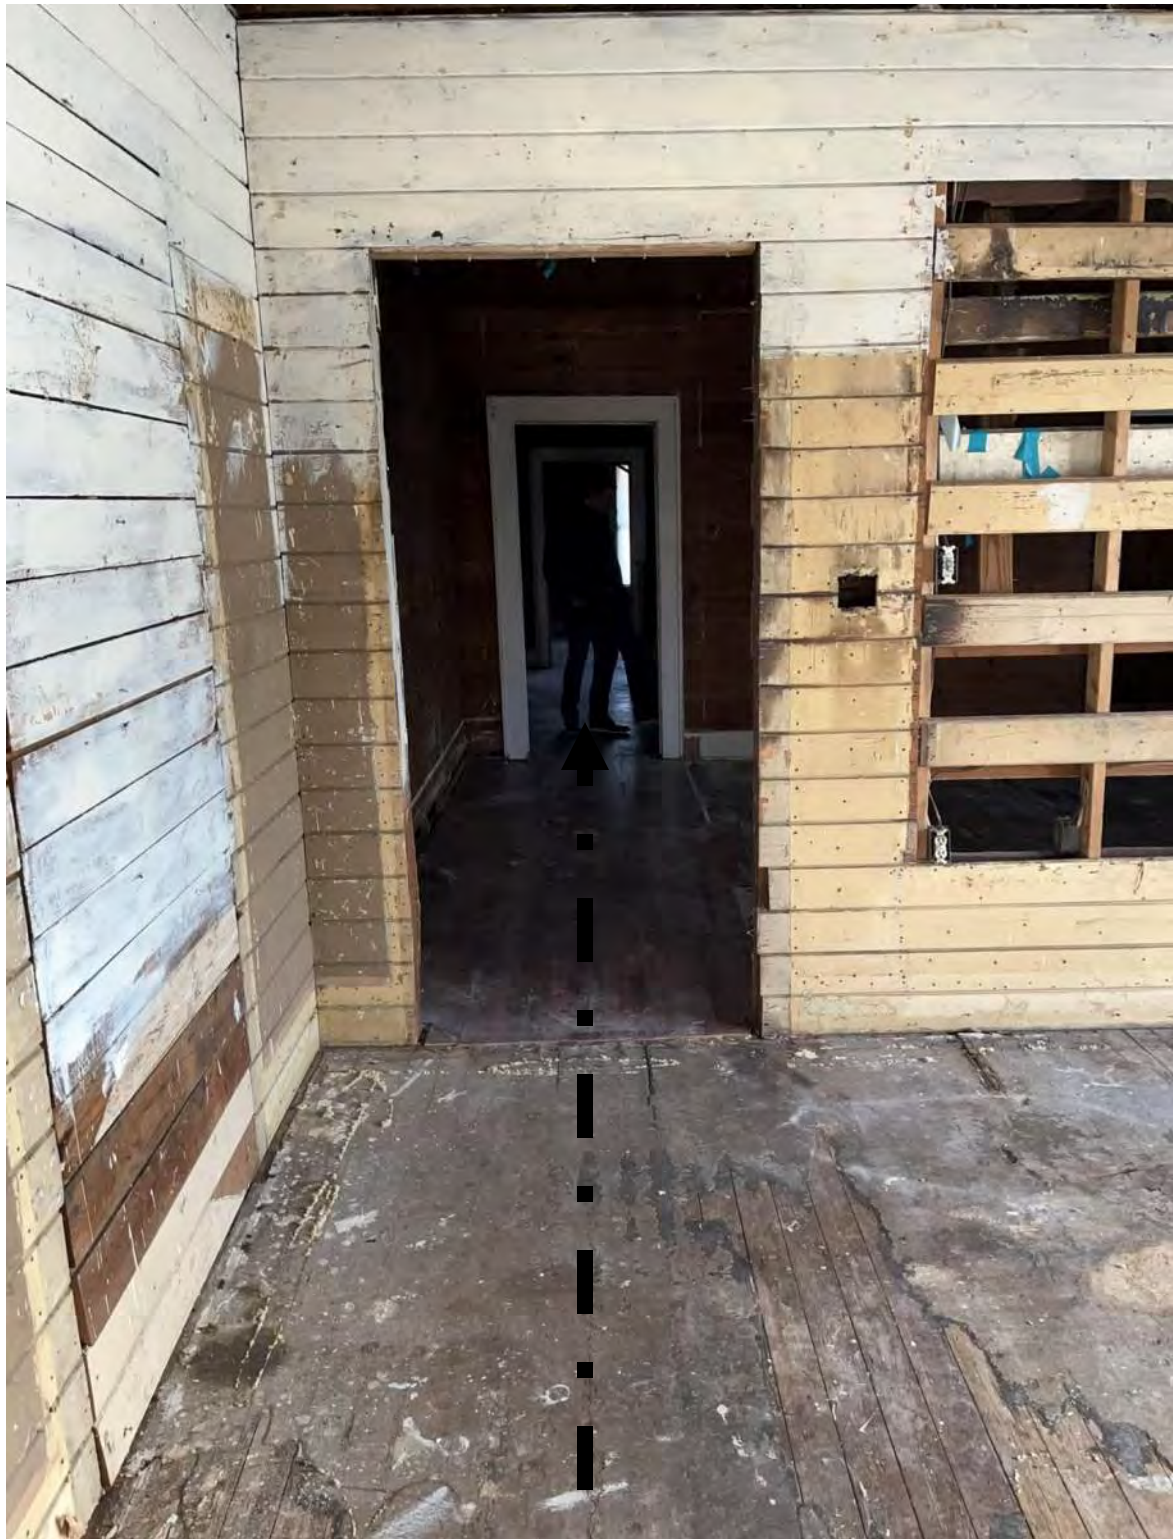
ALIGNMENT OF ORIGINAL 1900 DOORWAYS

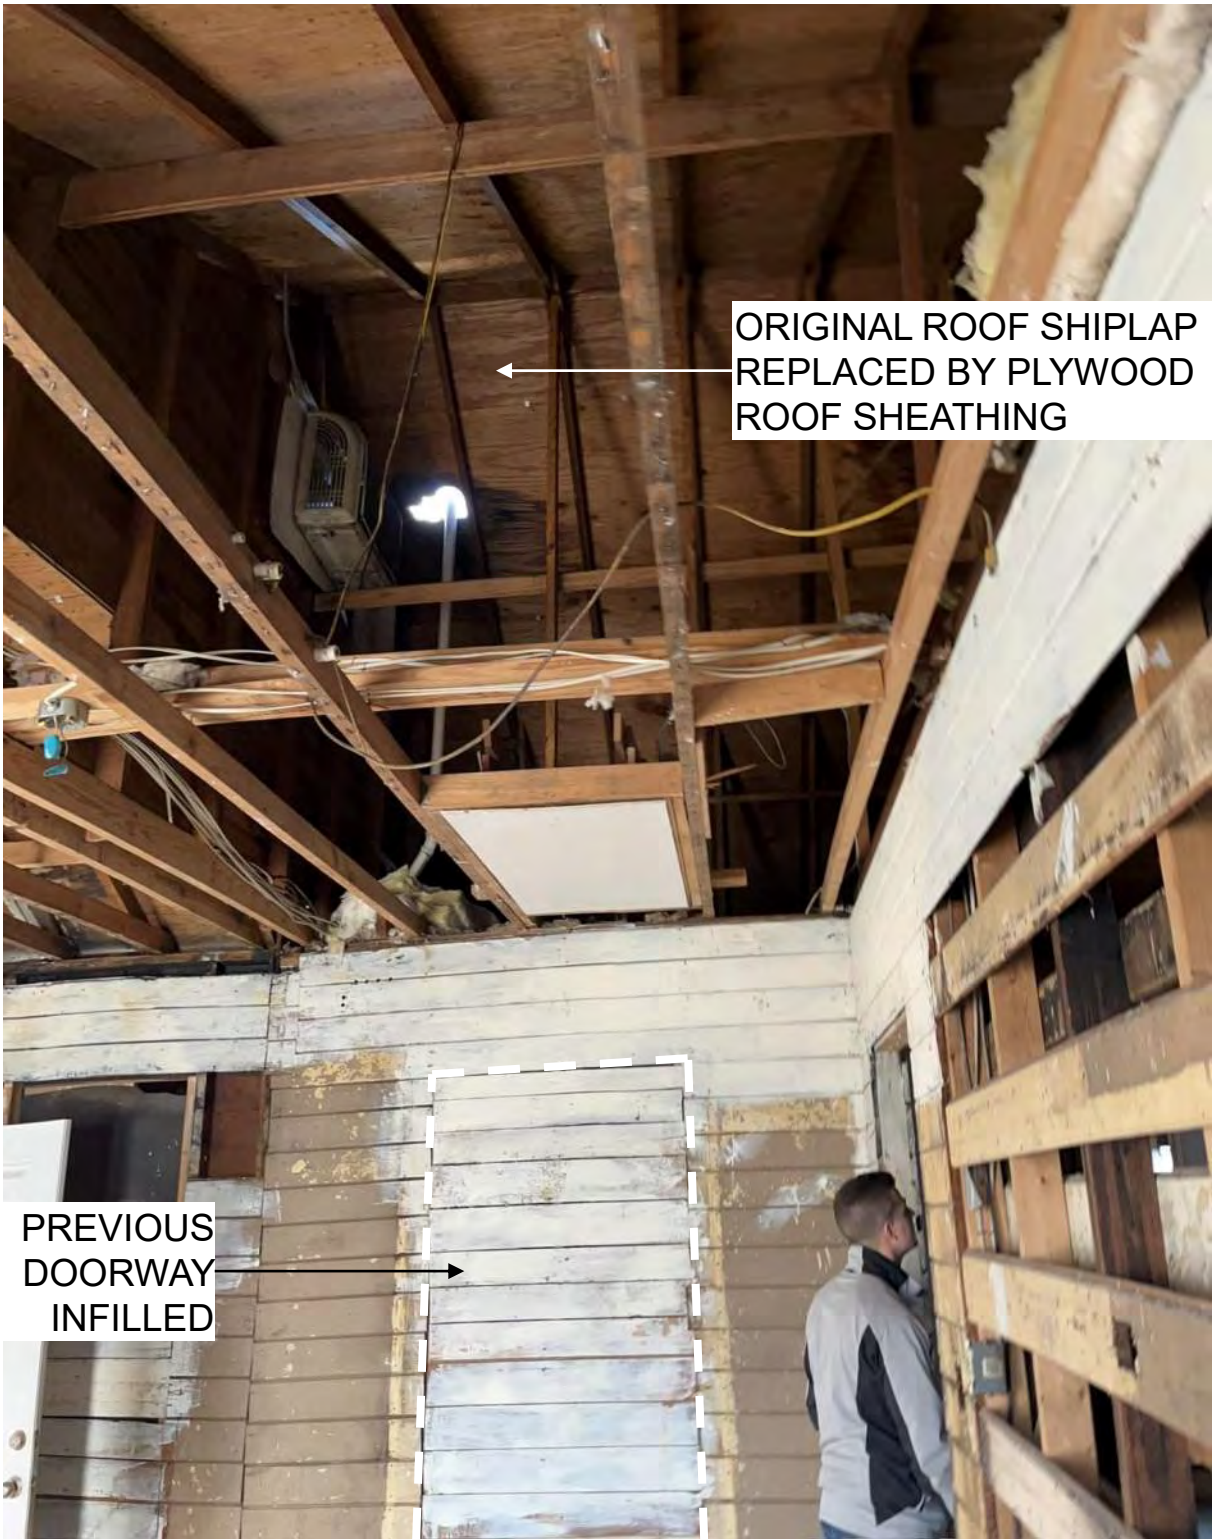
ORIGINAL BACK PORCH ABSORBED INTO HOME

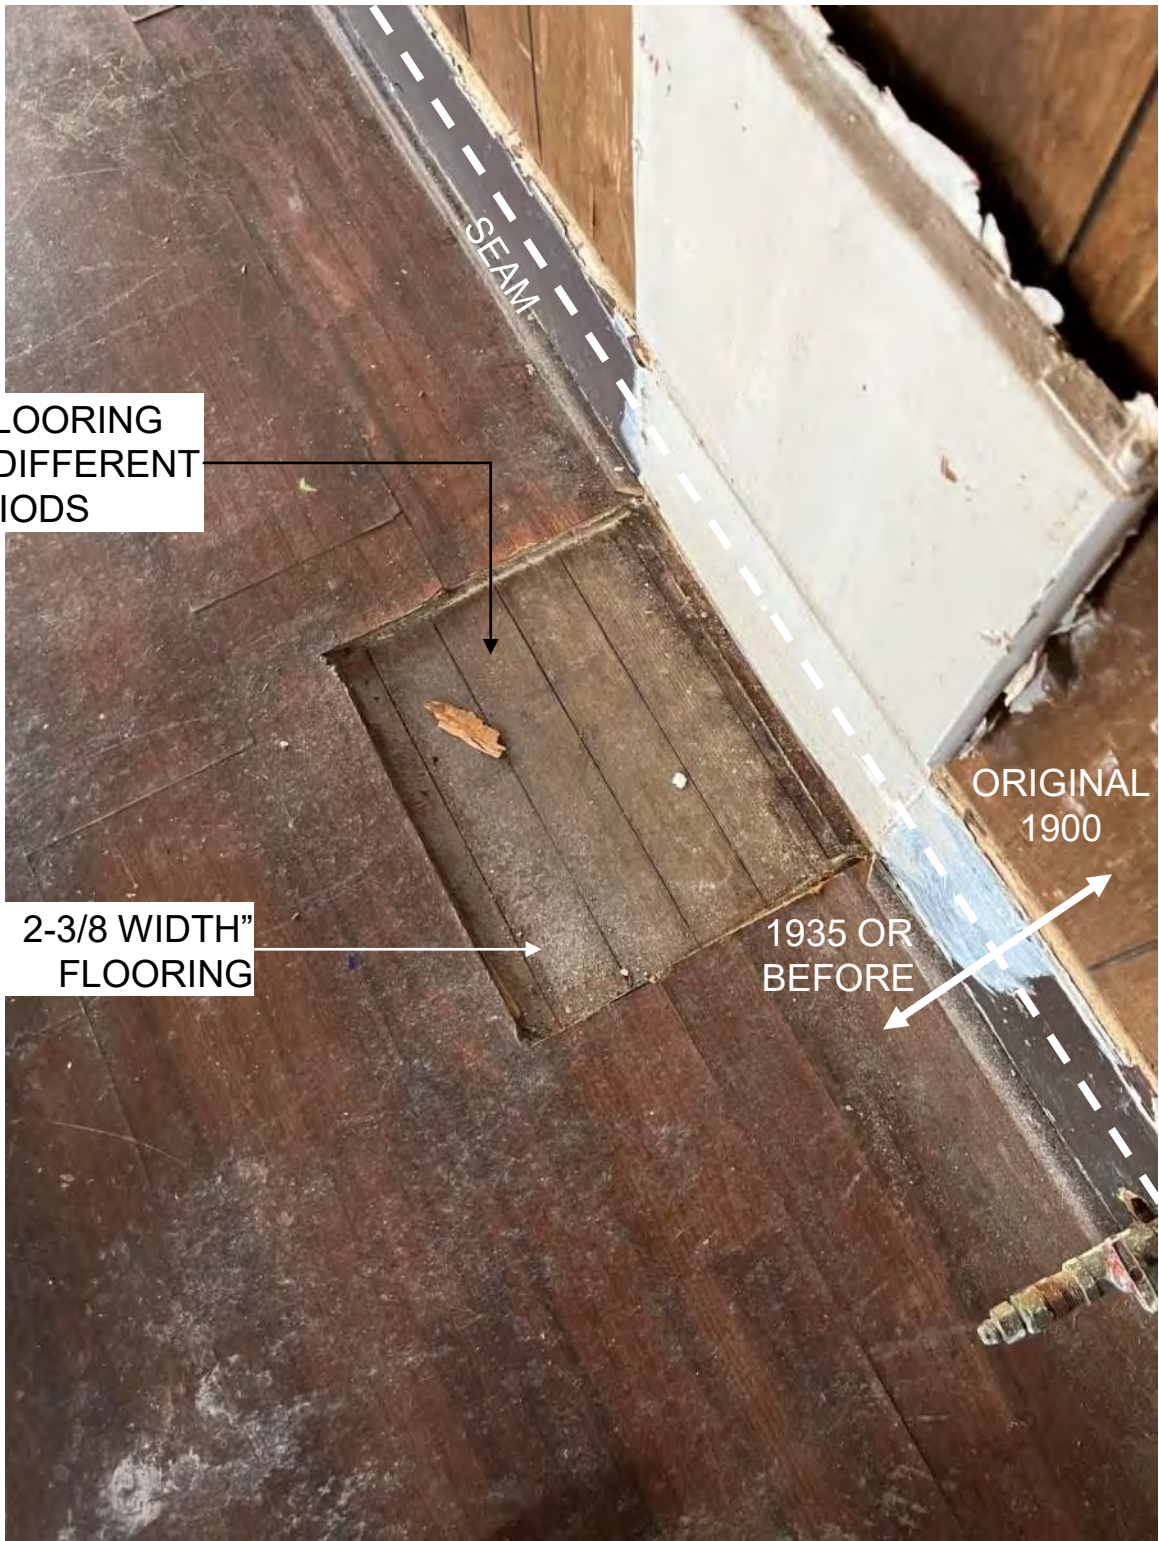
SIDE ADDITION FLOORING

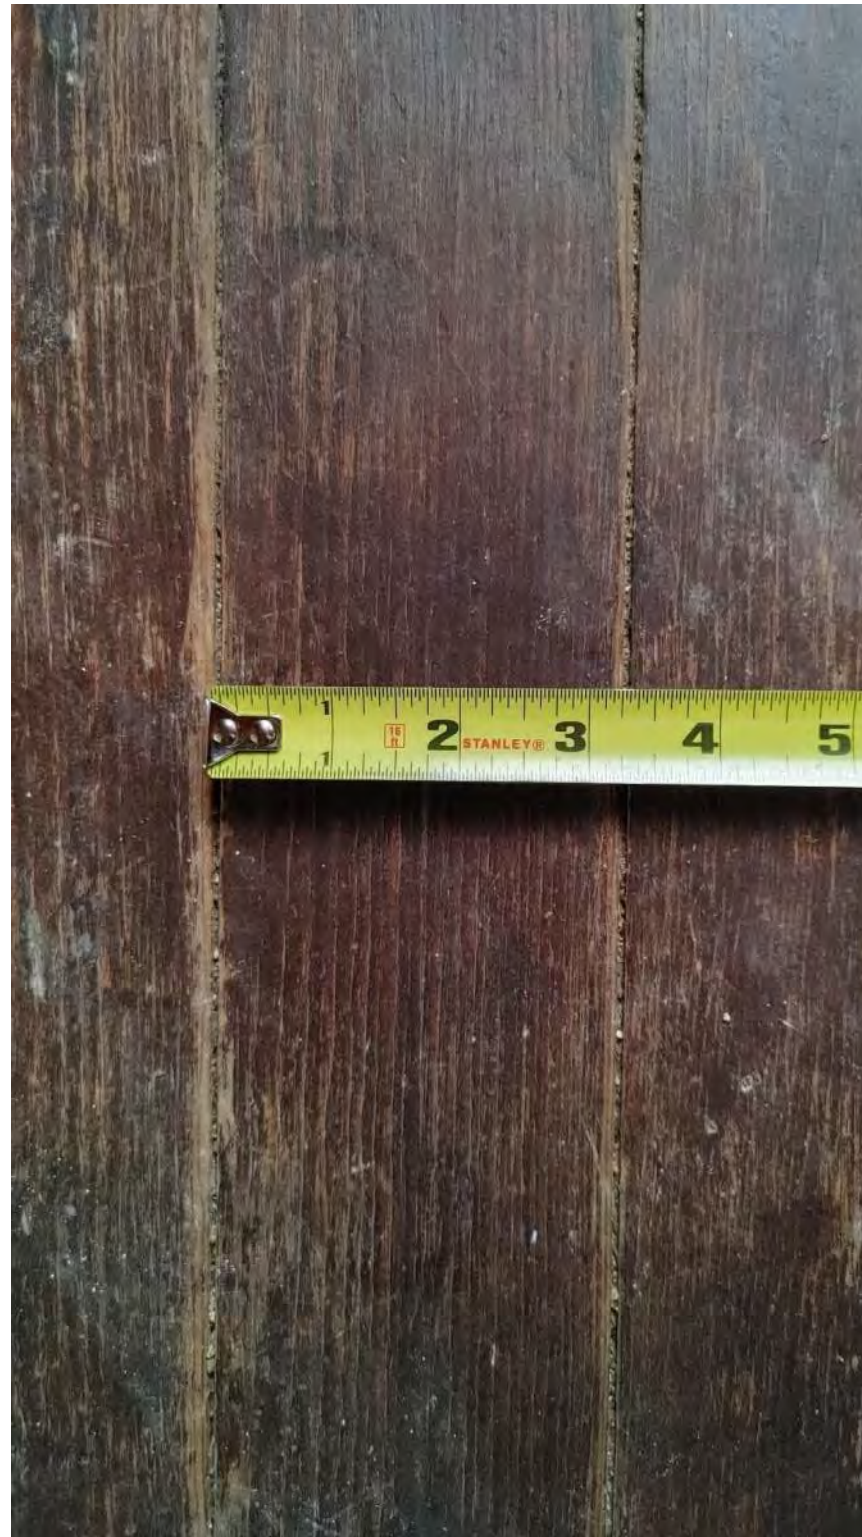
ORIGINAL 3-1/4" WIDTH FLOORING

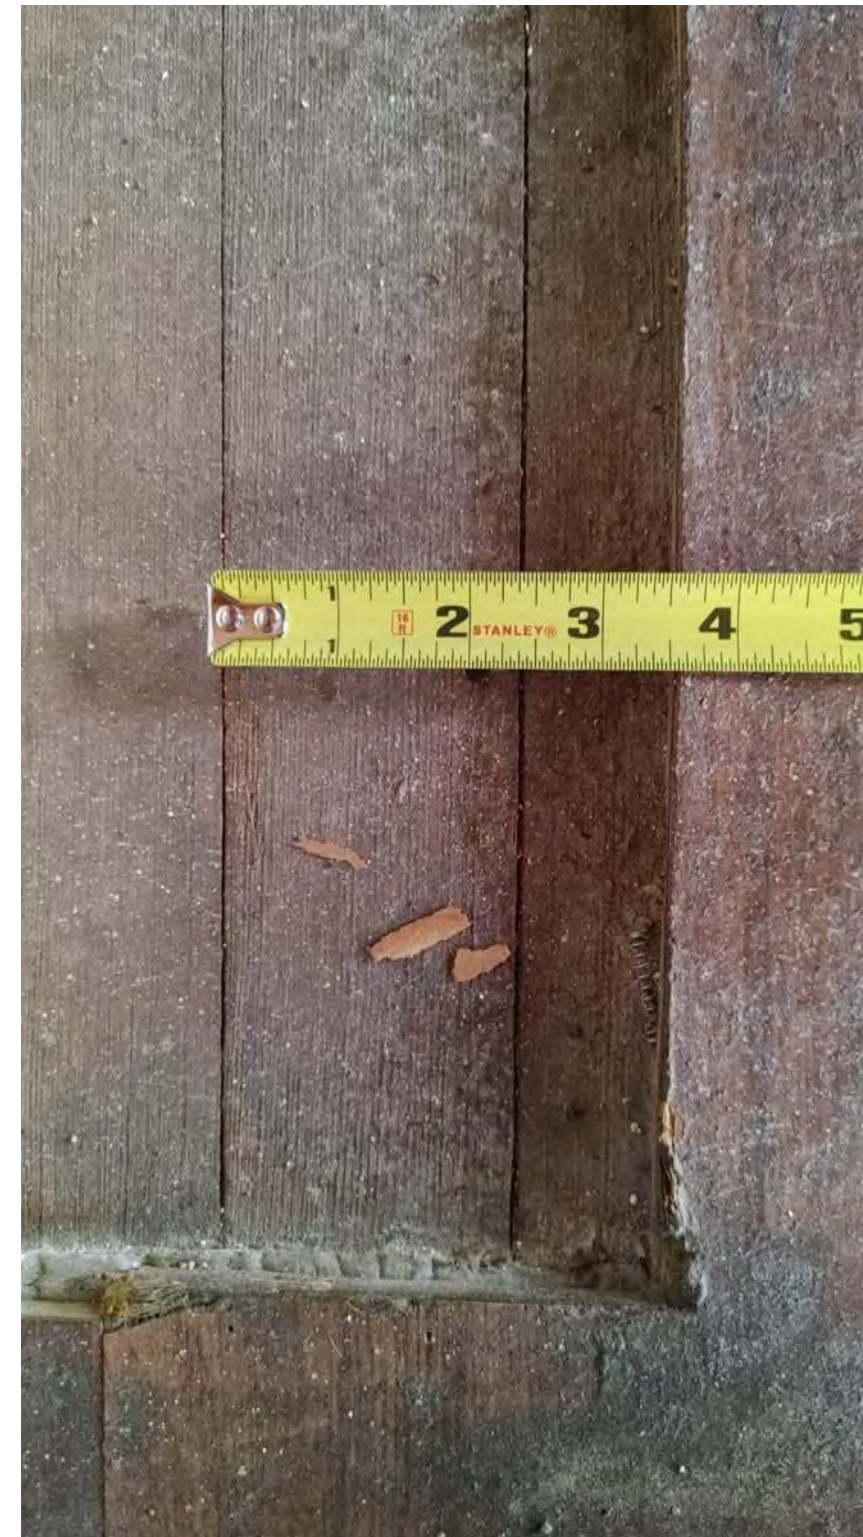
SIDE ADDITION 2-3/8" WIDTH FLOORING

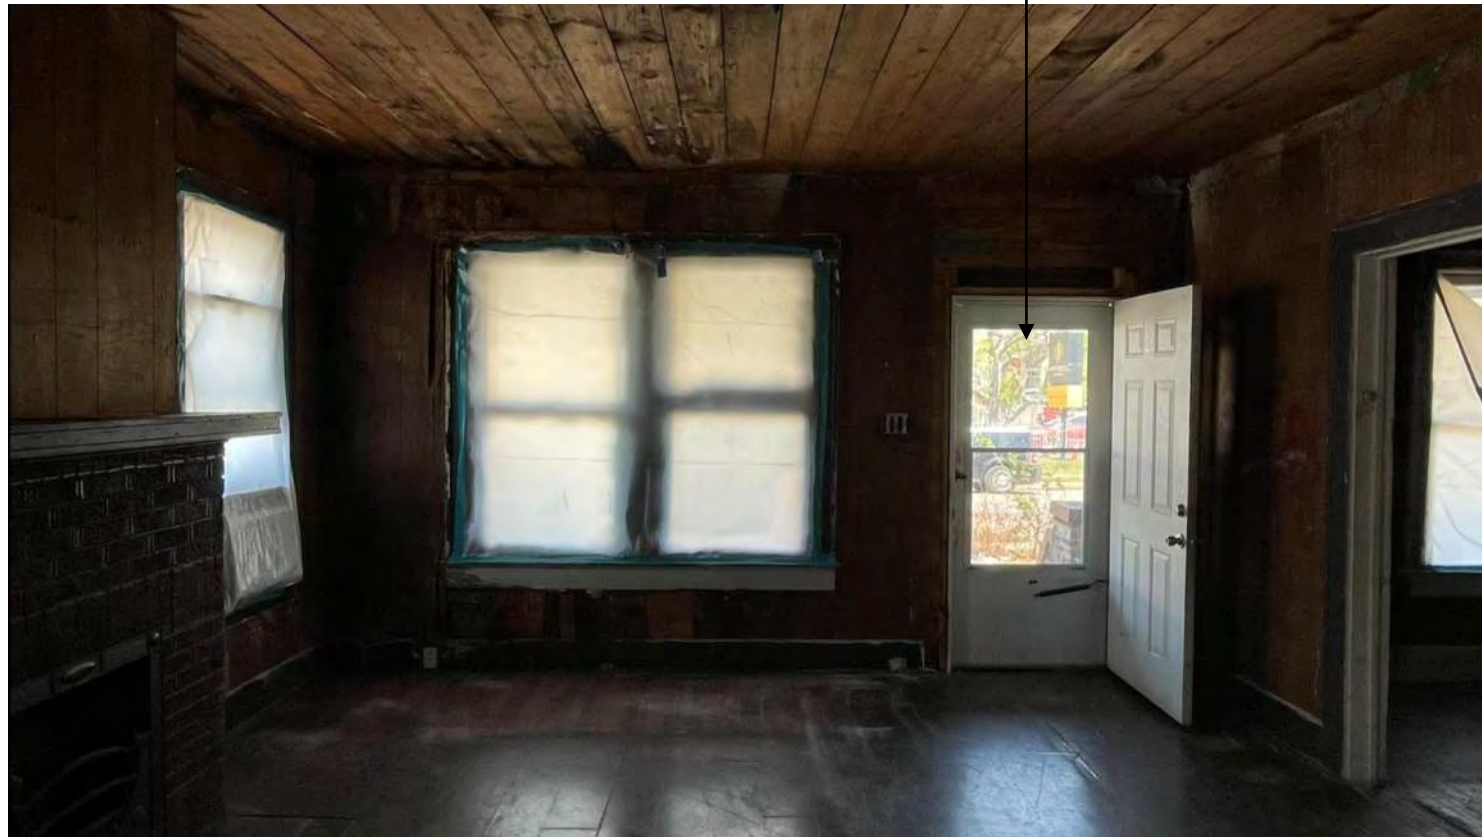
SIDE ADDITION FRONT ROOM – VIEW FACING NORTH

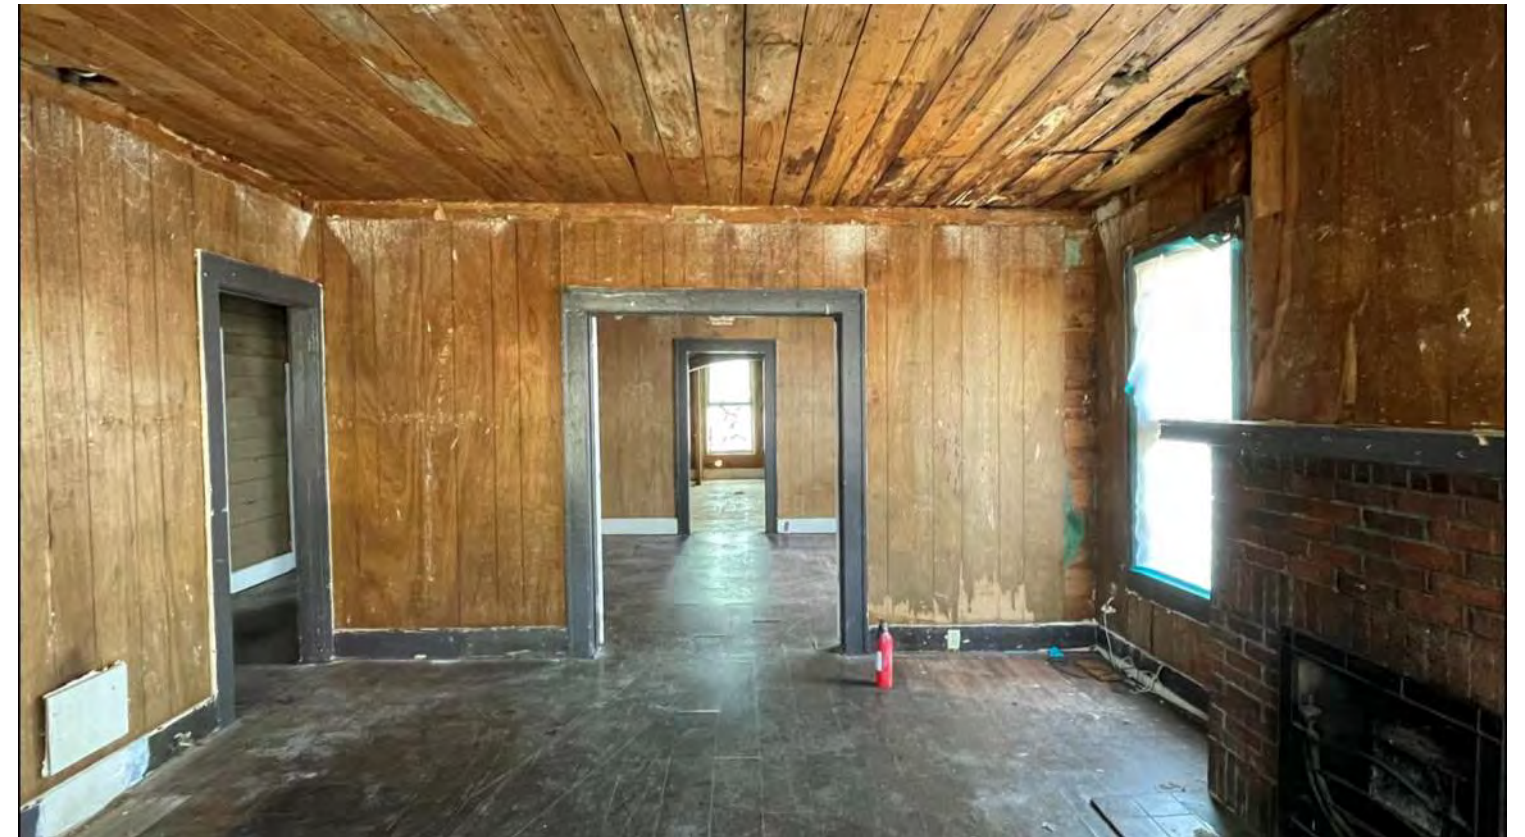
SIDE ADDITION FRONT ROOM – VIEW FACING SOUTH

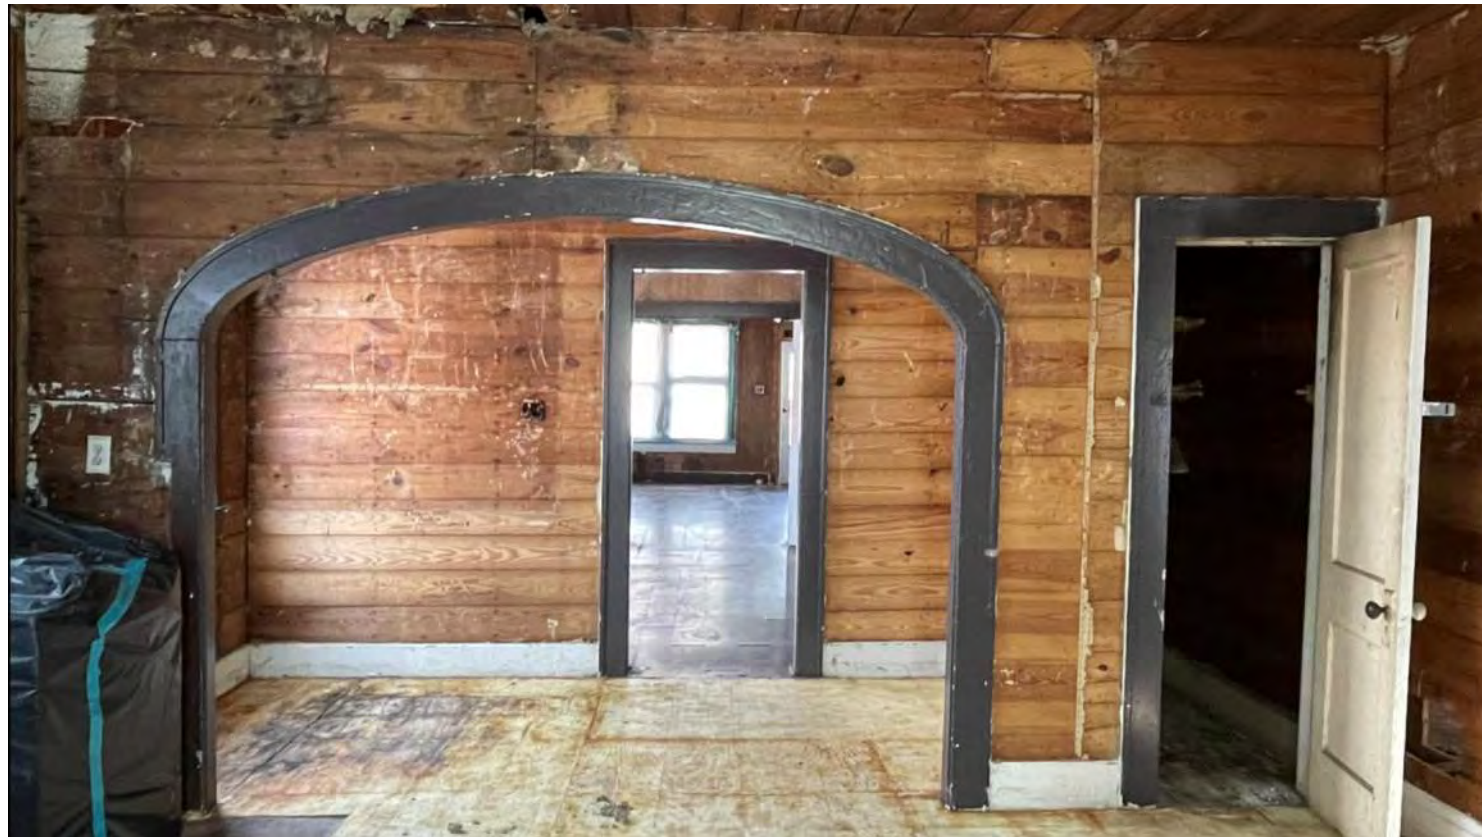
SIDE ADDITION BACK ROOM / KITCHEN – VIEW FACING NORTH

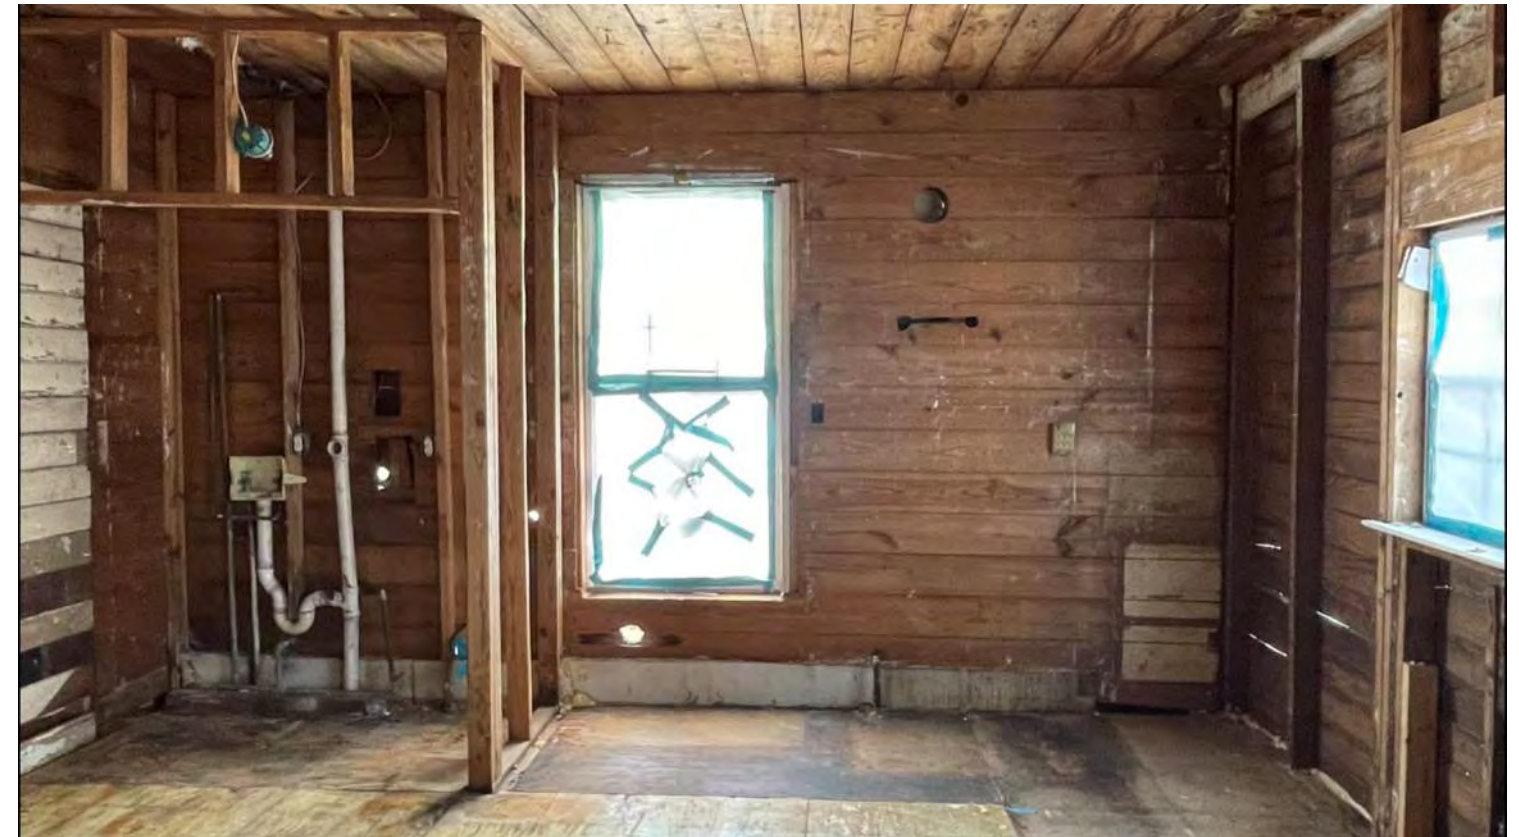
SIDE ADDITION BACK ROOM / KITCHEN – VIEW FACING SOUTH

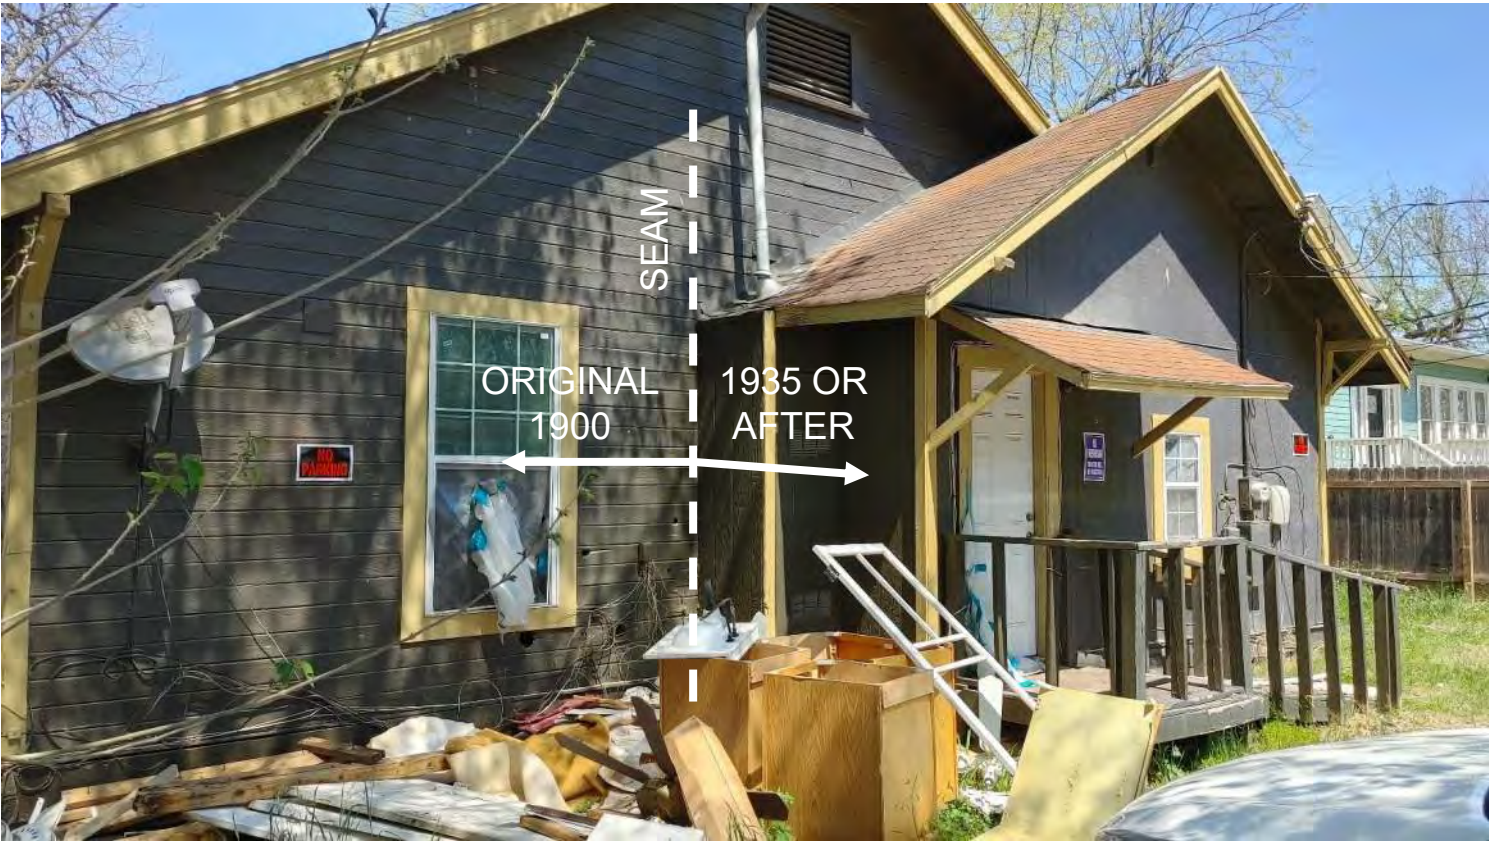
REAR EXTERIOR FAÇADE – VIEW FACING NORTHEAST

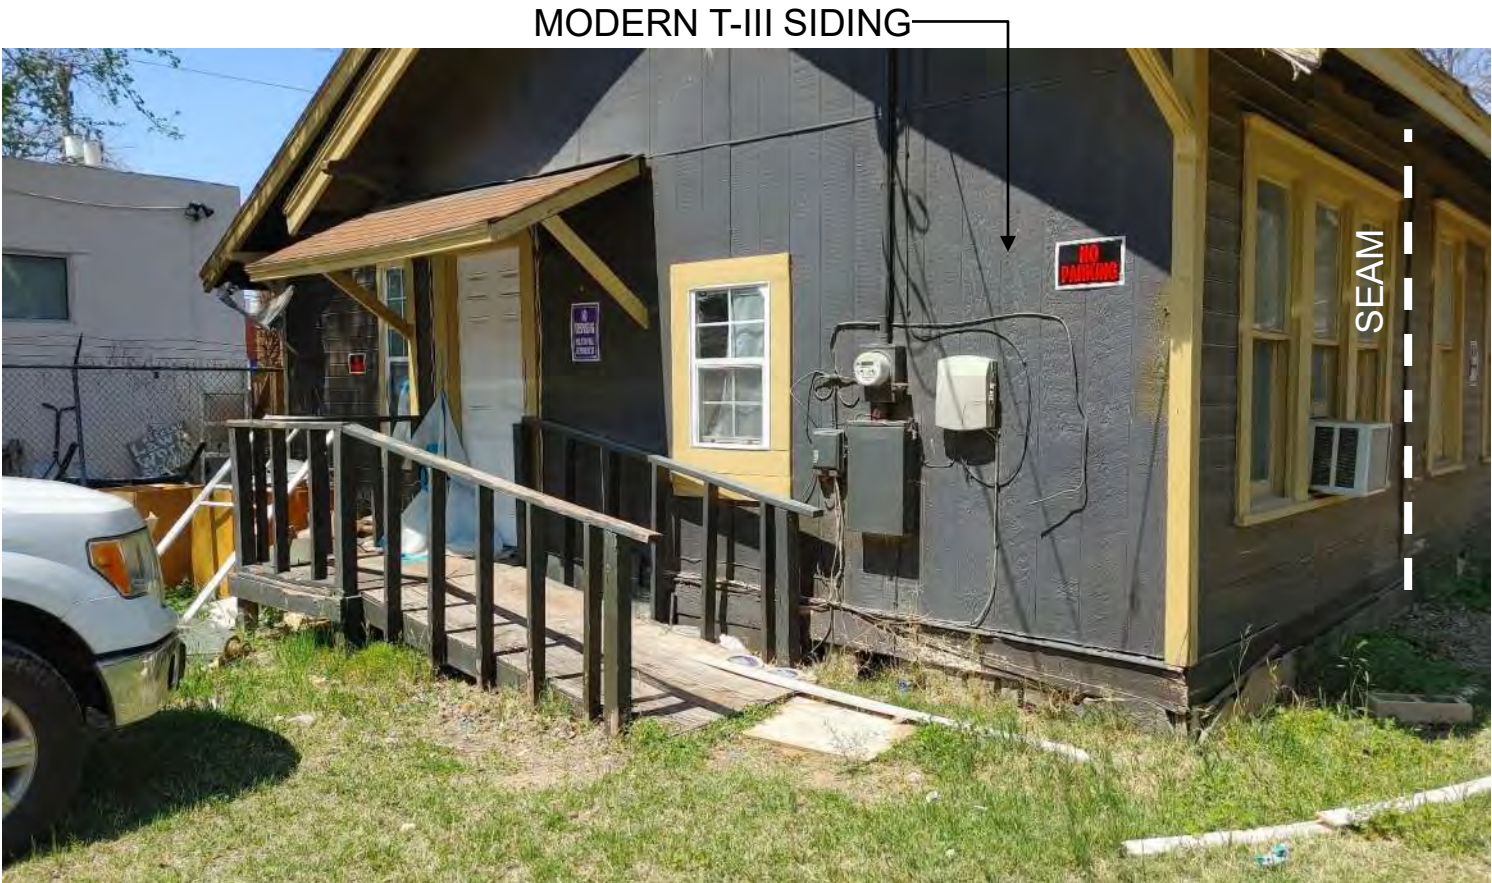
REAR EXTERIOR FAÇADE – VIEW FACING NORTHWEST
