Analysis of Existing Building at
1403 EAST CESAR CHAVEZ STREET
Historic Landmark Commission Hearing

MAY 04, 2022

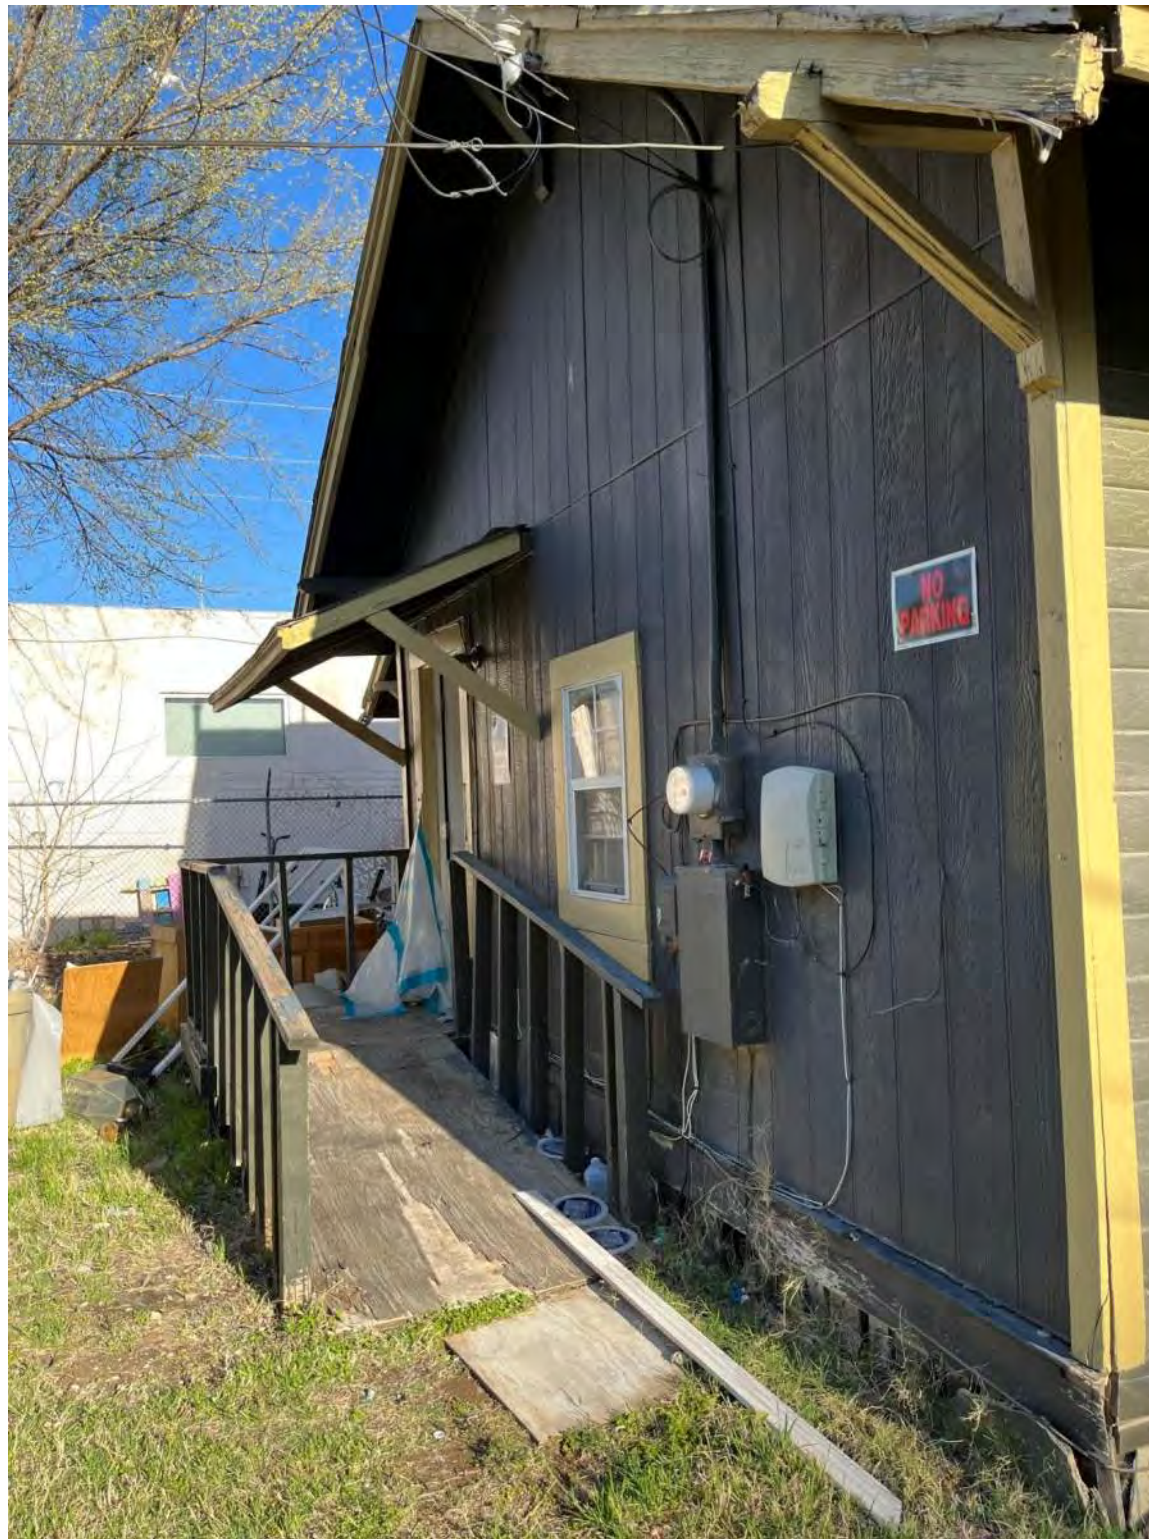
RAMP AT REAR EXTERIOR FAÇADE

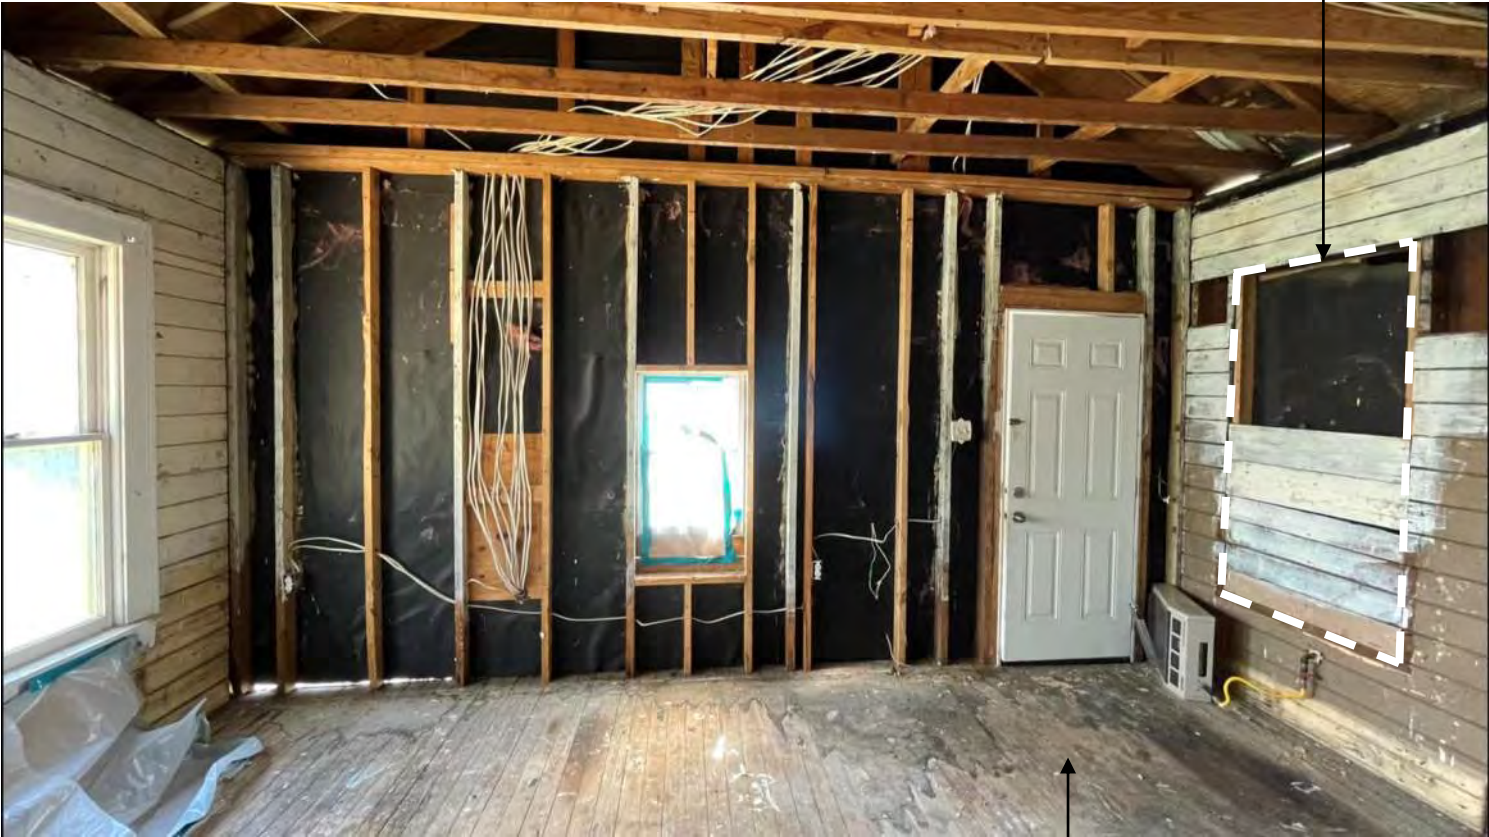
REAR ADDITIONS – VIEW FACING SOUTH

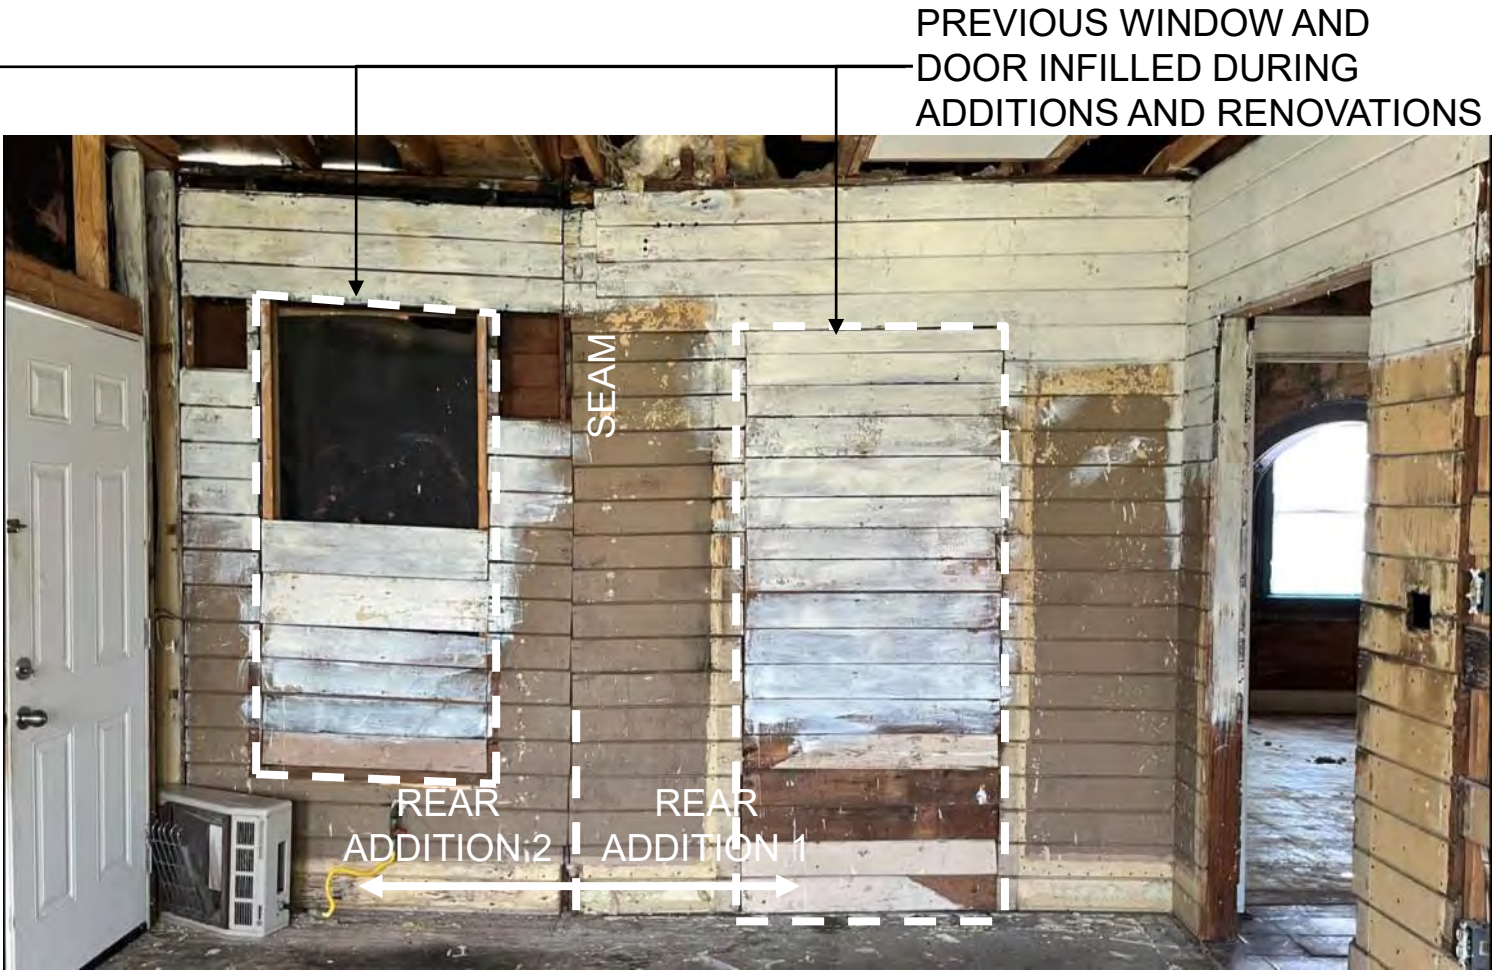
REAR ADDITIONS – VIEW FACING WEST

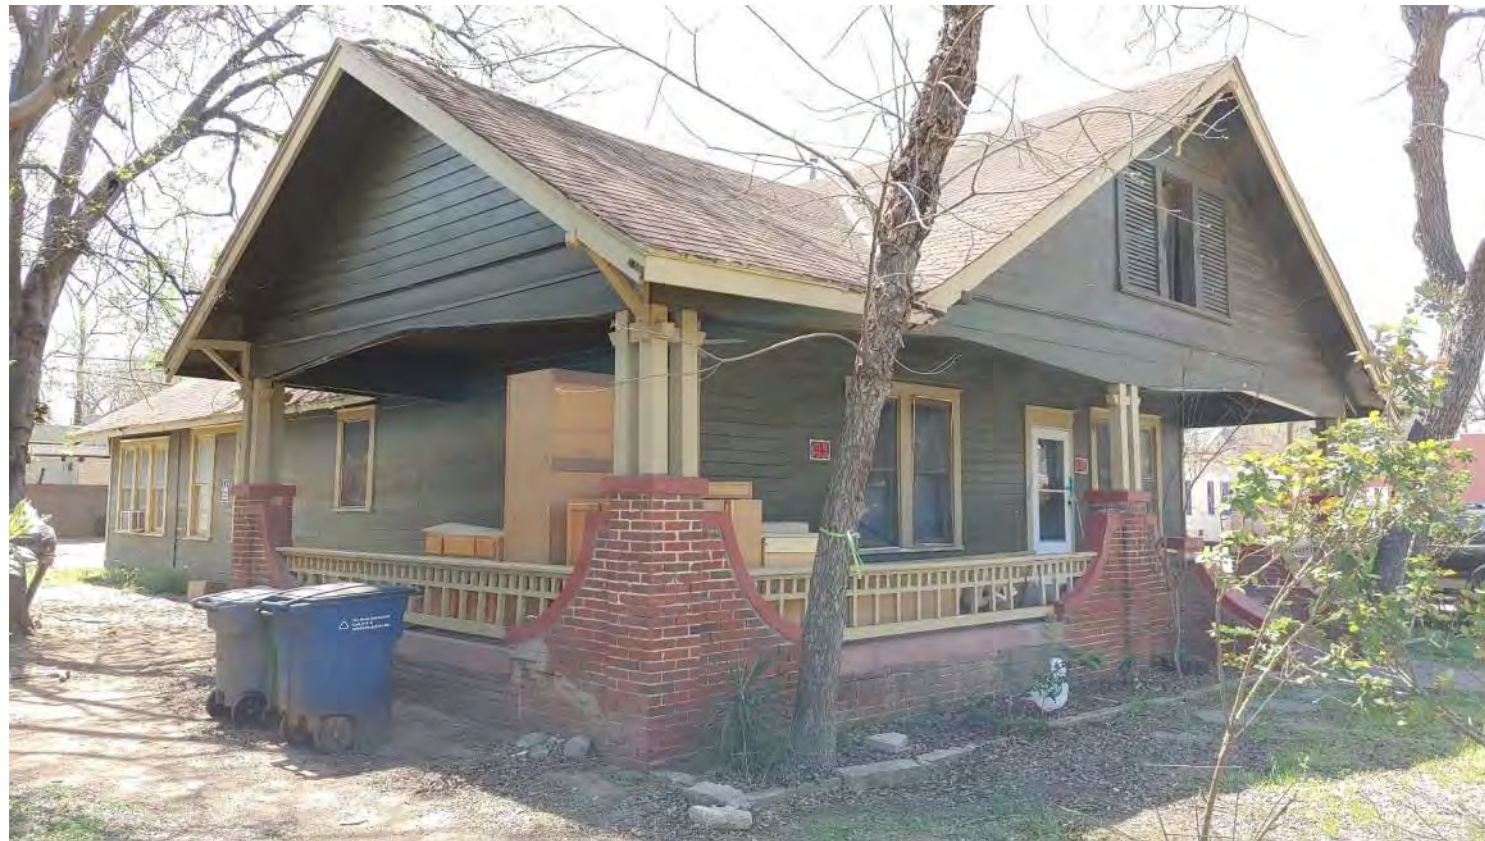
FRONT PORCH ADDITION – VIEW FACING SOUTHWEST

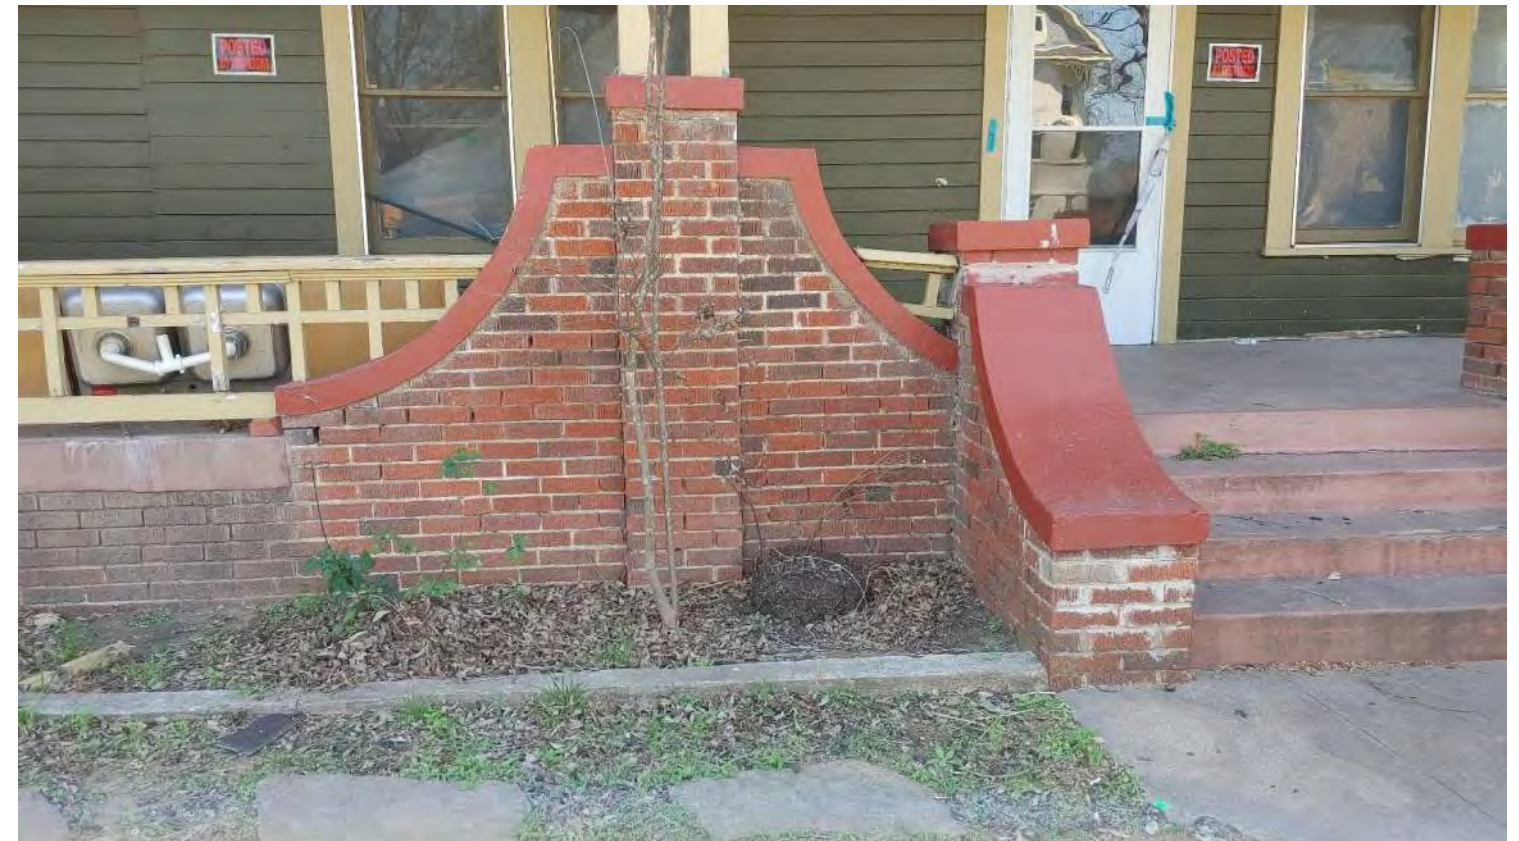
FRONT PORCH DETAIL – VIEW FACING SOUTH

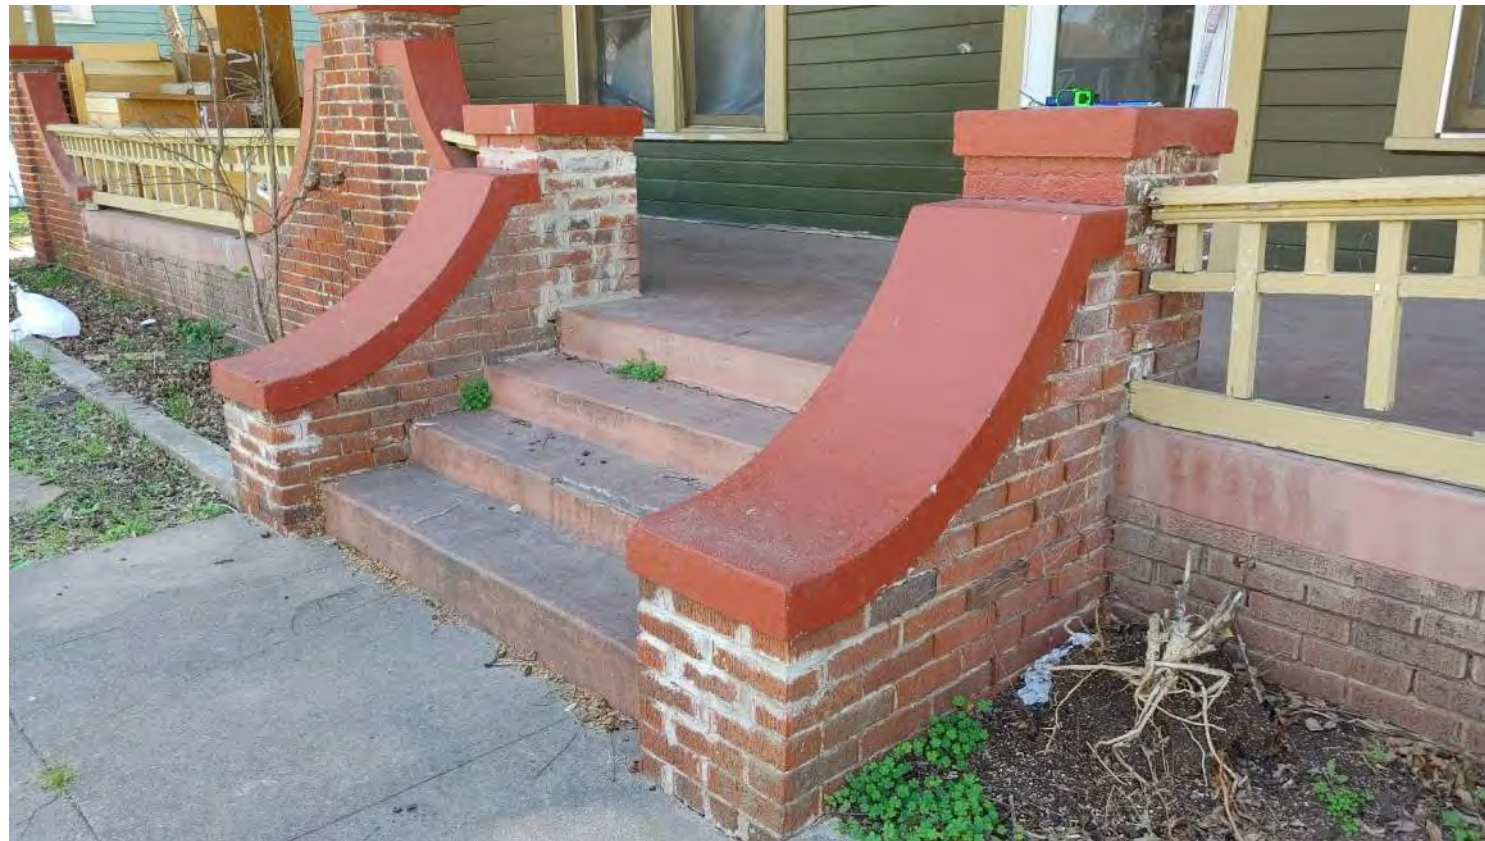
FRONT PORCH STEPS – VIEW FACING SOUTHEAST

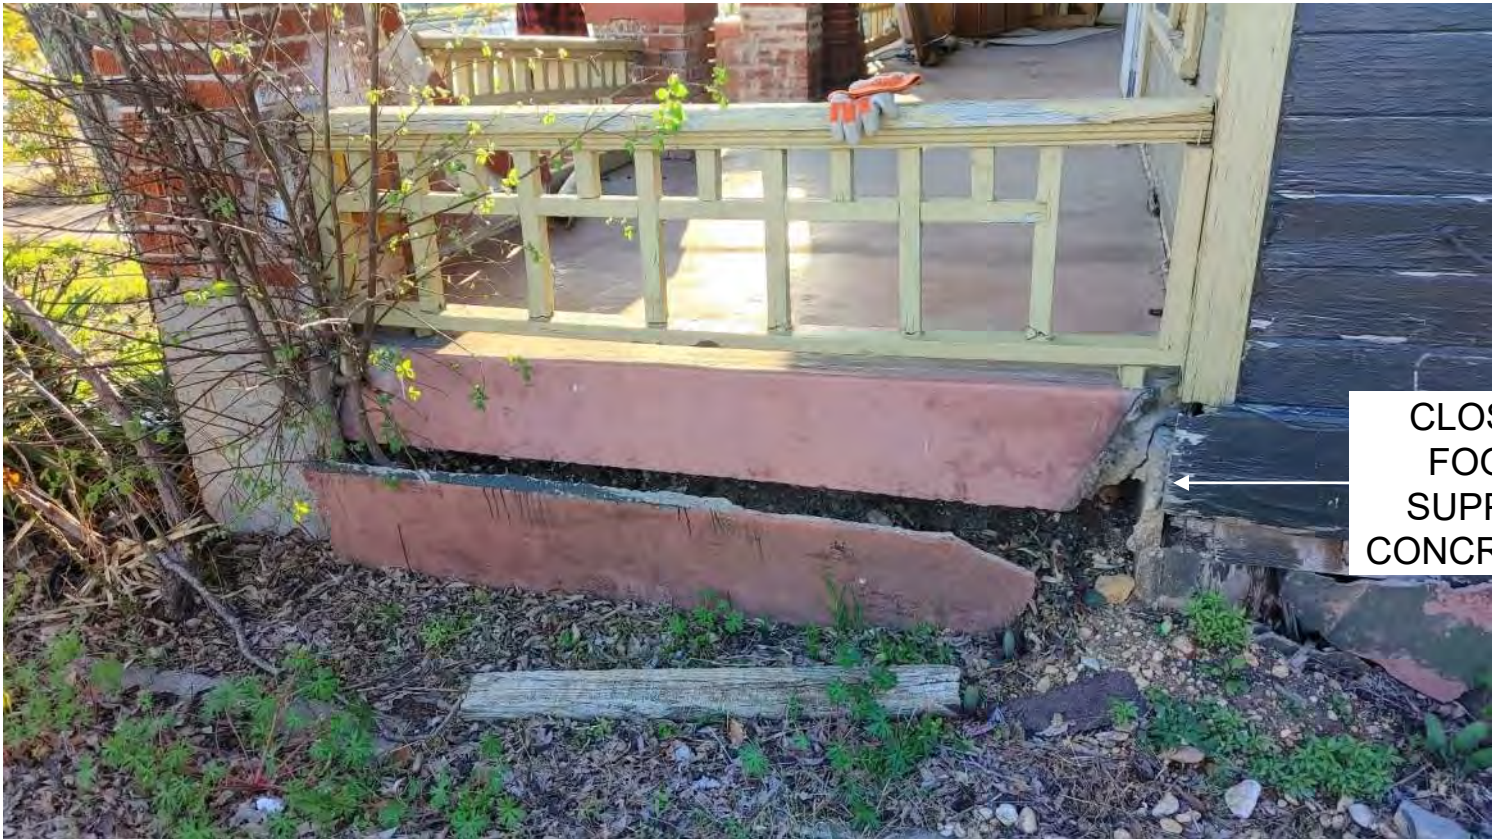
FRONT PORCH ADDITION – VIEW FACING EAST

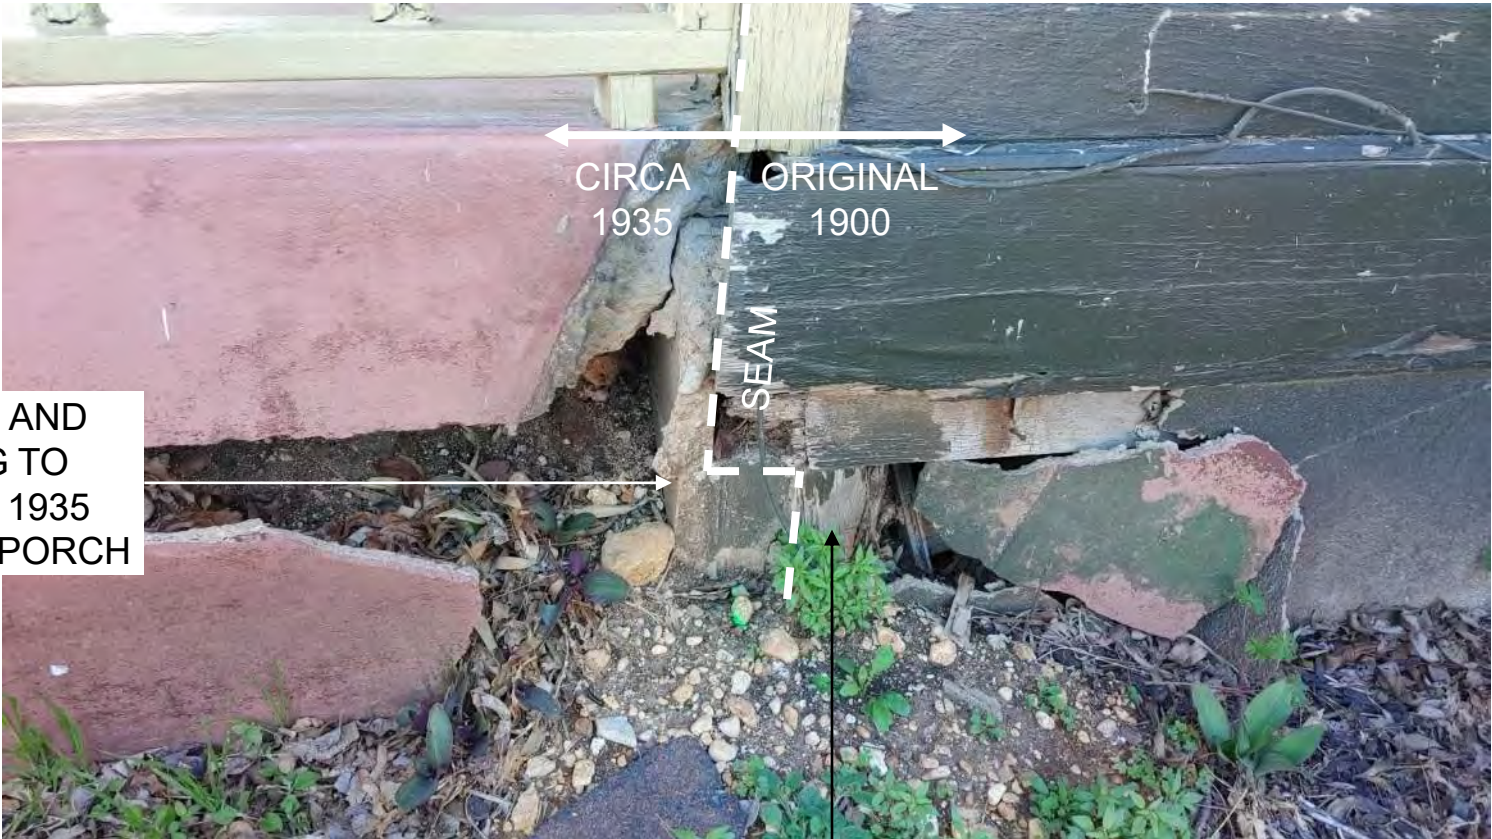
ENLARGED VIEW OF FRONT PORCH SEAM

The front porch is concrete with brick pilasters and partial walls. We suspect this may have been added later in the life of this house. The connection of the concrete porch slab to the house appears to have integrity issue. The projecting area at the rear of the house has a more recent made plywood siding indicating that some portion of the house may have been added later. The two large trees in front and one on the east side are located too close to the house. As a result, the roots have probably spread under the brick foundation pad and has caused severe movement.

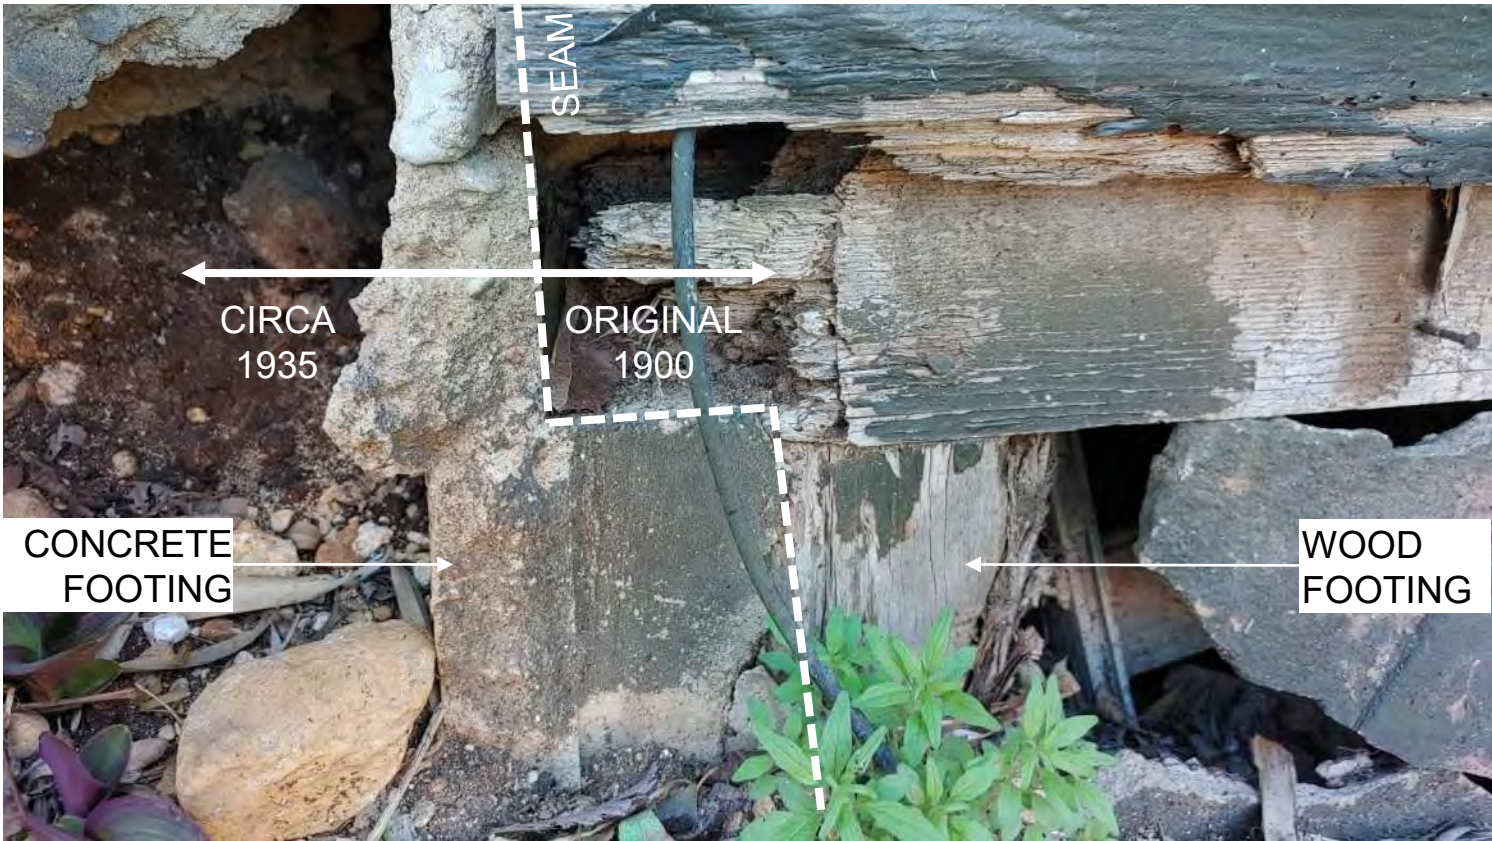
ENLARGED VIEW OF FRONT PORCH SEAM

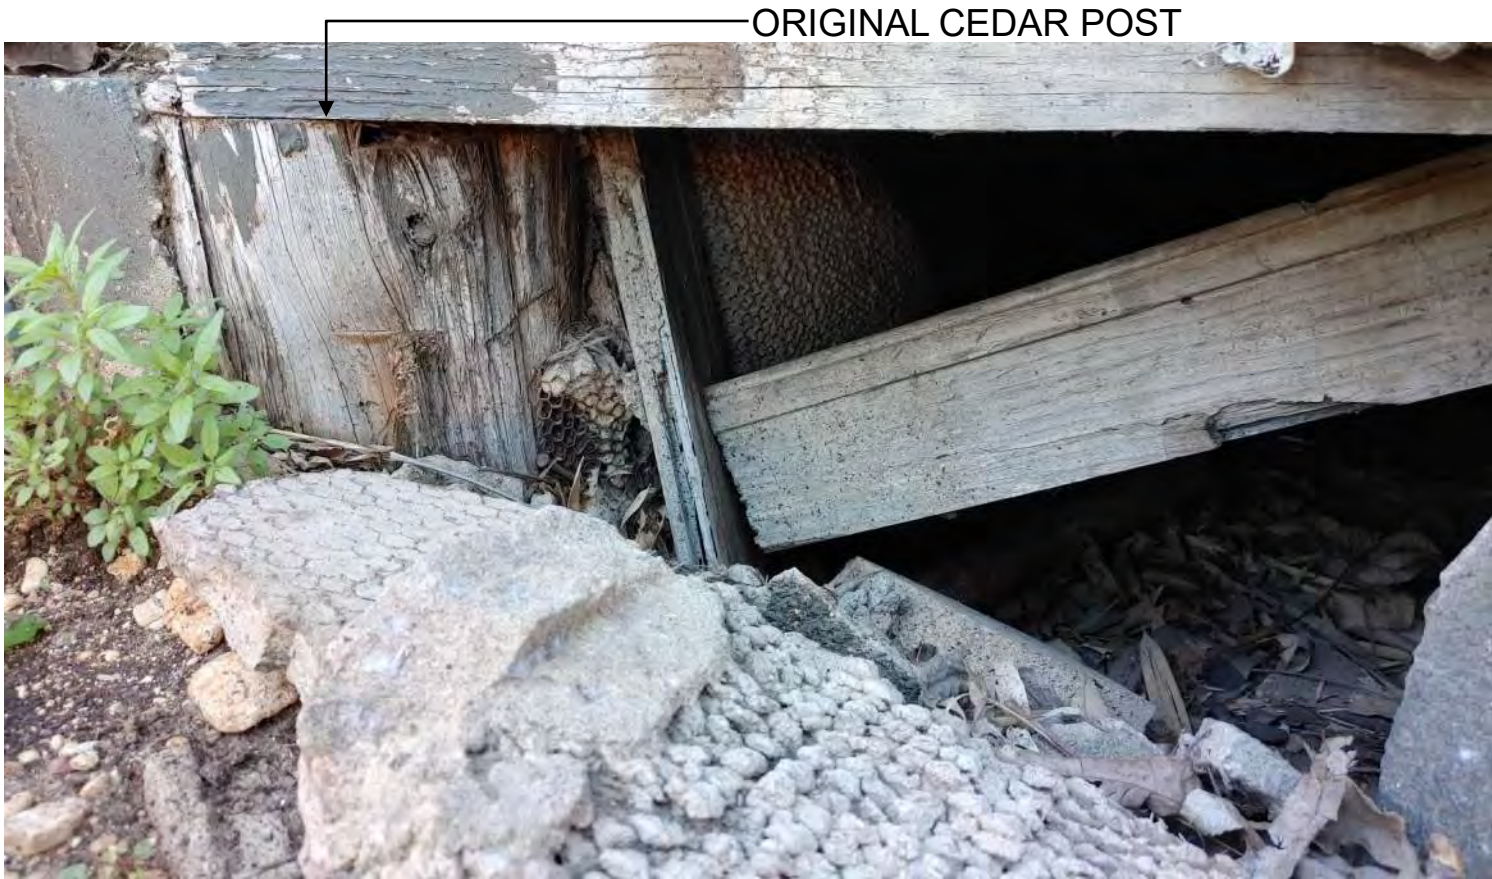
ENLARGED VIEW OF FRONT PORCH SEAM

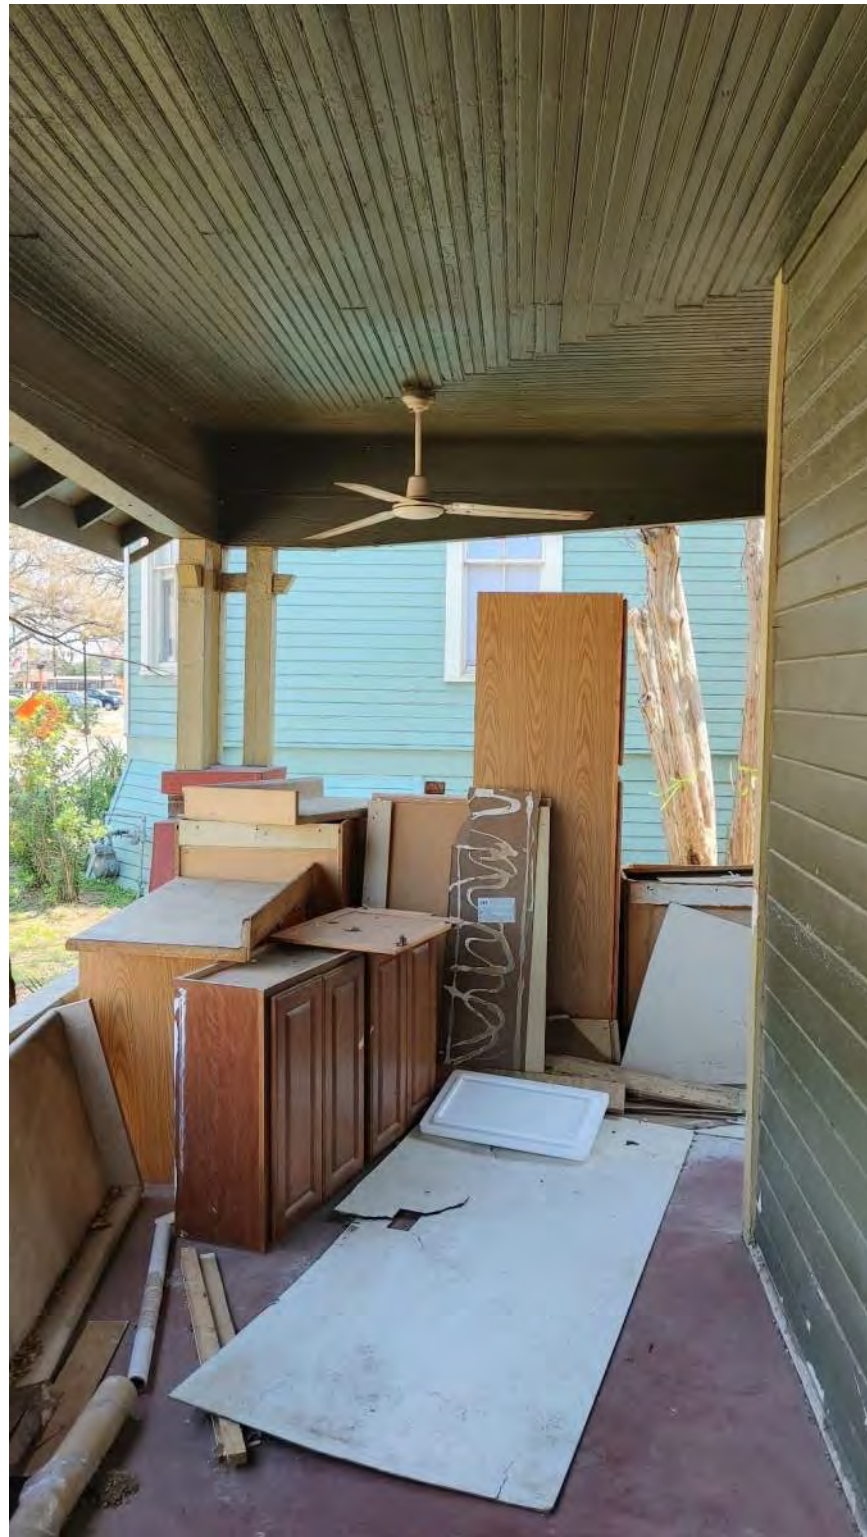
FRONT PORCH – VIEW FACING EAST

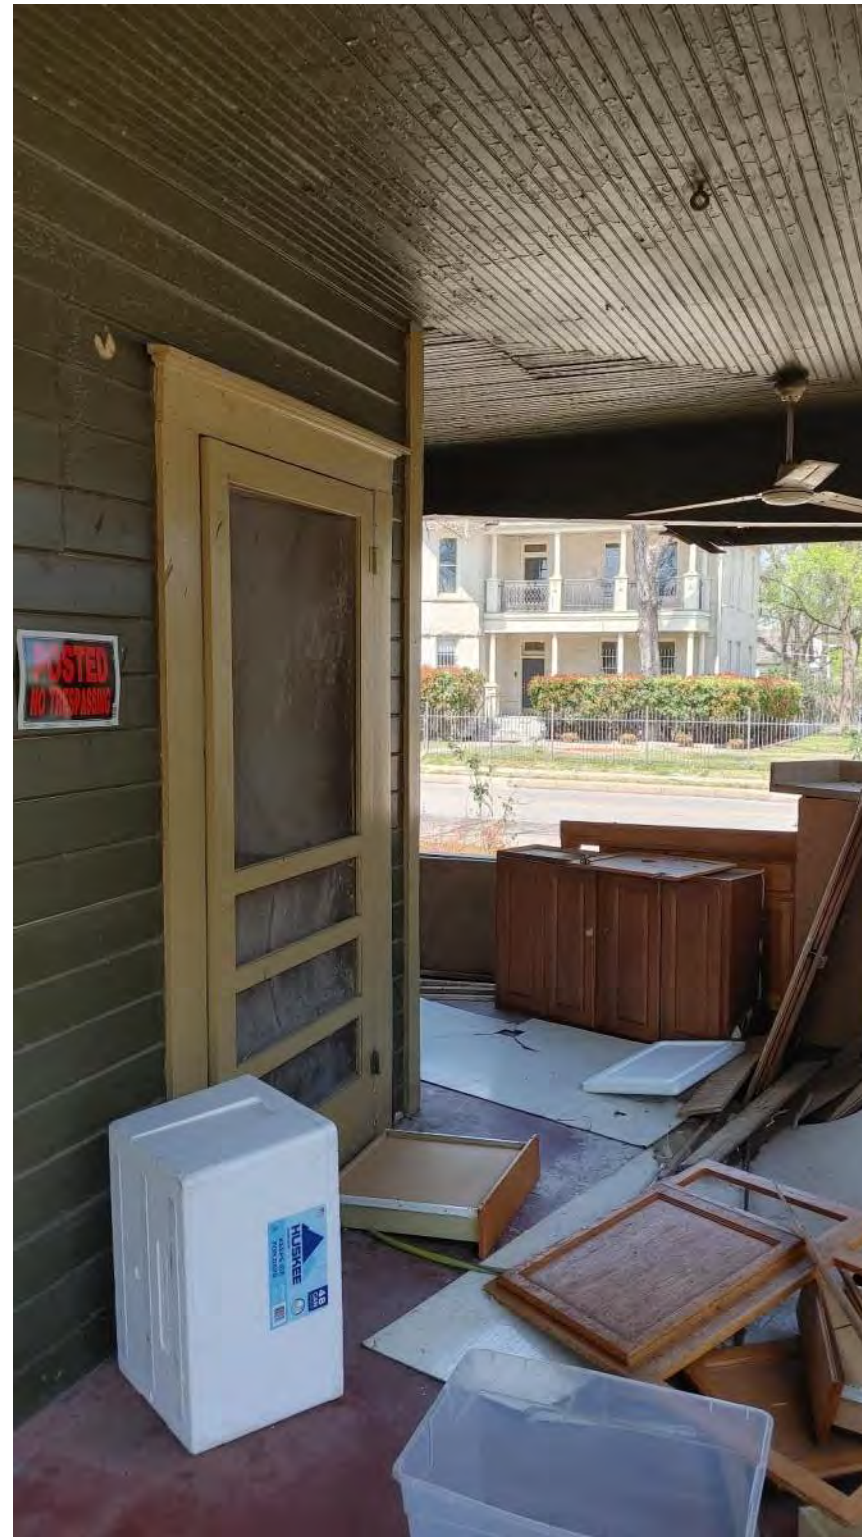
FRONT PORCH – VIEW FACING NORTH

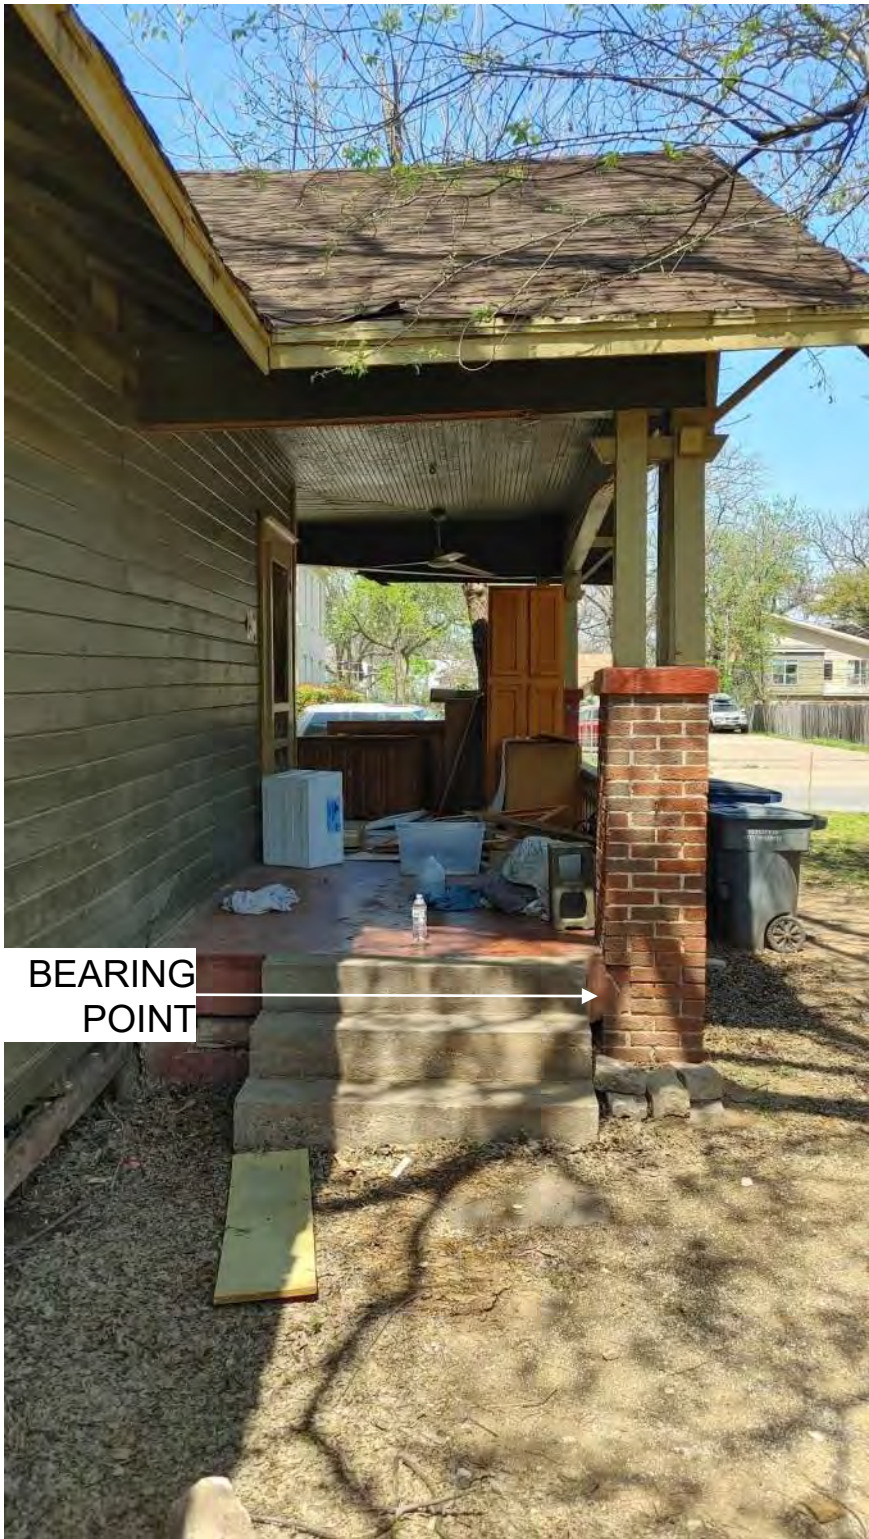
FRONT PORCH – VIEW FACING NORTH

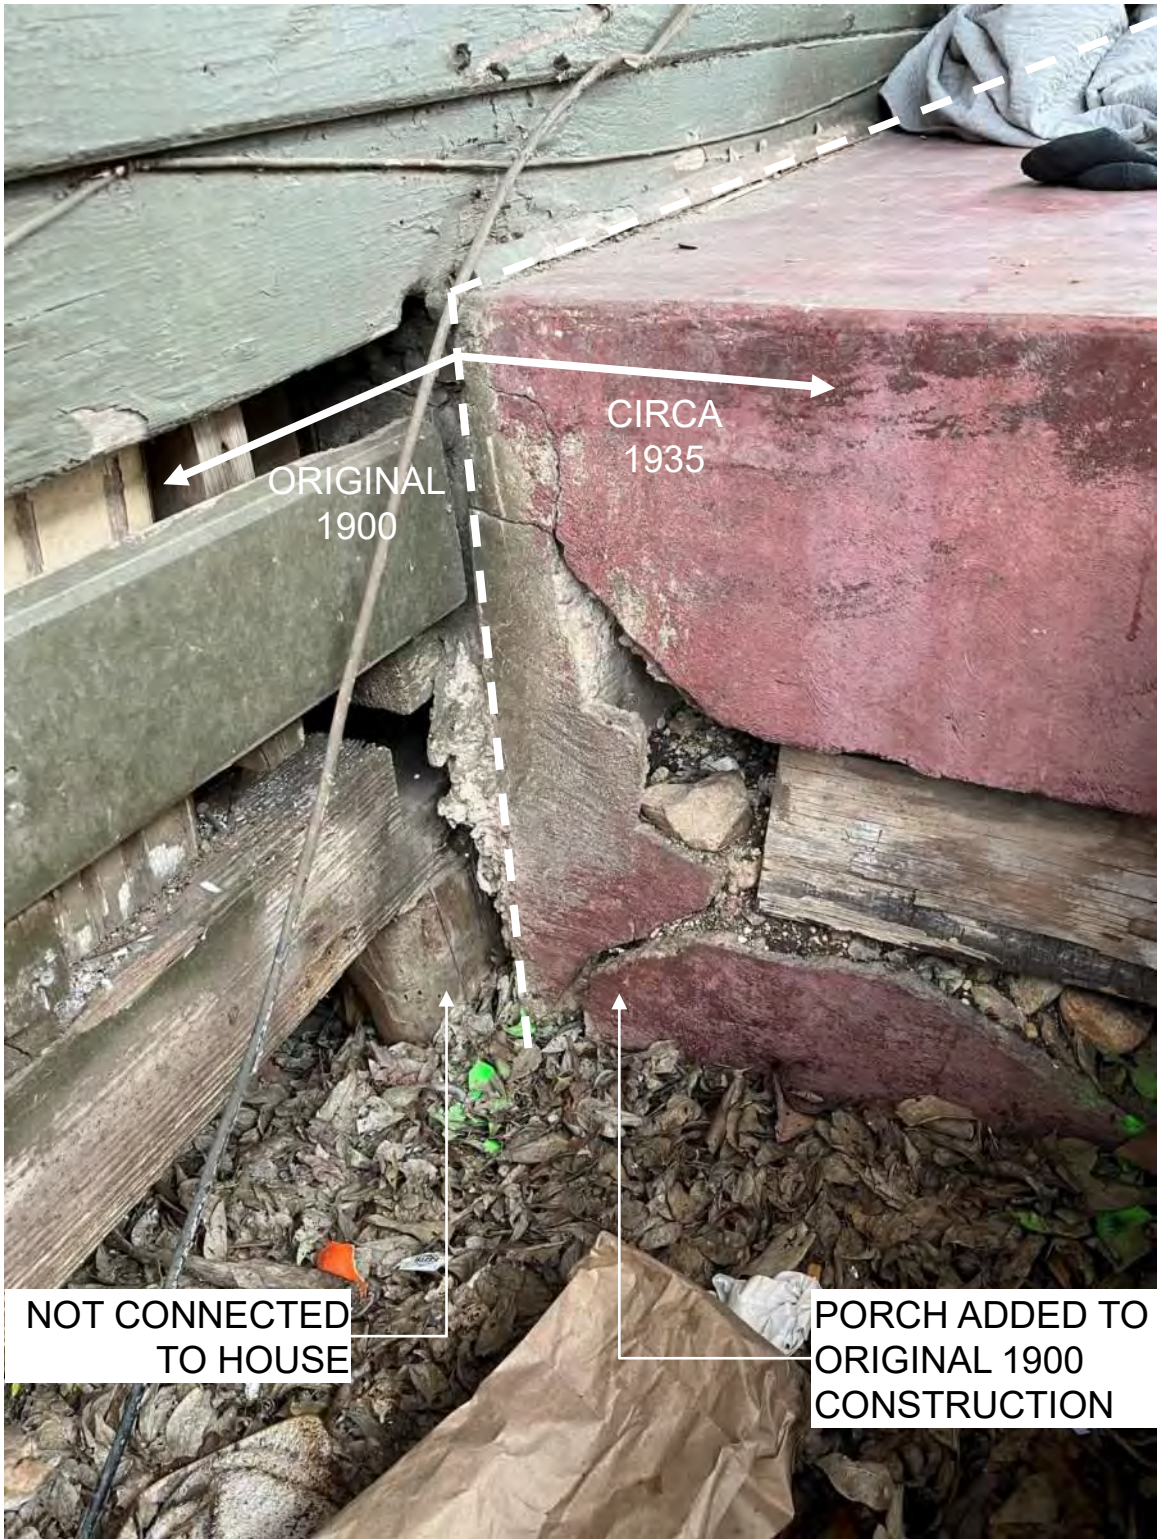
FRONT PORCH DETAIL

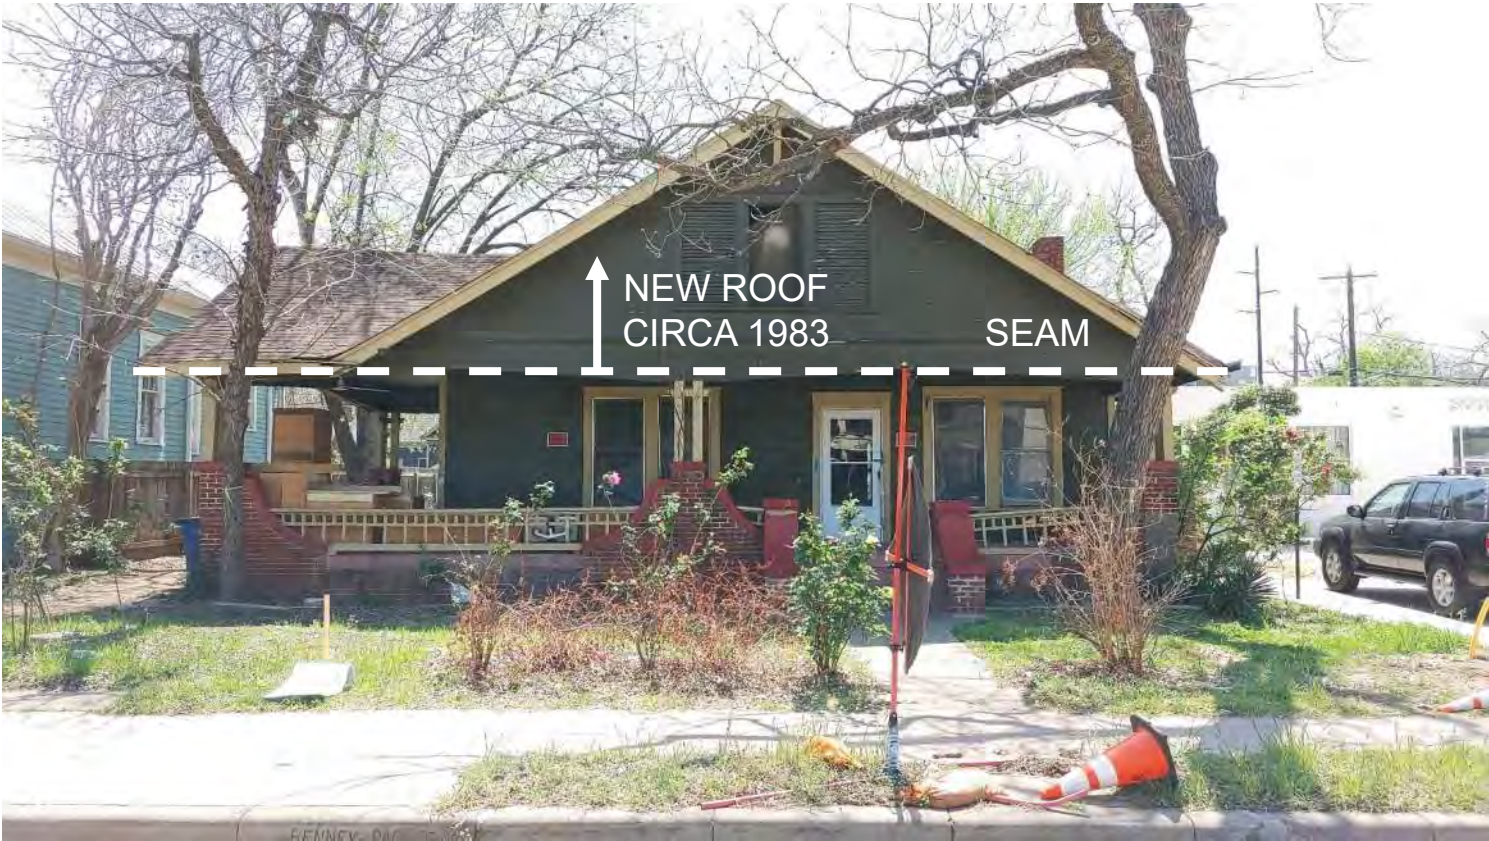
FRONT EXTERIOR FAÇADE – VIEW FACING SOUTH

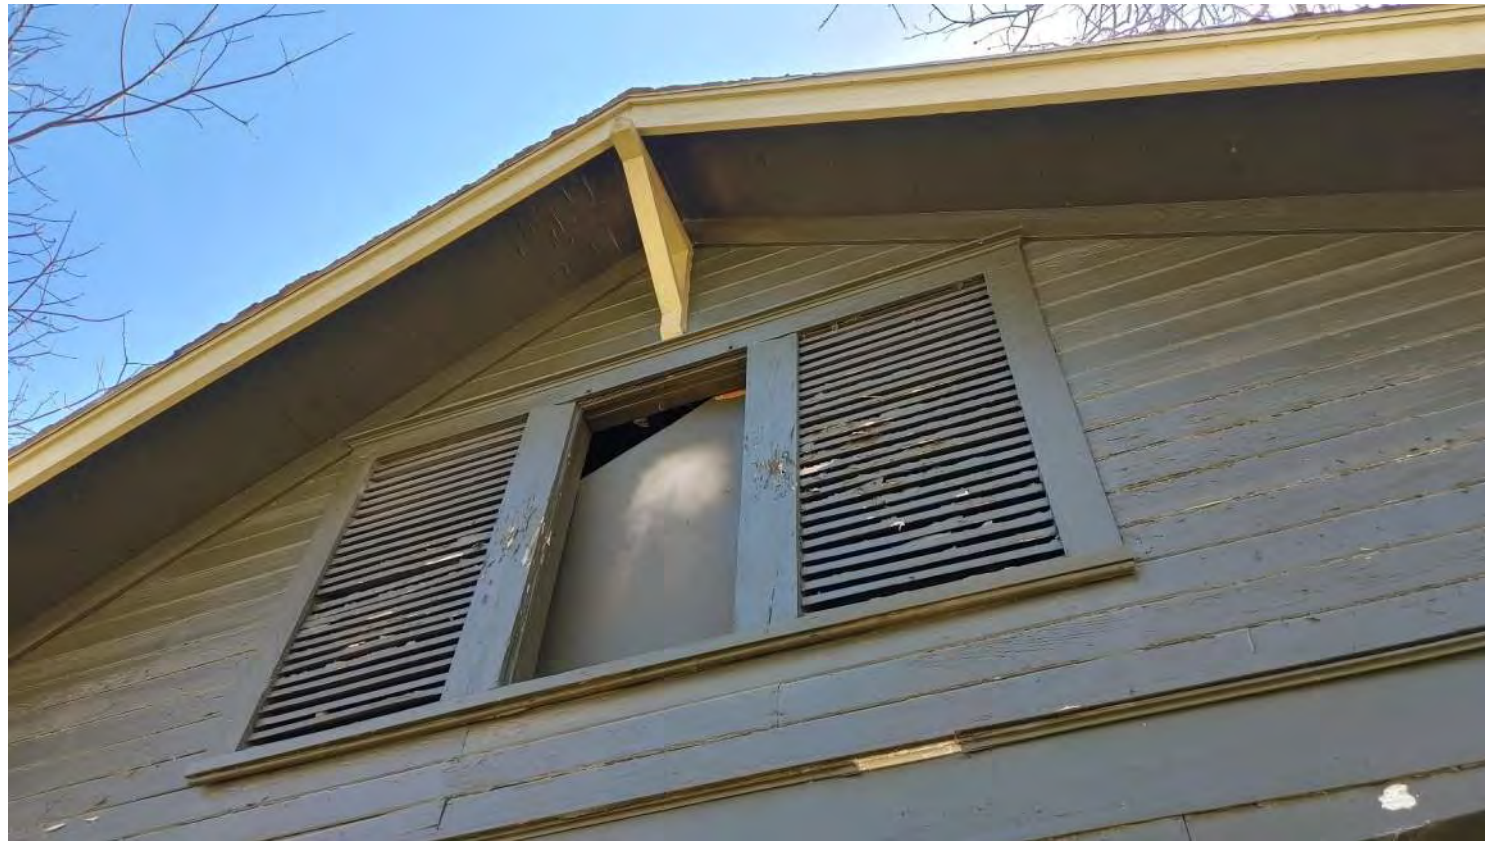
FRONT EXTERIOR FACE OF ROOF RENOVATION

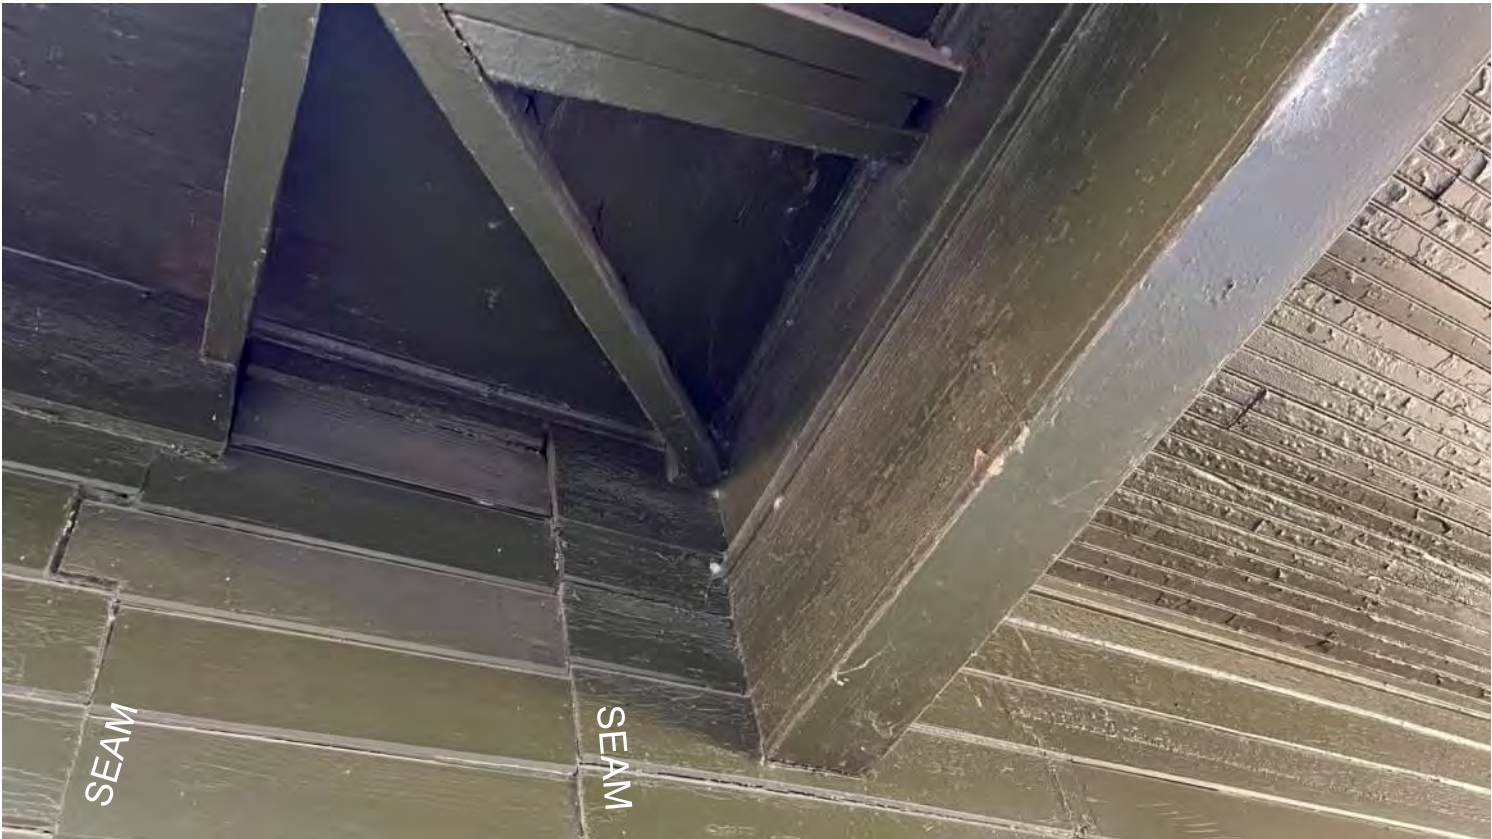
UNDERSIDE OF ROOF RENOVATION AT FRONT PORCH
