Analysis of Existing Building at
1403 EAST CESAR CHAVEZ STREET
Historic Landmark Commission Hearing

MAY 04, 2022

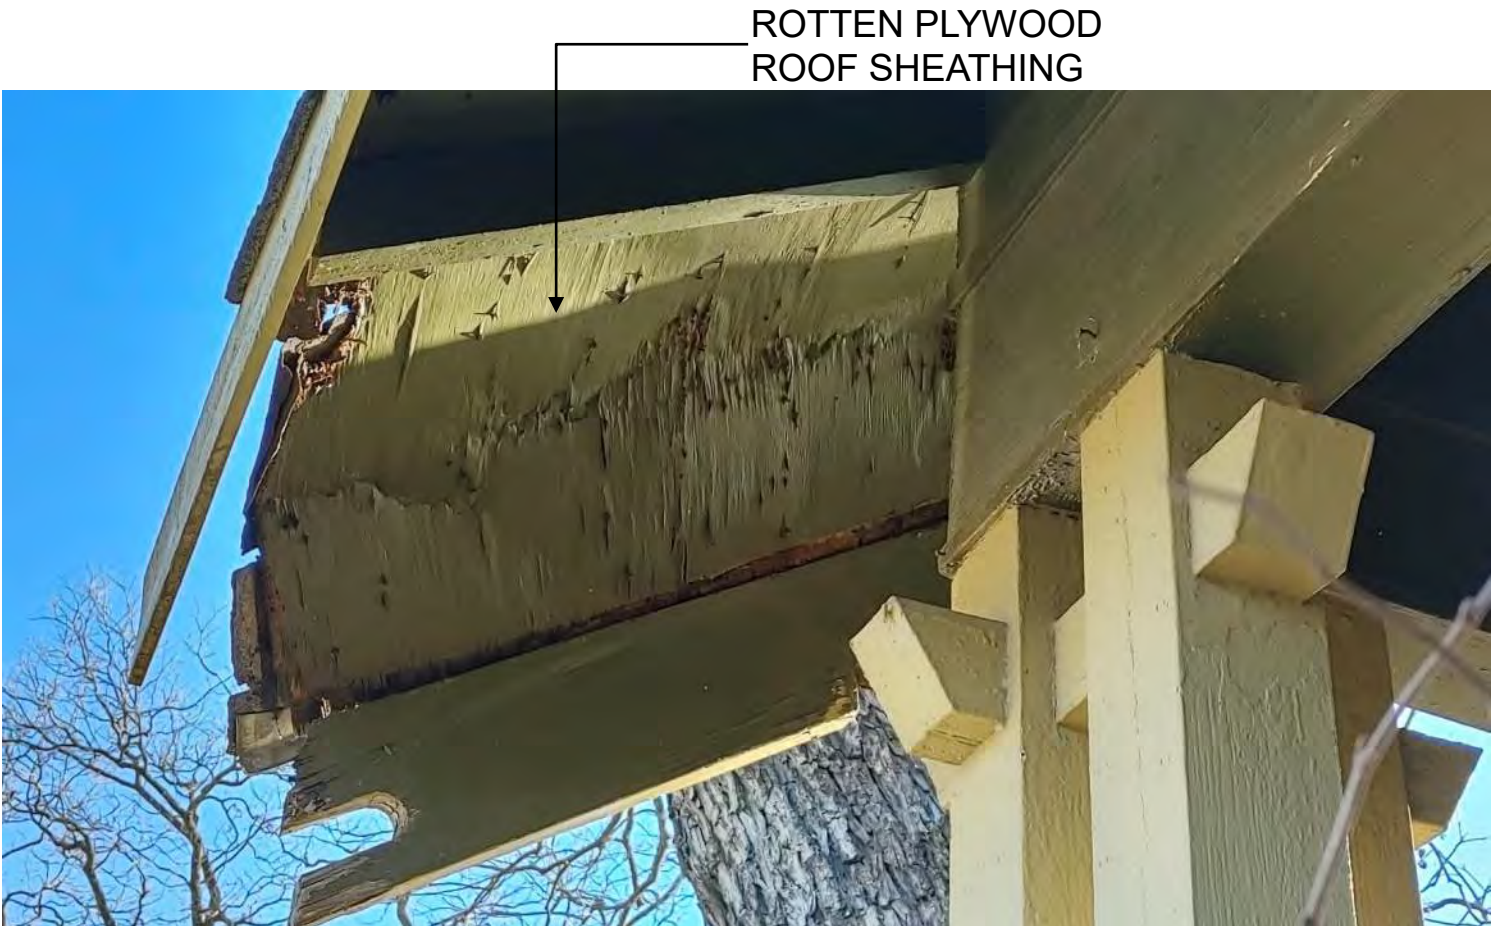
UNDERSIDE OF ROOF RENOVATION AT FRONT PORCH

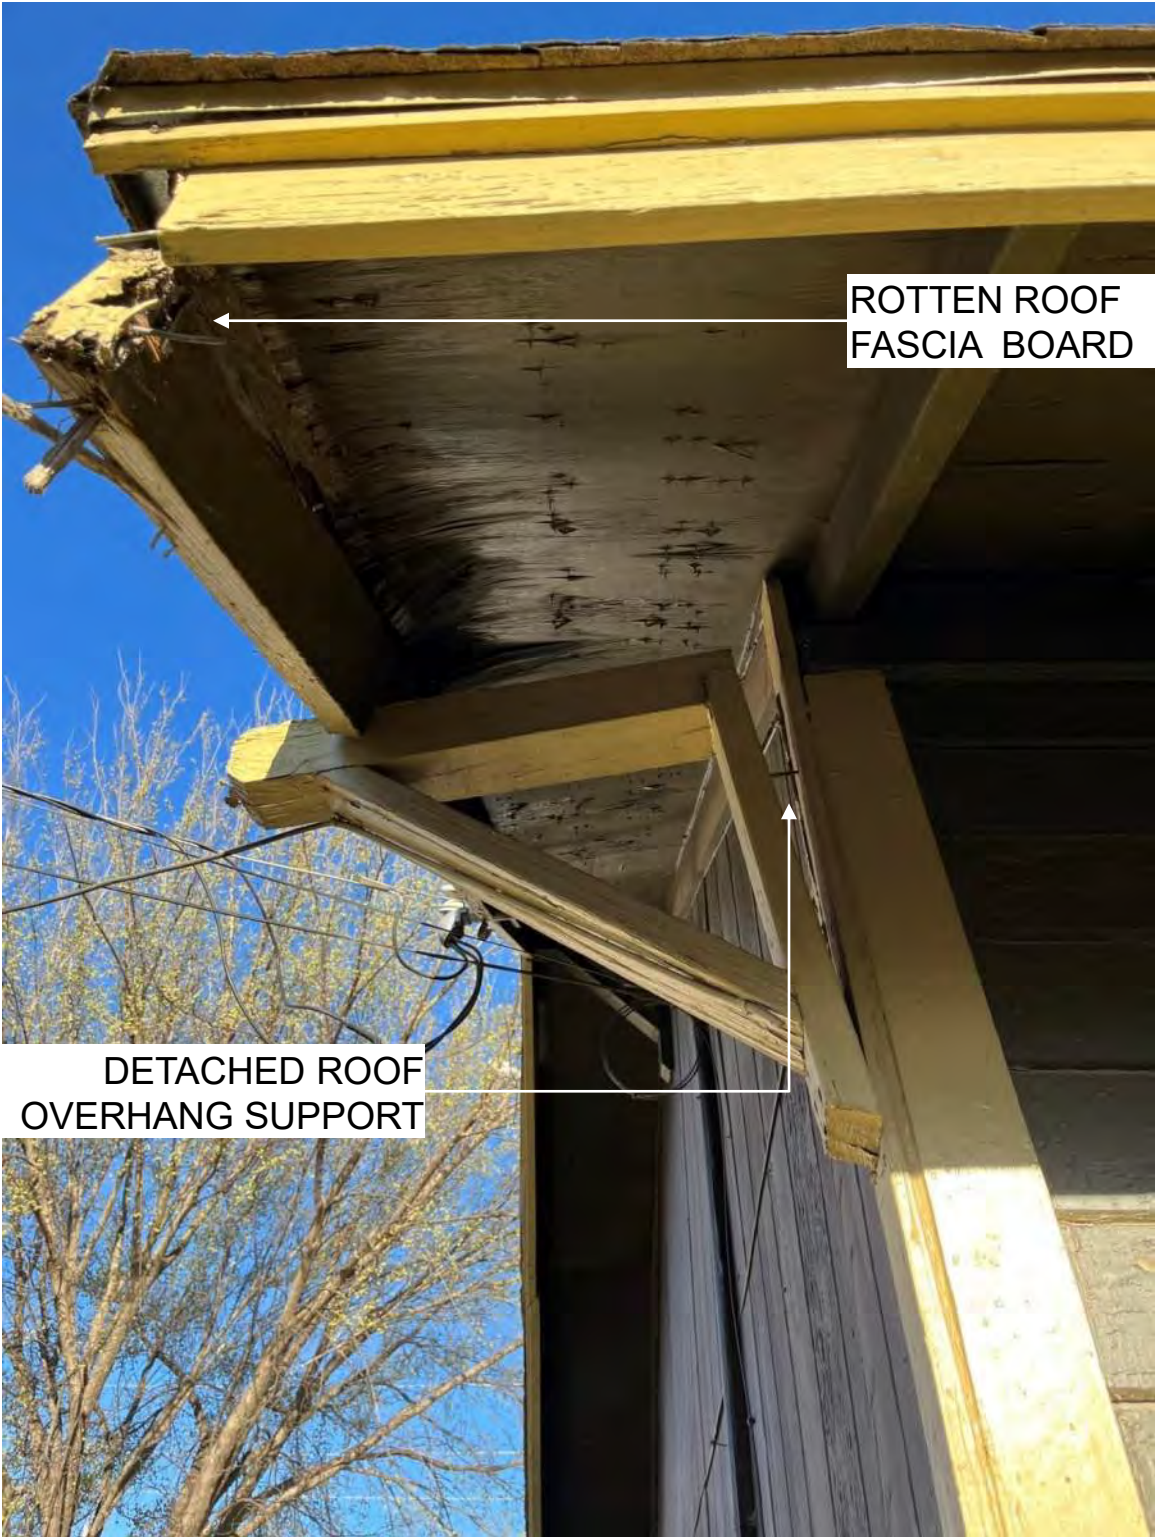
UNDERSIDE OF ROOF RENOVATION AT REAR FAÇADE

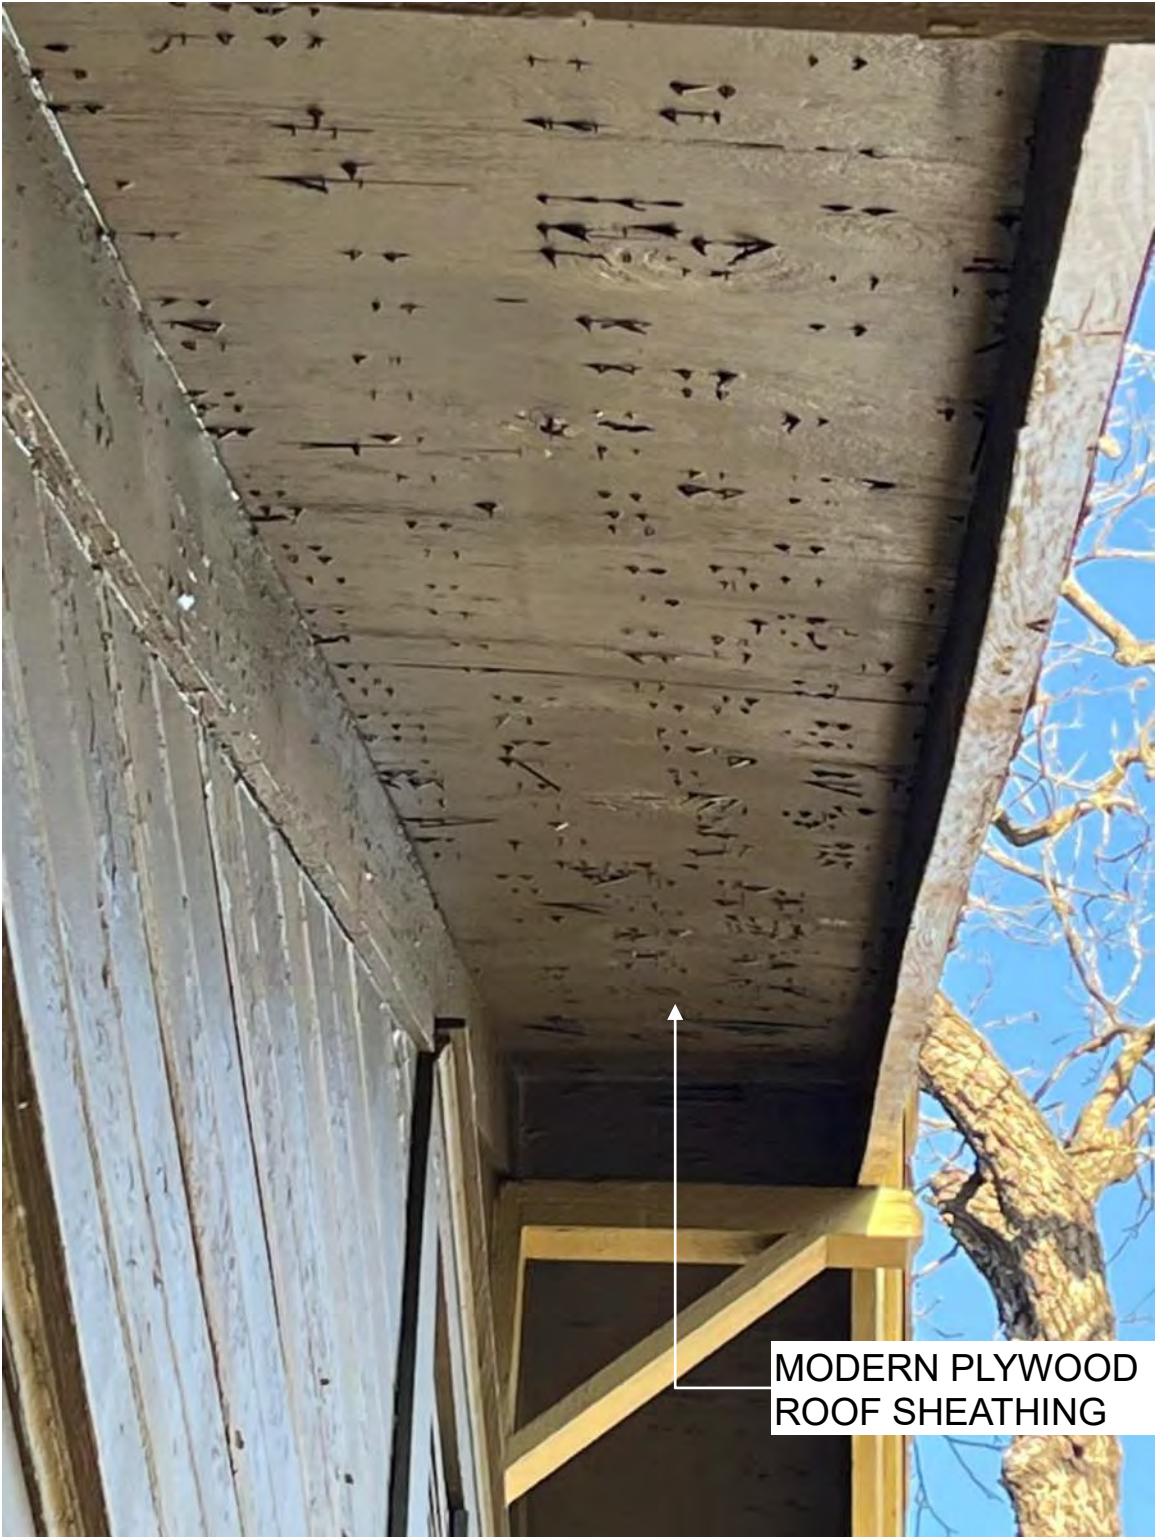
UNDERSIDE OF ROOF RENOVATION AT FRONT FAÇADE
