NSPECT PROPERTY INSPECTION REPORT

701 Sparks Ave, Austin, TX 78705

Property Inspection Report prepared for: Rahim Javanmardi

Inspection Date: 9/6/2023

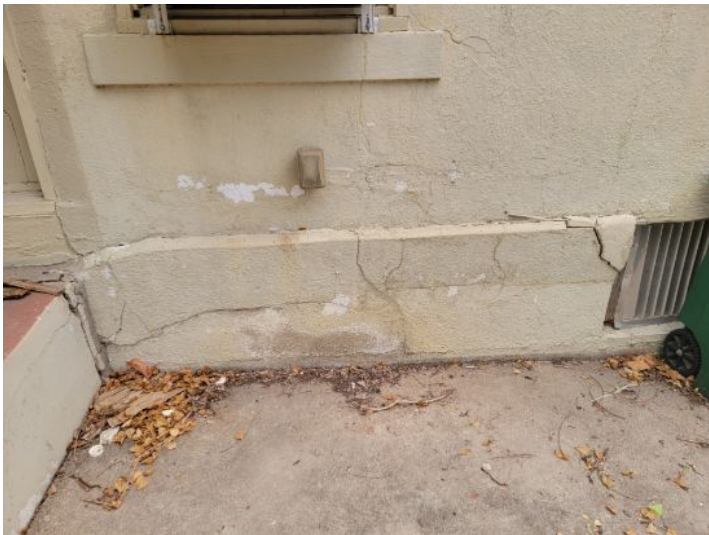
- At the time of the inspection evidence of foundation failure was observed. Cracking and repaired cracking was observed in the foundation walls. Cracking and repaired cracking was found in exterior and interior walls, and in ceilings. Floors were found to be unlevel, sloping and uneven. Doors throughout the main house were found to stick, drag, not latch and were out of square. Windows throughout the main house were found to bind and were found to be out of square. It is strongly recommended that a qualified and professionally licensed structural engineer be consulted.

Cracking in foundation wall

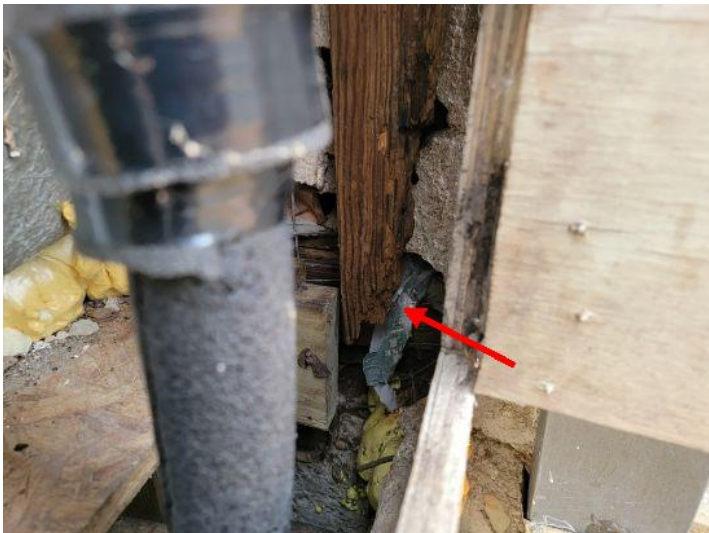
- Wood deterioration of crawlspace and basement structural members was observed in multiple locations throughout the crawlspace and basement. Recommend repair or replace.
- The crawlspace was found to be littered with wood debris. This is a conducive condition for termite infestation. Recommend clearing all debris from crawlspace.
- Evidence of possible organic growth was observed in the crawlspace and the basement. Recommend further investigation by a qualified and licensed mold assessment consultant and repair as deemed necessary.
- Basement structural support post was found to be rodent damaged and disconnected from beam. Recommend evaluation and repair.

Deteriorated structural member

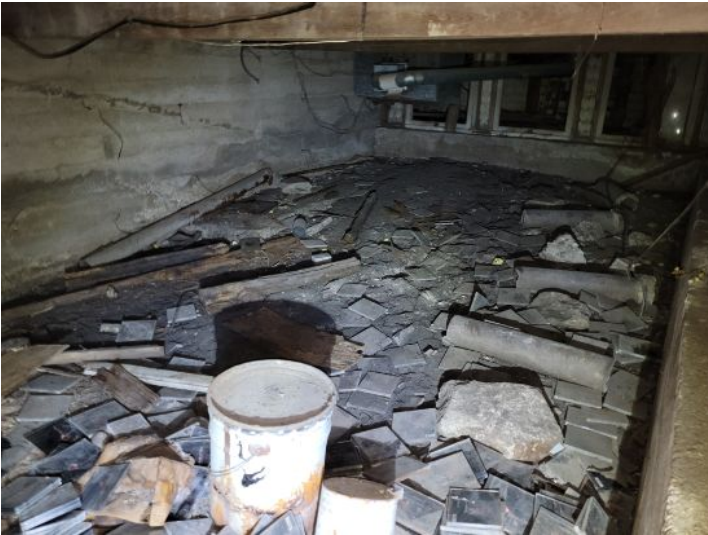
Wood debris in crawlspace

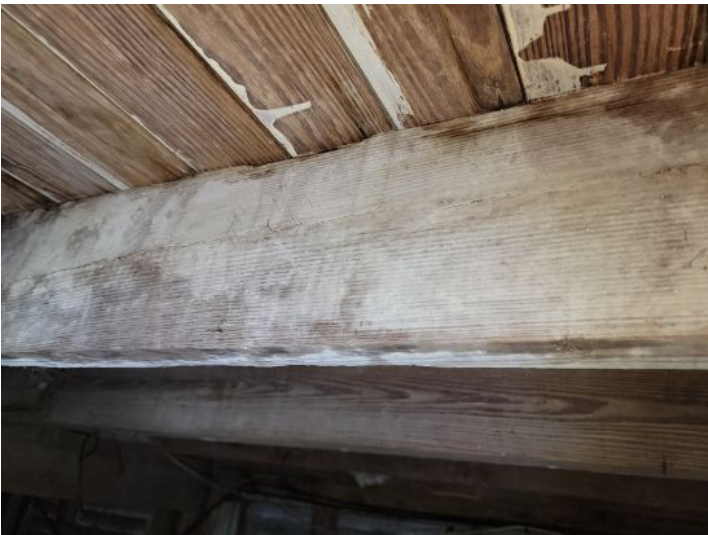
Possible organic growth in crawlspace

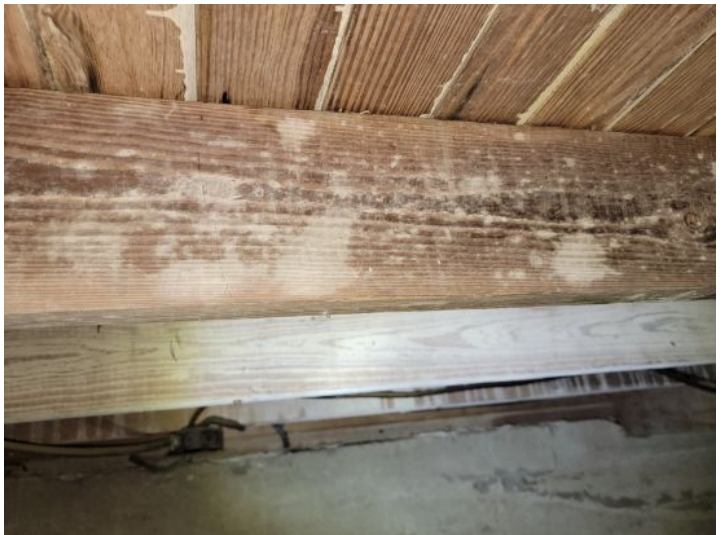
Possible organic growth in crawlspace

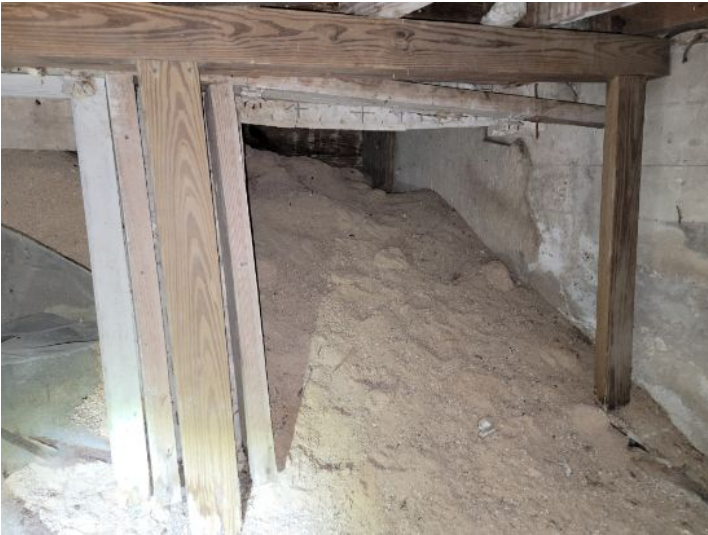
- Main House: Crawlspace: Some foundation beams appeared to be undersized and were deteriorated. Wood to ground contact was observed at some piers and other structural foundation supports. Wood to ground contact can lead to moisture and insect intrusion, and deterioration, Cedar piers were observed in the crawlspace. Poured concrete piers offer more support and are preferred. Some piers were found to be leaning and loose. Recommend further investigation by a qualified and professionally licensed structural engineer.

Crawlspace- wood to ground contact

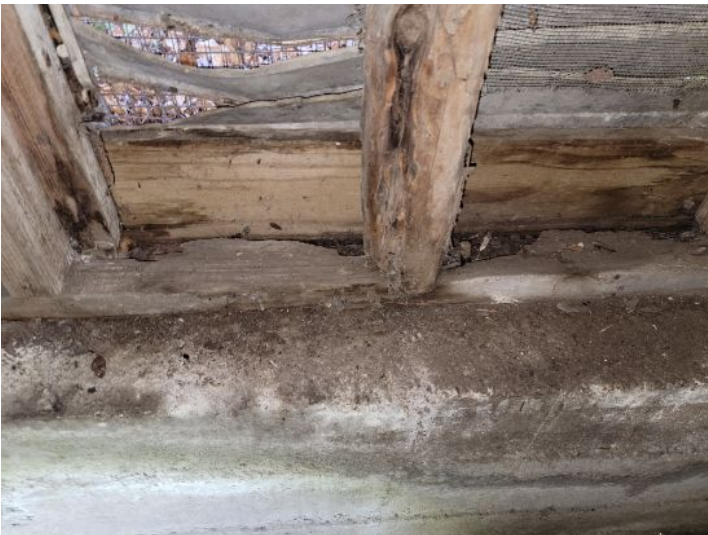
Crawlspace: Deteriorated structural support members

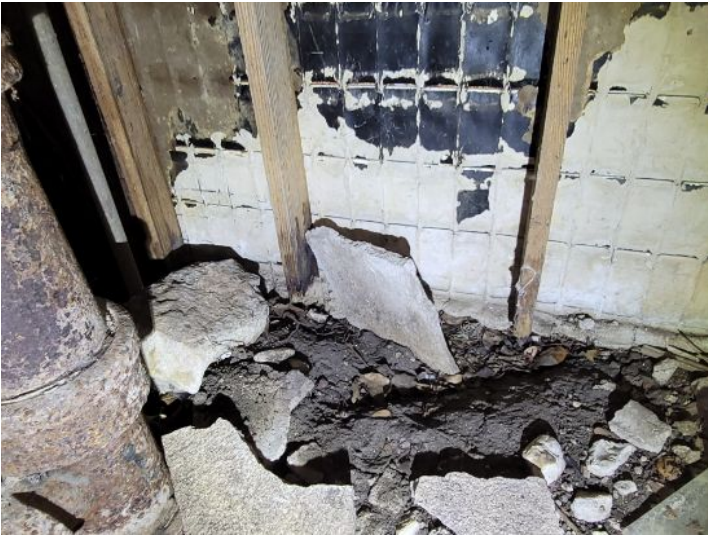
Crawlspace: Deteriorated structural support members

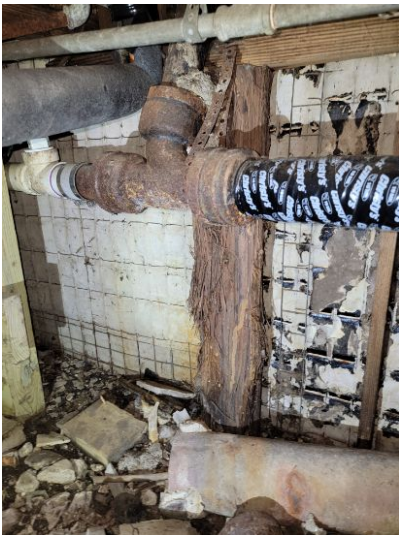
Cedar pier

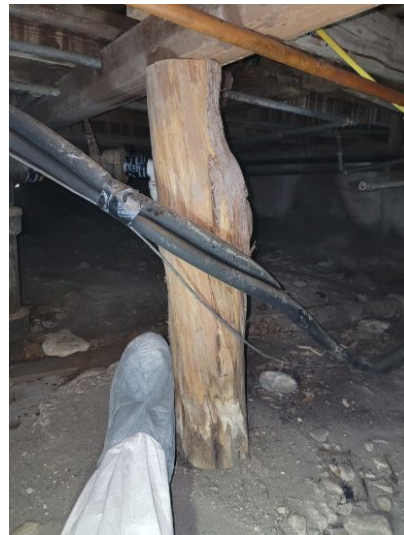
Loose cedar pier

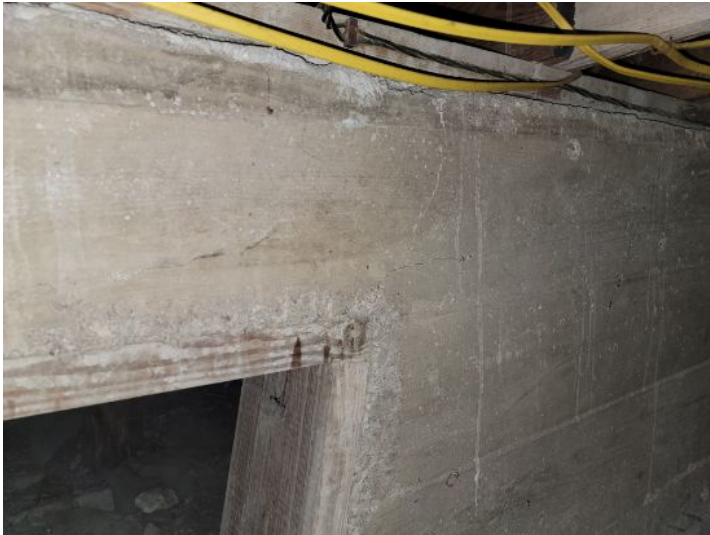
Cracking in foundation wall

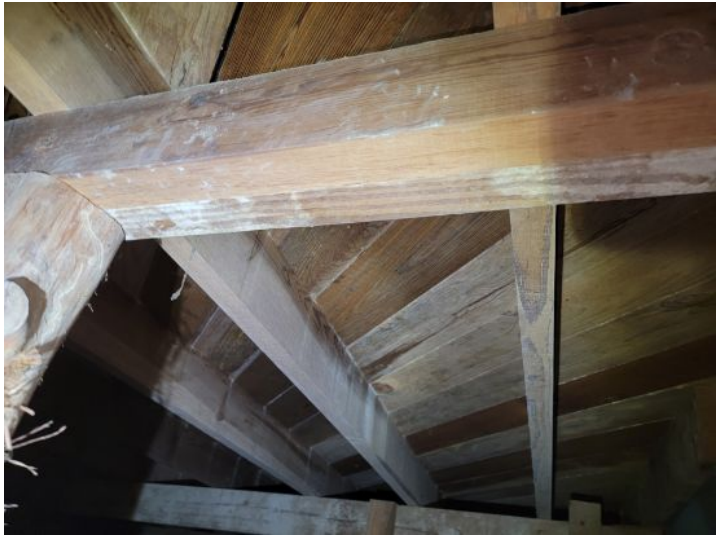
Possible organic growth

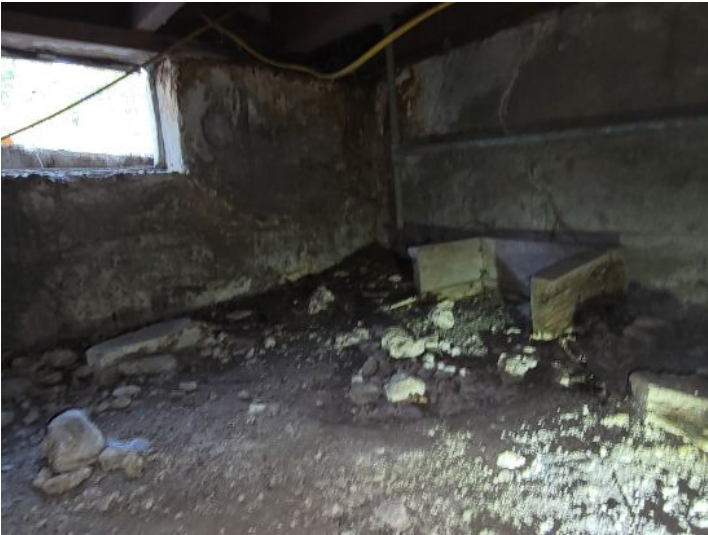
Wet area of crawlspace

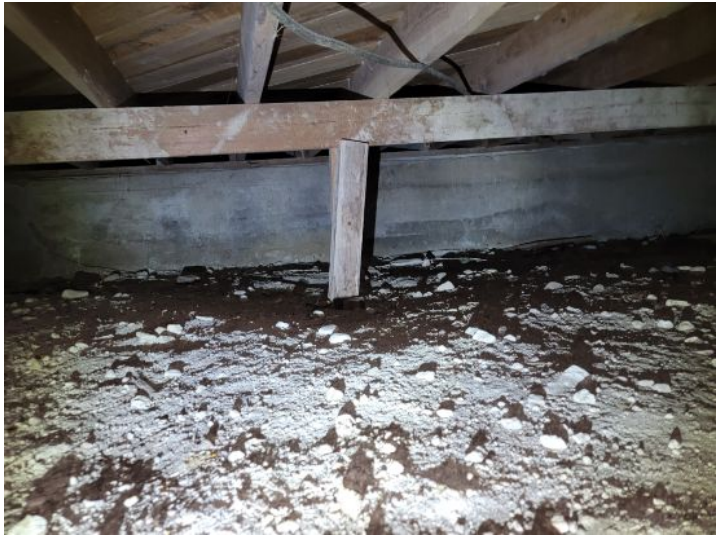
Possible organic growth

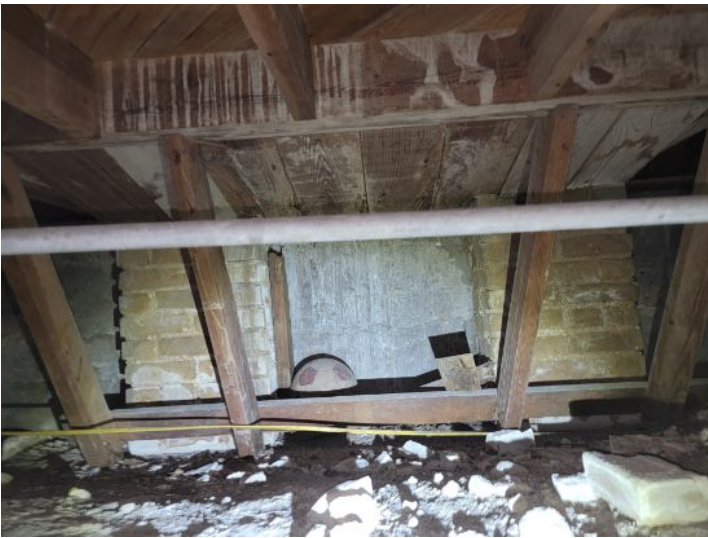
Wood to ground contact and possible organic growth

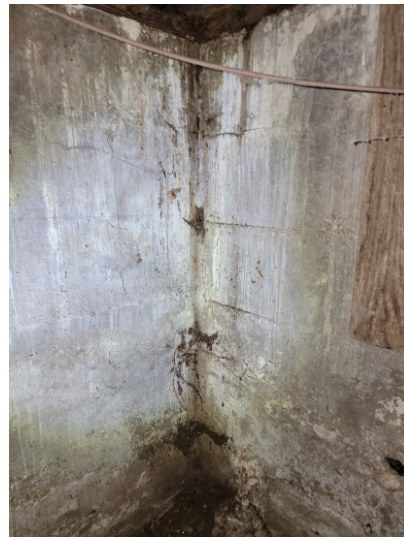
Wet area of crawlspace

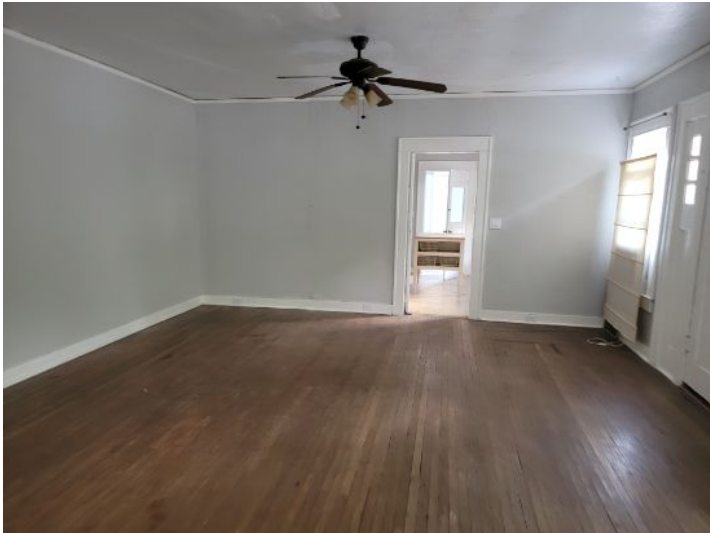
Unlevel and sloping floors

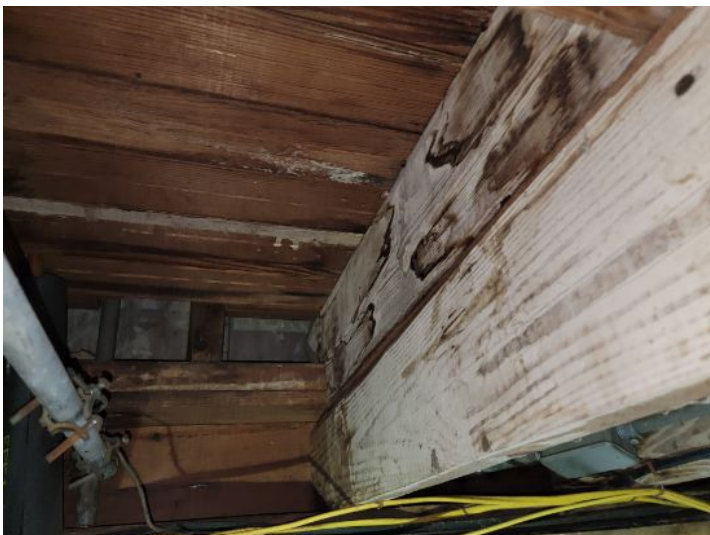
Possible organic growth in basement

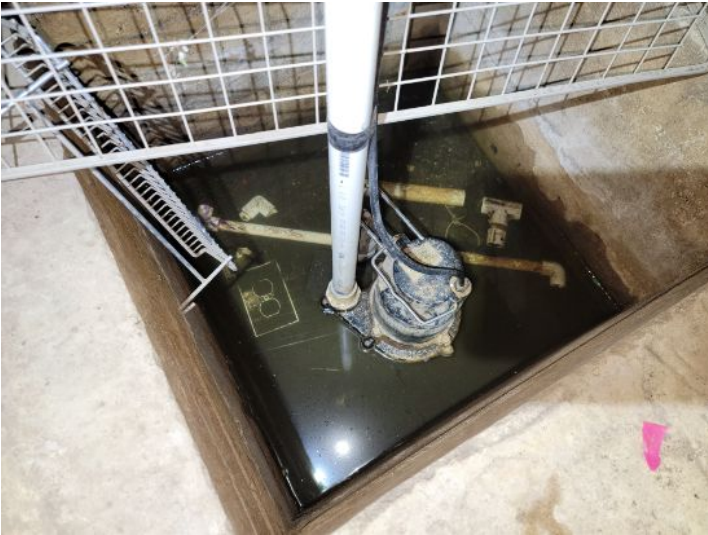
Sump pump well full of water and debris

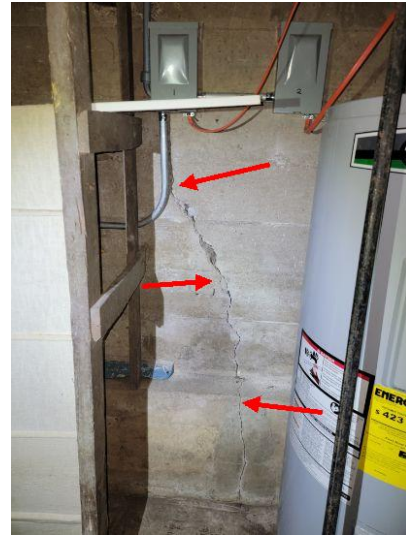
- Basement Foundation Main House: At the time of the inspection evidence of foundation failure was observed. Severe cracking was observed in the basement foundation walls and concrete slab floor. Evidence of moisture penetration into the basement was observed. The sump pump well was found to be filled with water. Wooden structural foundation members were found to be severely deteriorated. Recommend further investigation by a qualified and professionally licensed structural engineer.

Severe cracking in basement foundation wall

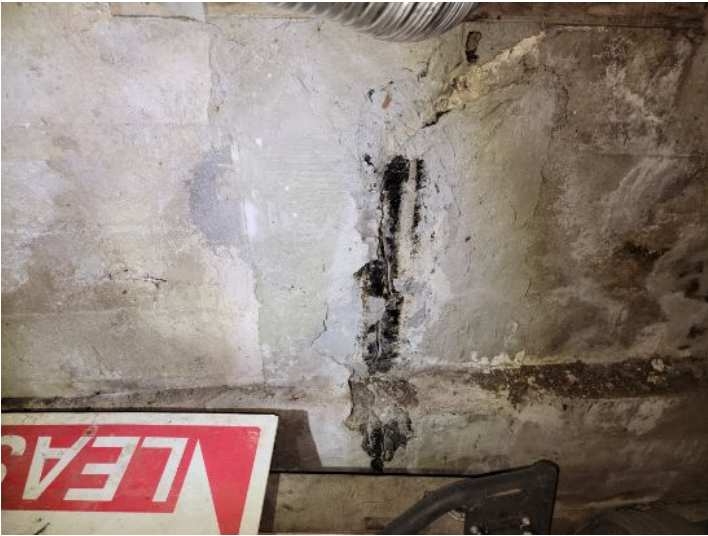
Cracking in basement foundation wall

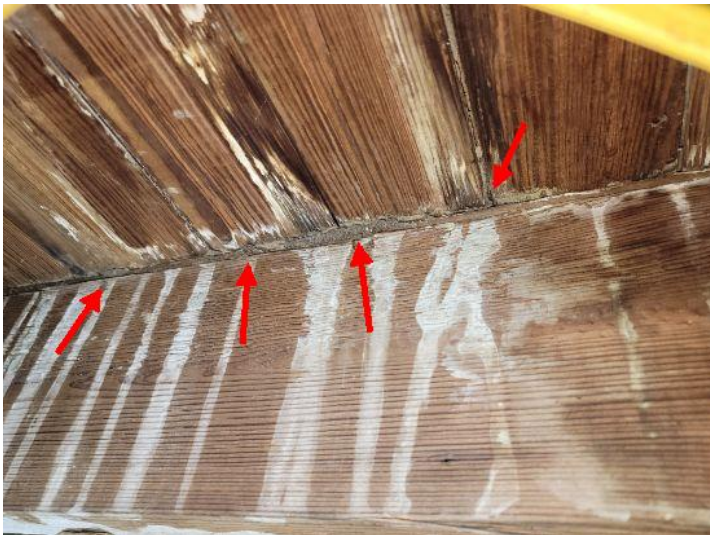
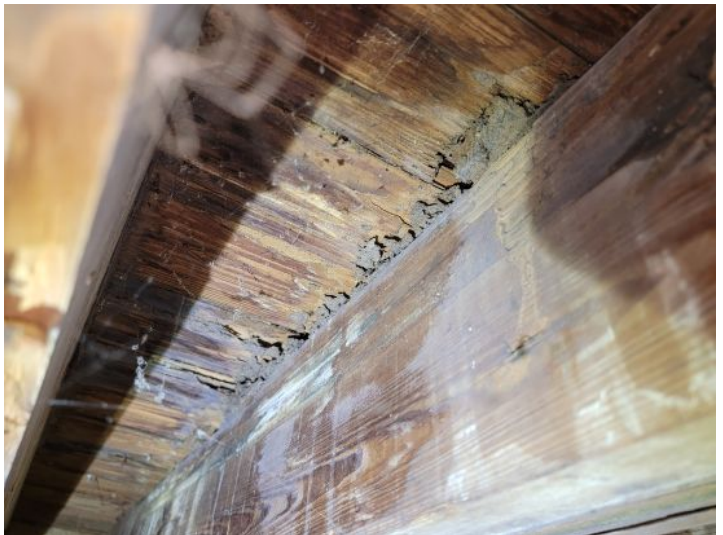
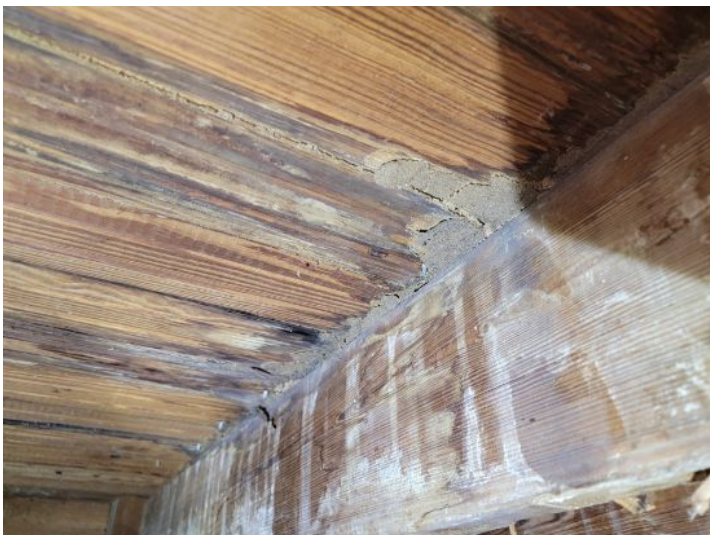
- Evidence of wood destroying insect activity was observed in the crawlspace foundation and basement foundation. Extensive and severe structural damage was observed. Recommend further investigation by a qualified and licensed pest control technician.

Evidence of wood destroying insect activity in basement

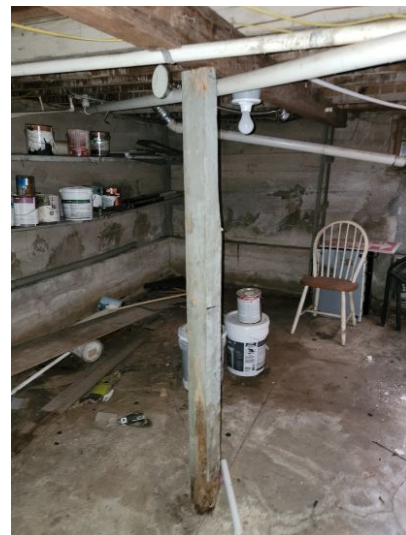
Rodent damaged basement support post

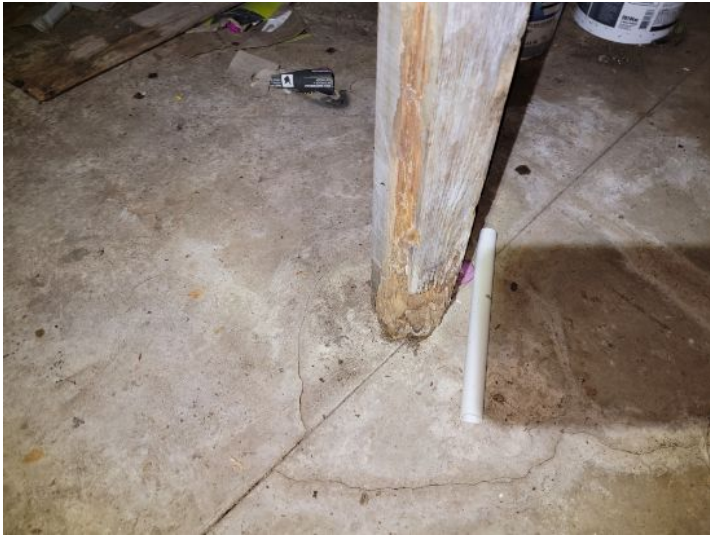
Rodent damaged basement support post

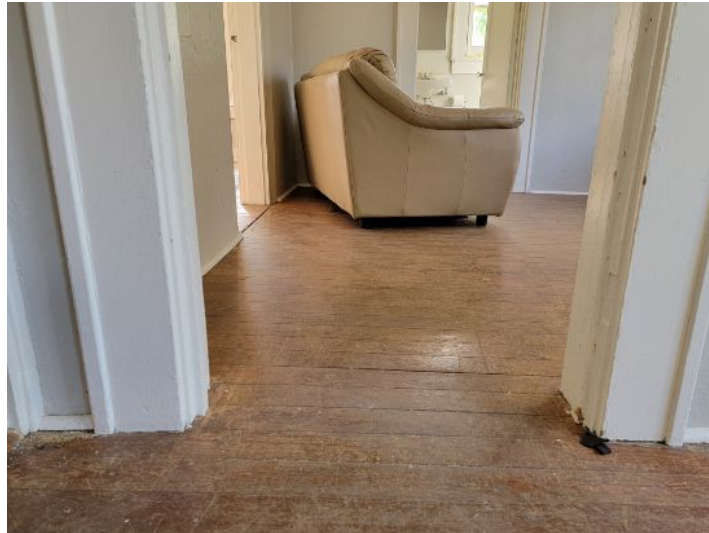
Severely unlevel floor

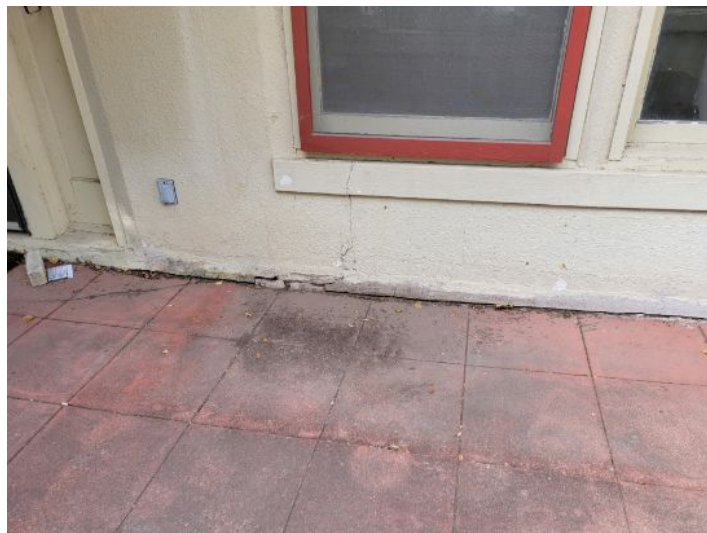
- The front porch was found to be sloped towards the wall of the house and evidence of moisture intrusion on the interior front wall of the house was observed. Recommend evaluation and repair by a qualified and professionally licensed structural engineer.

Front porch sloped towards the structure

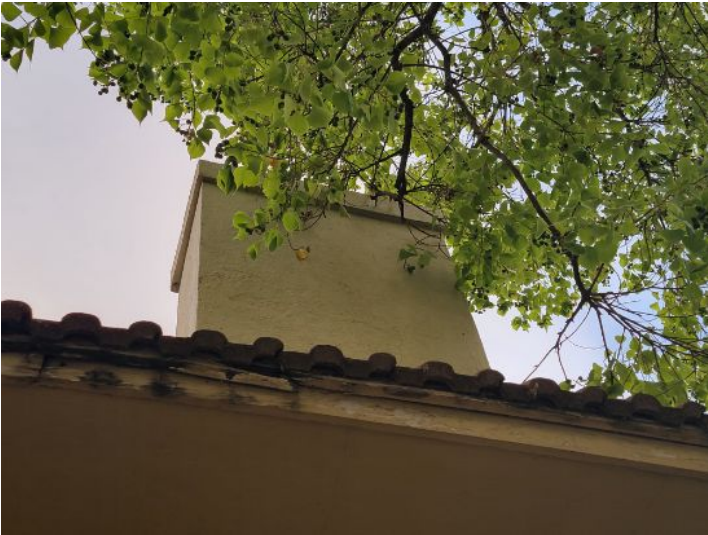
Trees contact roof and house

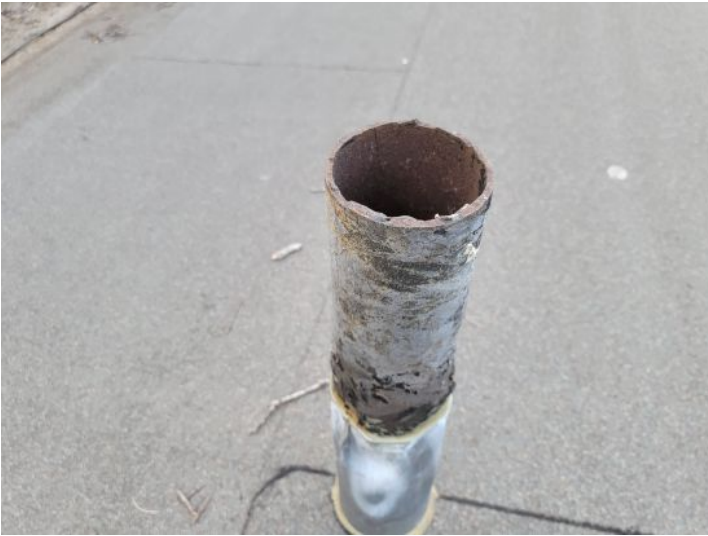
Improperly installed vent boot flashing

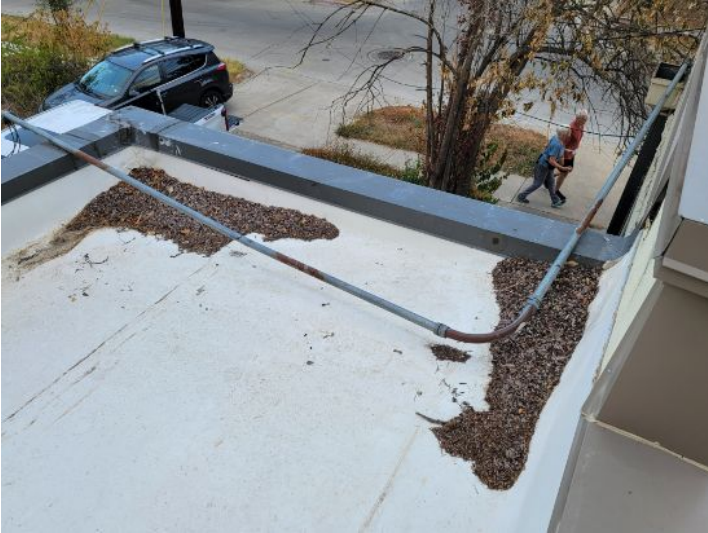
Debris on roof

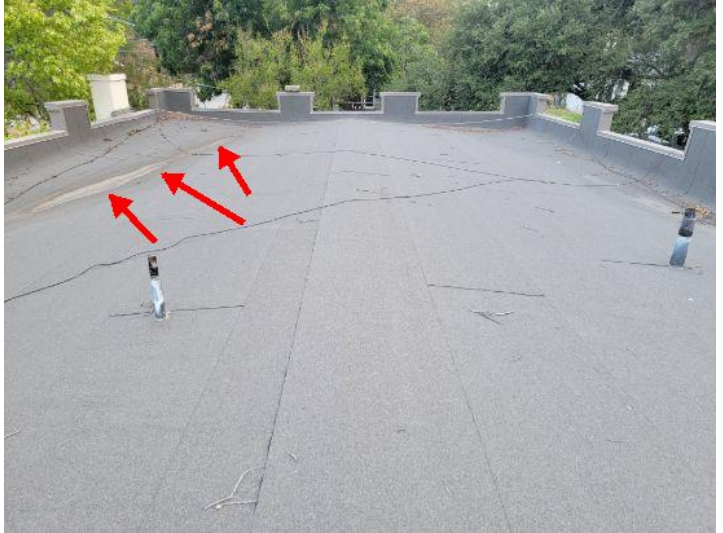
Evidence of previous standing water

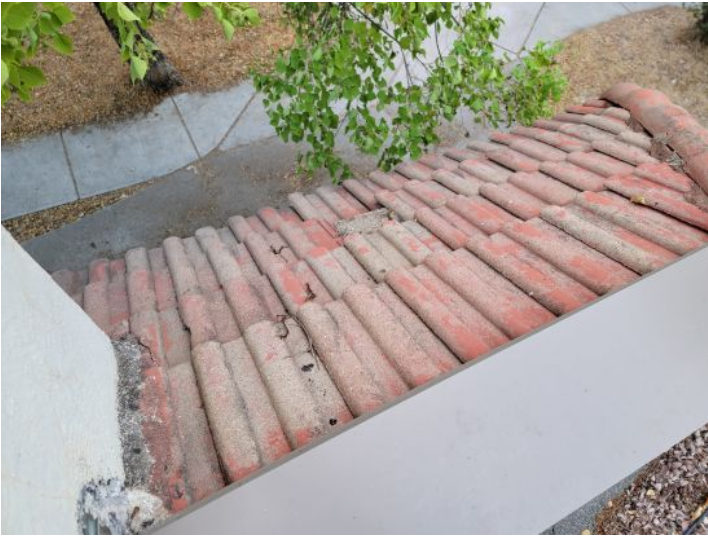
Cracked roof tiles

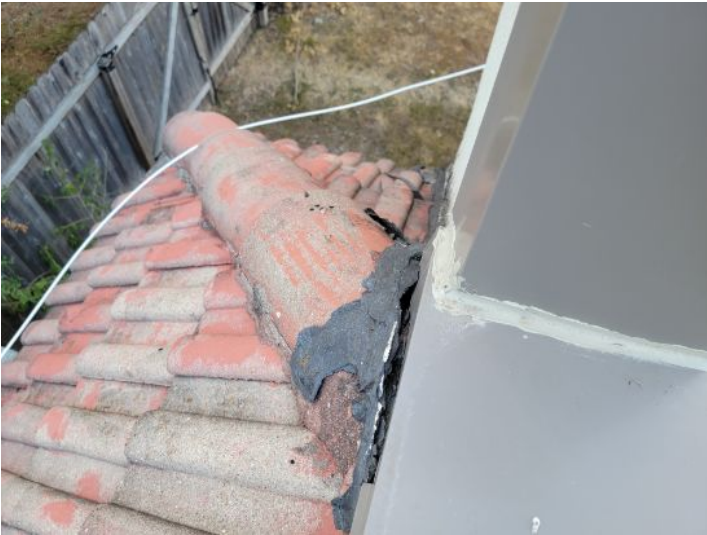
Damaged roof tiles

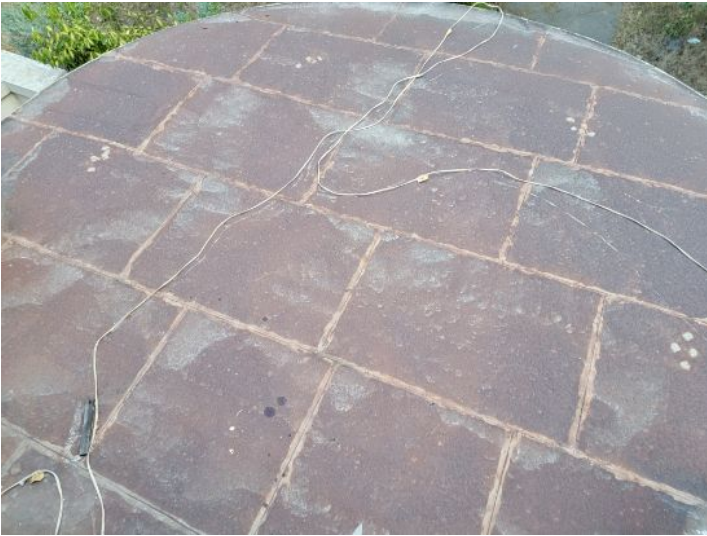
Rusted metal roof covering

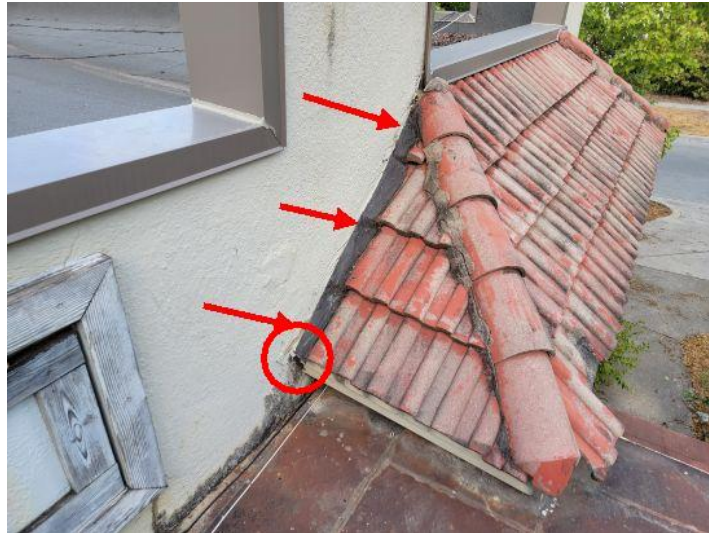
Improperly flashed sidewall and missing kickout flashing

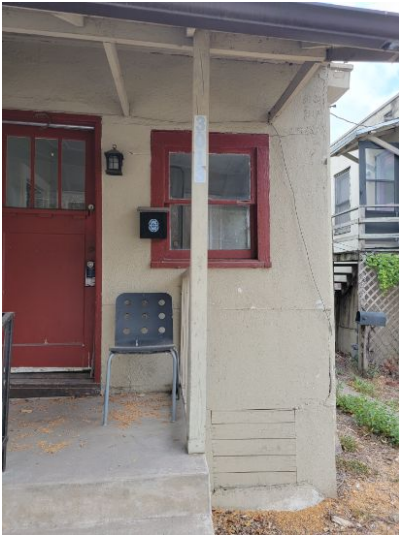
Bowed and warped support post

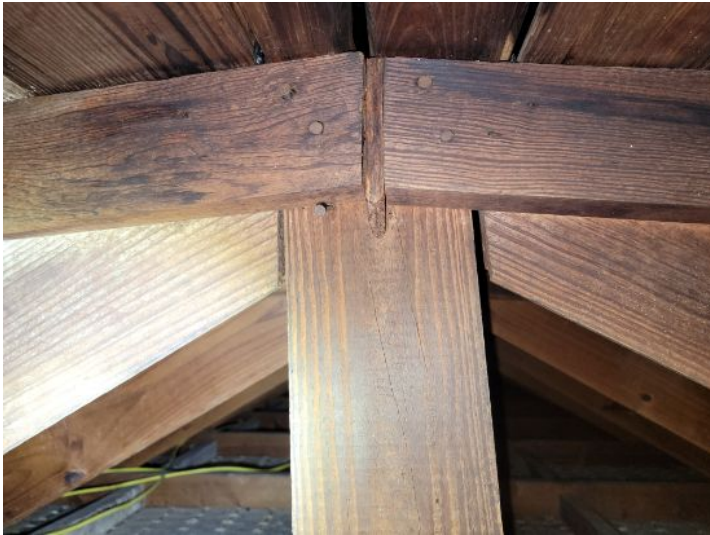
Gap in framing members. Water stains on decking and framing members.

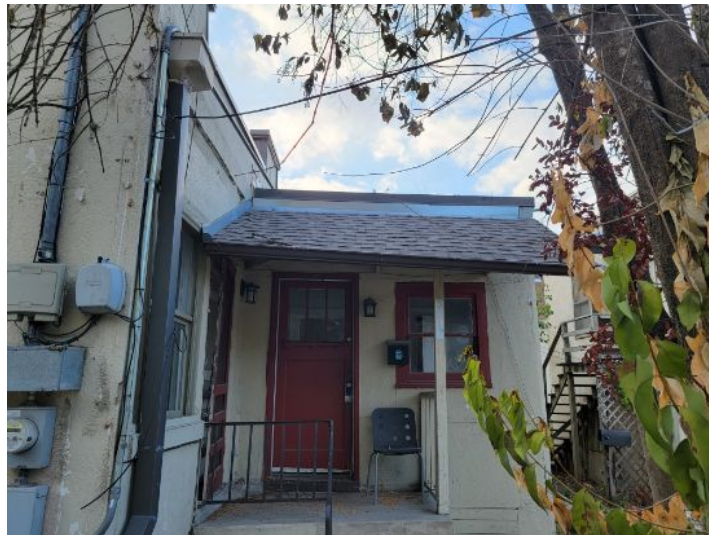
Unlevel porch roof

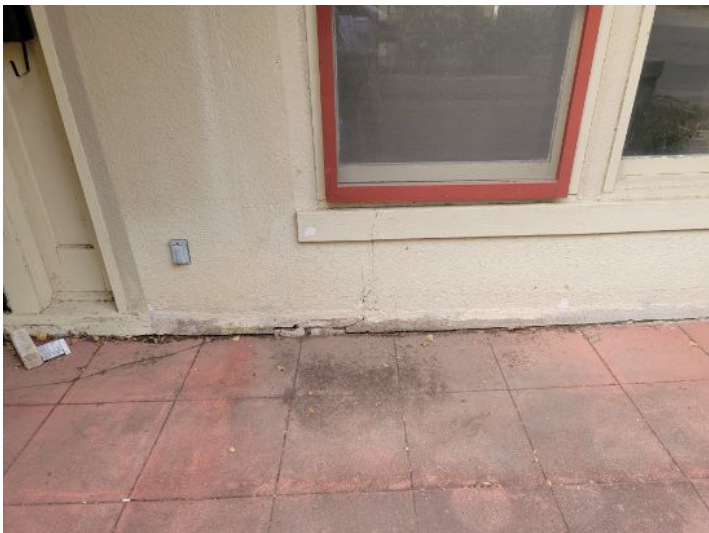
Cracking in stucco

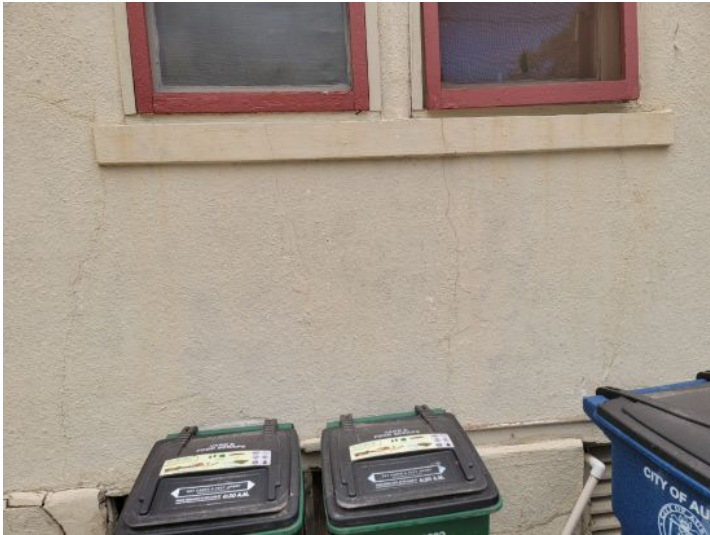
Cracking in stucco

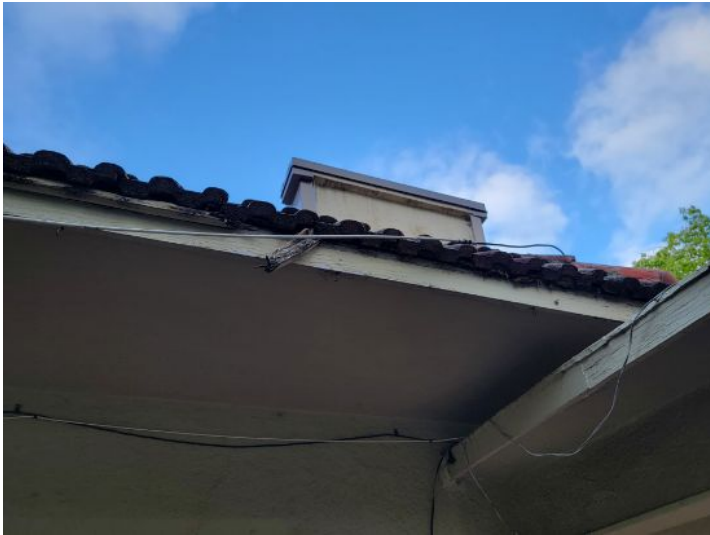
Deteriorated fascia

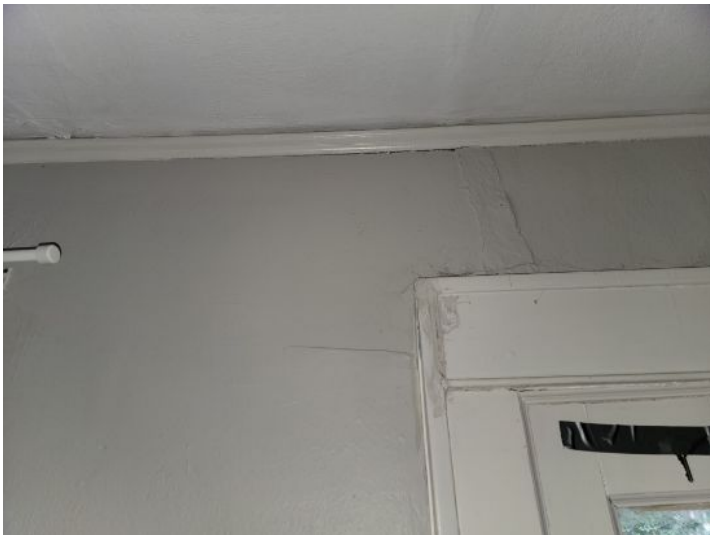
Cracking wall

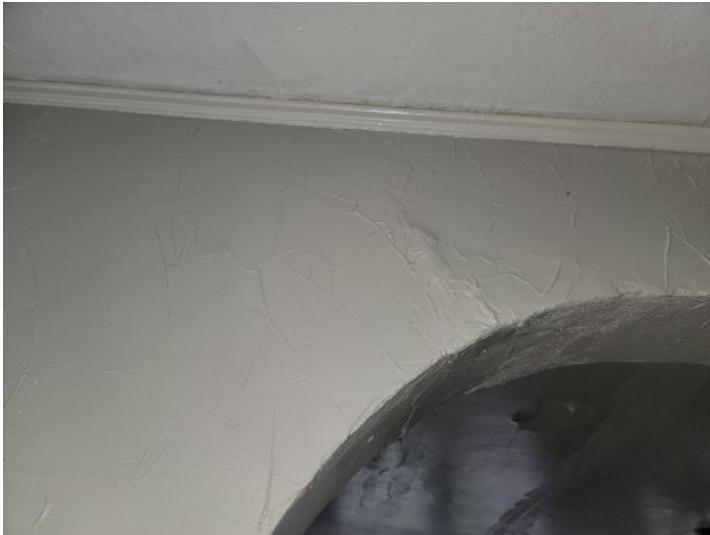
Repaired cracking

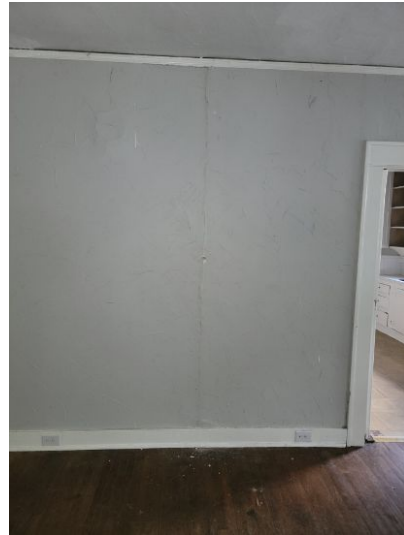
Cracking in wall

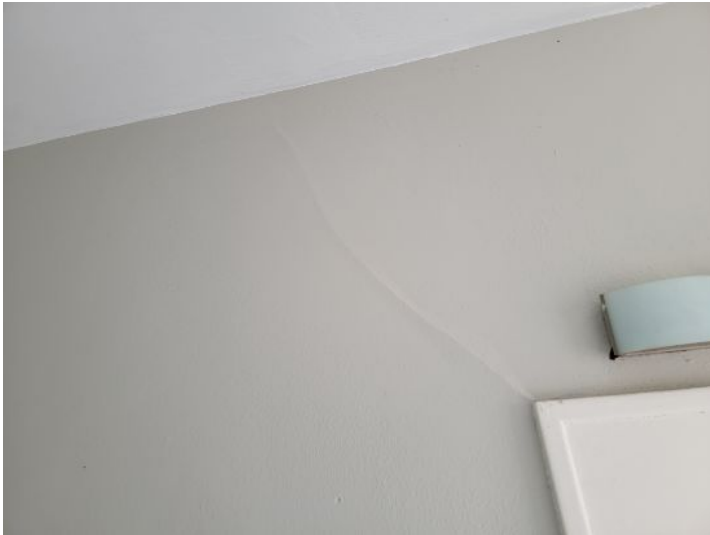
Repaired cracking in wall

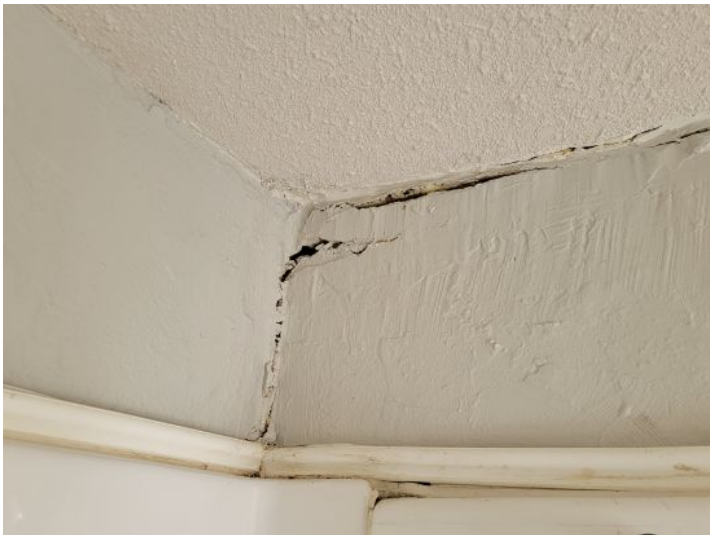
Damaged wall in 3013 Unit

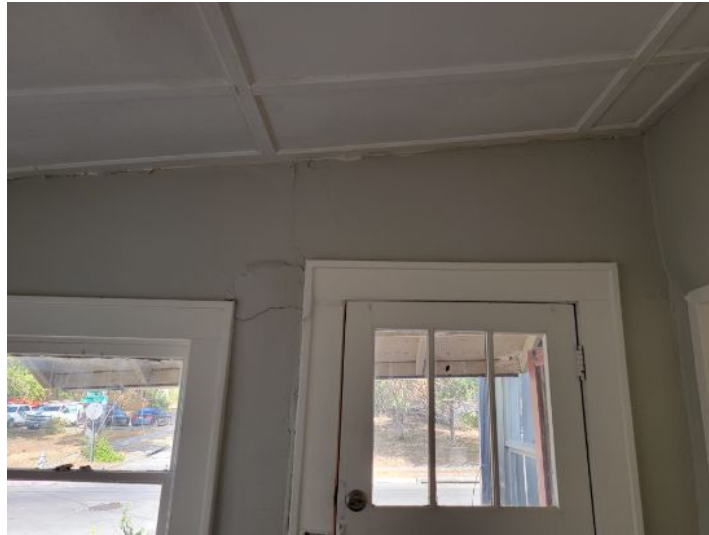
Cracking in wall

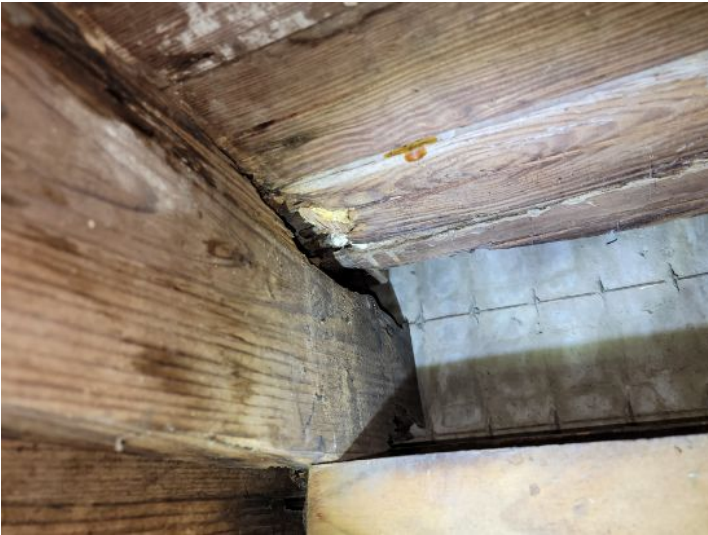
- Evidence of moisture penetration was observed on the sub floors and joists in the crawlspace and the basement. Recommend evaluation and repair.
- Severe deterioration of the floor joists was observed in the crawlspace and basement. Recommend repair or replace.

Deteriorated sub-floor and joist in crawlspace

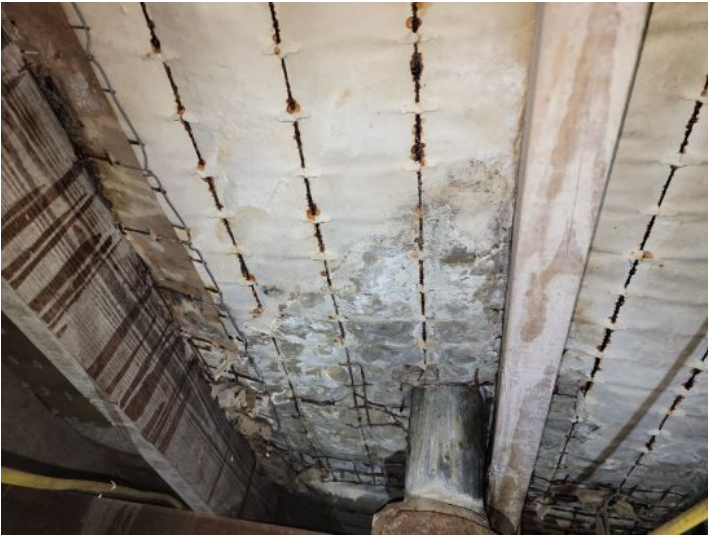
- Possible organic growth was observed on the sub floors and joists in the crawlspace and the basement. Recommend further evaluation by a qualified and licensed mold assessment consultant.

Evidence of moisture penetration and possible organic growth in crawlspace

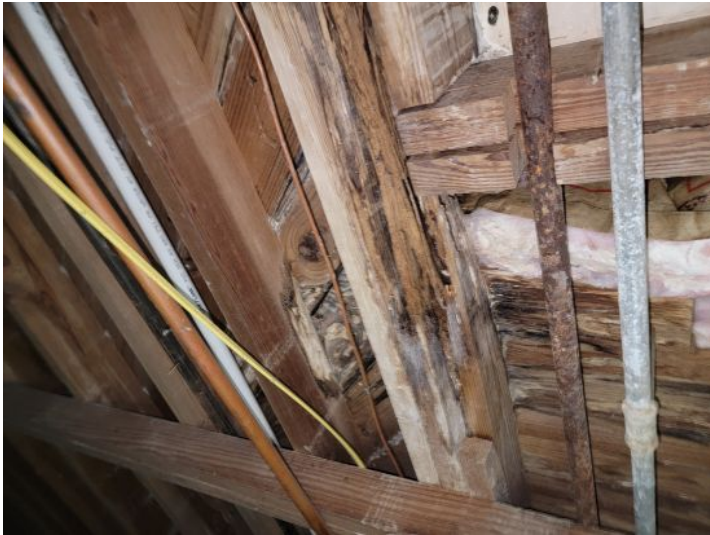
Deteriorated floor joists and sub-floor

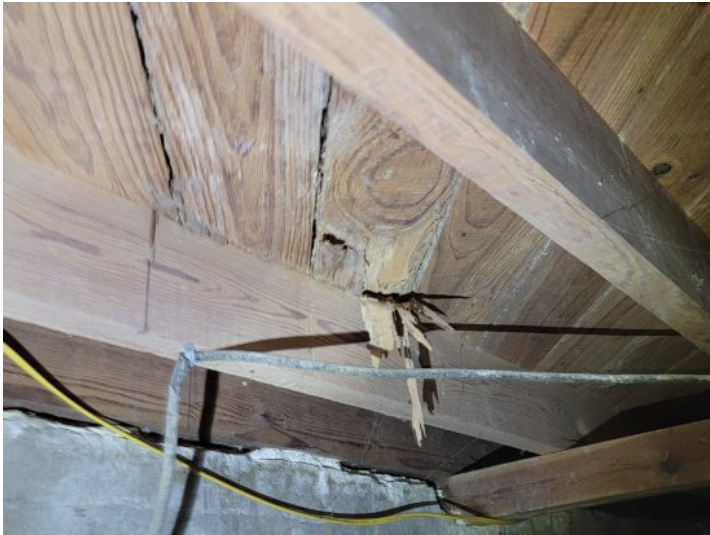
- Evidence of severe wood destroying insect activity was observed in the floor covering, sub floor and floor joists. Recommend further investigation by a qualified and licensed pest control technician.

Evidence of wood destroying insect activity in crawlspace

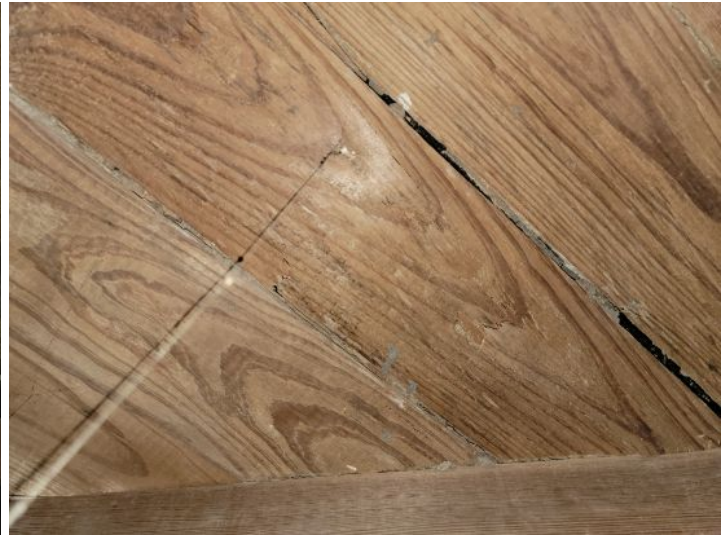
Evidence of wood destroying insect activity in crawlspace

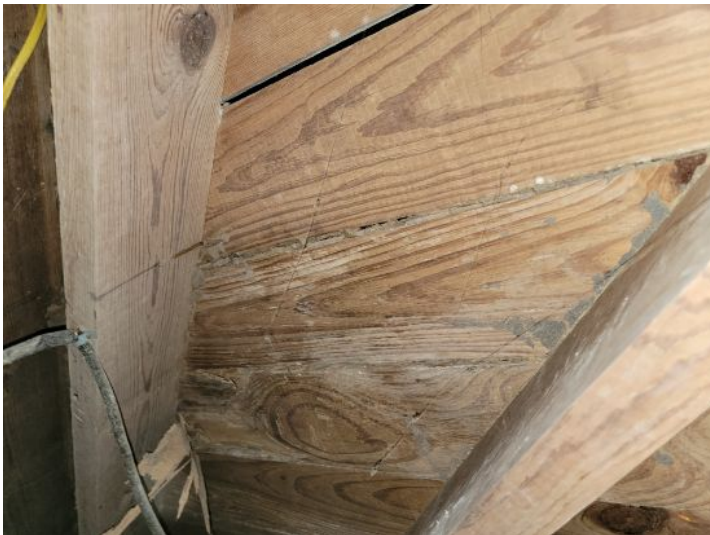
Evidence of wood destroying insect activity in crawlspace

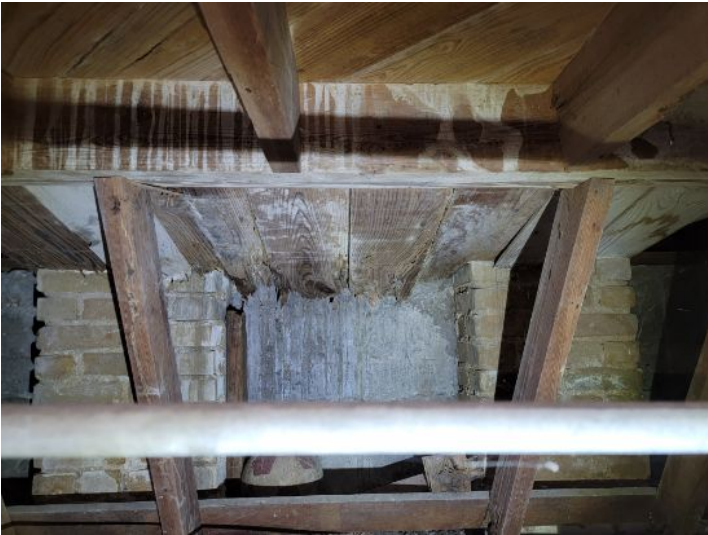
Deteriorated and fallen sub-floor

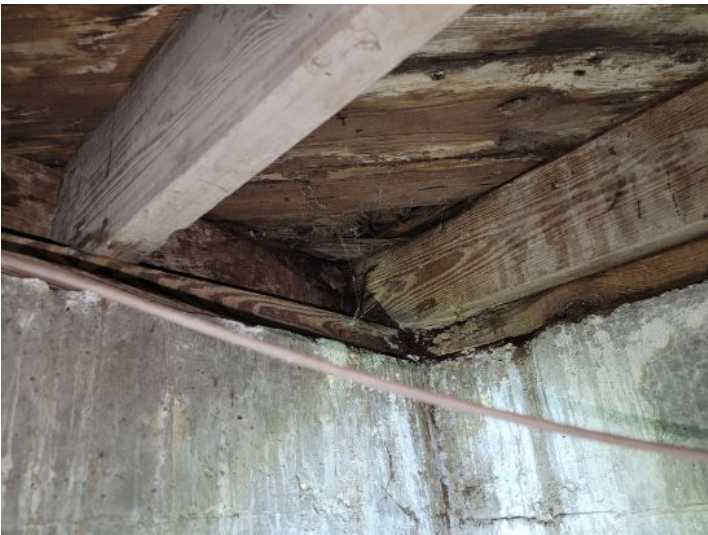
Deteriorated sub-floor members

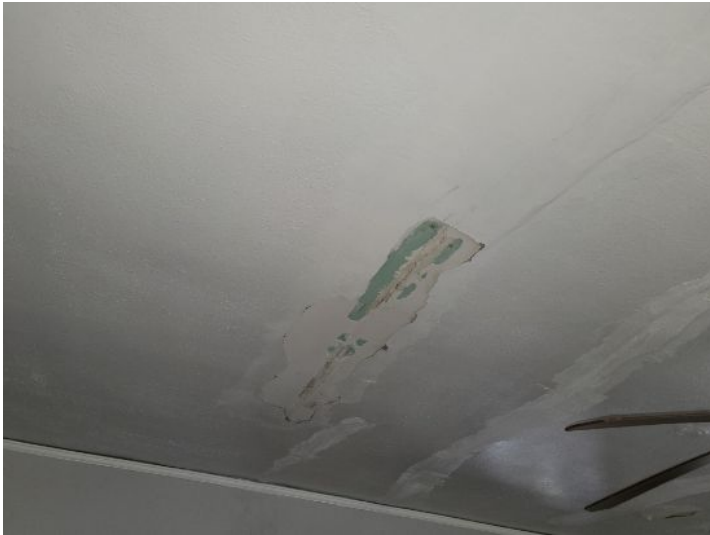
Evidence of moisture penetration

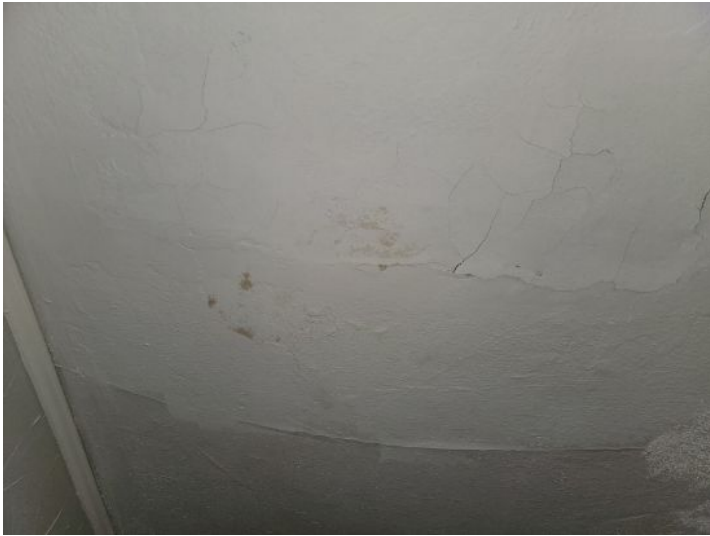
- Ceilings in various locations throughout the house were found to be sagging, caving in, loose and unlevel. Holes and damage were observed in the ceilings in various locations throughout both structures. Recommend evaluation and repair.

Sagging and damaged ceiling

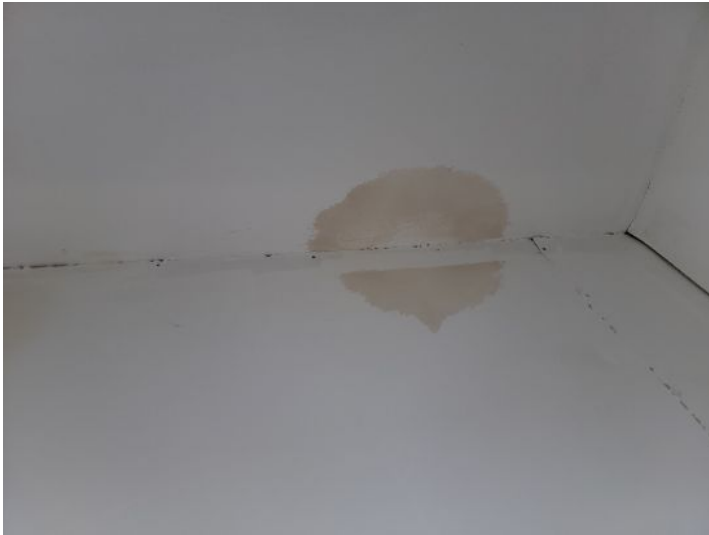
Moisture penetration
