NSPECT PROPERTY INSPECTION REPORT

701 Sparks Ave, Austin, TX 78705

Property Inspection Report prepared for: Rahim Javanmardi

Inspection Date: 9/6/2023

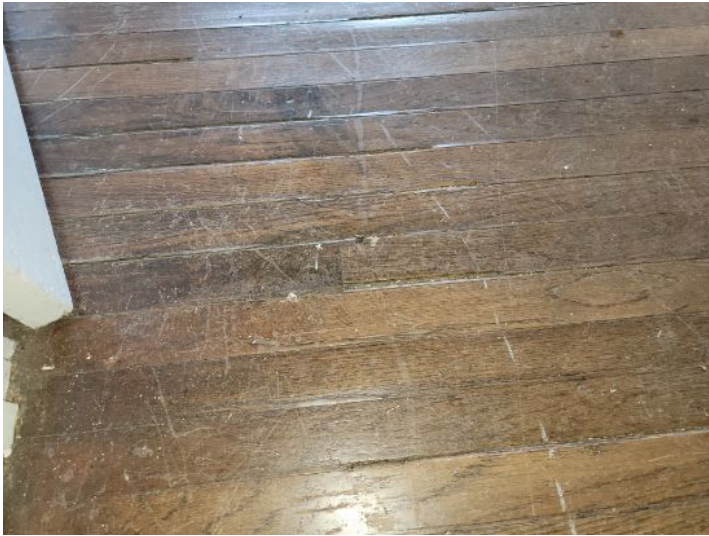
- Wood floor covering was found to be deteriorated, damaged, loose and cupping in multiple locations throughout the house. Evidence of moisture penetration was observed on the sub floor in the crawlspace. Severe deterioration of the sub-floor and floor joists were observed in the crawlspace. Floors throughout the house were found to be soft, spongy, sagging, squeaky, crowning, unlevel, sloping and uneven. Recommend further evaluation by a qualified and professionally licensed structural engineer.

Deteriorated wood floors

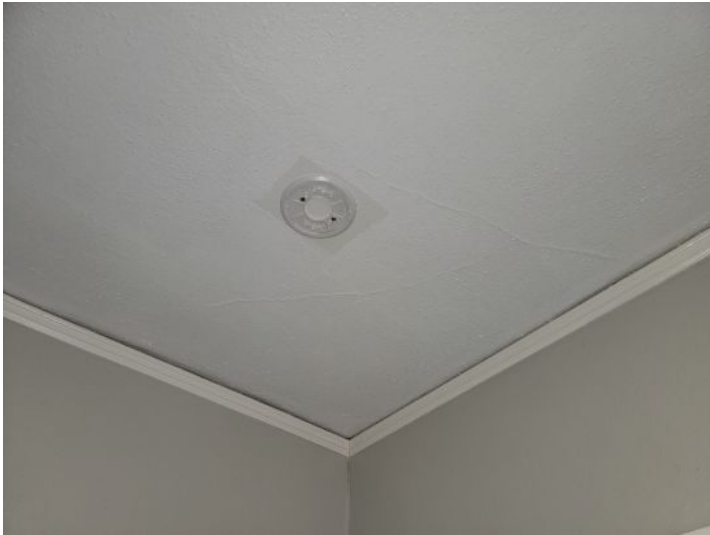
Cracking in ceiling

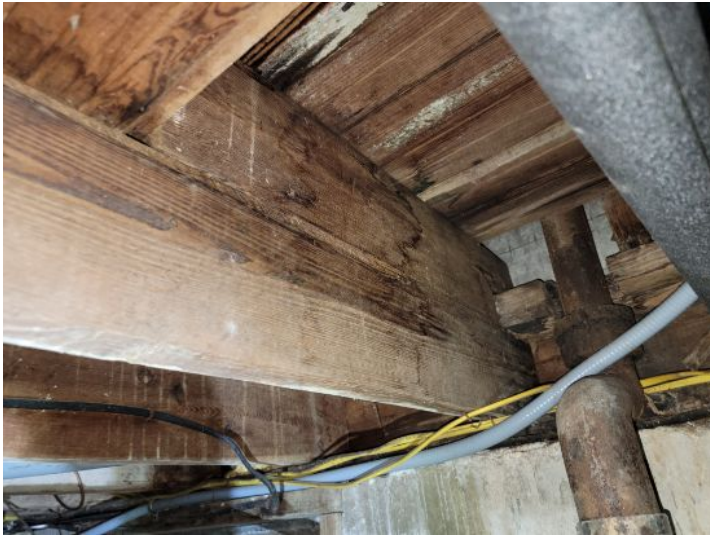
Basement: Evidence of moisture penetration and possible organic growth

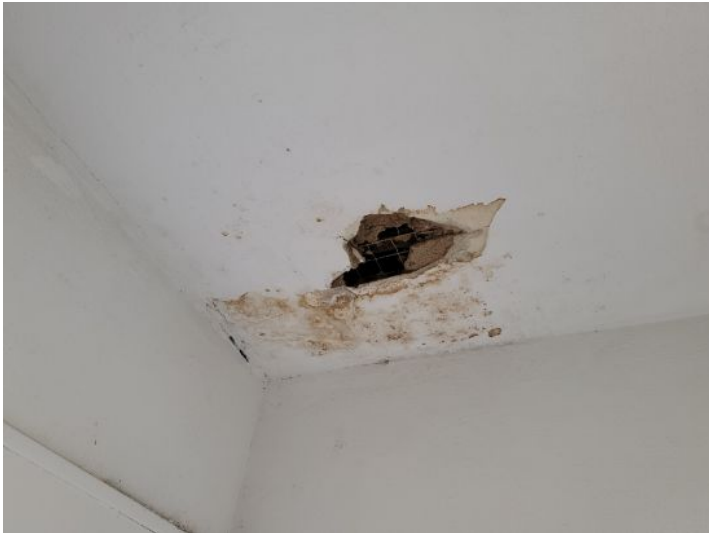
Water damaged ceiling

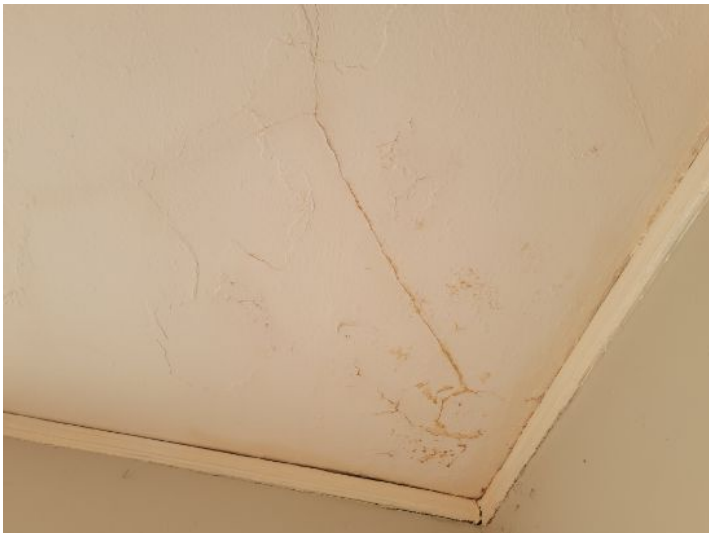
Cracking and water damaged ceiling

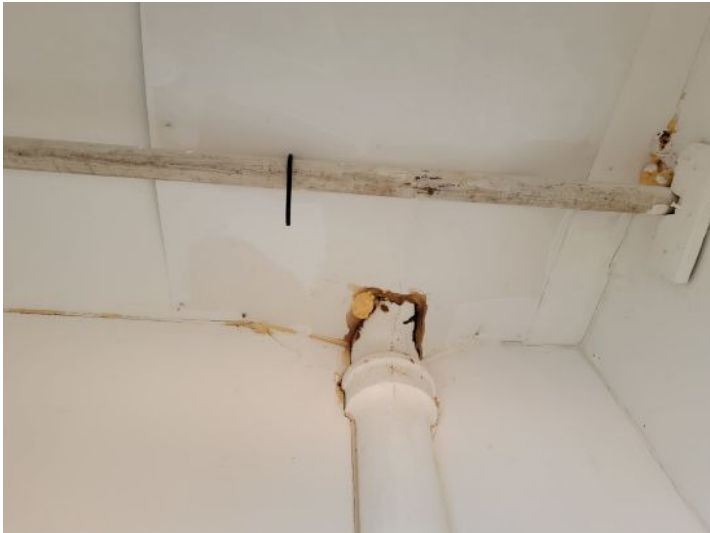
Water damaged ceiling and wall

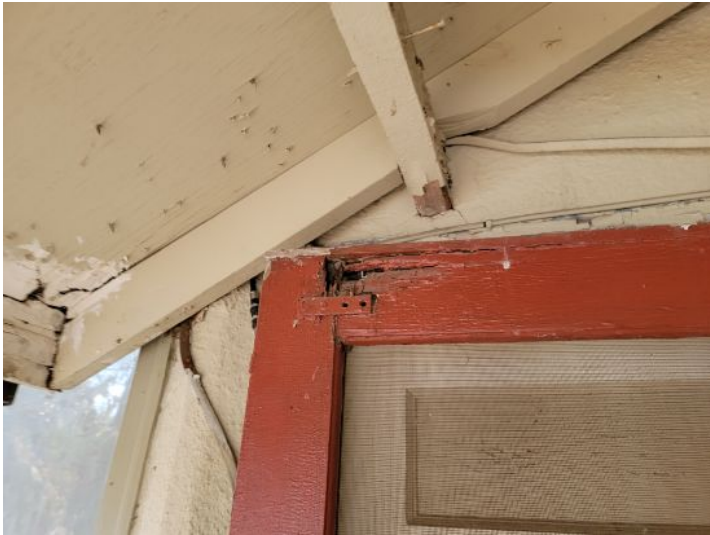
Deteriorated door

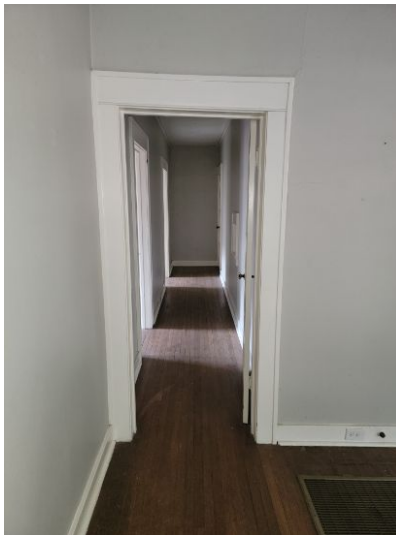
Door pass through out of square

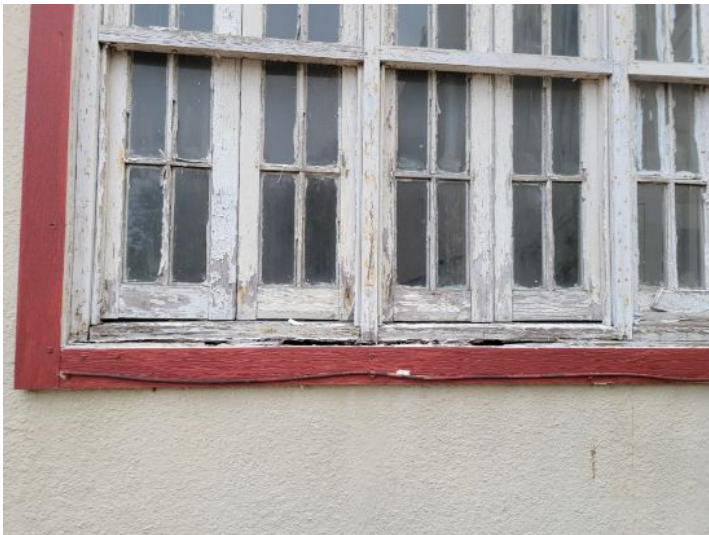
- Wooden window frames were found to be deteriorated in multiple locations throughout the house. Recommend repair or replace.
- Window panes were found to be broken on various windows. Recommend replacement of window glass.

Deteriorated window frames

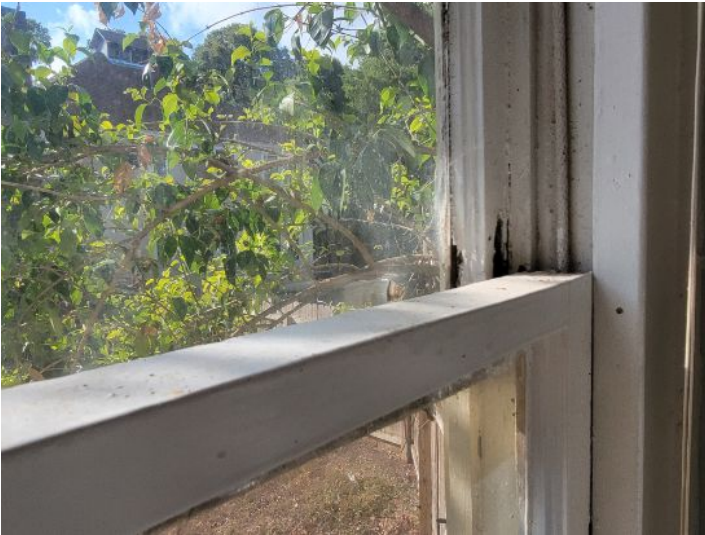
Deteriorated window frame

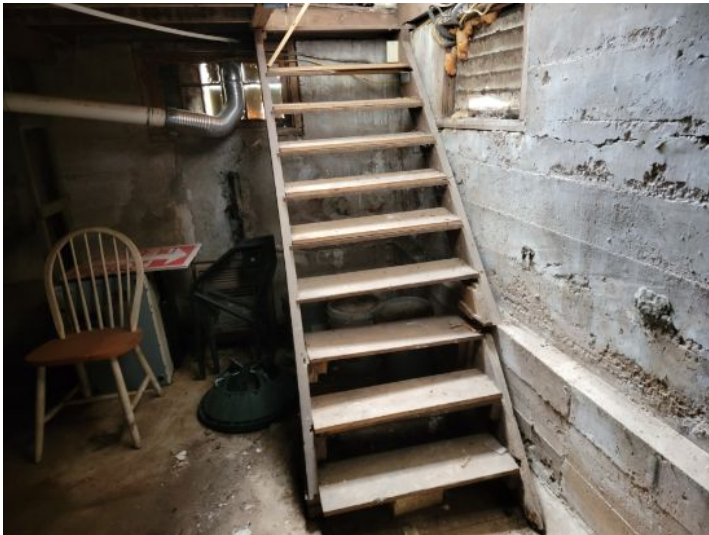
- Basement: Stair treads and/or risers were not found to meet safety requirements. This is a hazardous condition. Code Note: IRC R311.7.5 Stair Treads and Risers Stair treads and risers shall meet the requirements of this section. For the purposes of this section, dimensions and dimensioned surfaces shall be exclusive of carpets, rugs or runners. Share url icon R311.7.5.1 Risers The riser height shall be not more than 7 3/4 inches (196 mm). The riser height shall be measured vertically between leading edges of the adjacent treads. The greatest riser height within any flight of stairs shall not exceed the smallest by more than 3/8 inch (9.5 mm). Risers shall be vertical or sloped from the underside of the nosing of the tread above at an angle not more than 30 degrees (0.51 rad) from the vertical. At open risers, openings located more than 30 inches (762 mm), as measured vertically, to the floor or grade below shall not permit the passage of a 4-inch-diameter (102 mm) sphere. Exceptions: The opening between adjacent treads is not limited on spiral stairways. The riser height of spiral stairways shall be in accordance with Section R311.7.10.1. Share url icon R311.7.5.2 Treads The tread depth shall be not less than 10 inches (254 mm). The tread depth shall be measured horizontally between the vertical planes of the foremost projection of adjacent treads and at a right angle to the tread's leading edge. The greatest tread depth within any flight of stairs shall not exceed the smallest by more than 3/8 inch (9.5 mm). Recommend repair.

Non code compliant stairs

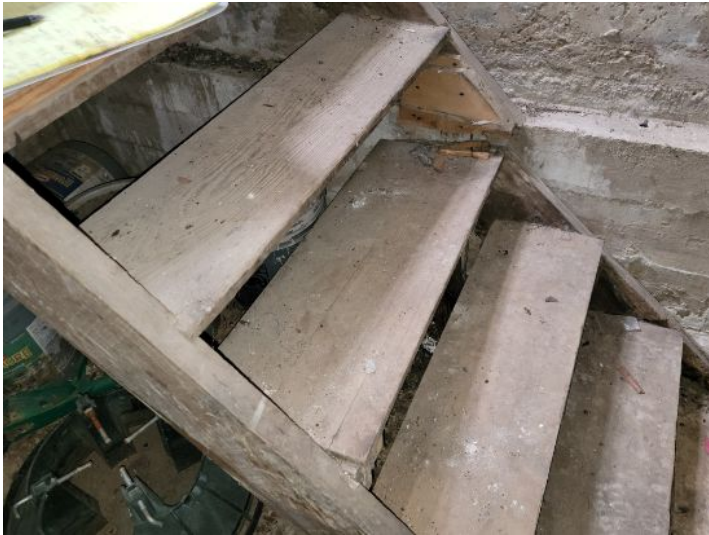
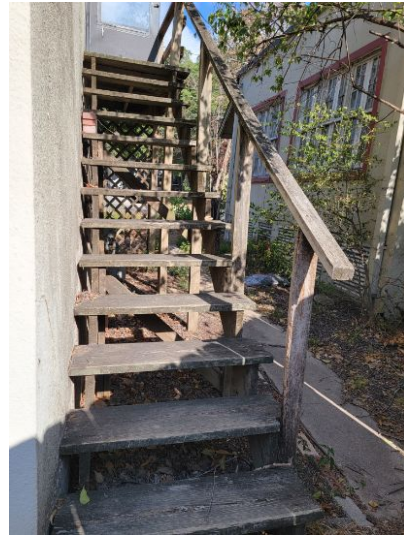
- The stairway servicing the basement was found to be damaged and was unsafe to walk on. Recommend repair or replace.

Damaged steps

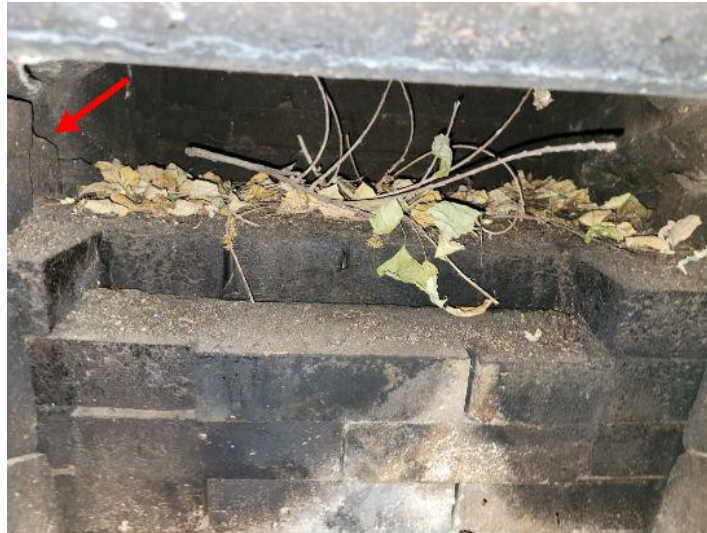
- Damper was found to be missing. Recommend installation of damper.
- Chimney was found to lack a weather cap to keep rain out. Recommend installation of weather cap.
- Firebox and chimney chase were found to be littered with debris. Recommend cleaning of firebox and flue by a qualified and licensed chimney sweep technician.
- The firebox and chimney flue were found to lack a damper control. Recommend evaluation and repair by a qualified and licensed chimney sweep technician.
- Cracking was observed in the firebox. This is a hazardous condition. Recommend further evaluation by a qualified and licensed chimney sweep technician and repair or replace.

Cracking and debris in firebox/flue

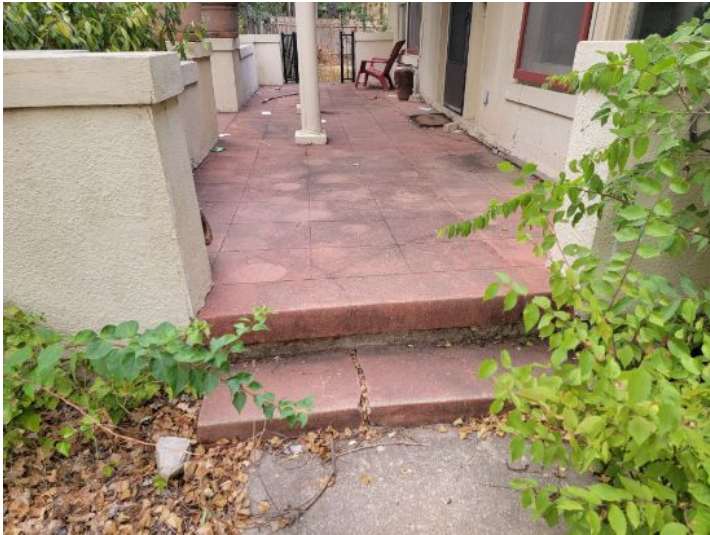
- Severe cracking and settling creating trip hazards were observed in the patio and porch floors. Recommend evaluation and repair by a qualified and professional concrete flat work contractor.

Cracking in front porch floor

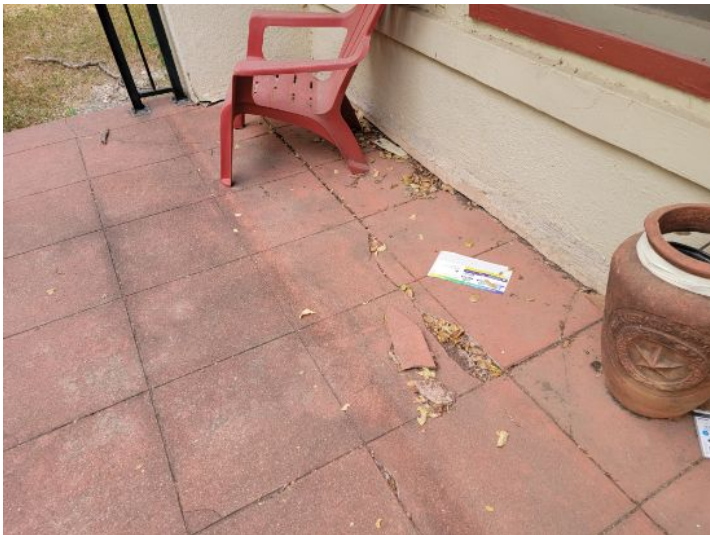
Cracking in front porch floor

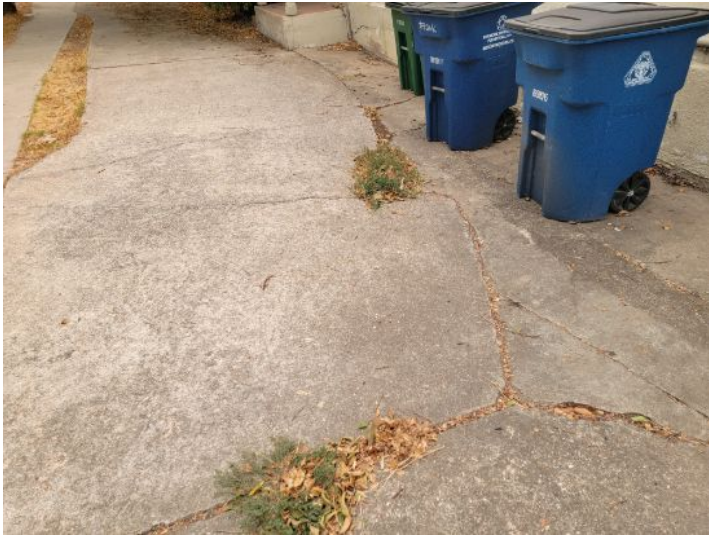
Trip hazards in driveway

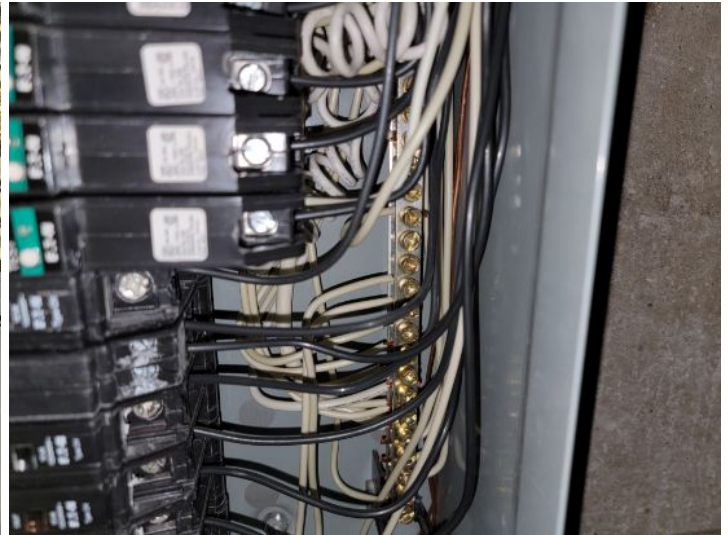
Double tapping of neutrals

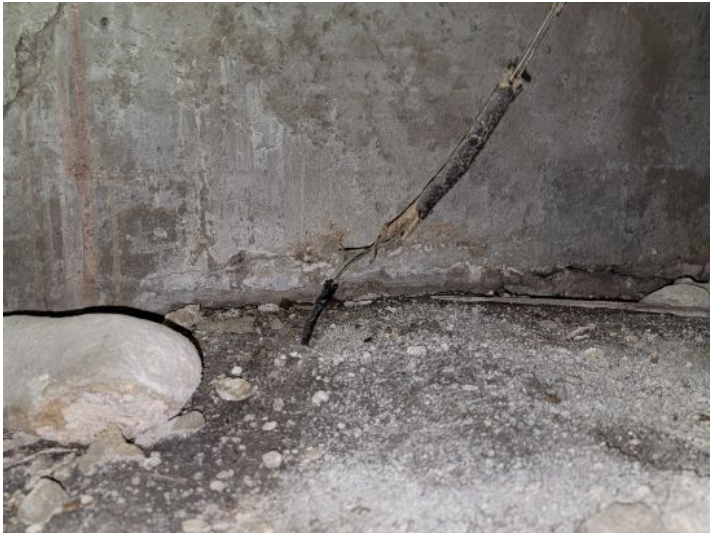
- Electrical service to both structures was turned off and the electrical systems were not inspected.
- Damaged and exposed wiring was observed in the crawlspace. This is a hazardous condition. Recommend evaluation and repair by a qualified and licensed electrician.

Damaged and exposed wiring

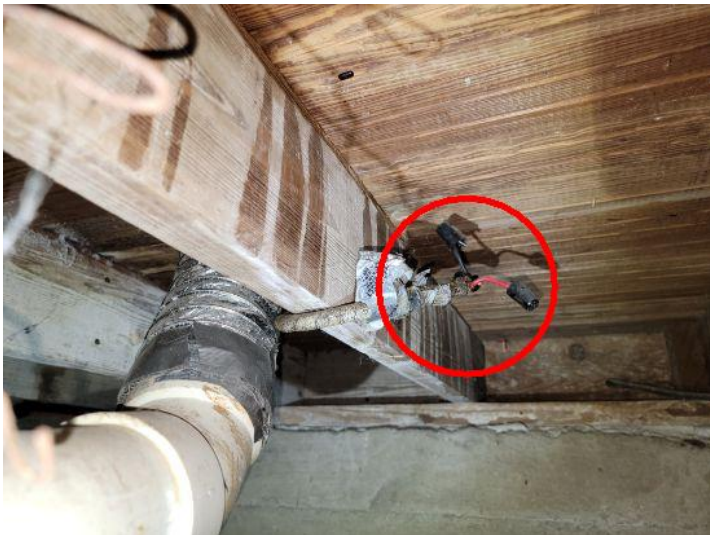
- Junction box located in 701 Sparks laundry room was found to lack a cover. Recommend installation of junction box cover.
- Improperly terminated and abandoned wiring was observed in the basement. Recommend evaluation and repair by a qualified and licensed electrician.

Improperly terminated wiring

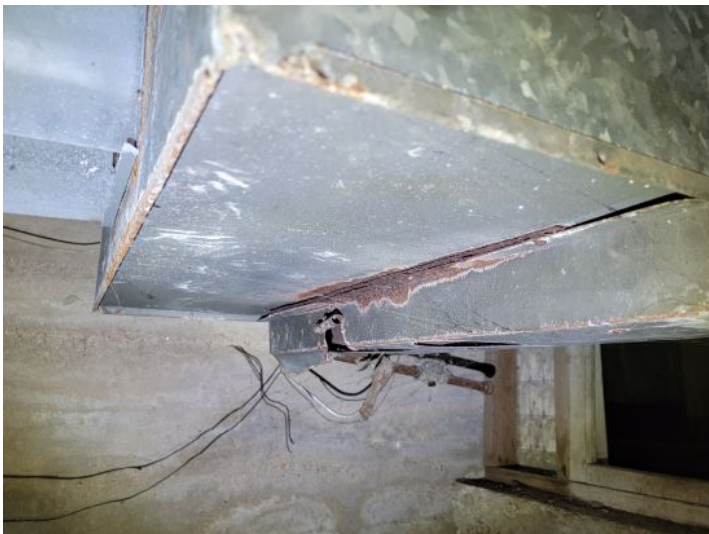
- Heating equipment was not inspected due to lack of electrical service and gas service to the house.
- Gas furnaces located in the crawlspace were found to be severely rusted. Recommend repair or replace.
- Sediment trap was found to be missing from gas line. A sediment trap which is sometimes called a drip leg (although technically different) is a capped off section of gas line which is installed in such a way that any debris or moisture in the gas line will be caught in the trap where it can be cleaned out easily. The reason for this is to ensure safe operation of an appliance by keeping debris out of the tiny orifices of the gas valves. Recommend installation of sediment trap.
- The combustion flue vent pipe was found to lack proper clearance from combustable materials. Recommend proper installation of vent.

Rusted gas furnace

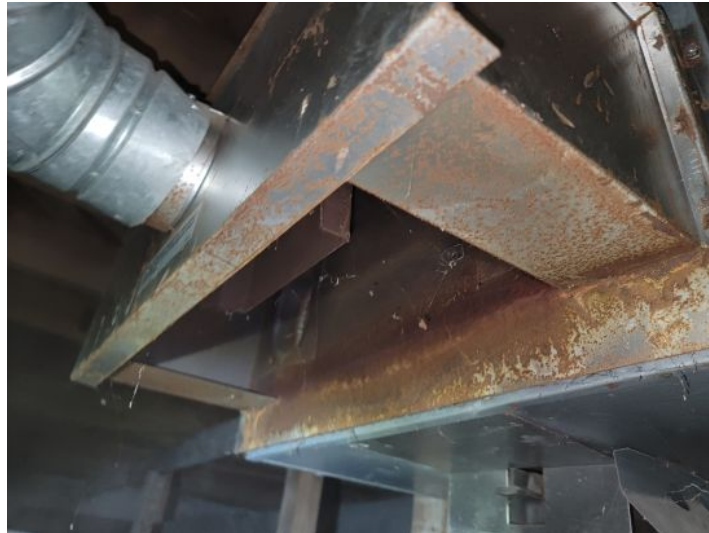
Rusted heater

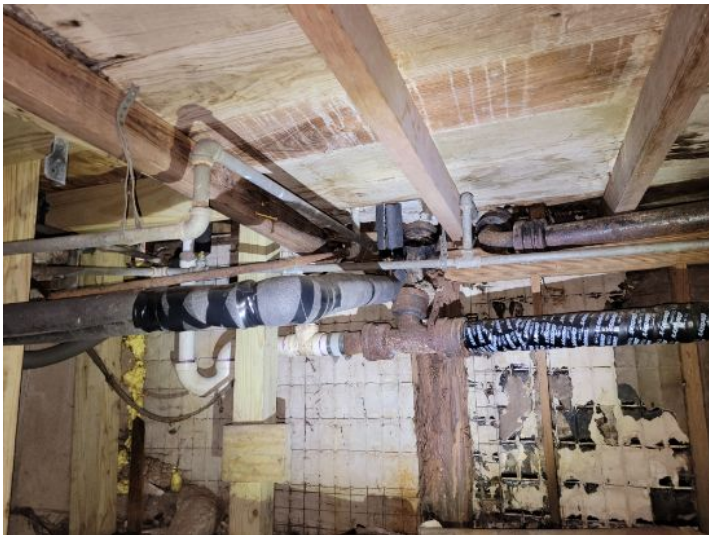
Uninsulated water piping

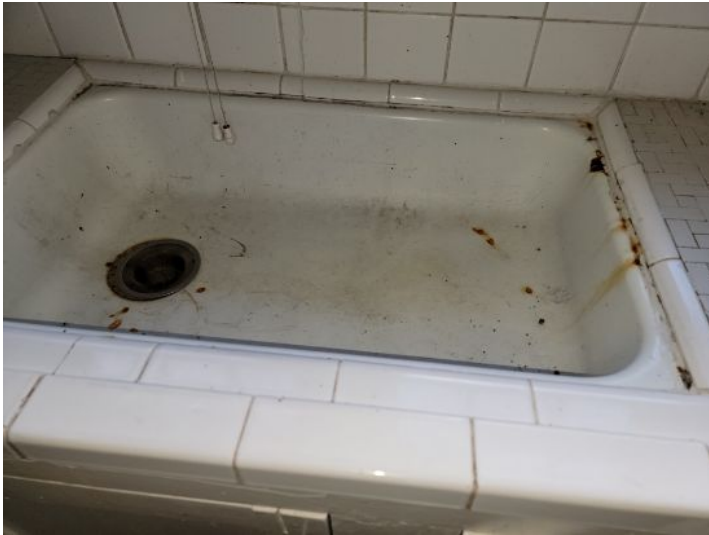
Rusted sink

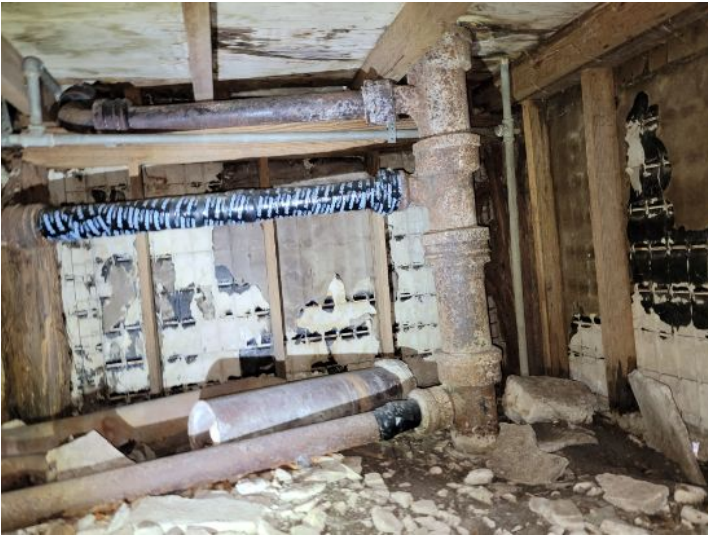
Corroded and rusted cast iron drain piping

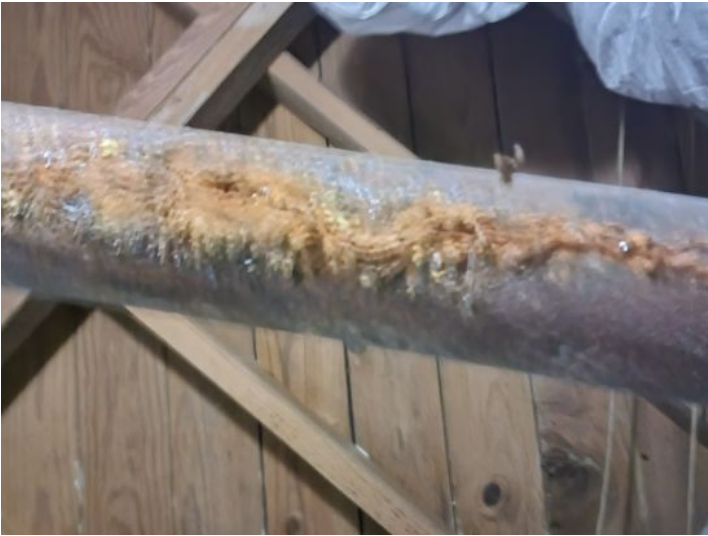
Corroded and rusted cast iron drain piping

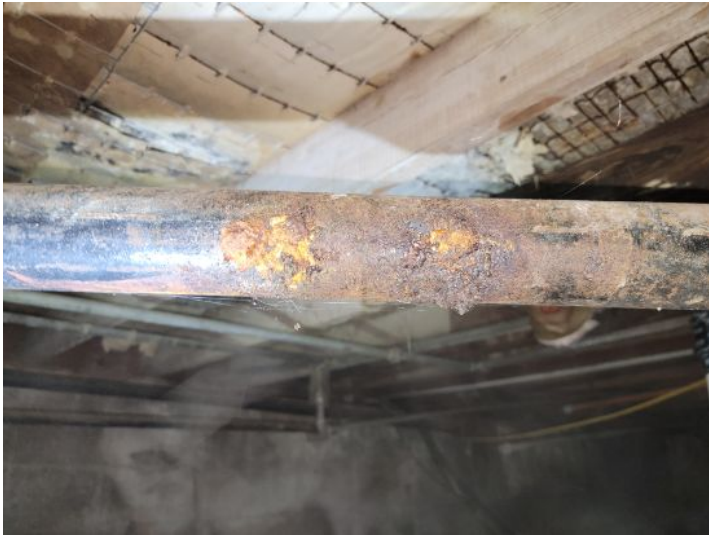
Rusted and corroded cast iron drain piping

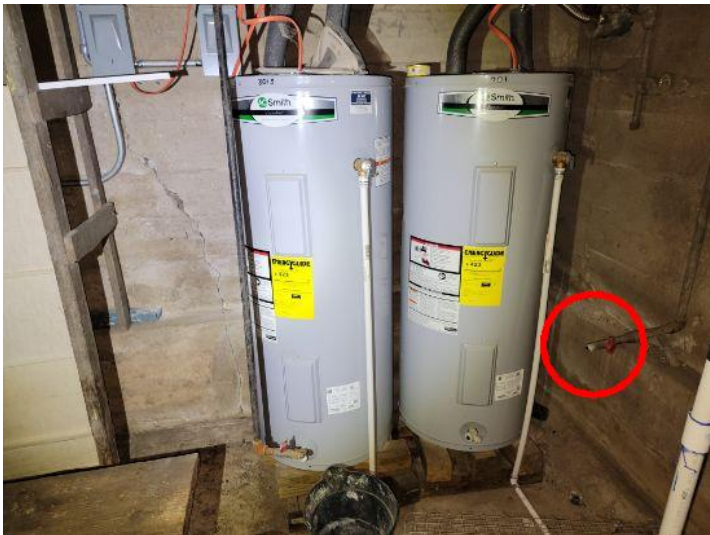
Water heaters and uncapped gas line

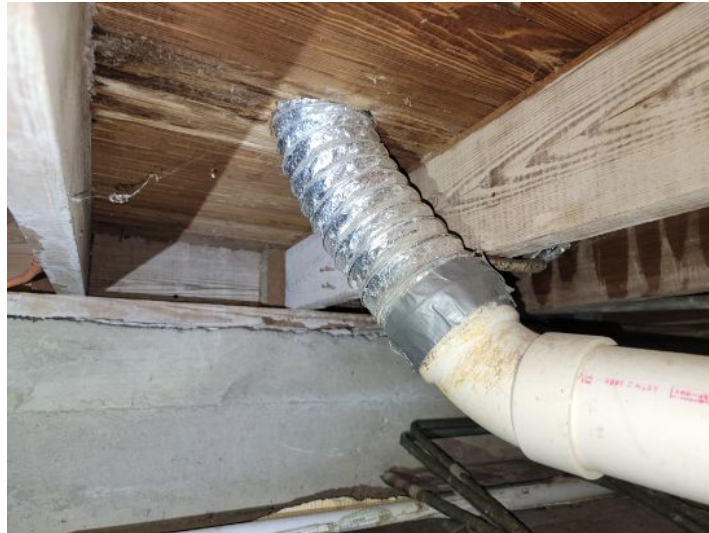
Improper dryer exhaust duct
