1611 WETHERSFIELD

**1611 WETHERSFIELD, AUSTIN TEXAS 78703**  
**NEW CONSTRUCTION / ADDITION SUBMITTAL**

# AUSTIN PROPERTY INSPECTIONS, PLLC

1611 Wethersfield Rd  
Austin, TX 78703

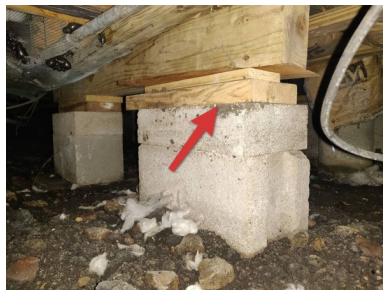
Cinder block pier and wood shims.

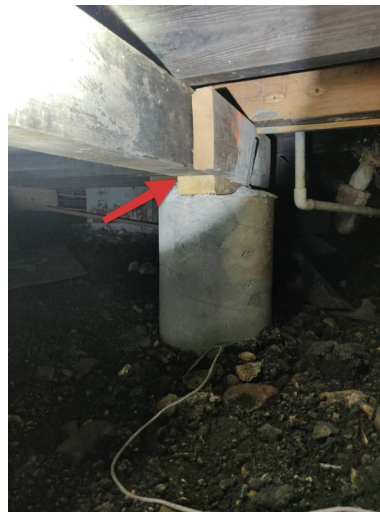
Concrete pier and wood shims.

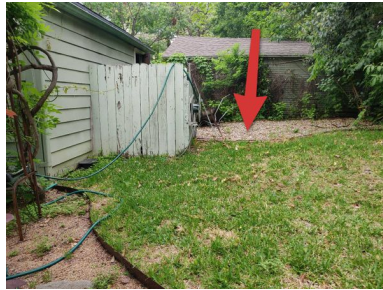
- The grading at the back of the home slopes toward the foundation; recommend monitoring the drainage at this area and improving as needed.

Back.

- Recommend maintaining at least four inches of clearance between the ground level and the siding.
- Recommend maintaining proper drainage away from the base of the foundation.

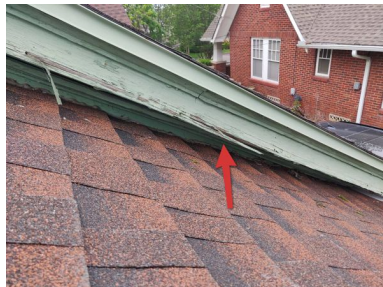
- The back fascia is damaged.

Back - fascia.

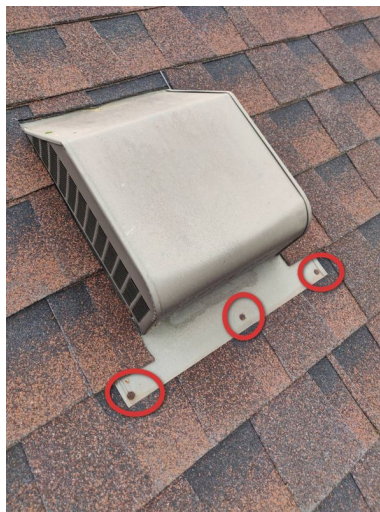
- Several roofing fasteners are exposed and rusted. Recommend sealing the exposed fasteners on the roof at the ridge row shingle and at the roof penetration flashings.

Left side - exposed fasteners.

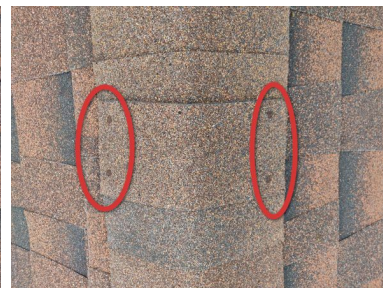
Back, ridge - exposed fasteners.

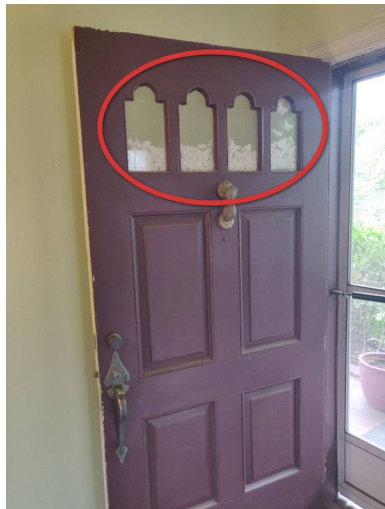
- Marked safety glass missing at the front door.
- Unable to close the back bedroom door. The door hits the frame.
- Unable to operate the back porch door. It is painted shut.
- The right side bathroom door rubs on the floor.
- Due to be presence of belongings, not all the doors were accesible for inspection.

Front door.

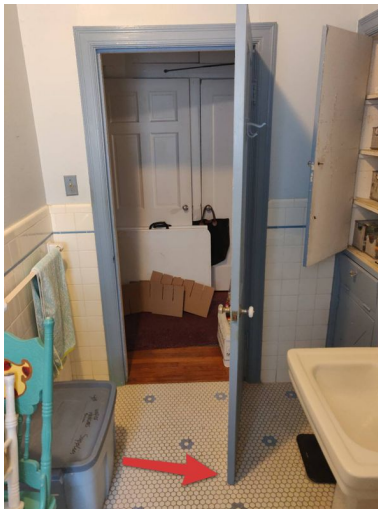
Right bathroom door.

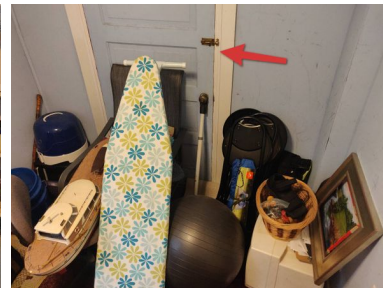
Laundry room - inaccessible.

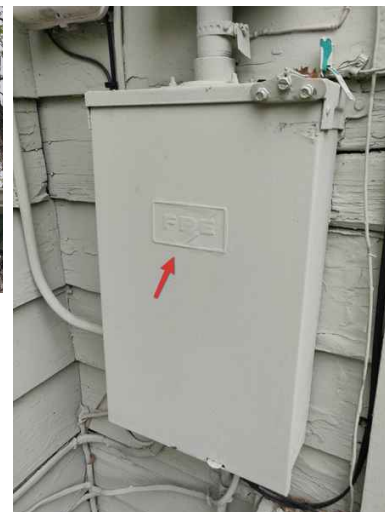
- FPE panel observed.

Main electrical panel - Federal Pacific Electric (FPE).

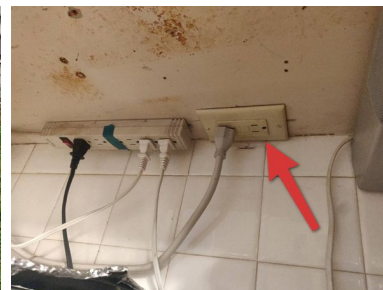
Kitchen - not GFCI protected.

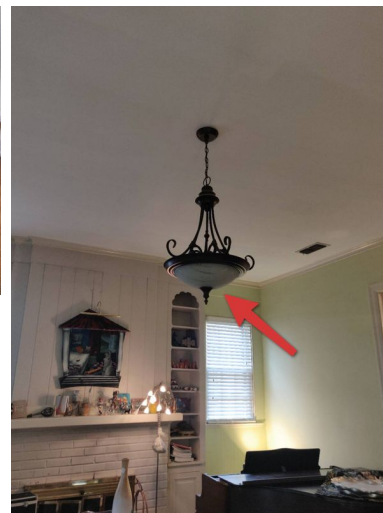
Living room - inoperable.

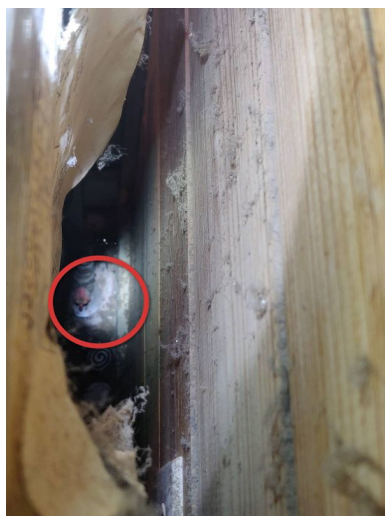
- The gas valve handle should be accessible without moving the unit.

Range gas shut-off valve.
