Appendix

UMLAUF HPEU PLAN

EXISTING CONDITIONS ASSESSMENT

Existing Conditions
Accessibility Assessment

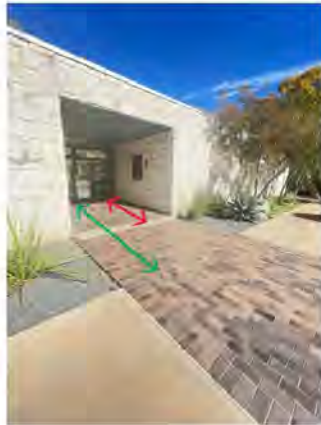
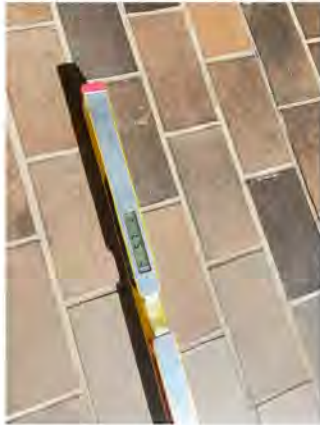
LOCATION: Entrance

FINDING: There is a portion of the pavers (red) that has a running slope exceeding 5% and therefore would need to meet ramp requirements of flat landings and handrails. However, if regraded (green) the running slope would be reduced to less than 5% and handrails and level landings are not required.

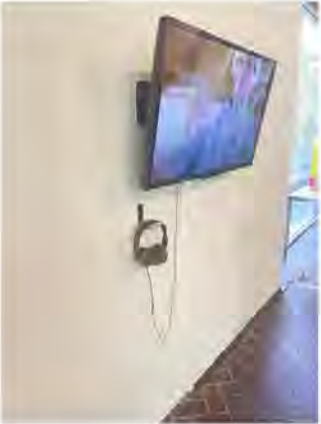
LOCATION: TV in the Gallery

FINDING: The wall mounted television protrudes off the wall more than 4". A slimmer TV or cane detection underneath shall be provided.

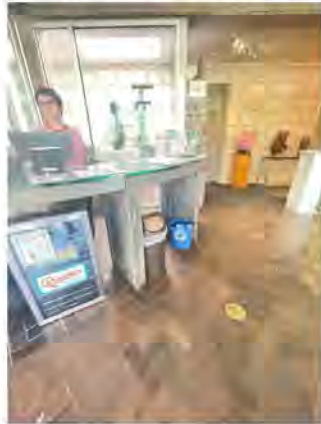
LOCATION: Information and Transaction counter

FINDING: The counter is too high and shall provide a lower accessible counter at 36" maximum height.

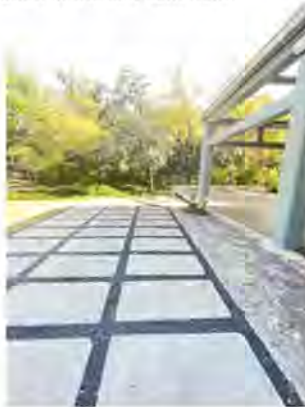
LOCATION: Checkered paver area

FINDING: The large paver and black gravel creates uneven surfaces. The area does not have to be accessible as long as a duplicate item is provided in an accessible area nearby. For example, if there are tables and chairs here, ensure accessible tables and chairs are provided nearby. If the bar is here, there shall be another accessible bar, etc. See Title II information in the last comment.

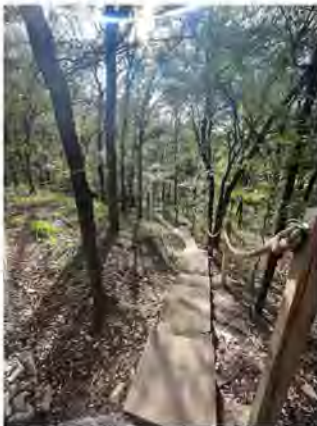
LOCATION: From the Gardens to the Umlauf House

FINDING: Currently the only pedestrian path from the gardens is via small stone steps. If a garden accessible route is not achievable, accessible parking shall be provided at the residence for guests to use as the vehicular exception.

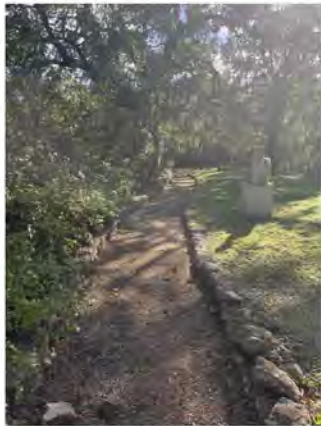
LOCATION: Sculpture Park
FINDING: The paths to the sculpture park are generally accessible. When a compliant ground surface is provided, the path shall be regraded to meet compliance.

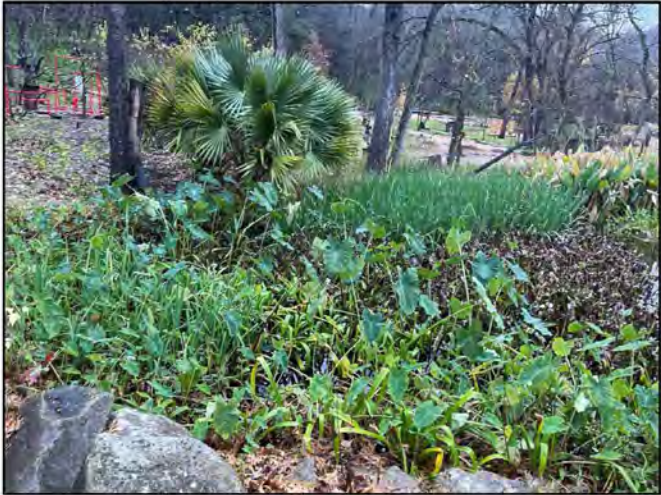
PHOTO 1
A man-made ornamental pond (P-1) was located on the western portion of the subject site

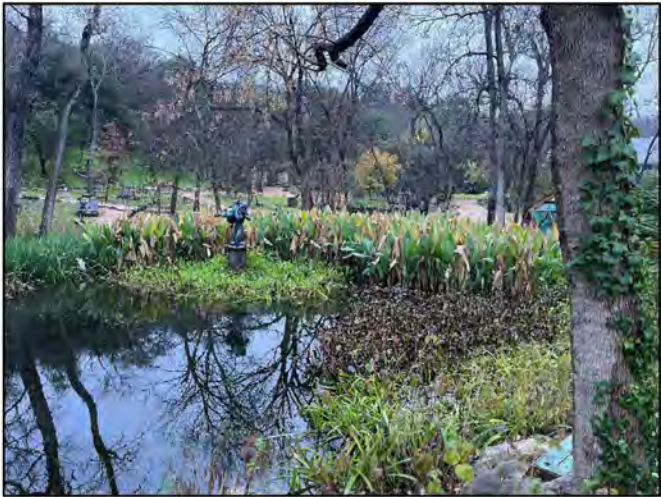
PHOTO 3
A man-made ornamental pond (P-1) was located on the western portion of the subject site

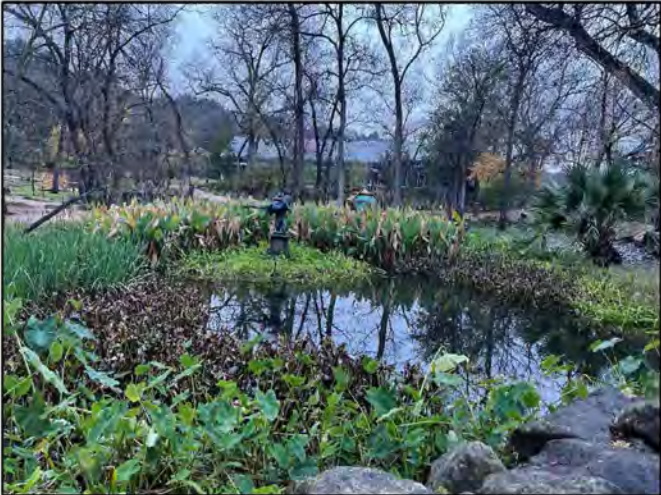
PHOTO 2
A man-made ornamental pond (P-1) was located on the western portion of the subject site

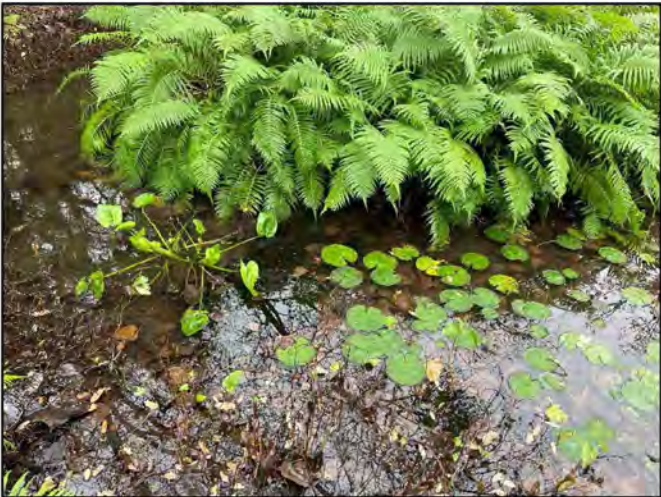
PHOTO 4
A man-made ornamental pond (P-2) was located on the central portion of the subject site

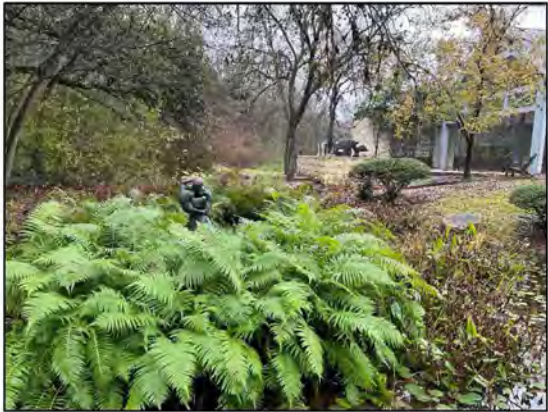
PHOTO 5
A man-made ornamental pond (P-2) was located on the central portion of the subject site

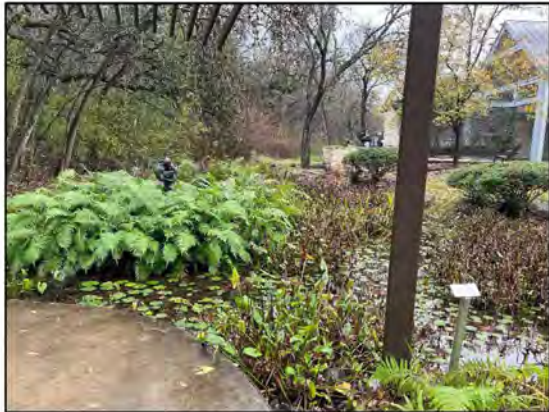
PHOTO 6
A man-made ornamental pond (P-2) was located on the central portion of the subject site

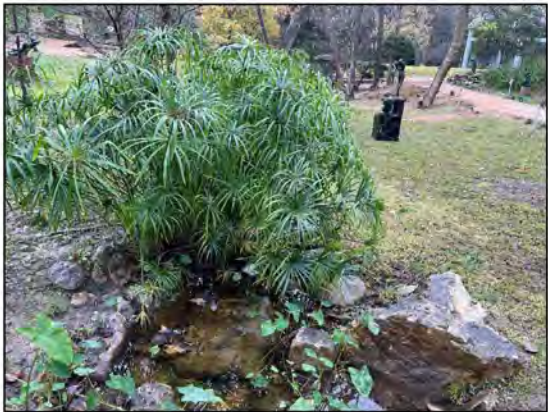
PHOTO 7
A man-made ornamental channel (T-1) was located across the subject site

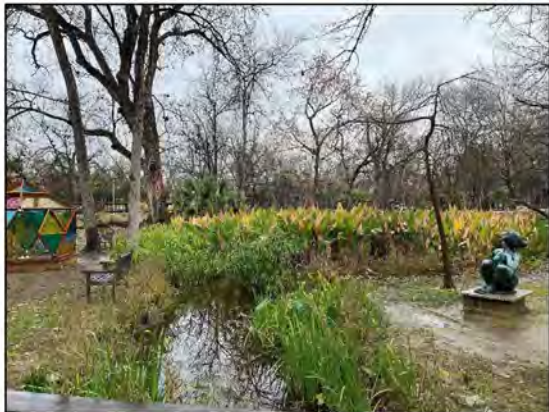
PHOTO 8
A man-made ornamental channel (T-1) was located across the subject site

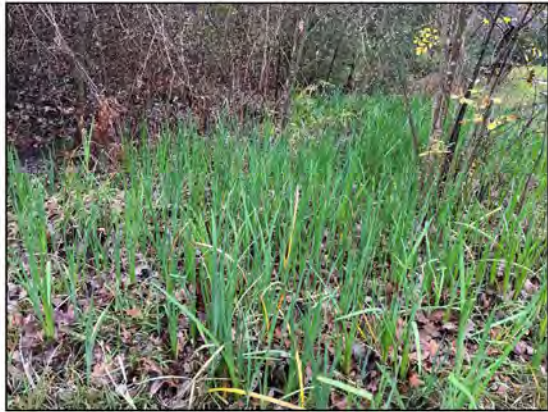
PHOTO 9
A man-made ornamental channel (T-1) was located across the subject site

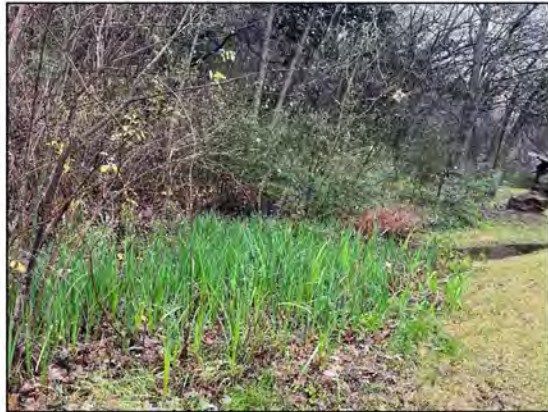
PHOTO 10
A man-made ornamental channel (T-1) was located across the subject site
